Mount Thorley Warkworth

2019 Annual Review

Mount Thorley Warkworth (MTW) is an integrated operation of two open cut coal mines, Warkworth Mining Limited (WML) and Mount Thorley Operations (MTO). This Annual Review reports on the environmental performance of MTW for the period 1 January 2019 to 31 December 2019.

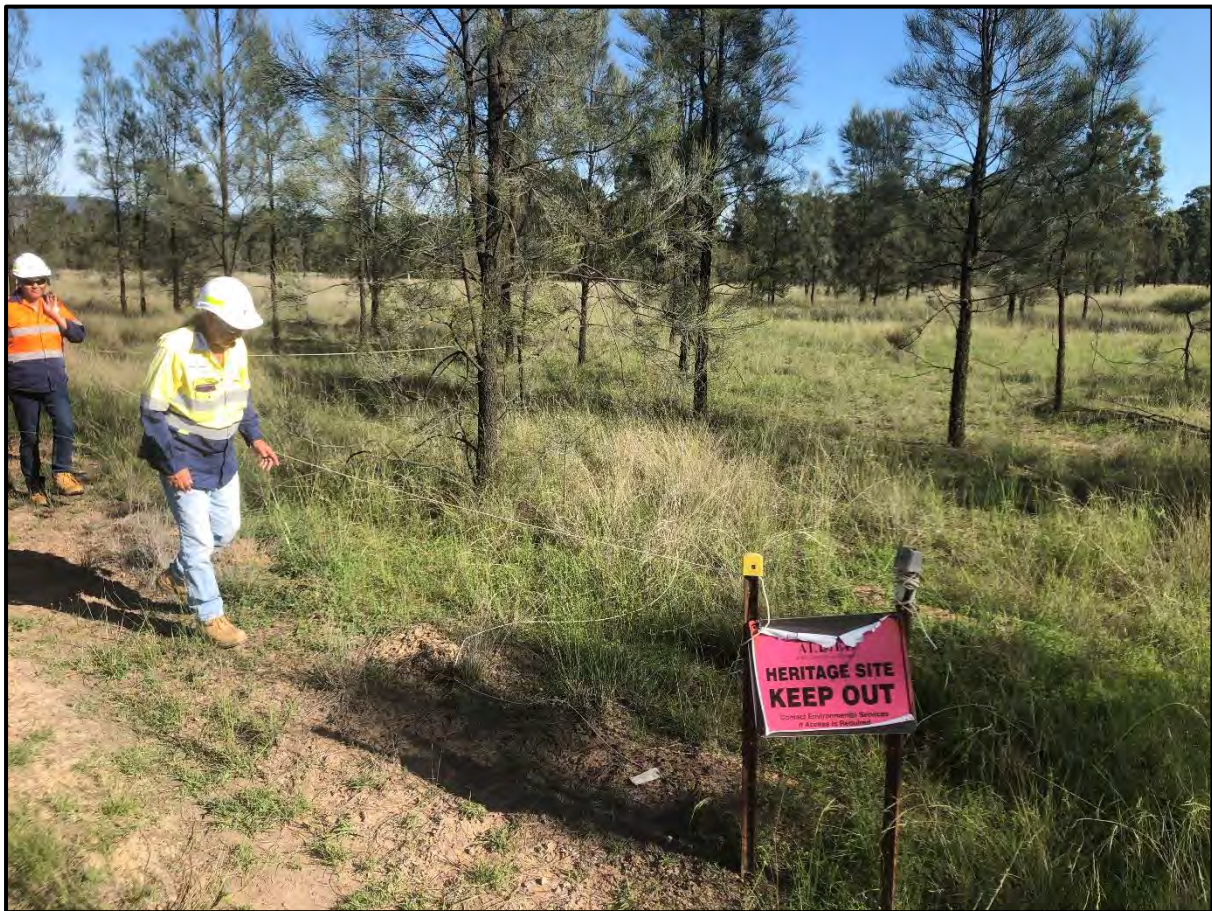
The majority of ACH sites inspected had barricading installed that had deteriorated and required mending or reinstalling. It is recommended that barricading, fencing and signage at these sites be re-installed/repared to prevent inadvertent disturbance.

Example of dilapidated barricading

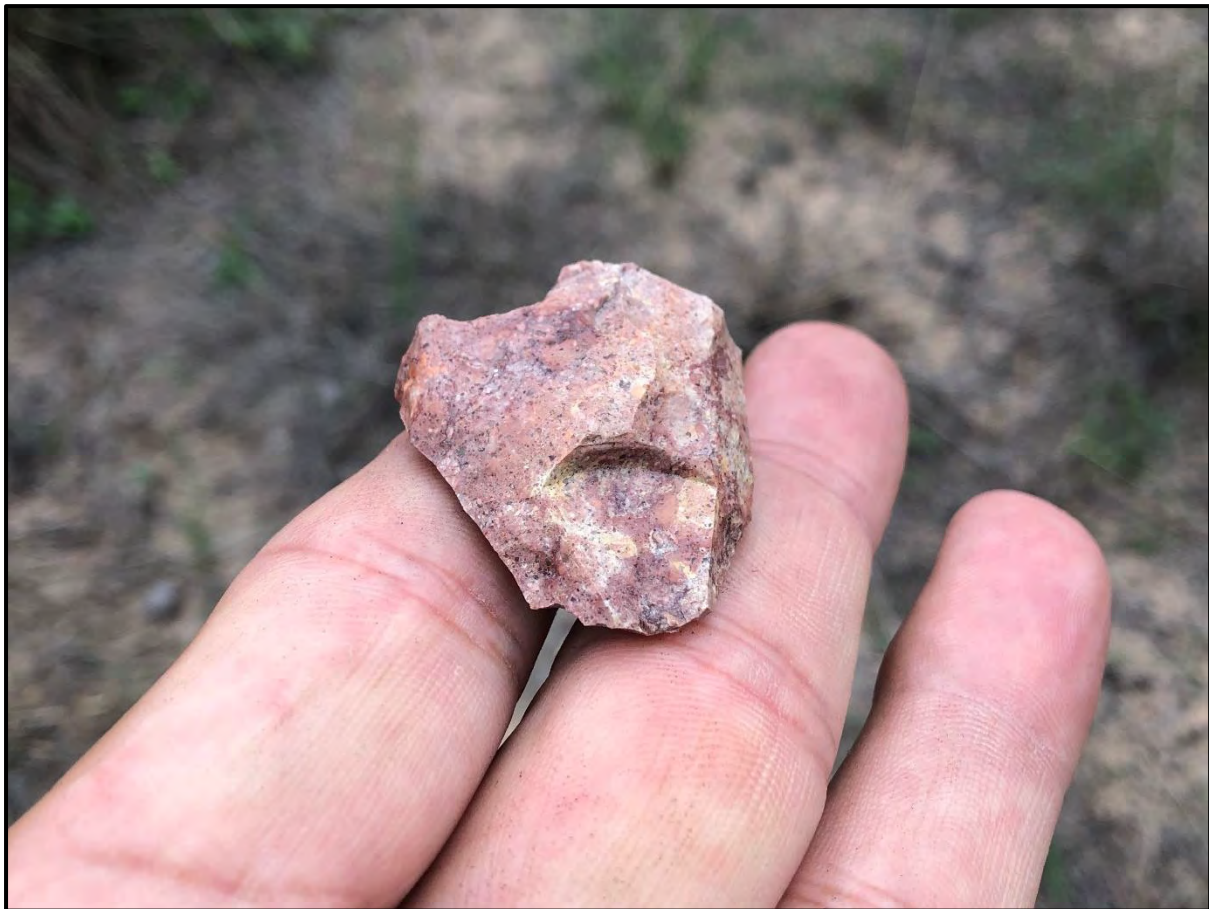
Limited information is on file regarding ACH site WB3, which was recorded off Charlton Rd several decades ago when GIS/GPS equipment was less advanced and accurate than today. Previous inspections have failed to relocate the site, however, during the current compliance inspection a silcrete flaked piece was identified near to the registered co-ordinates (317593e 6385352n). It is recommended that the site record be relocated to these co-ordinates within the MTW GIS system.

Silcrete flaked piece from WB3

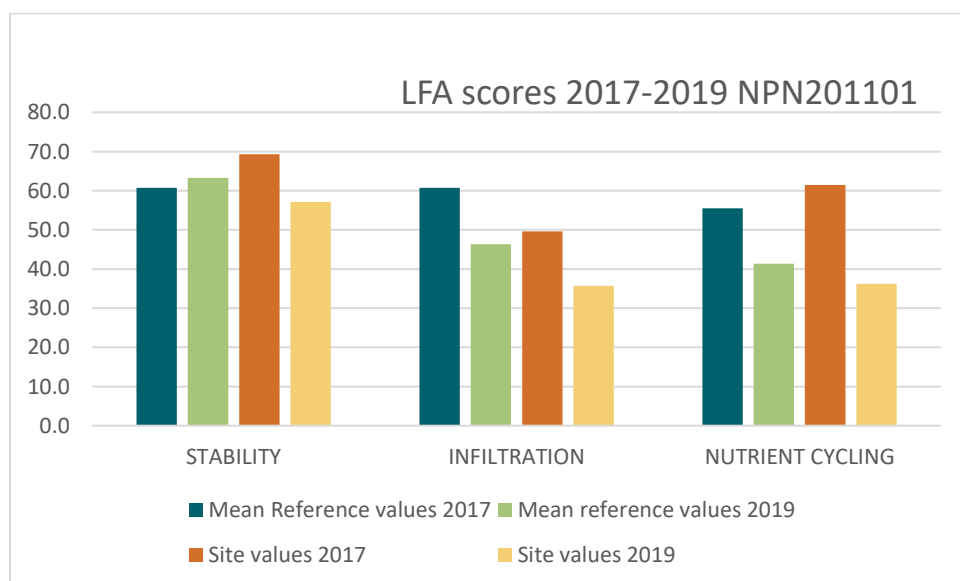
In order to avert a decline at this site the causes of the decline in LFA indices should be addressed. Stability would be increased by the addition of coarse litter which would have
