Mount Thorley Warkworth  
Community Consultative Committee

**Business Papers – February 2017**

Materials ahead of meeting of the committee on 13 February 2017

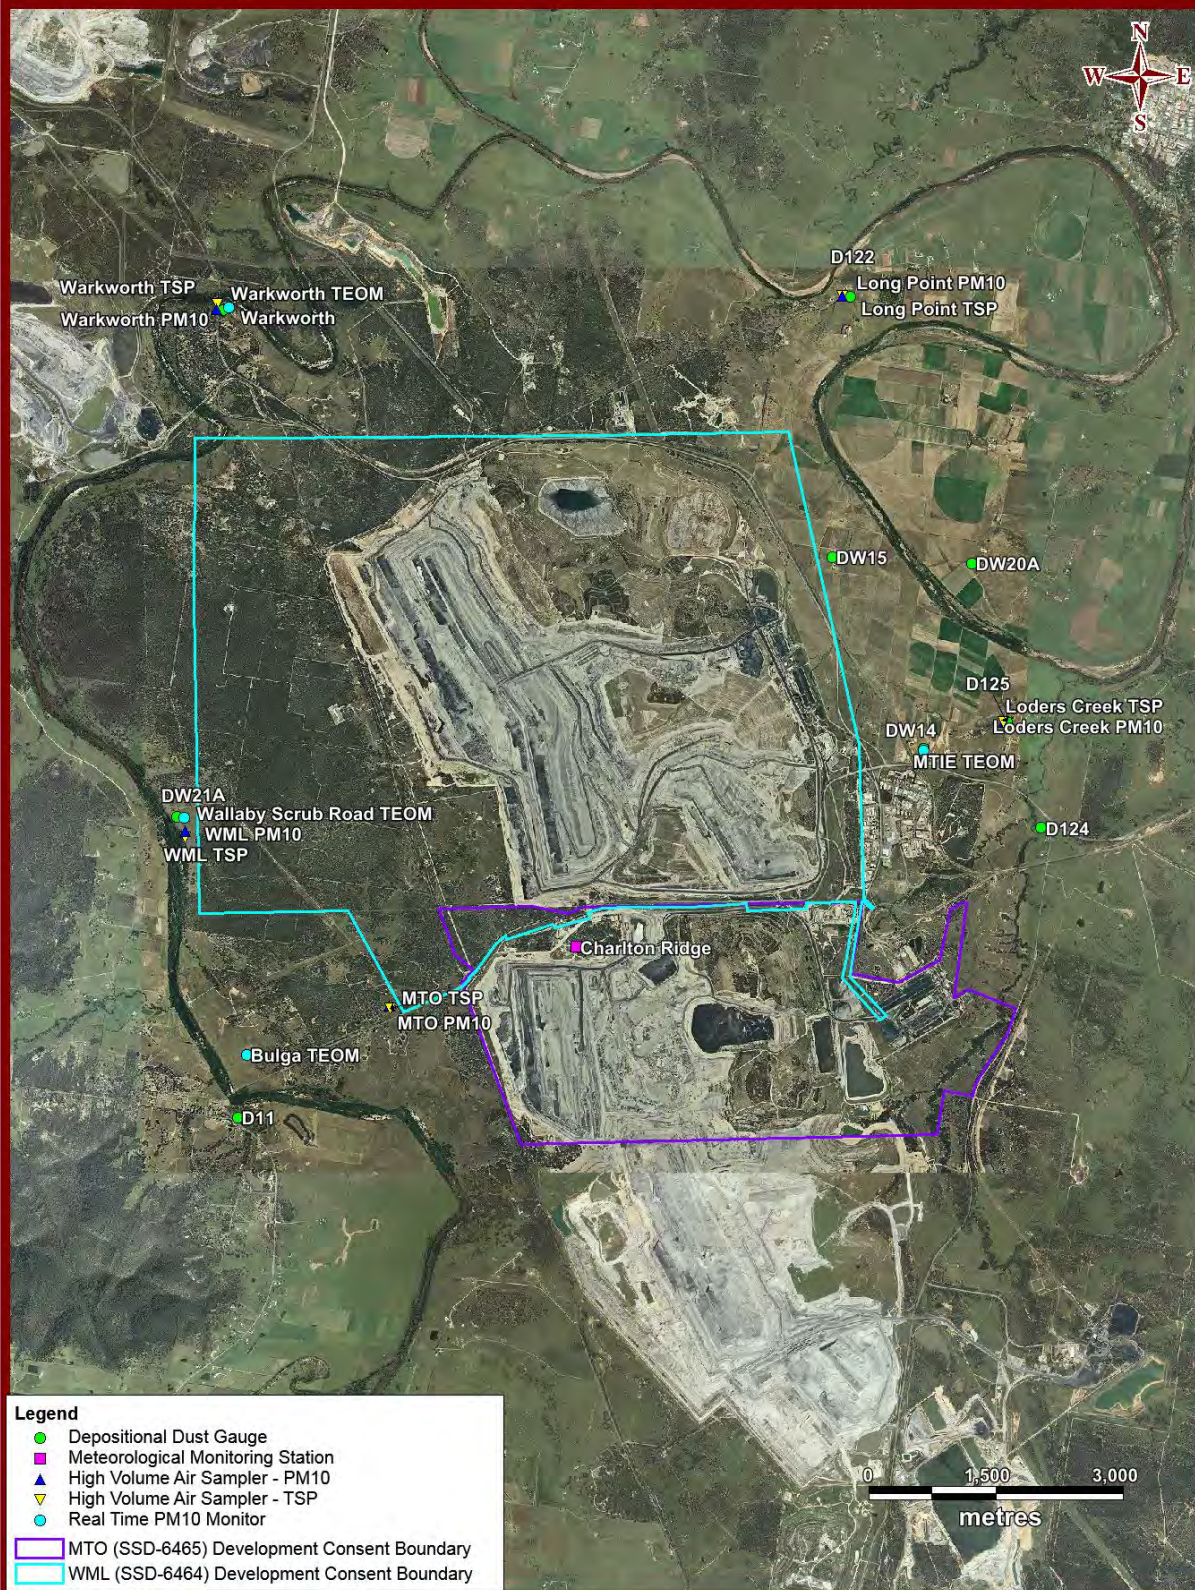
**Figure 3: Air Quality Monitoring Locations**

Suspended particulates are measured by a network of High Volume Air Samplers (HVAS) measuring Total Suspended Particulates (TSP) and Particulate Matter <10µm (PM<sub>10</sub>). The location of these monitors can be found in Figure 3. Each HVAS was run for 24 hours on a six-day cycle in accordance with EPA requirements.

Meteorological data is collected at MTW’s ‘Charlton Ridge’ meteorological station (refer to Figure 3: Air Quality Monitoring Locations).

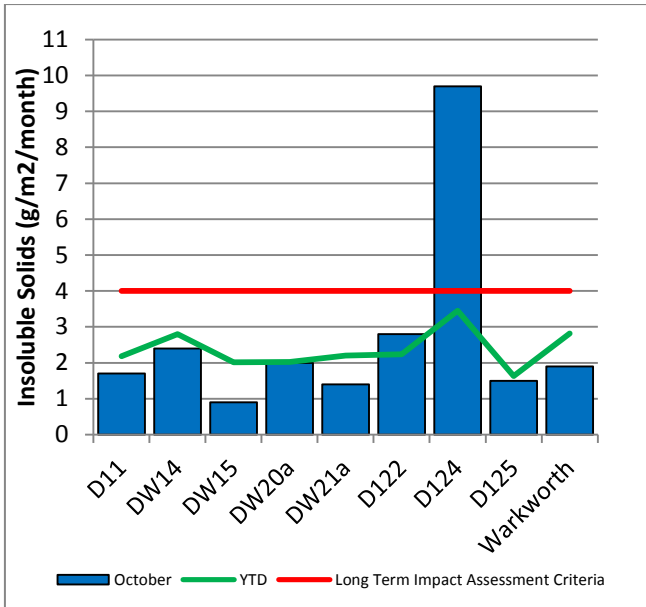
Figure 4: Depositional Dust – October 2016

Figure 4 displays Insoluble solids results from depositional dust gauges during the reporting period compared against the year-to-date average and the annual impact assessment criteria.

During the reporting period the D124 monitor recorded a monthly result above the long term impact assessment criteria of 4.0 g/m² per month. Field notes associated with D124 confirm the presence of insects and bird droppings. As such the result is considered contaminated and will be excluded from calculation of the annual average.

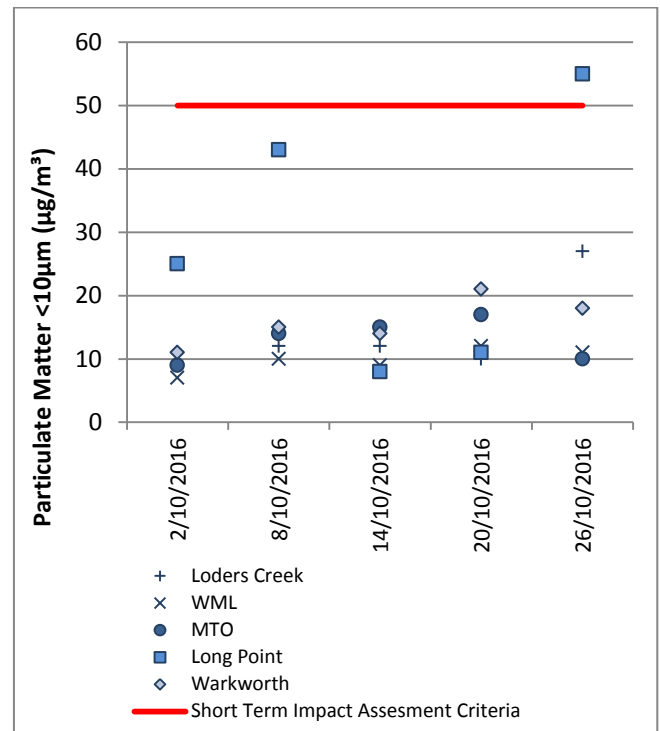
**Figure 5: Individual PM<sub>10</sub> Results – October 2016**

Figure 5 shows the individual PM<sub>10</sub> results at each monitoring station against the short term impact assessment criteria of 50µg/m<sup>3</sup>.

On 26/10/2016 one HVAS PM<sub>10</sub> unit recorded a result greater than the short term (24hr) PM<sub>10</sub> impact assessment criteria; Long Point (55 µg/m<sup>3</sup>). At the time of preparation of this report, the result is under investigation. Preliminary advice has been provided to the Department of Planning & Environment.

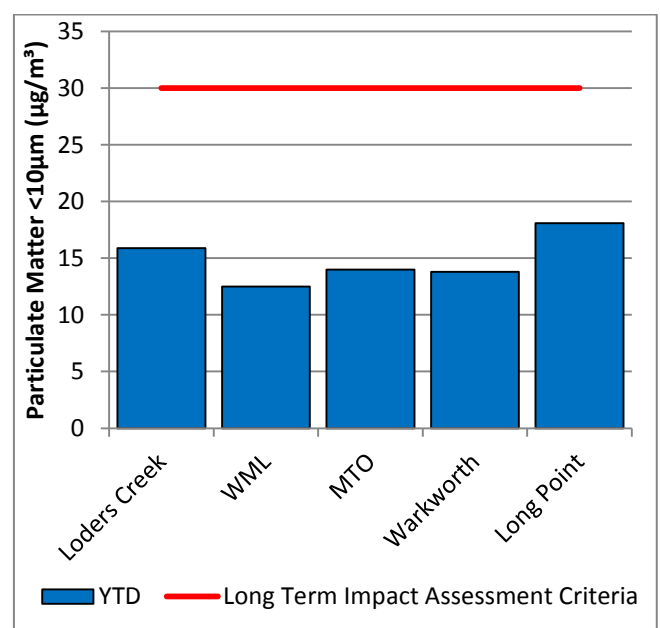
**Figure 6: Annual Average PM<sub>10</sub> – October 2016**

Figure 6 shows the annual average PM<sub>10</sub> results against the long term impact assessment criteria.

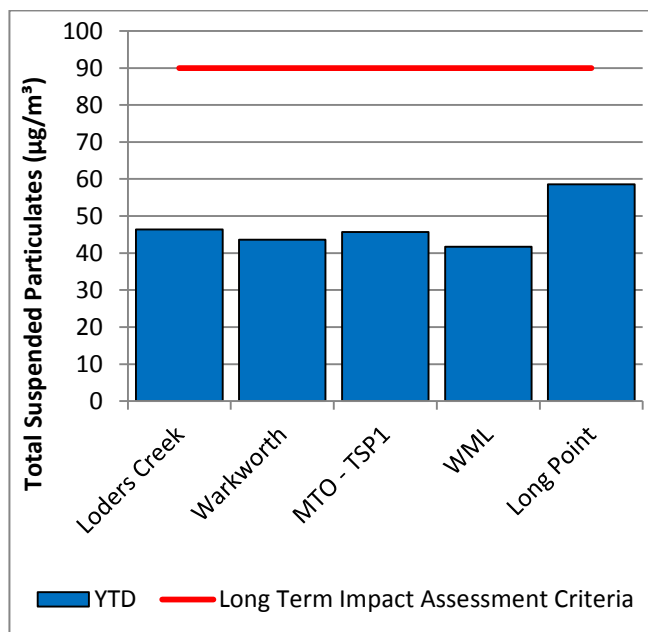
**Figure 7: Annual Average Total Suspended Particulates – October 2016**

Figure 7 shows the annual average TSP results compared against the long term impact assessment criteria of 90µg/m<sup>3</sup>.

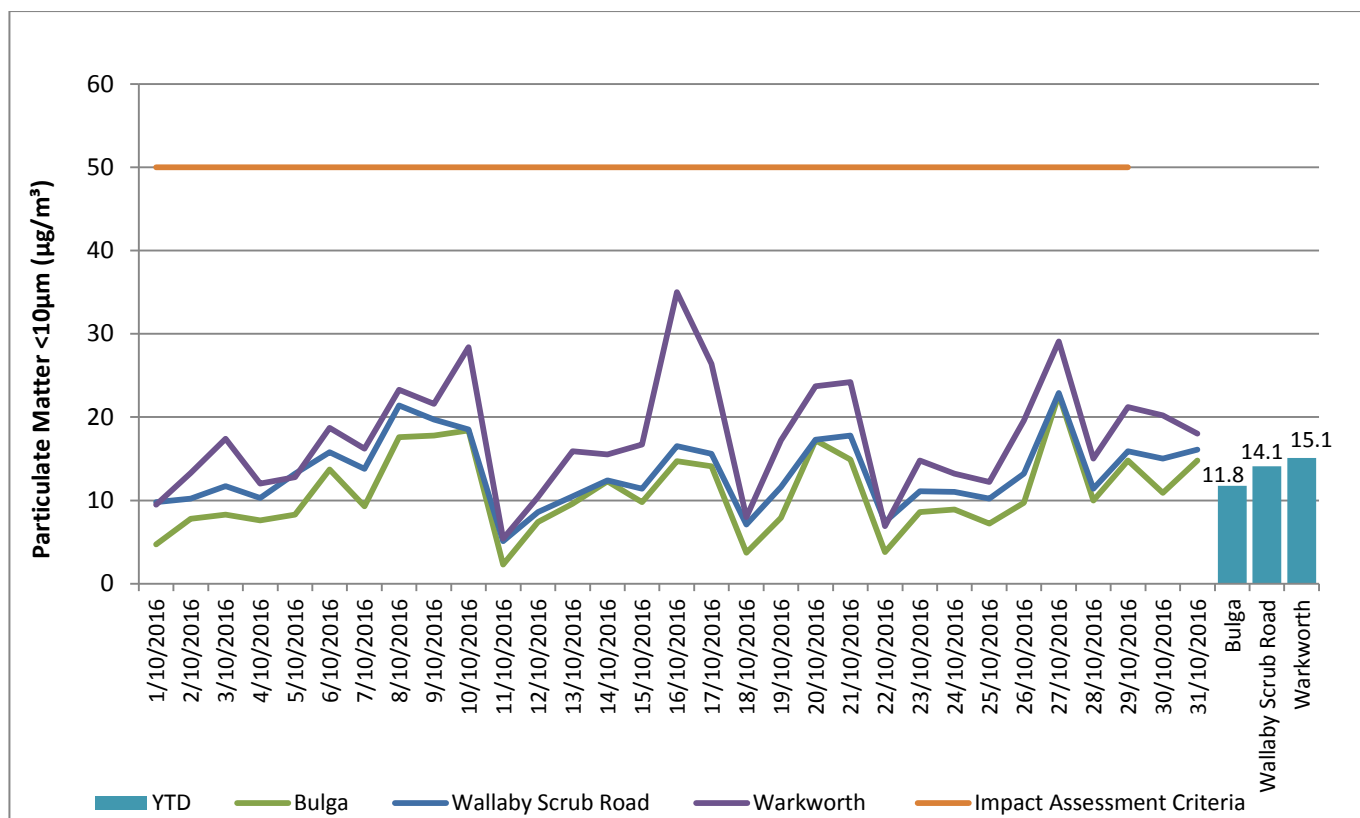
**Figure 8: Real Time PM<sub>10</sub> daily 24hr average and annual average – October 2016**

During October, the real time monitoring system generated 45 automated air quality related alerts, including 37 alerts for adverse meteorological conditions and 8 alerts for elevated PM<sub>10</sub> levels.

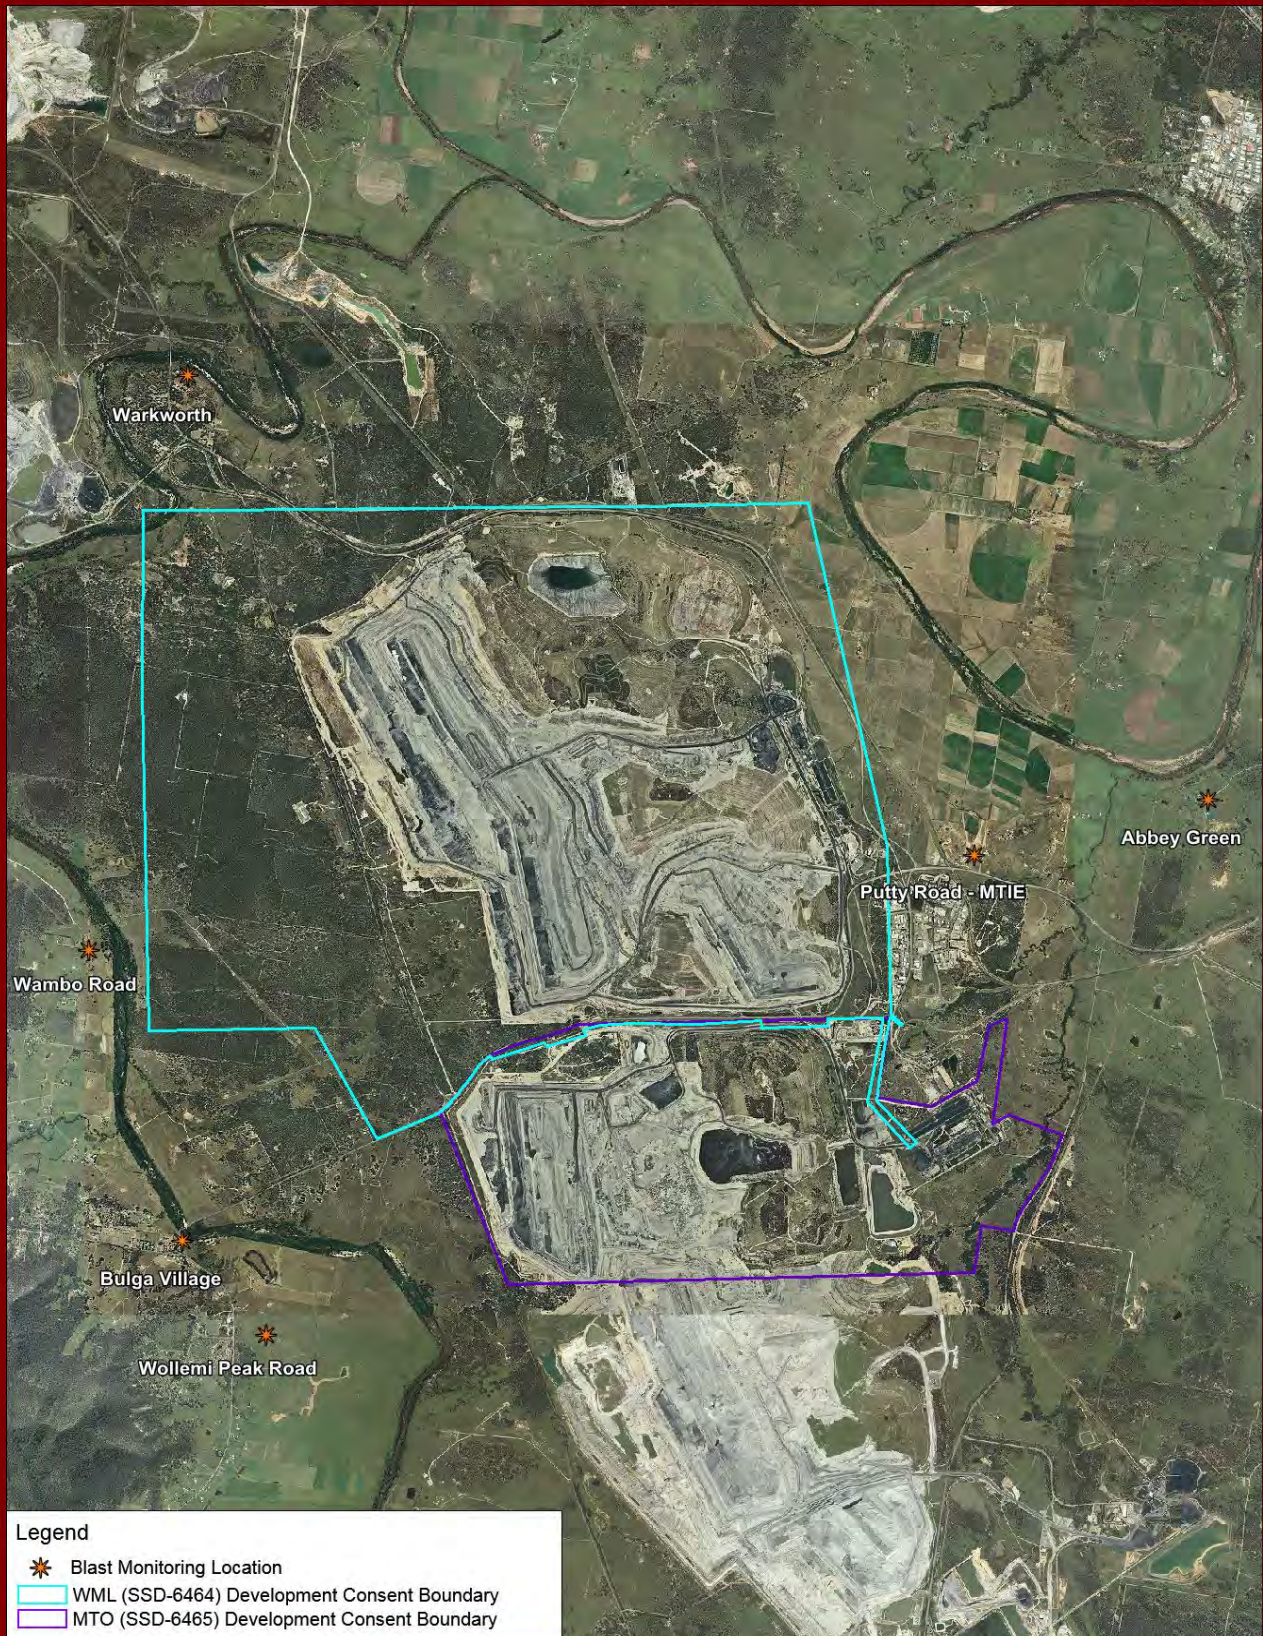
**Figure 15: MTW Blast Monitoring Location Plan**

**Mount Thorley Warkworth  
Blast Monitoring Locations**

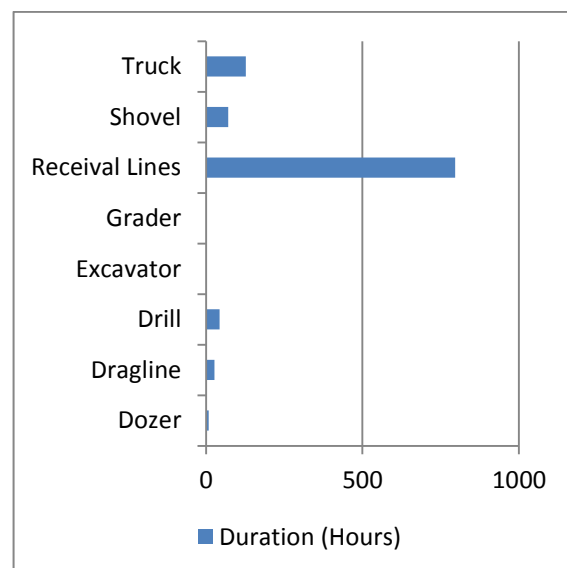
**Figure 17: Operational Downtime by Equipment Type – October 2016**

During October, a total of 1076 hours of equipment downtime was logged in response to environmental events such as dust, noise and adverse meteorological conditions. Operational downtime by equipment type is shown in Figure 17.

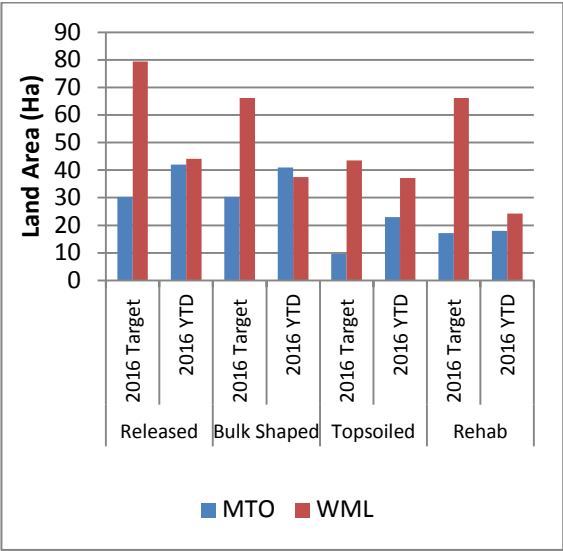
**Figure 18: Rehabilitation YTD – October 2016**

During October, 12.1 Ha of land was released, 17.3 Ha of land was bulk shaped, 15.4 Ha of land was topsoiled, 16.4 Ha of land was composted and 15.4 Ha of land was rehabilitated. Year-to-date progress can be viewed in **Error! Reference source not found.**

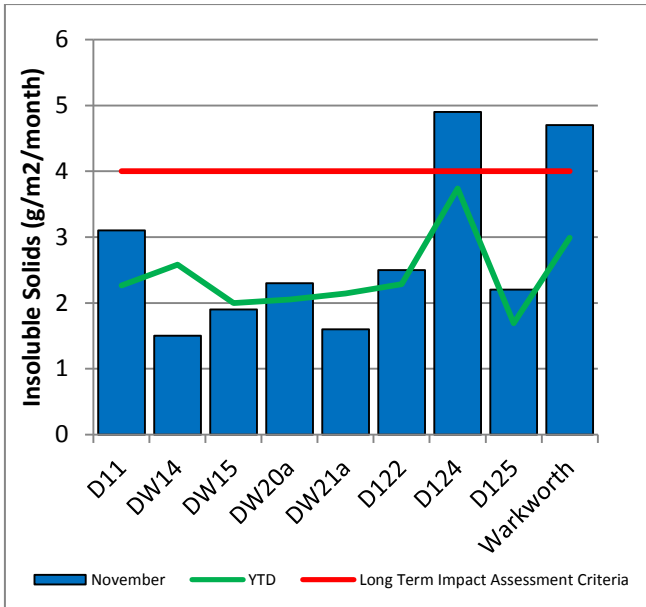
Figure 4: Depositional Dust – November 2016

Figure 4 displays Insoluble solids results from depositional dust gauges during the reporting period compared against the year-to-date average and the annual impact assessment criteria.

During the reporting period the D124 and Warkworth monitors recorded monthly results above the long term impact assessment criteria of 4.0 g/m² per month. Field notes associated with Warkworth confirm the presence of insects and bird droppings. As such the result is considered contaminated and will be excluded from calculation of the annual average. There is no evidence to suggest that the D124 result is contaminated. Accordingly, this result will be included in the annual average calculation.

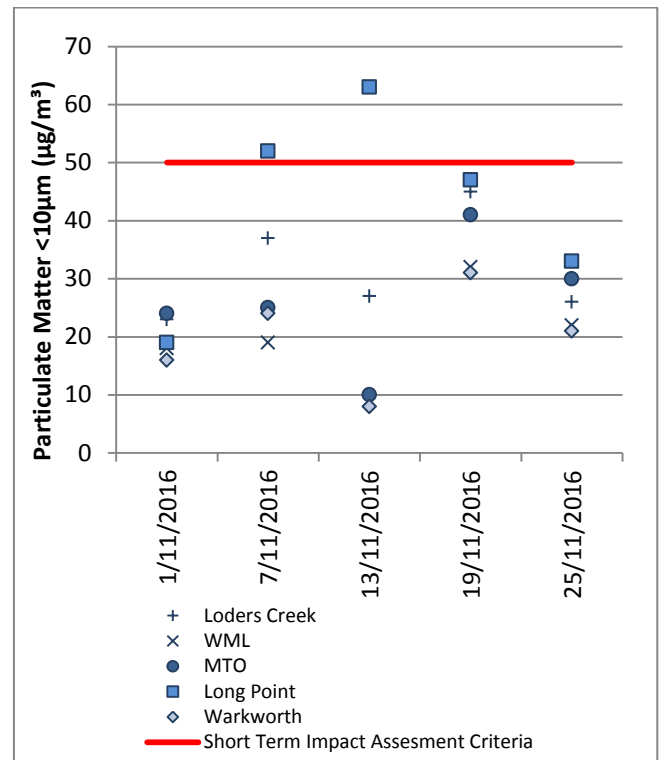
**Figure 5: Individual PM<sub>10</sub> Results – November 2016**

Figure 5 shows the individual PM<sub>10</sub> results at each monitoring station against the short term impact assessment criteria of 50µg/m<sup>3</sup>.

On 7/11/2016 and on 13/11/2016 one HVAS PM<sub>10</sub> unit recorded a result greater than the short term (24hr) PM<sub>10</sub> impact assessment criteria; Long Point (52 µg/m<sup>3</sup> and 63 µg/m<sup>3</sup> respectively). Preliminary investigation indicates that MTW is not the main contributor to elevated PM<sub>10</sub> levels on these days.

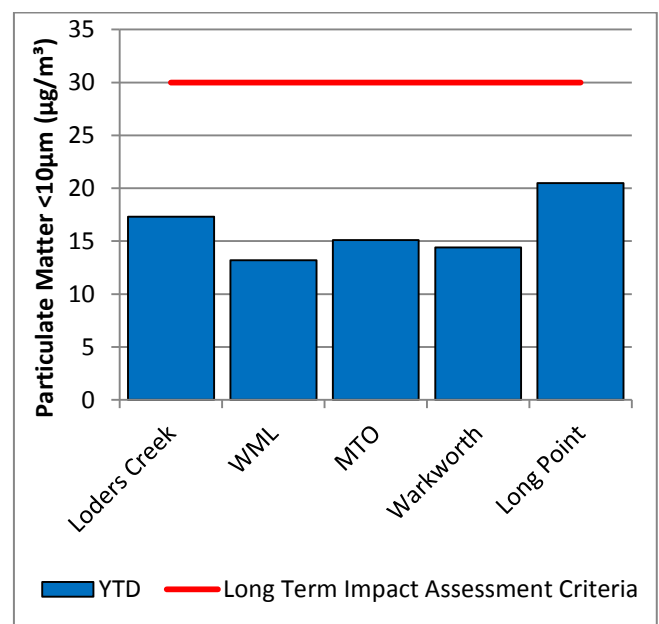
**Figure 6: Annual Average PM<sub>10</sub> – November 2016**

Figure 6 shows the annual average PM<sub>10</sub> results against the long term impact assessment criteria.

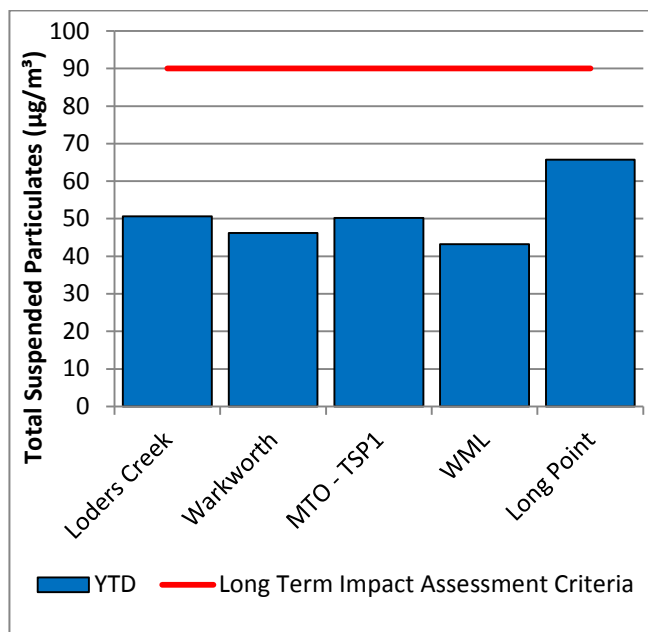
**Figure 7: Annual Average Total Suspended Particulates – November 2016**

Figure 7 shows the annual average TSP results compared against the long term impact assessment criteria of 90µg/m<sup>3</sup>.

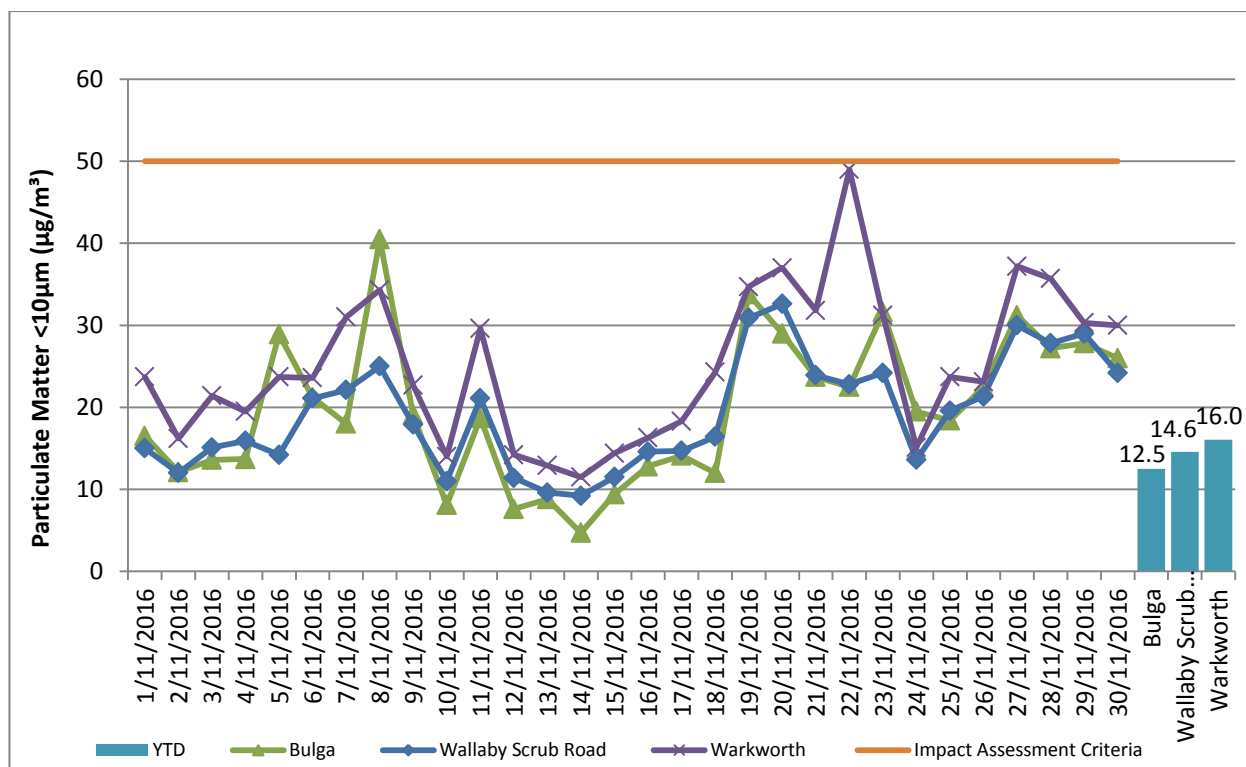
**Figure 8: Real Time PM<sub>10</sub> daily 24hr average and annual average – November 2016**

During November, the real time monitoring system generated 56 automated air quality related alerts, including 27 alerts for adverse meteorological conditions and 29 alerts for elevated PM<sub>10</sub> levels.

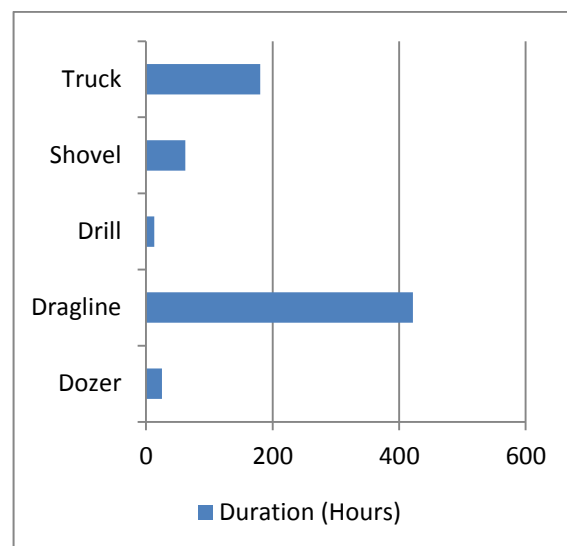
**Figure 17: Operational Downtime by Equipment Type – November 2016**

During November, a total of 702.4 hours of equipment downtime was logged in response to environmental events such as dust, noise and adverse meteorological conditions. Operational downtime by equipment type is shown in Figure 17.

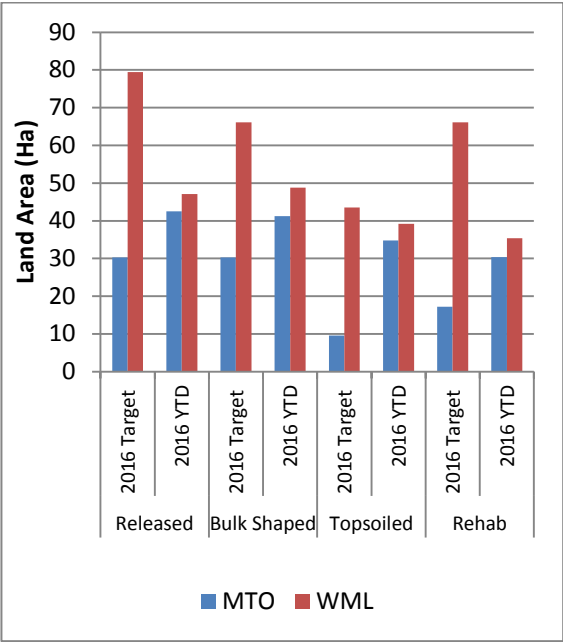
**Figure 18: Rehabilitation YTD – November 2016**

During November, 3.4 Ha of land was released, 11.5 Ha of land was bulk shaped, 13.9 Ha of land was topsoiled, 29.9 Ha of land was composted and 23.5 Ha of land was rehabilitated. Year-to-date progress can be viewed in **Error! Reference source not found.**

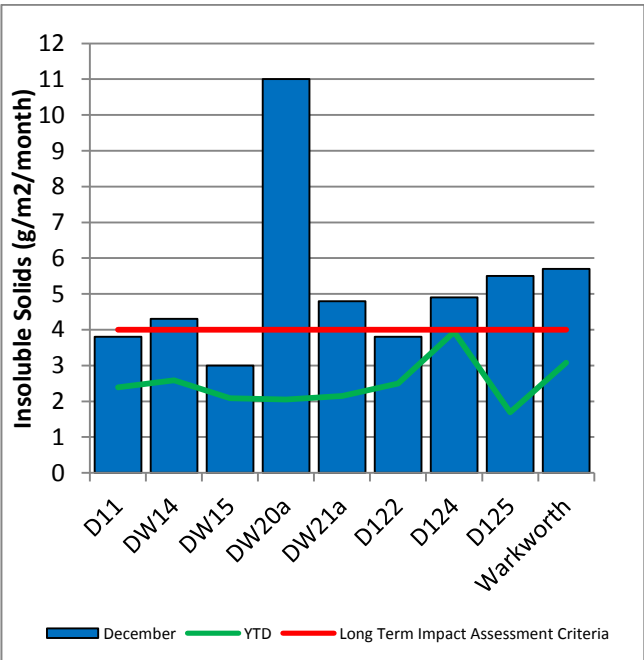
Figure 4: Depositional Dust – December 2016

During the reporting period the DW14, DW20a, DW21a, D124, D125 and Warkworth monitors recorded monthly results above the long term impact assessment criteria of 4.0 g/m<sup>2</sup> per month. Field notes associated with DW14, DW20a, DW21a and D125 confirm the presence of insects and bird droppings. As such the results are considered contaminated and will be excluded from calculation of the annual average. There is no evidence to suggest that the D124 and Warkworth results are contaminated. Accordingly, the results will be included in the annual average calculation.

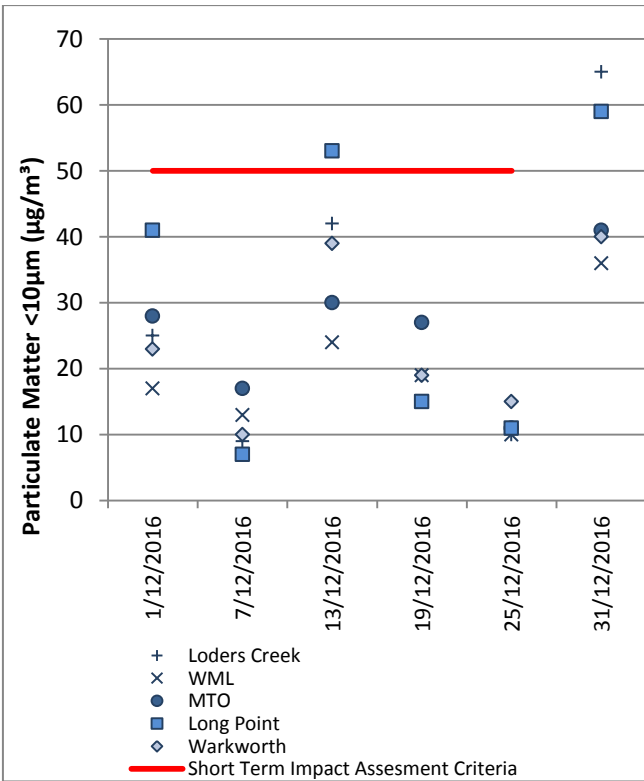
Figure 5: Individual PM<sub>10</sub> Results – December 2016

Preliminary investigation indicates that MTW was outside of the main arc of influence for Long Point on the 13<sup>th</sup> December and for Long Point and Loder's Creek on the 31<sup>st</sup> December. Accordingly, no further action is required.

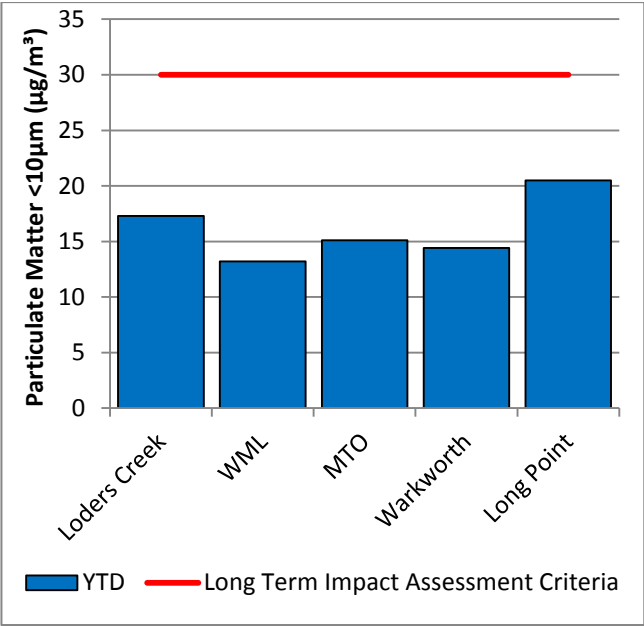
Figure 6: Annual Average PM<sub>10</sub> – December 2016

Figure 6 shows the annual average PM<sub>10</sub> results against the long term impact assessment criteria.

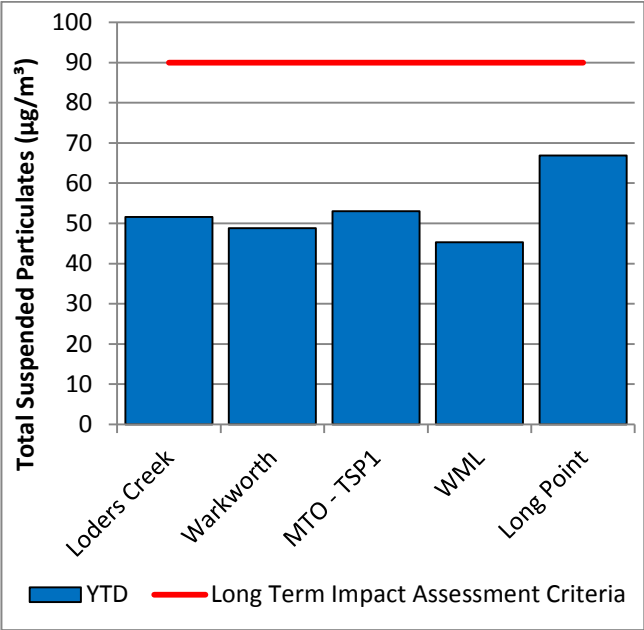
Figure 7: Annual Average Total Suspended Particulates – December 2016

Figure 7 shows the annual average TSP results compared against the long term impact assessment criteria of 90µg/m³.

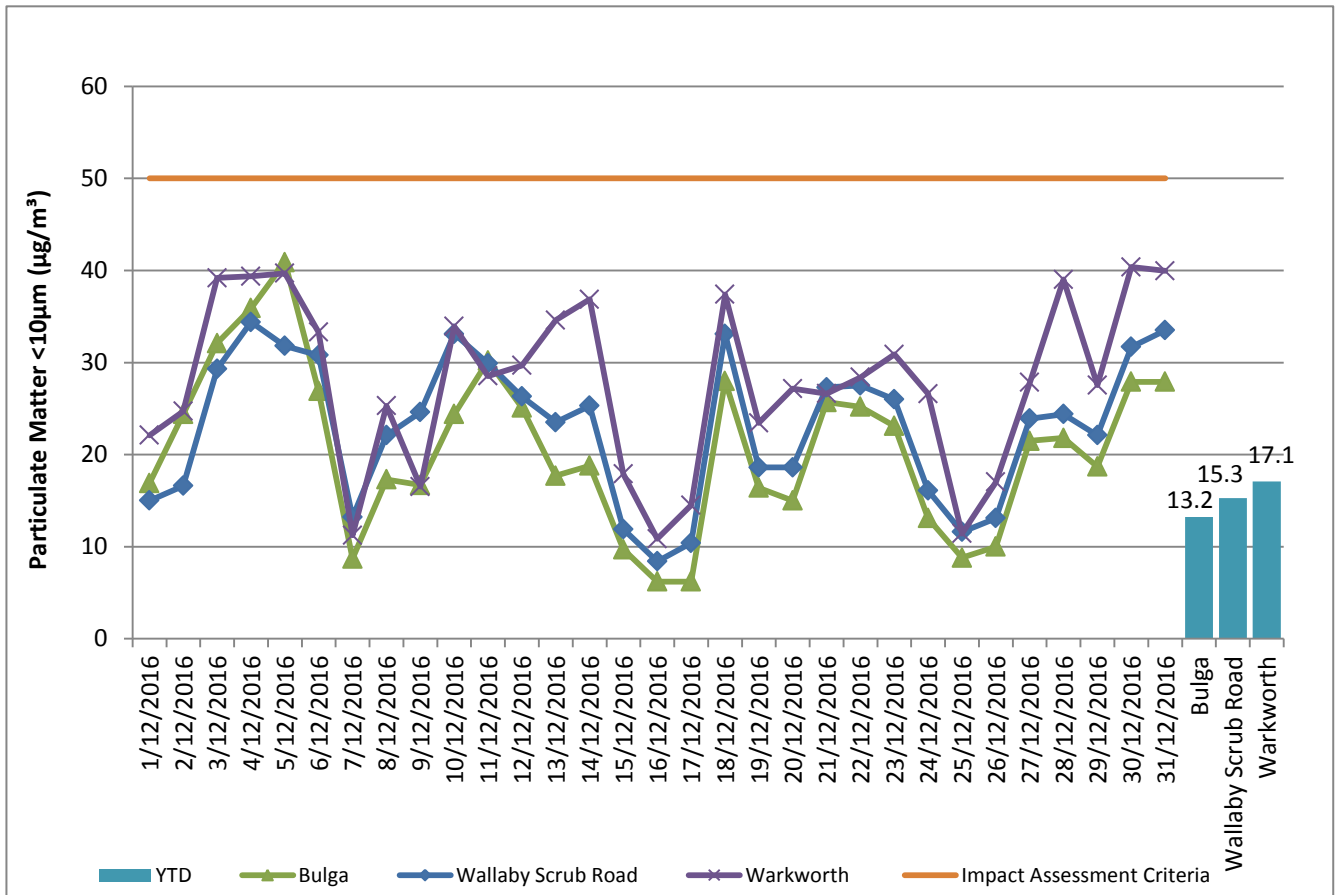
**Figure 8: Real Time PM<sub>10</sub> 24hr average and Year-to-date average – December 2016**

During December, the real time monitoring system generated 42 automated air quality related alerts, including 21 alerts for adverse meteorological conditions and 21 alerts for elevated dust levels.

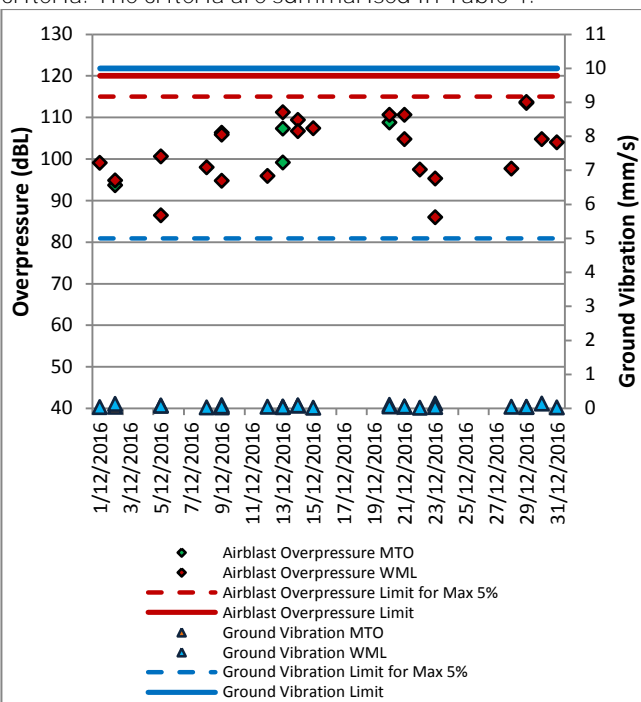
**Figure 60: Abbey Green Blast Monitoring Results - December 2016**

During December 2016, 28 blasts were initiated at MTW. Figure 60 to Figure 65 show the blast monitoring results for the reporting period against the impact assessment criteria. The criteria are summarised in Table 4.

During the reporting period no blasts exceeded the 115 dB(L) 5% threshold for airblast overpressure or 5mm/s 5% threshold for ground vibration

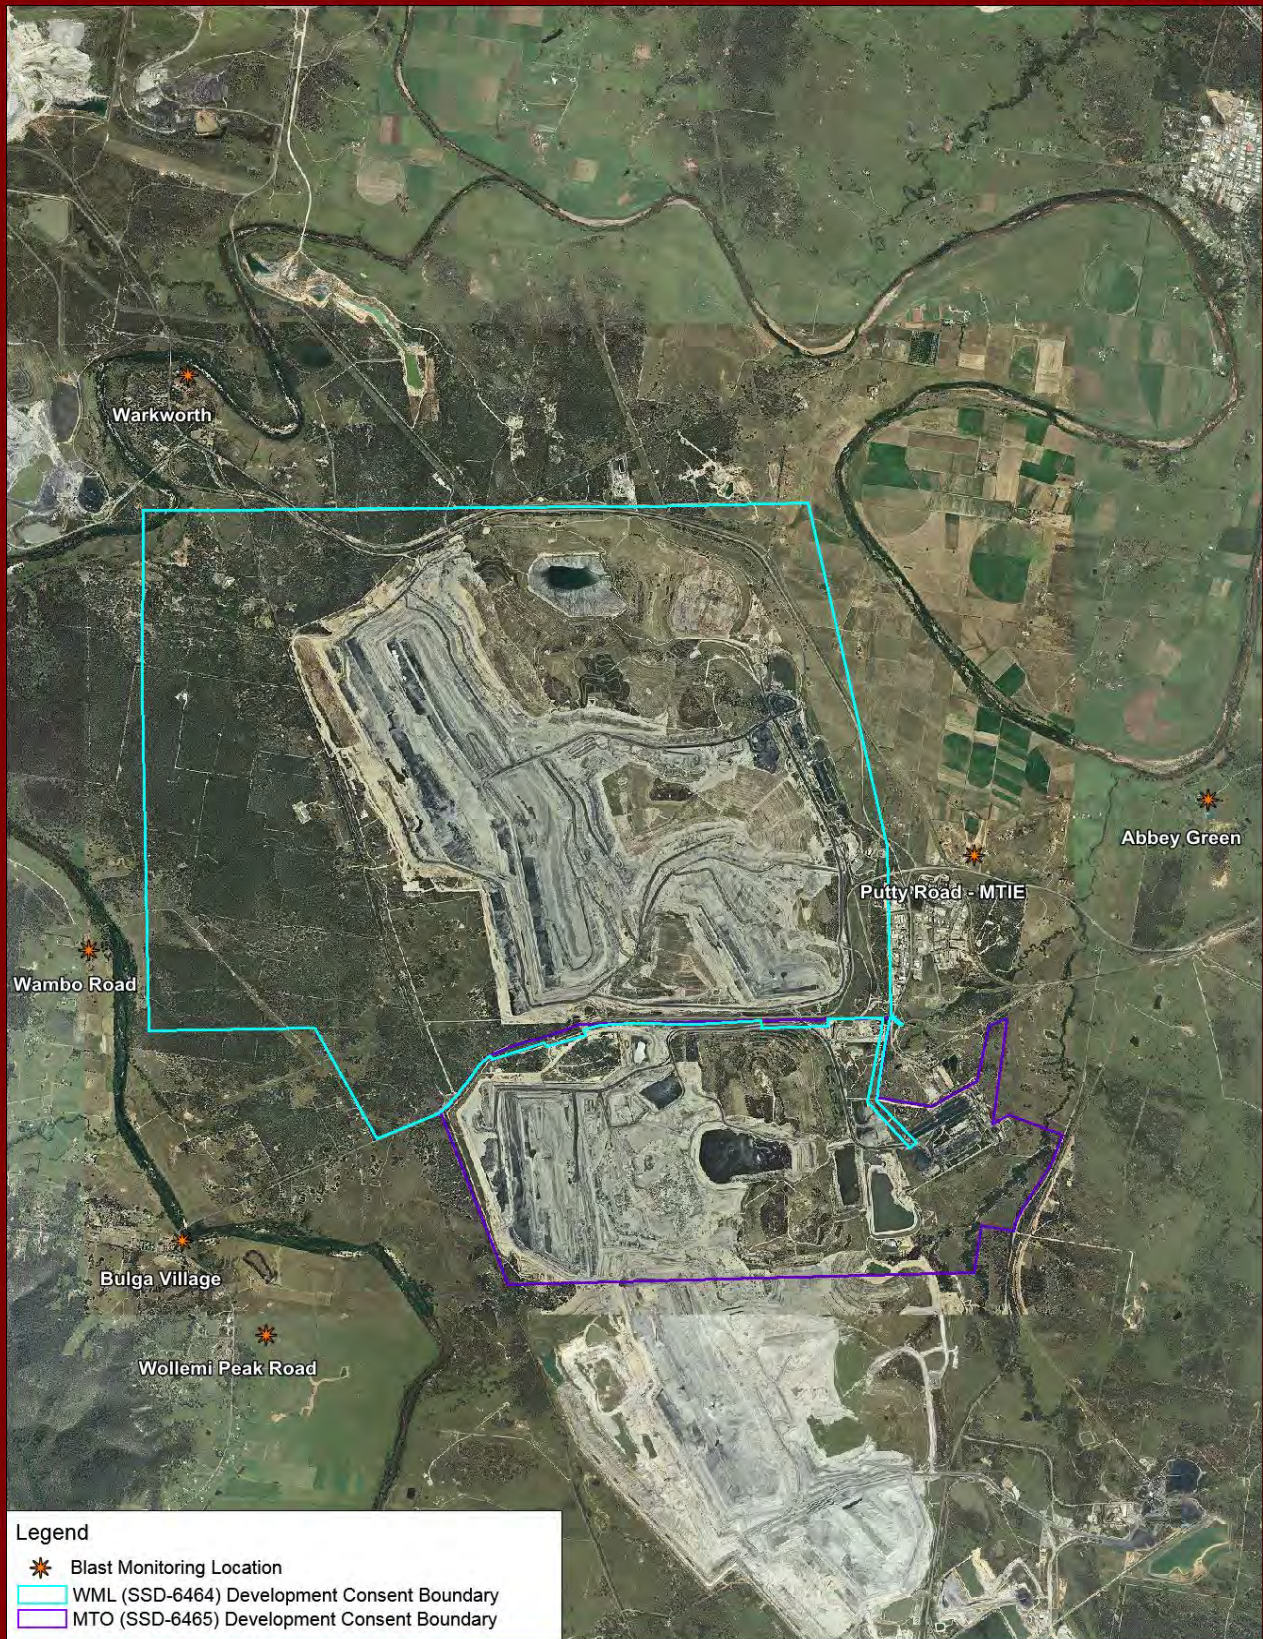
**Figure 66: Blast and Vibration Monitoring Location Plan**

**Mount Thorley Warkworth  
Blast Monitoring Locations**

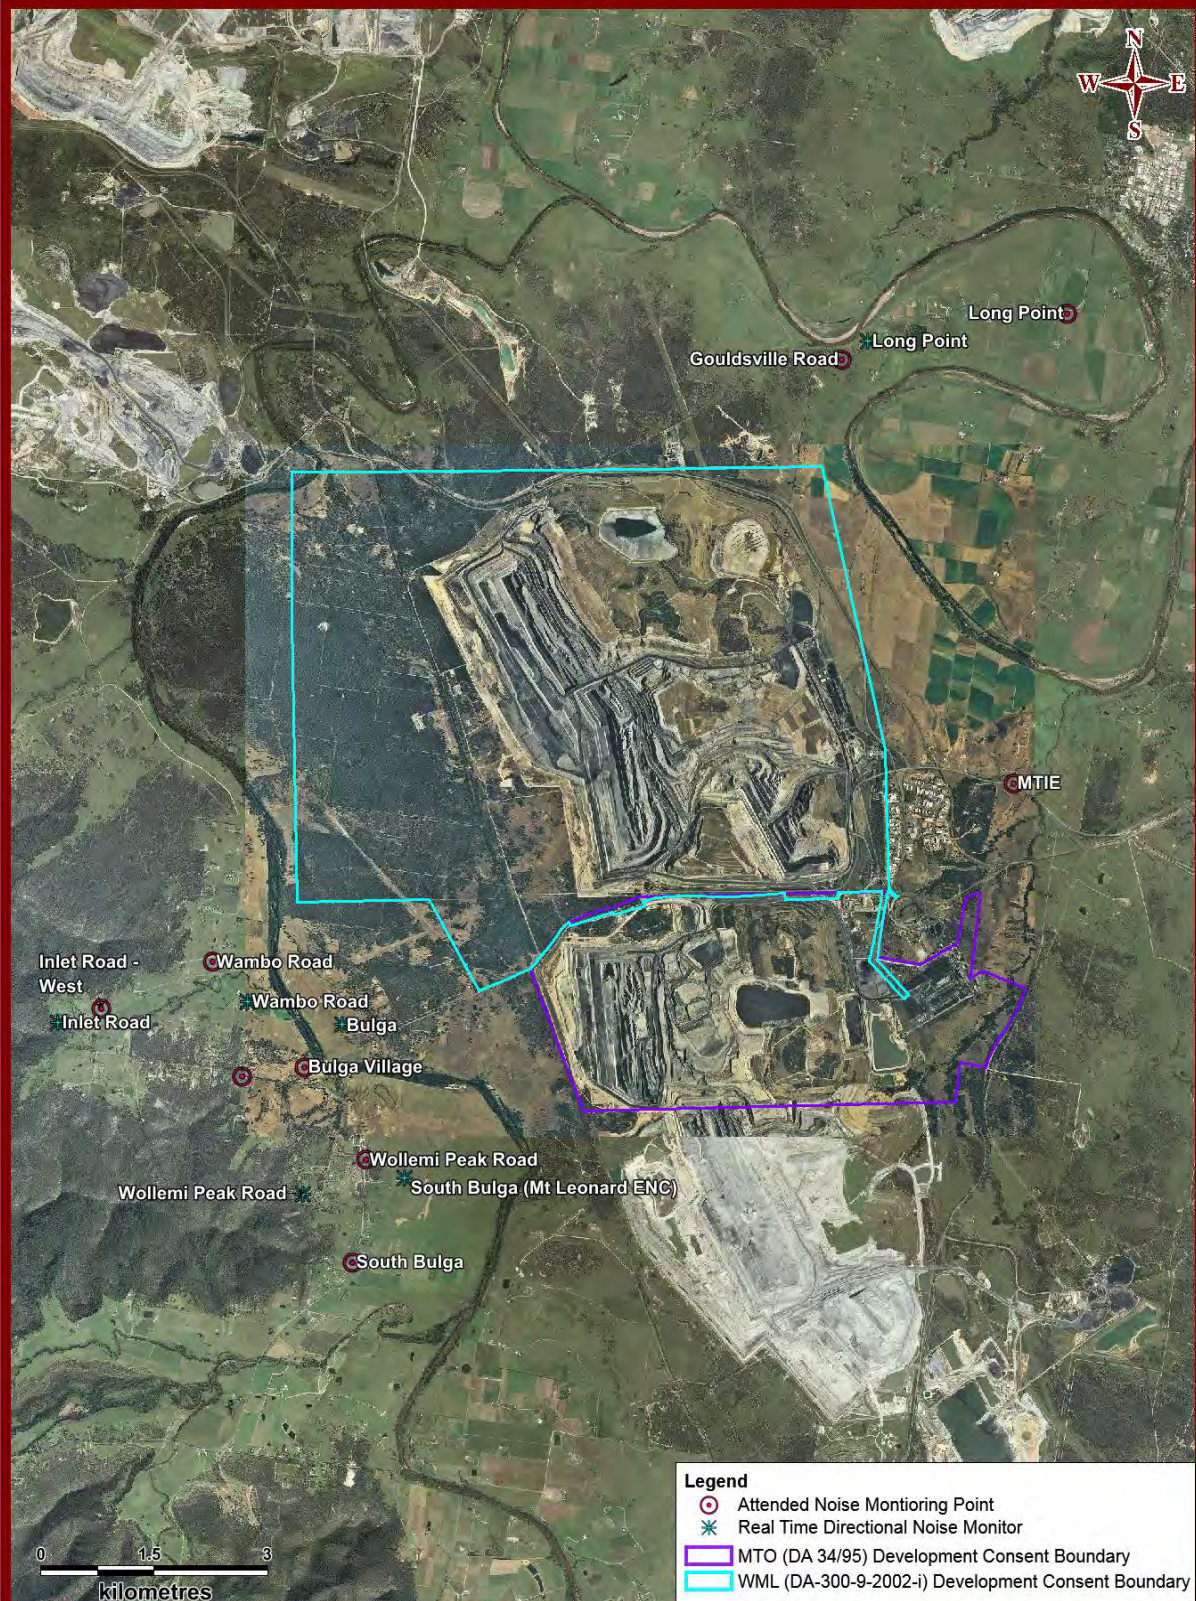
**Figure 67: Noise Monitoring Location Plan**

Routine attended noise monitoring is carried out in accordance with the MTW Noise Management Plan. A review against EIS predictions will be reported in the Annual Review. The purpose of the noise surveys is to quantify and describe the acoustic environment around the site and compare results with specified limits. Unattended monitoring (real time noise monitoring) also occurs at seven sites surrounding MTW. The attended noise monitoring locations are displayed in Figure 67.
