Mount Thorley Warkworth
Community Consultative Committee

Business Papers – May 2017

Materials ahead of meeting of the committee on 22 May 2017

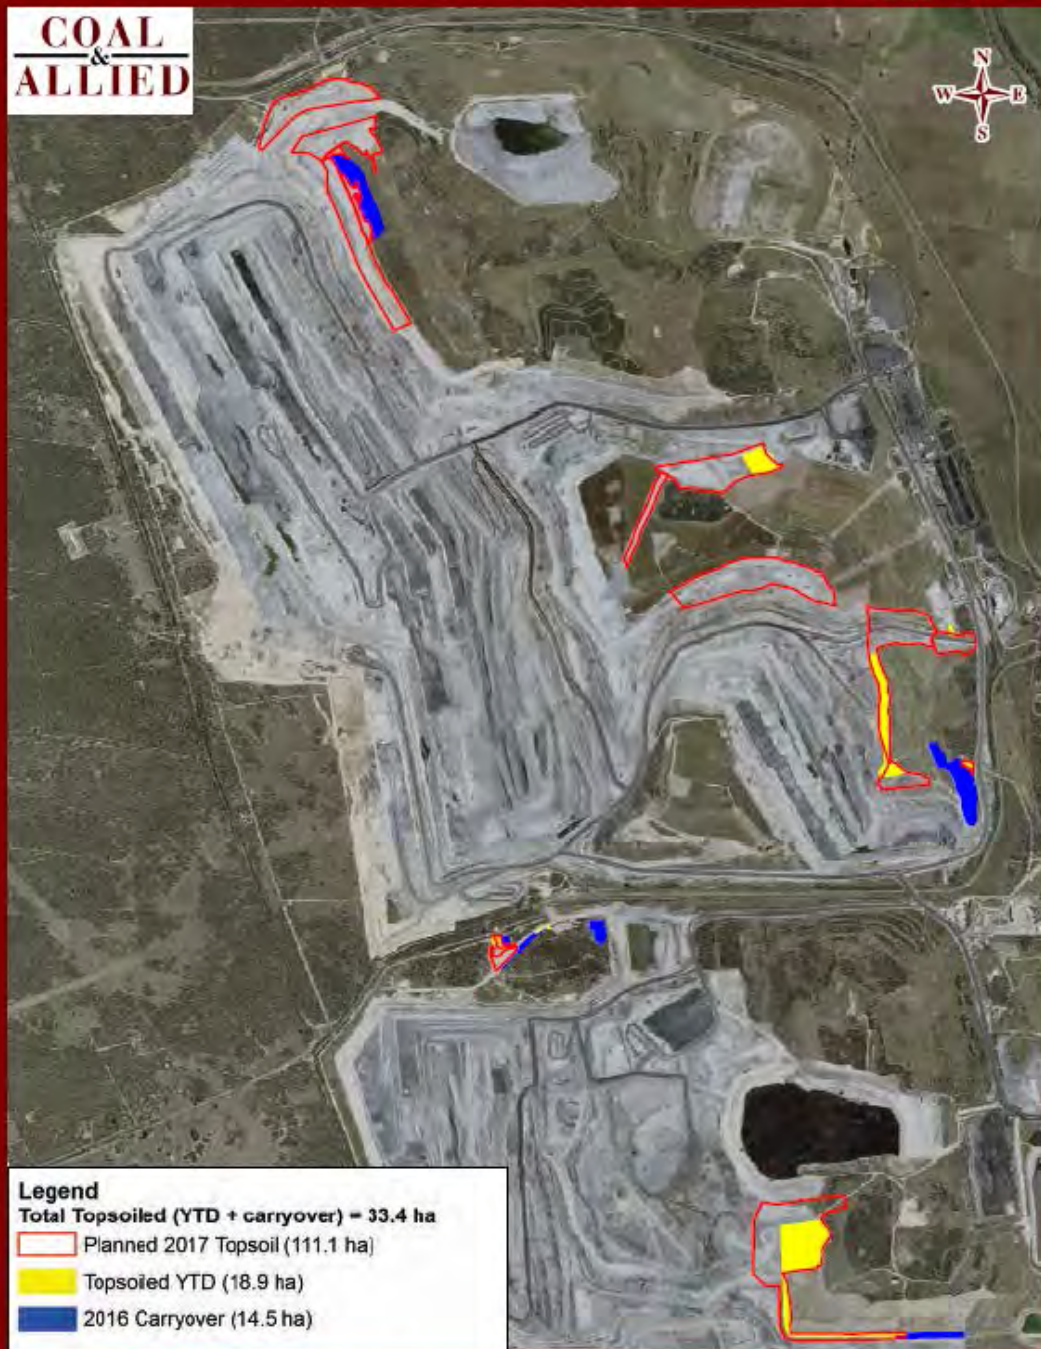
Plan of: **Composted 2017**
Location: **MTW**

Legend
Total Composted (YTD + carryover) = 31.6 ha
Planned 2017 Composted (115.9 ha)
Composted YTD (25.5 ha)
2016 Carryover (6.1 ha)

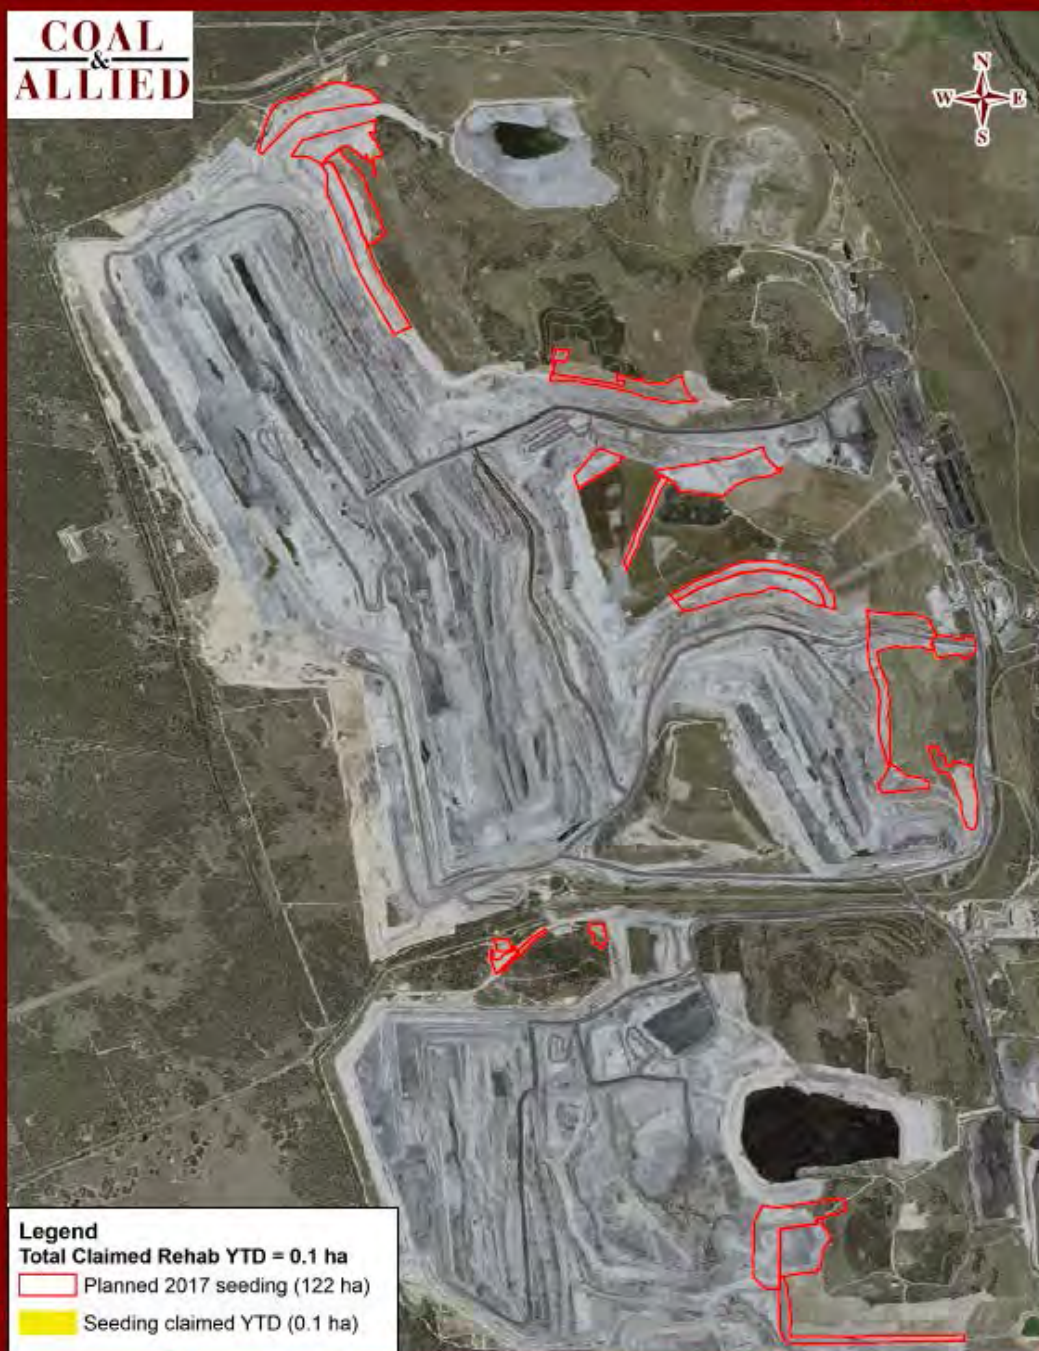
Plan of: **Disturbance 2017**
Location: **MTW**

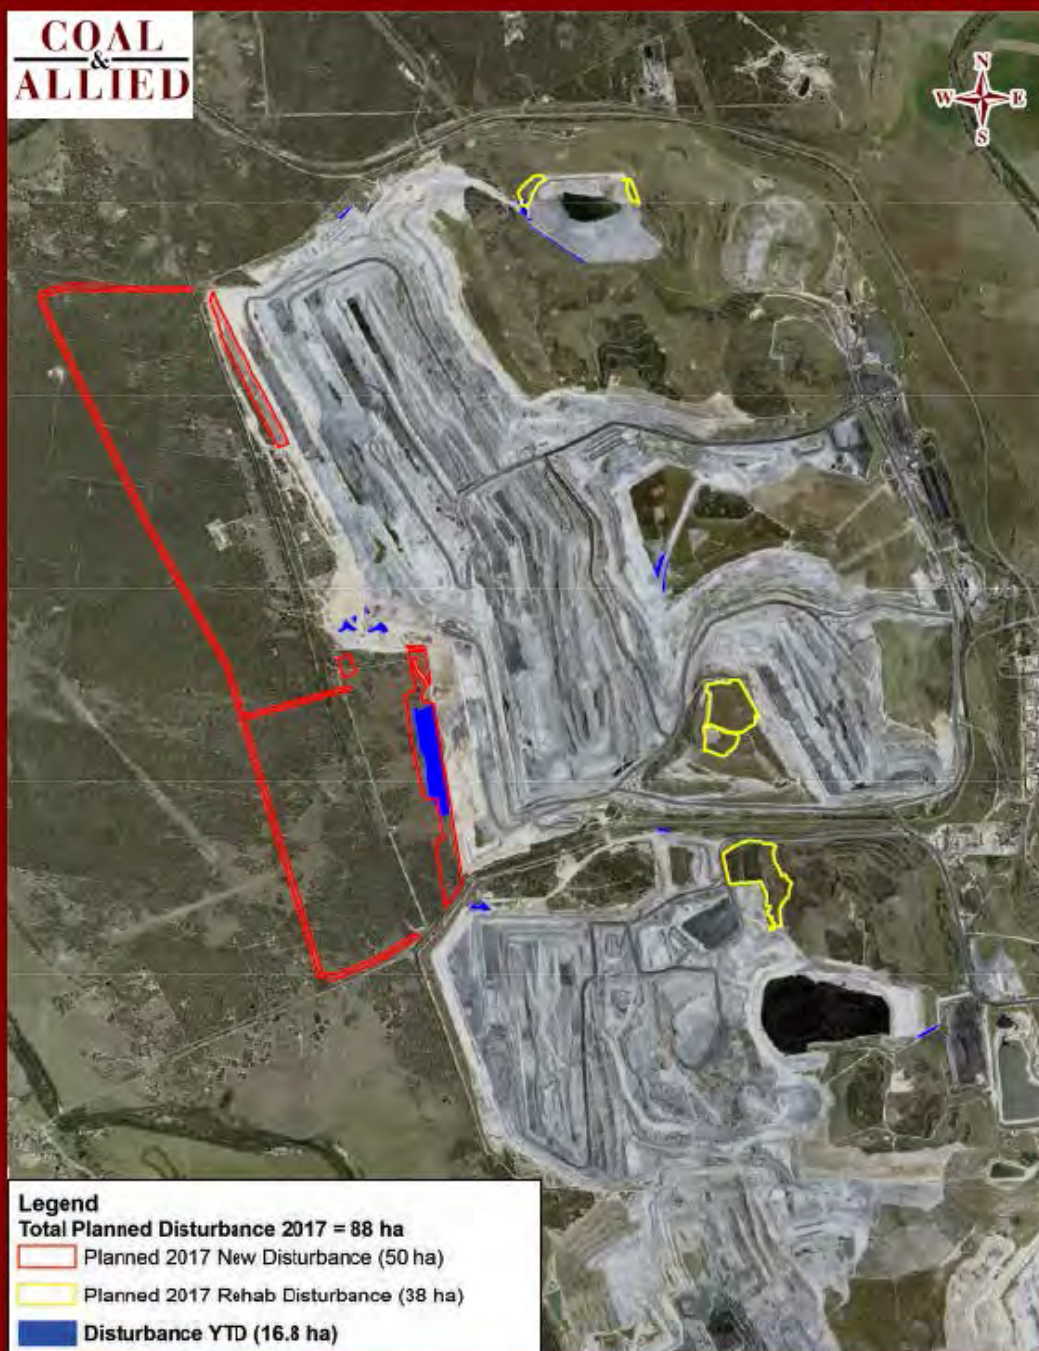
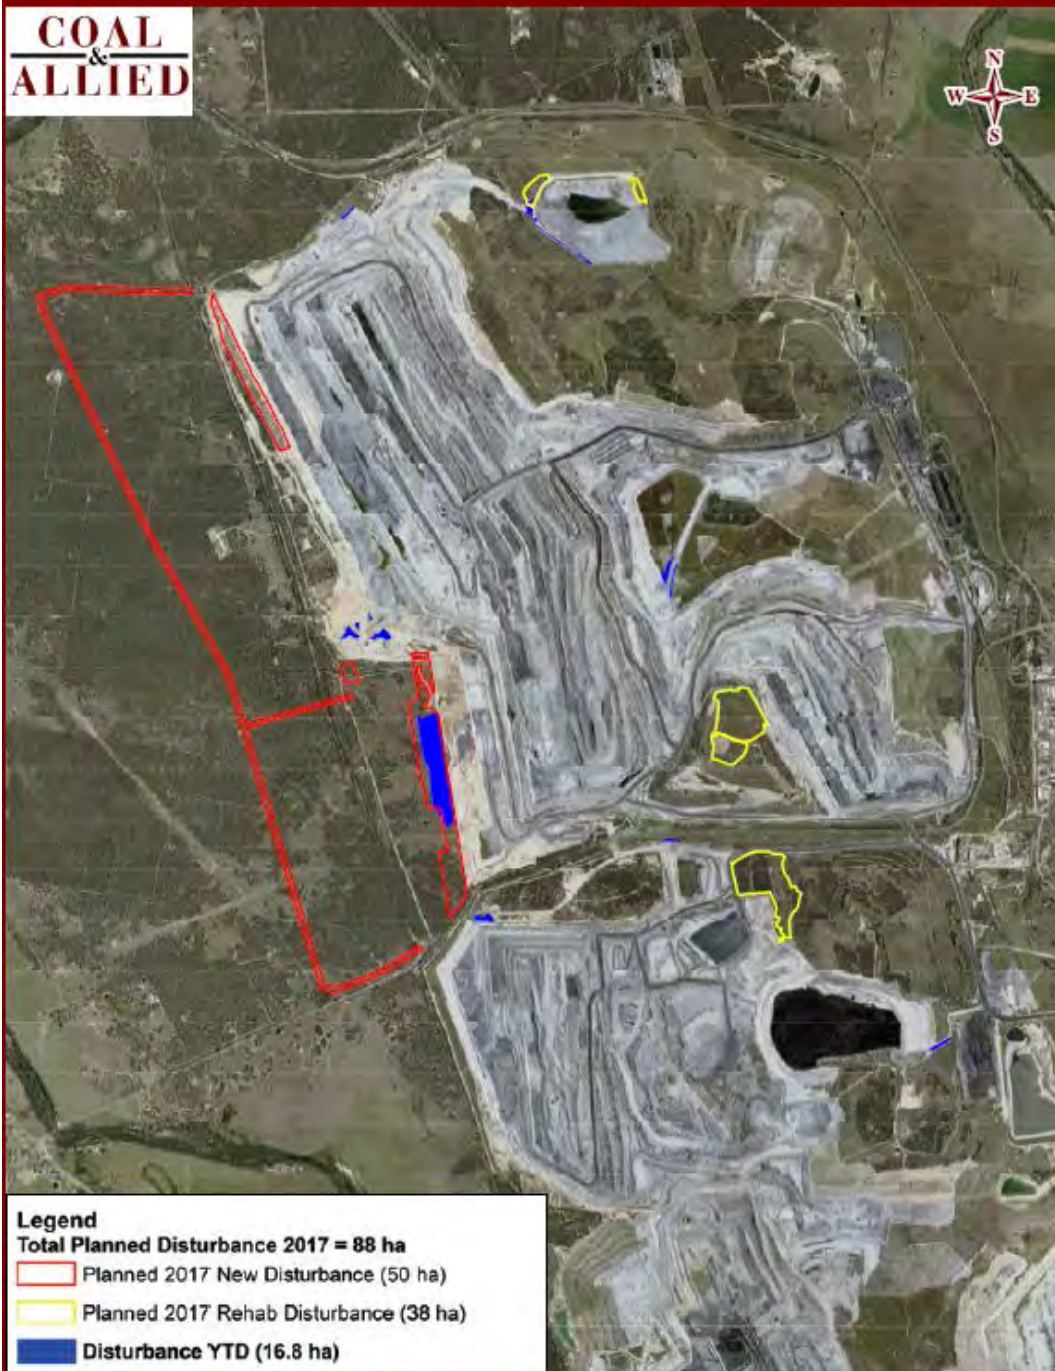
Plan of: Disturbance 2017

Disturbance was predominantly in Warkworth's West Pit area, for mine advance, and to construct a water management contour along the western extent of the disturbance to manage water off pre-strip activities. A total of 16.8 ha have been disturbed at the end of March.

Total Planned Disturbance 2017 = 88 ha

Planned 2017 New Disturbance (50 ha)

Planned 2017 Rehab Disturbance (38 ha)

Disturbance YTD (16.8 ha)

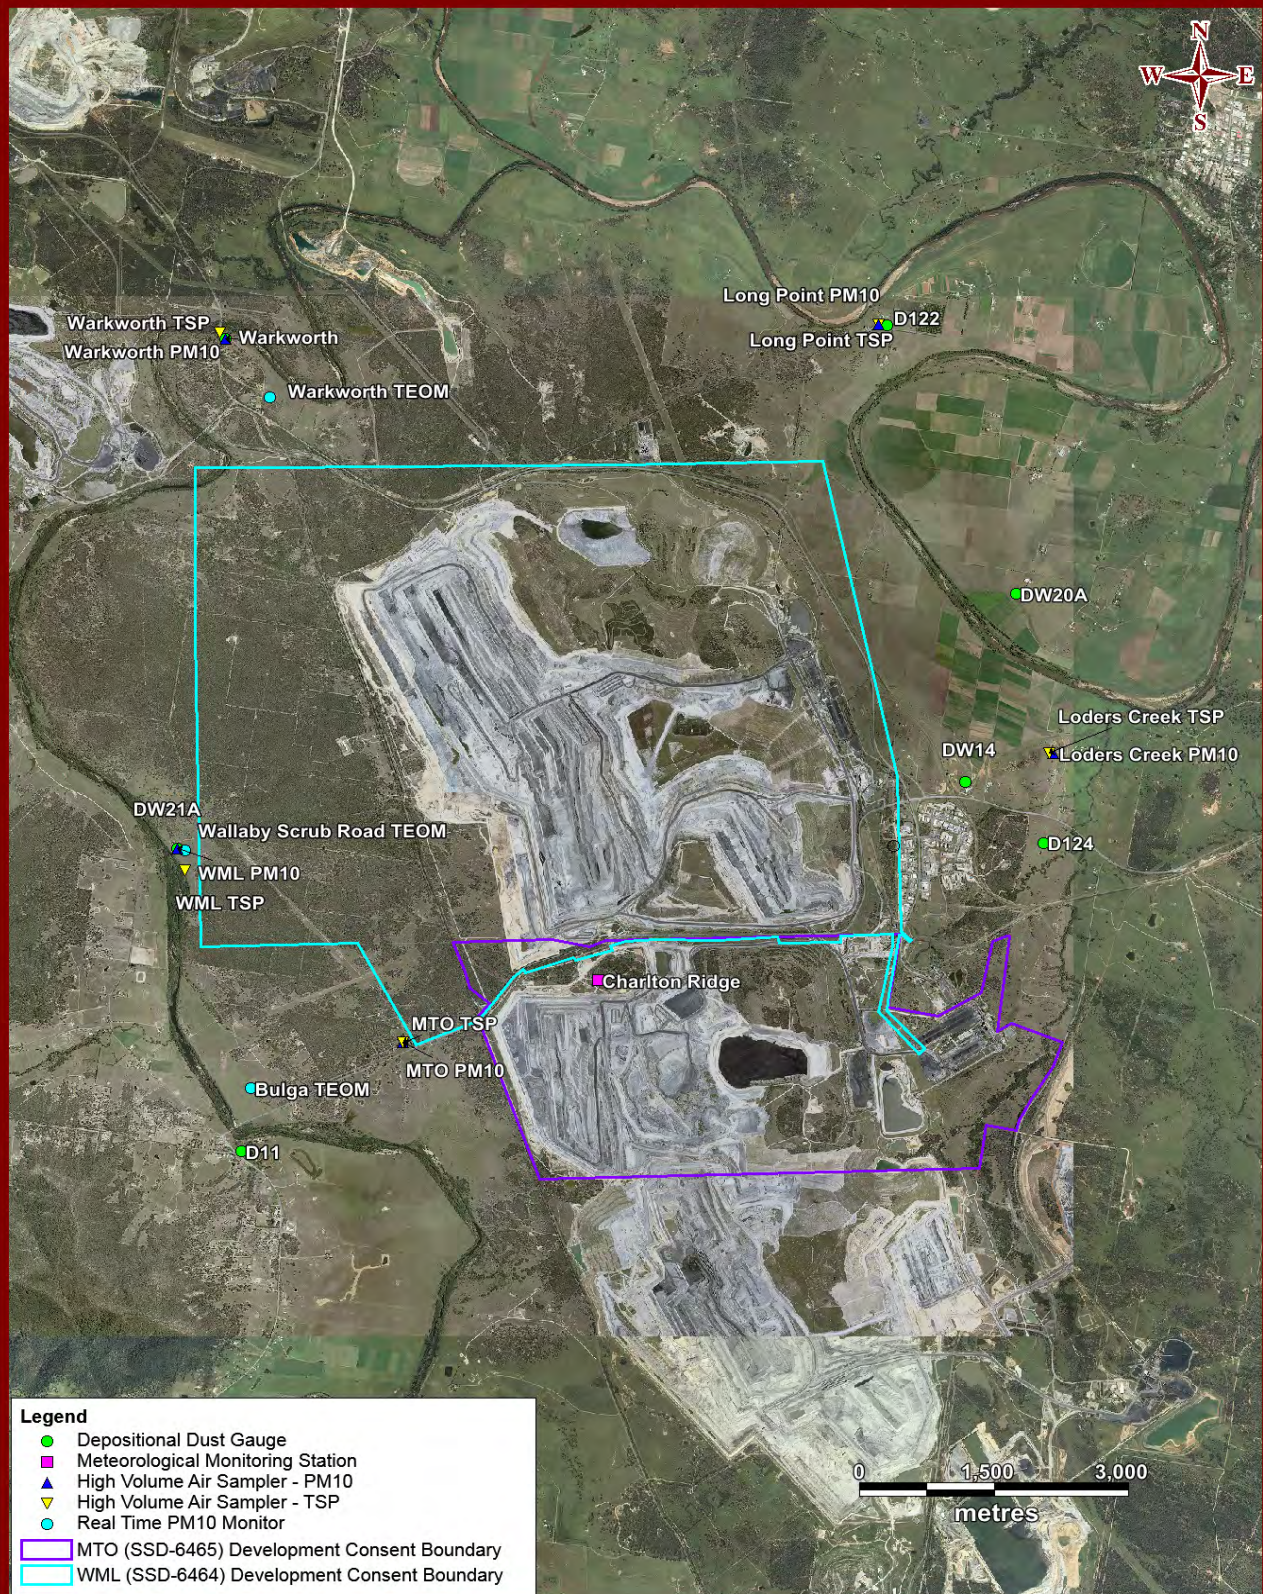
Figure 3: Air Quality Monitoring Locations

Suspended particulates are measured by a network of High Volume Air Samplers (HVAS) measuring Total Suspended Particulates (TSP) and Particulate Matter <10µm (PM₁₀). The location of these monitors can be found in Figure 3. Each HVAS was run for

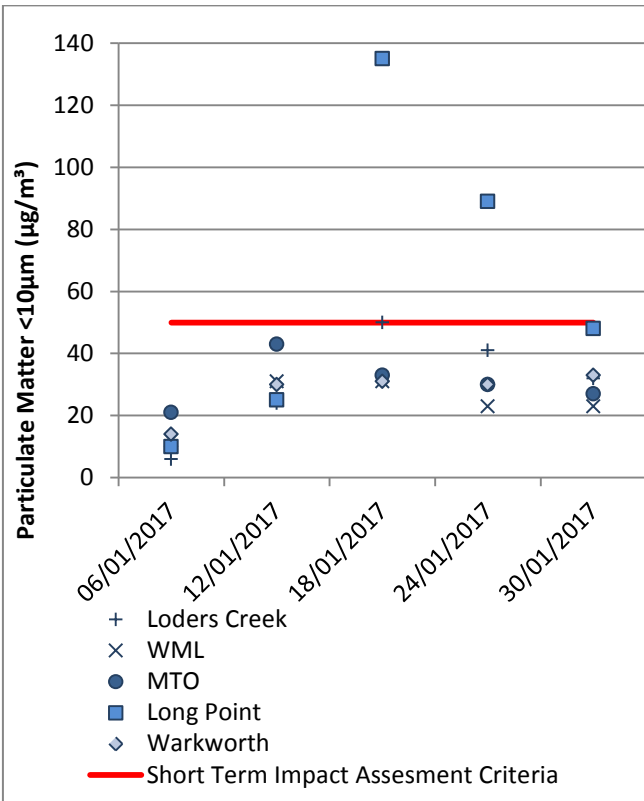
Figure 5: Individual PM₁₀ Results – January 2017

On 18/01/2017 and on 24/01/2017, one HVAS PM₁₀ unit recorded a result greater than the short term (24hr) PM₁₀ impact assessment criteria; Long Point (135 µg/m³) and Long Point (89 µg/m³) respectively.

Investigation indicates that the Long Point HVAS failed to collect valid samples on the 18th and 24th January due to local livestock impacting the monitor. The proximity of the monitor to livestock is being increased, through the relocation of a nearby chook yard and also a demountable horse yard away from the monitor.

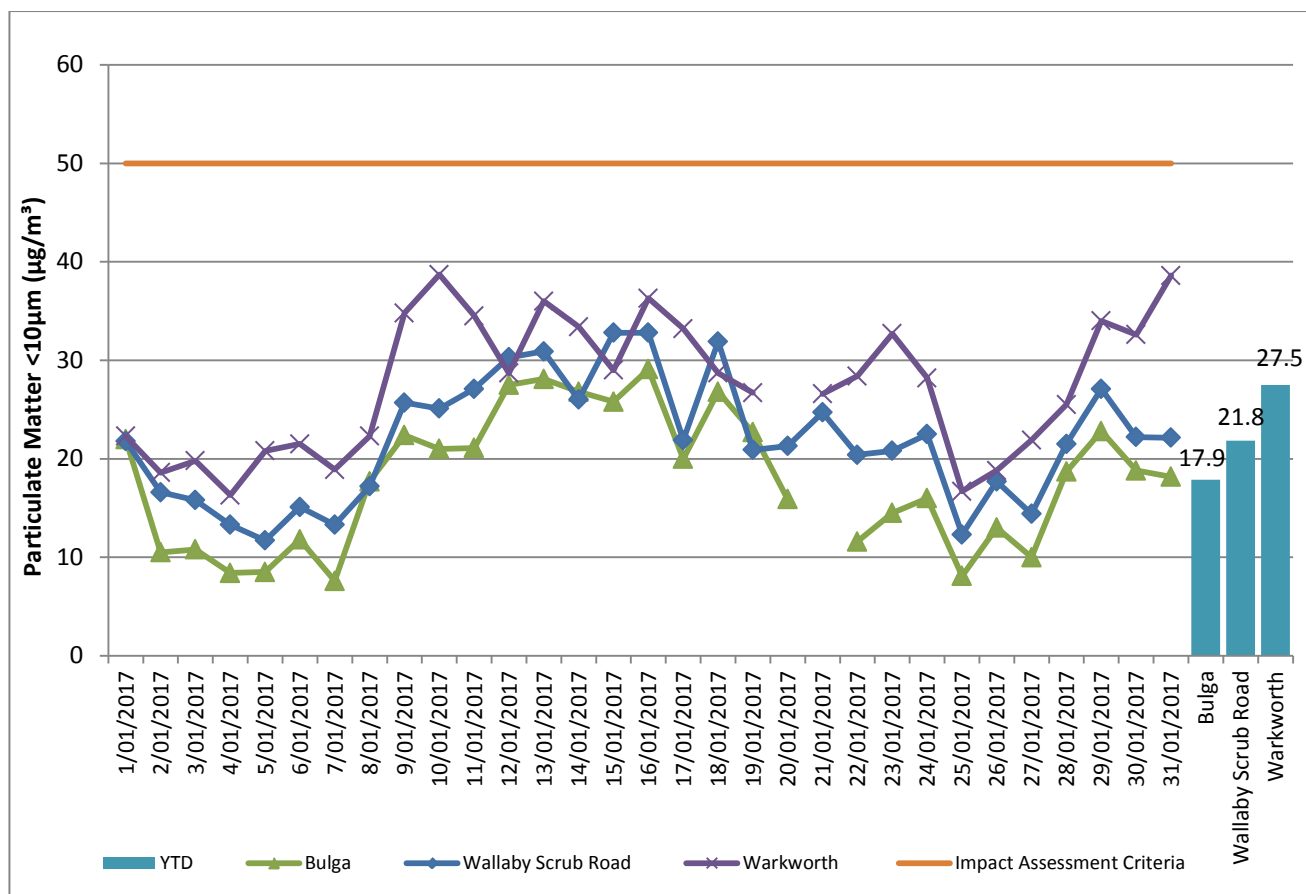
Figure 8: Real Time PM₁₀ daily 24hr average and annual average – January 2017

During January, the real time monitoring system generated 76 automated air quality related alerts, including 14 alerts for adverse meteorological conditions and 62 alerts for elevated PM₁₀ levels.

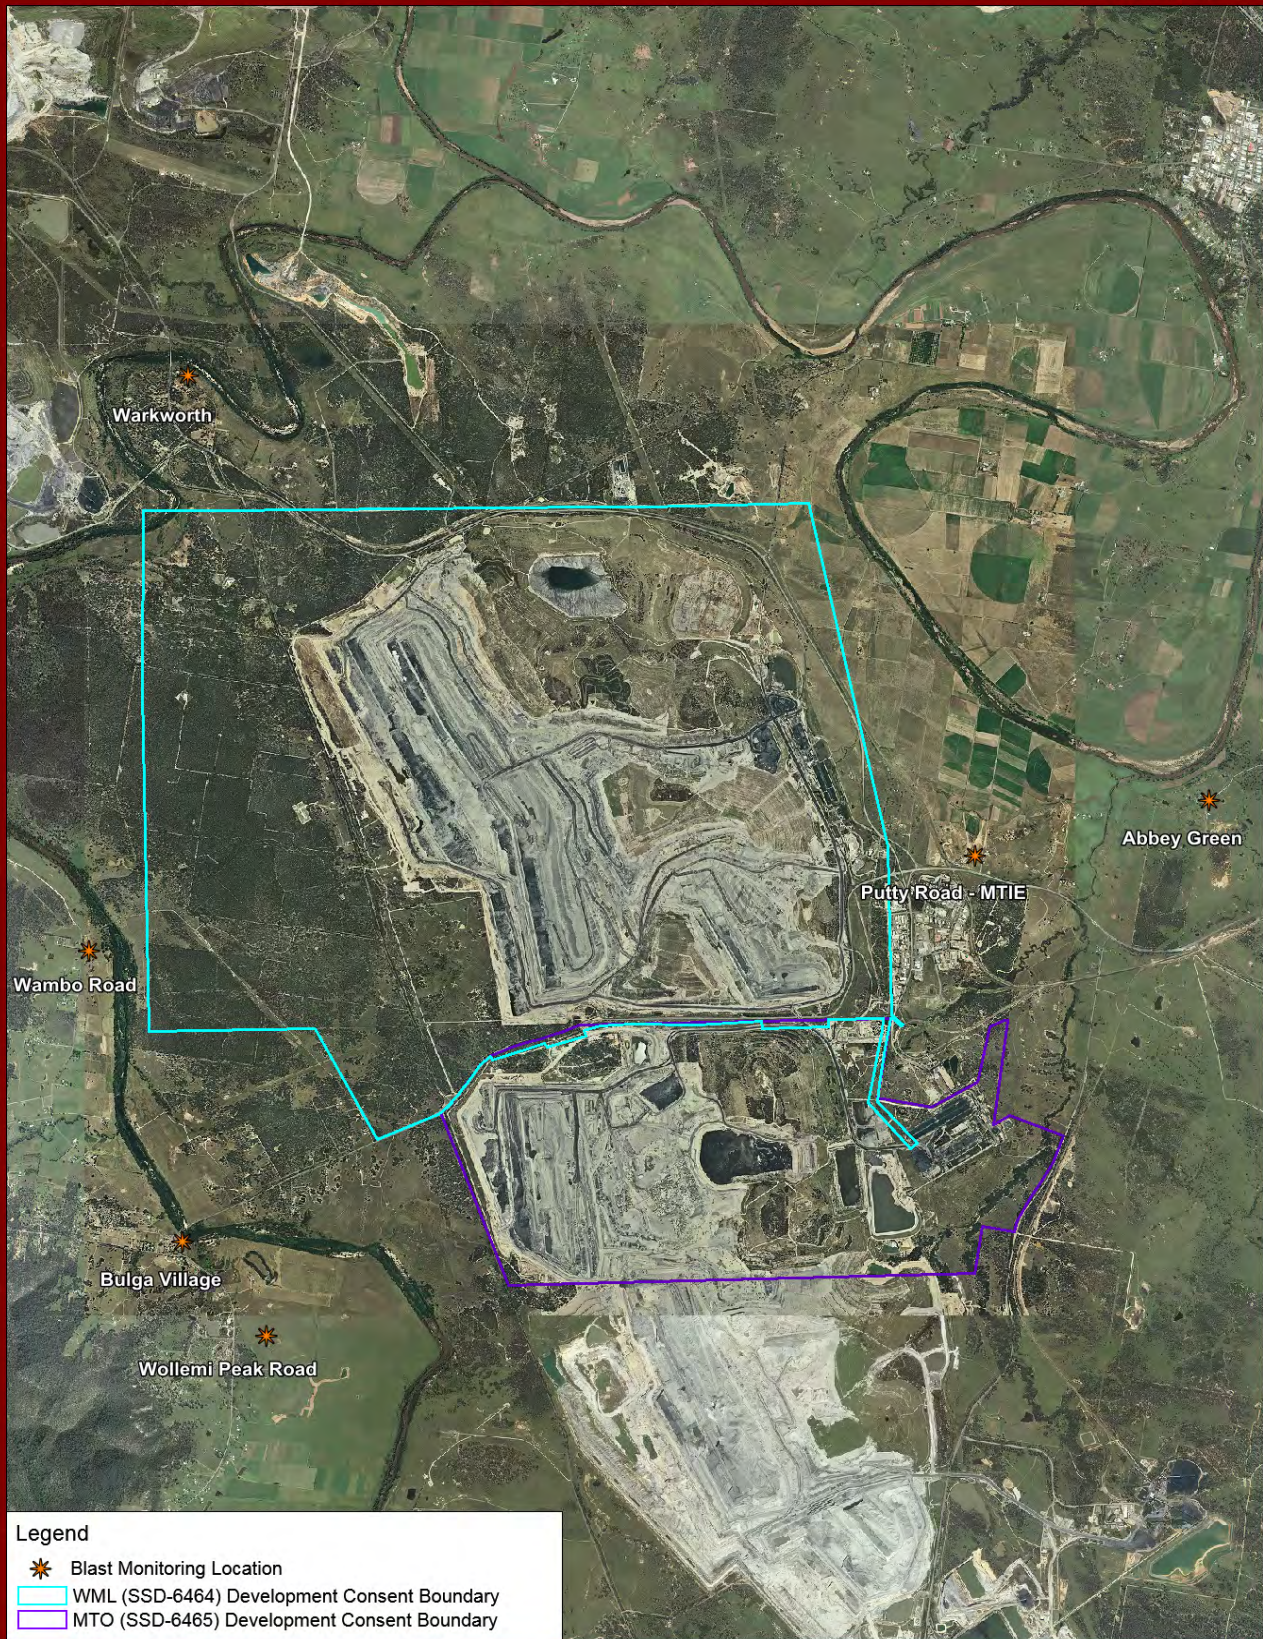
Figure 15: MTW Blast Monitoring Location Plan

Mount Thorley Warkworth Blast Monitoring Locations

The location of these monitors can be found in Figure 15.

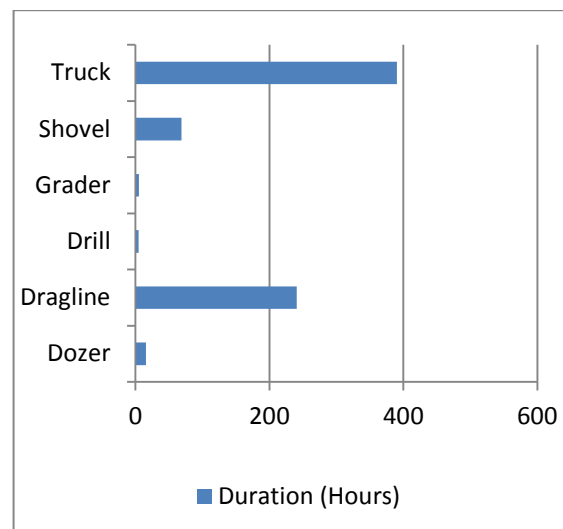
Figure 17: Operational Downtime by Equipment Type – January 2017

During January, a total of 726.1 hours of equipment downtime was logged in response to environmental events such as dust, noise and adverse meteorological conditions. Operational downtime by equipment type is shown in Figure 17.

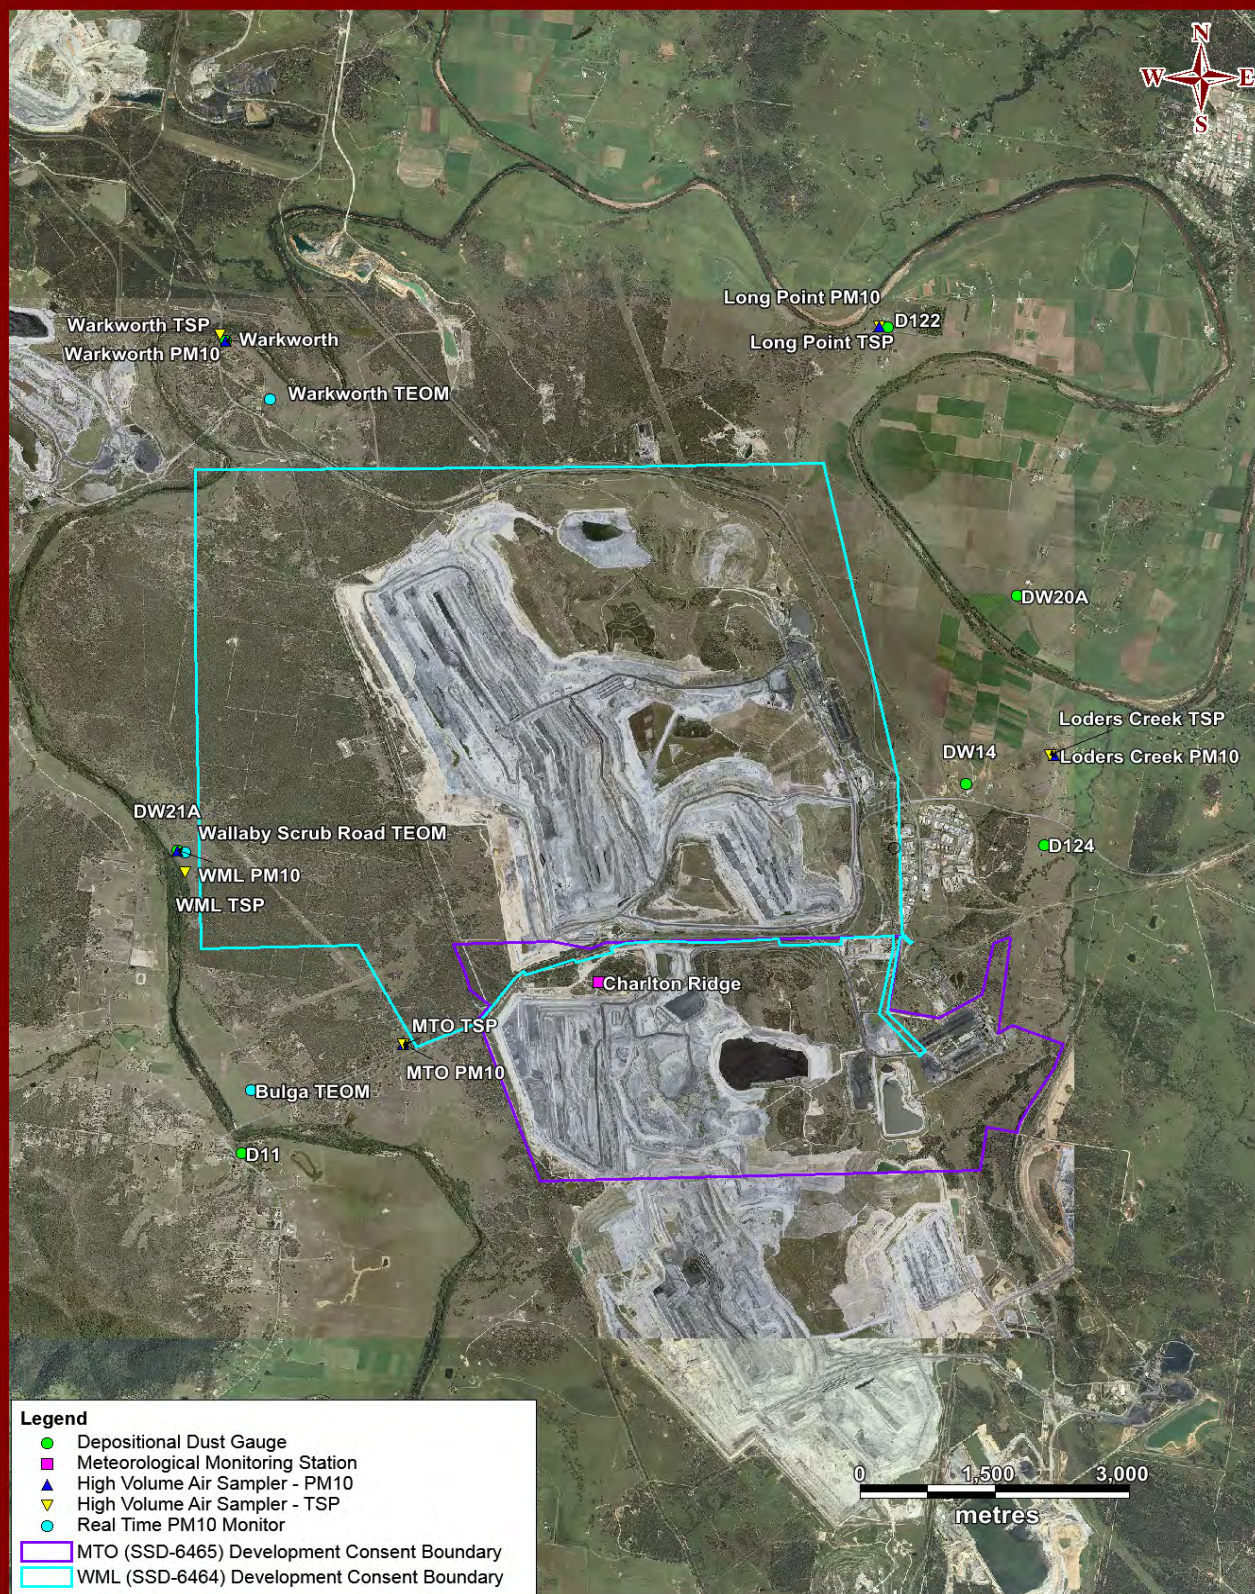
Figure 3: Air Quality Monitoring Locations

Suspended particulates are measured by a network of High Volume Air Samplers (HVAS) measuring Total Suspended Particulates (TSP) and Particulate Matter <10µm (PM₁₀). The location of these monitors can be found in Figure 3. Each HVAS was run for

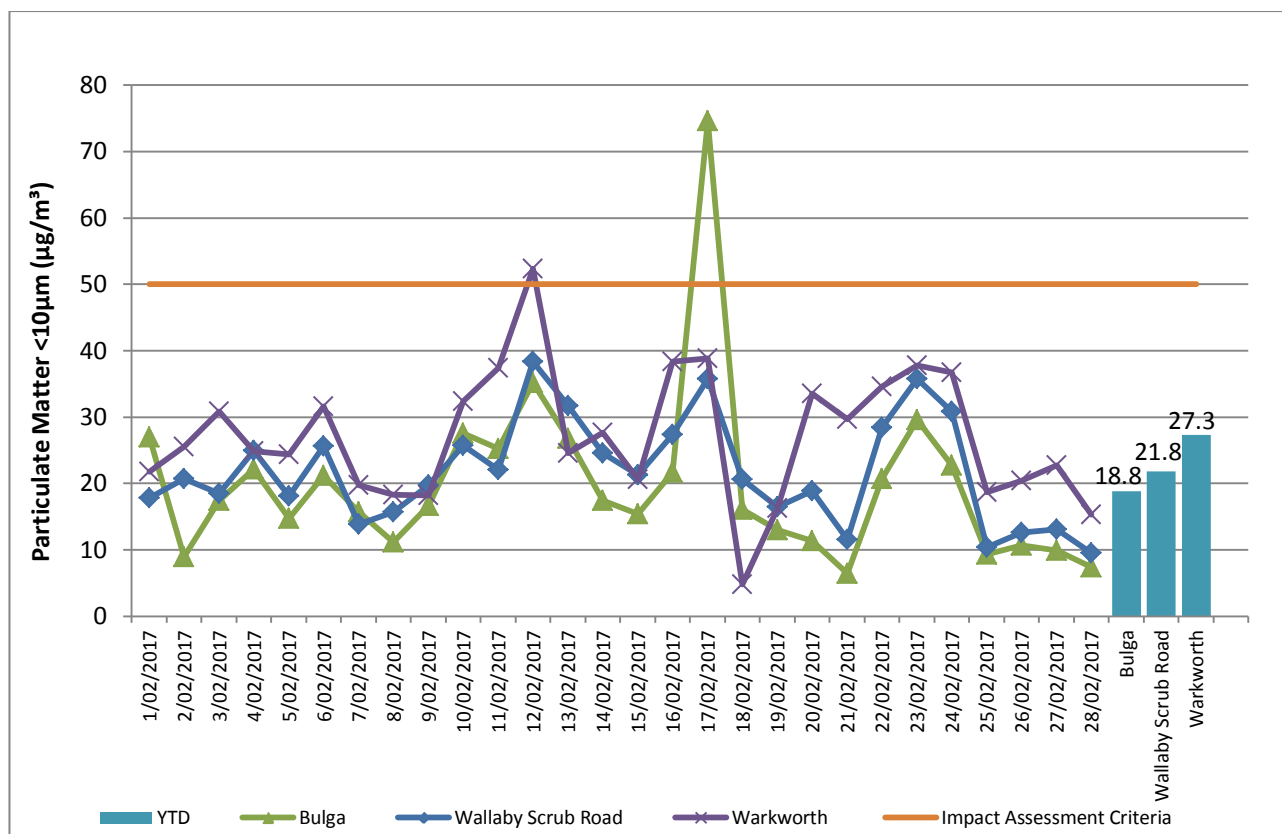
Figure 8: Real Time PM₁₀ daily 24hr average and annual average – February 2017

During February, the real time monitoring system generated 104 automated air quality related alerts, including 9 alerts for adverse meteorological conditions and 95 alerts for elevated PM₁₀ levels.

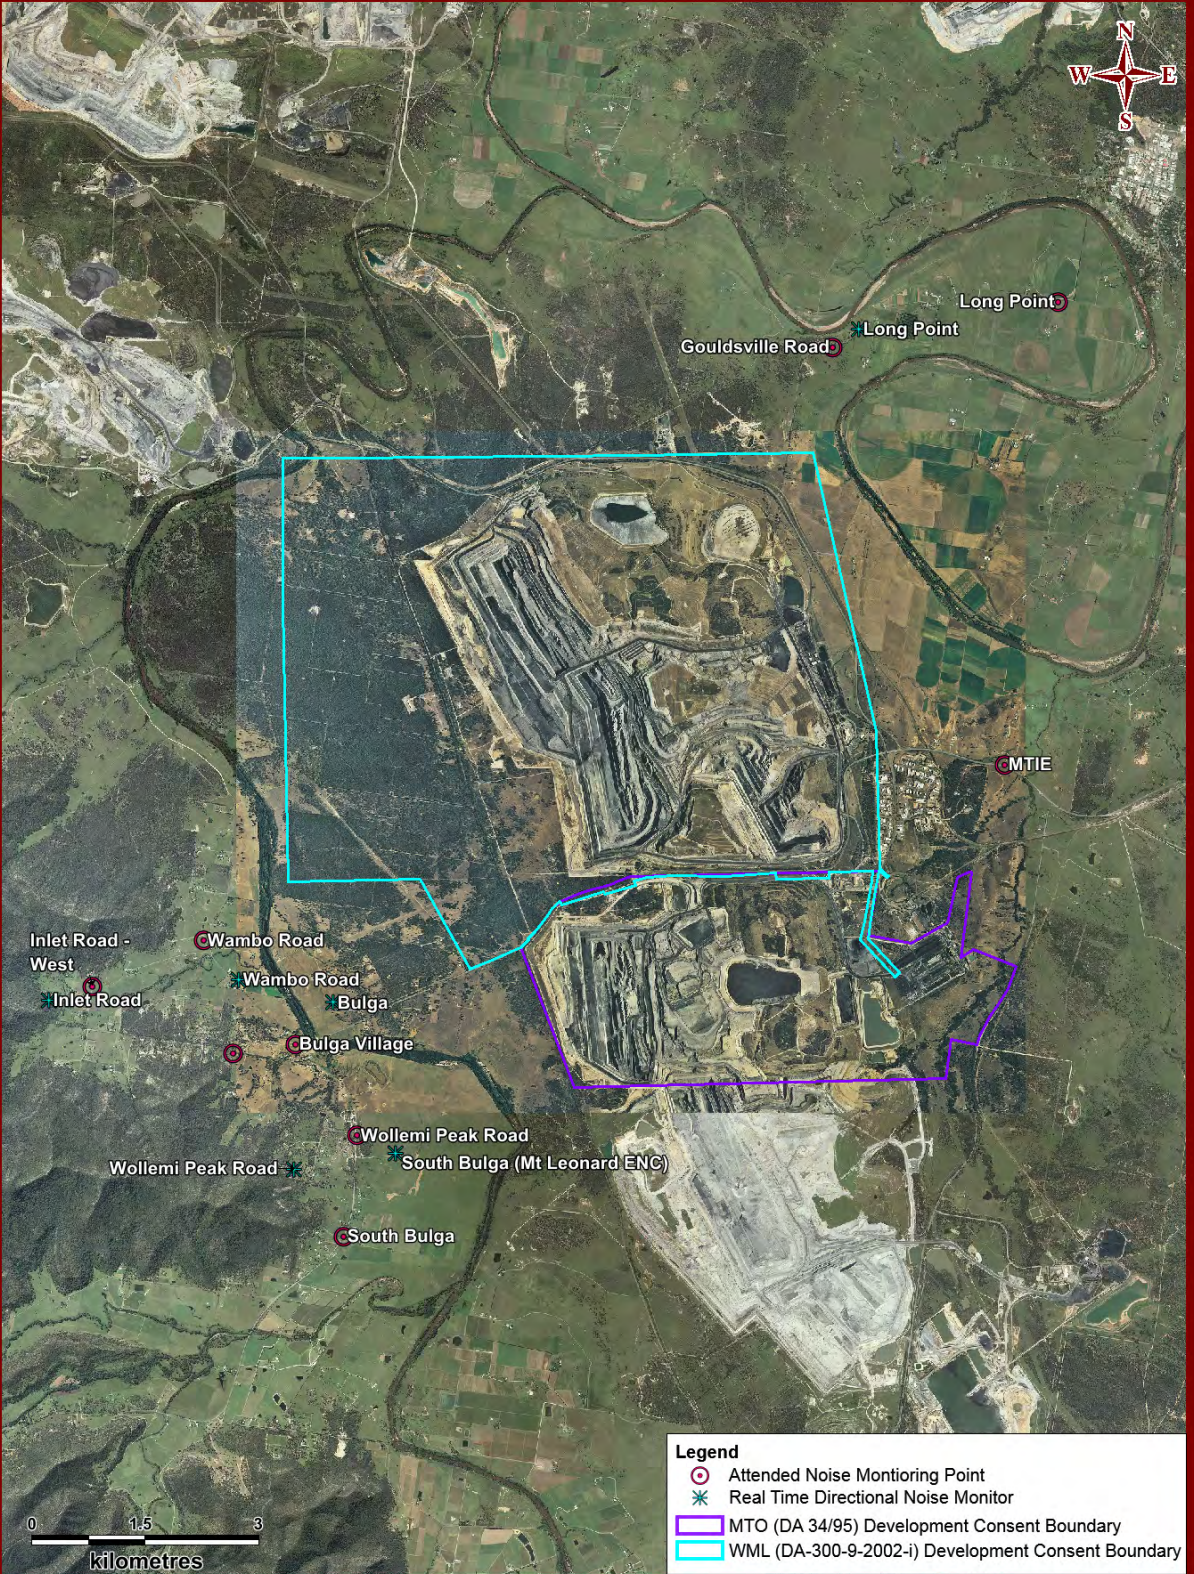
Figure 16: Noise Monitoring Location Plan

Resulting L_{Aeq} noise levels exceeded the WML impact assessment criteria by 1 dB at Inlet Road and by 2dB at Wambo Road, and remained in compliance at all other locations.

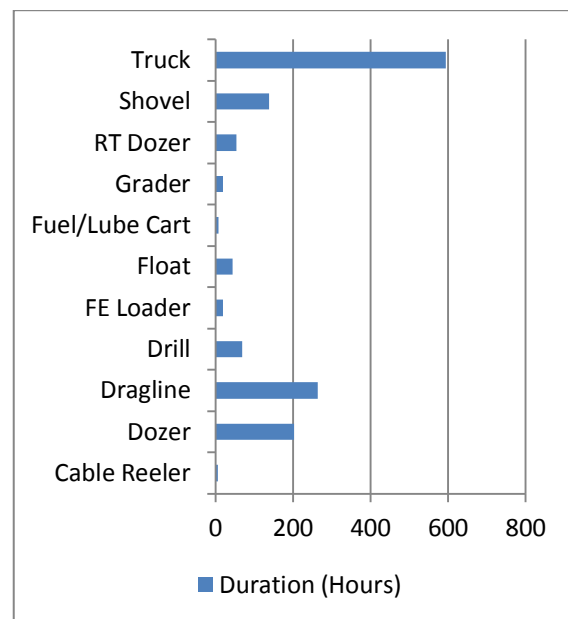
Figure 17: Operational Downtime by Equipment Type – February 2017

During February, a total of 1416.4 hours of equipment downtime was logged in response to environmental events such as dust, noise and adverse meteorological conditions. Operational downtime by equipment type is shown in Figure 17.

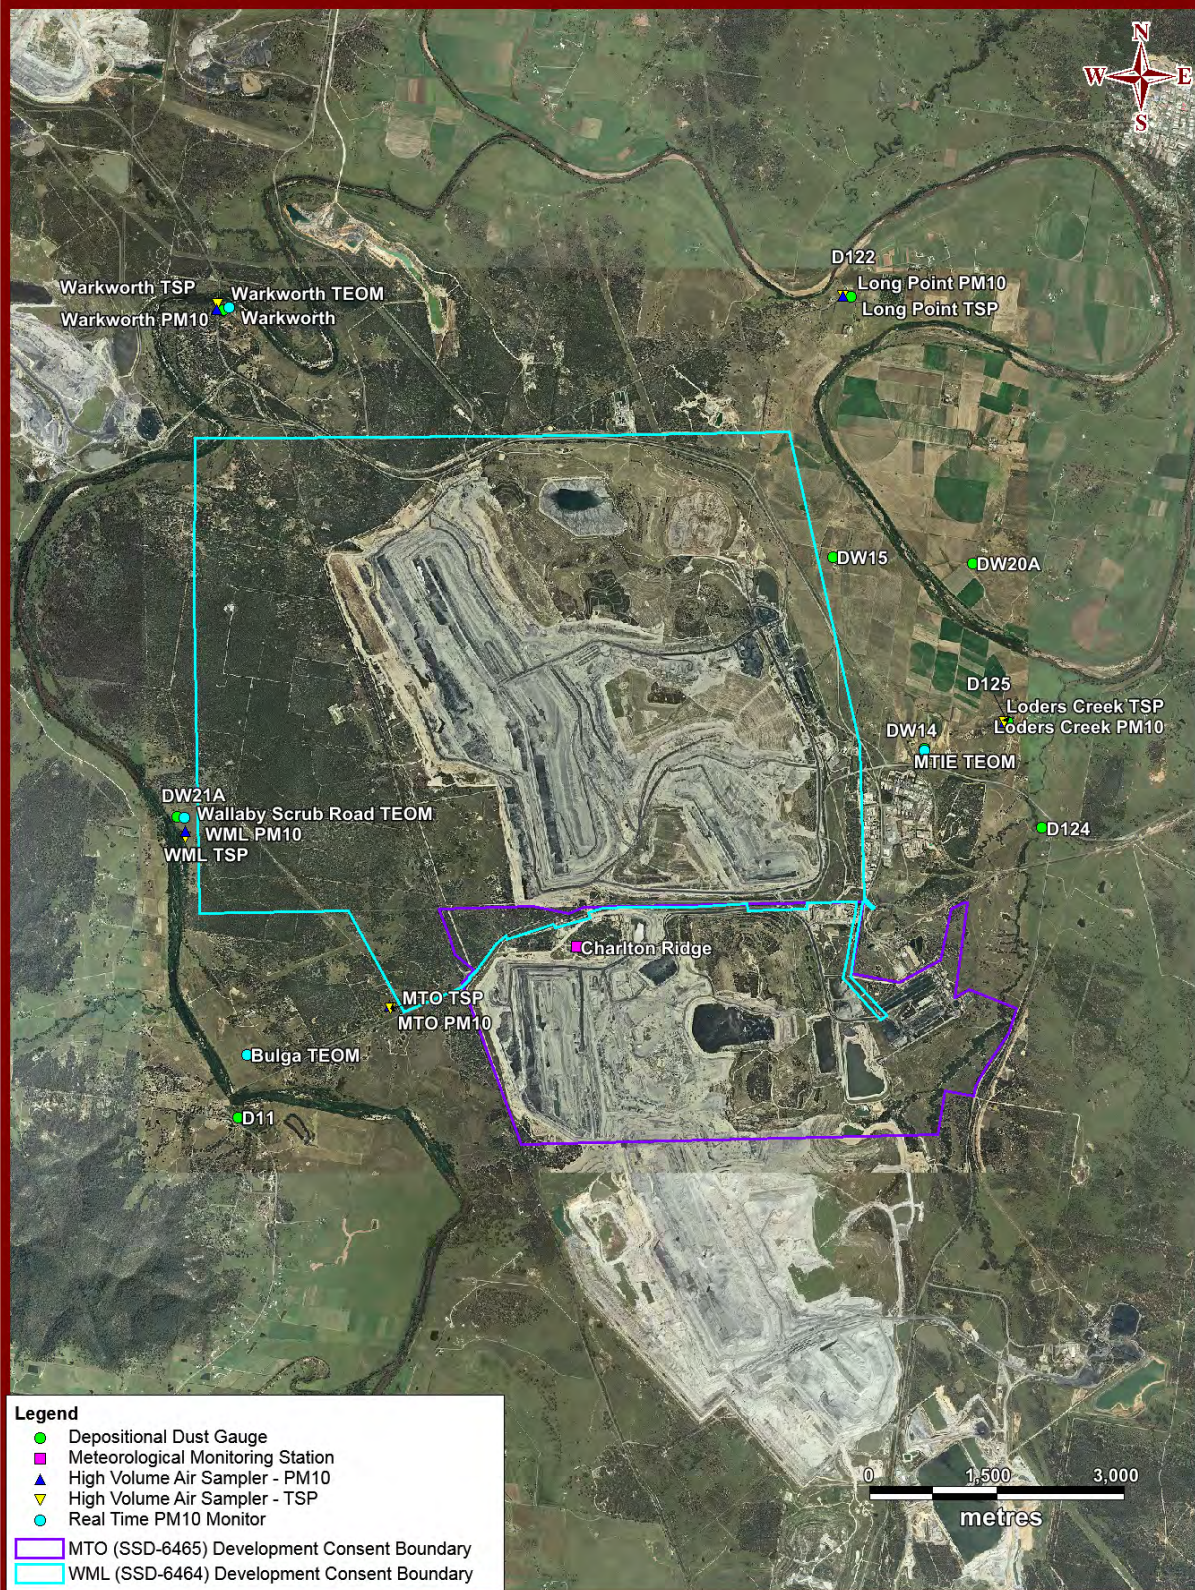
Figure 3: Air Quality Monitoring Locations

Suspended particulates are measured by a network of High Volume Air Samplers (HVAS) measuring Total Suspended Particulates (TSP) and Particulate Matter <10µm (PM₁₀). The location of these monitors can be found in Figure 3. Each HVAS was run for 24 hours on a six-day cycle in accordance with EPA requirements.

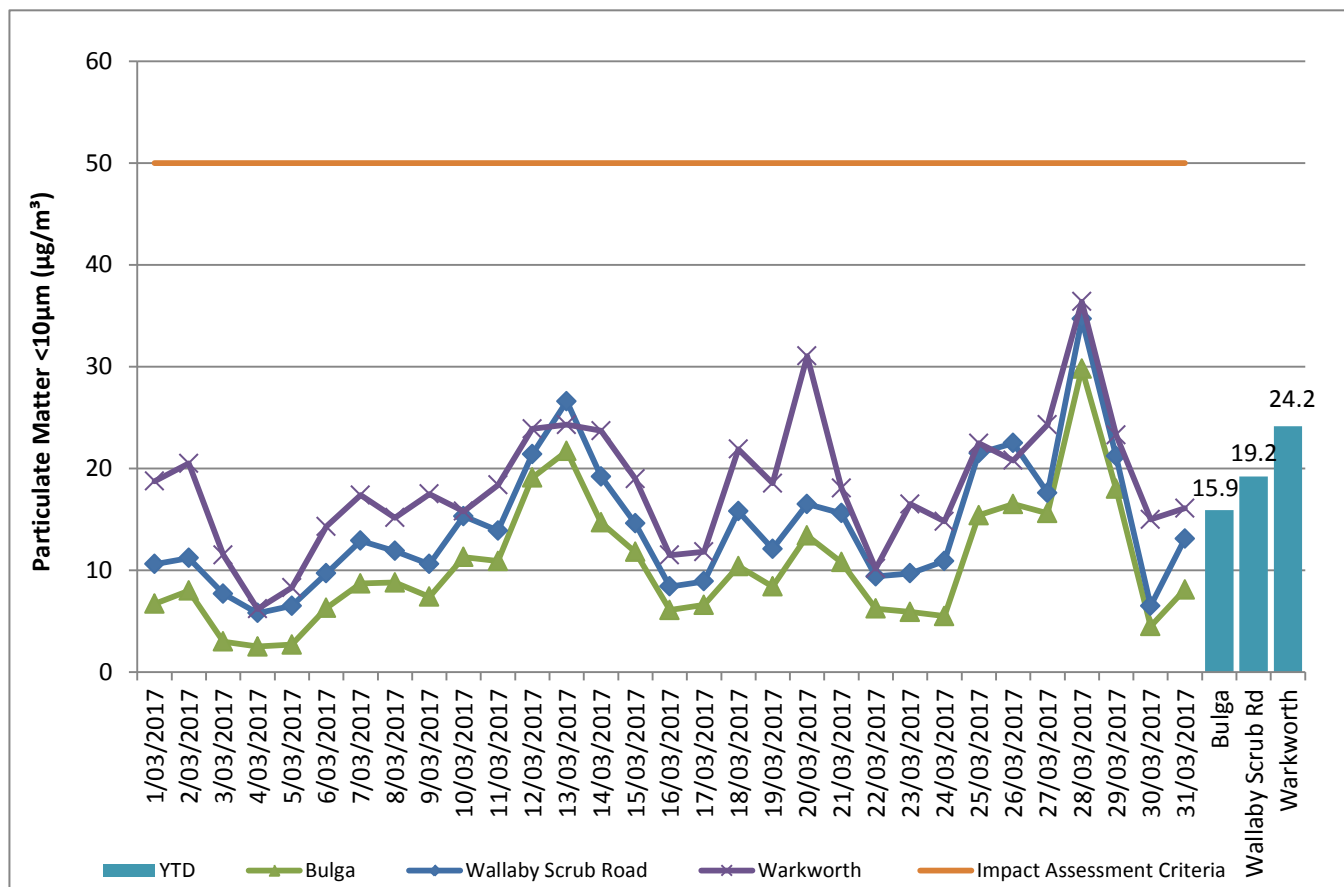
Figure 8: Real Time PM₁₀ 24hr average and Year-to-date average – March 2017

During March, the real time monitoring system generated 37 automated air quality related alerts, including 5 alerts for adverse meteorological conditions and 32 alerts for elevated dust levels.
