Mount Thorley Warkworth
Community Consultative Committee

Business Papers – May 2017

Materials ahead of meeting of the committee on 22 May 2017

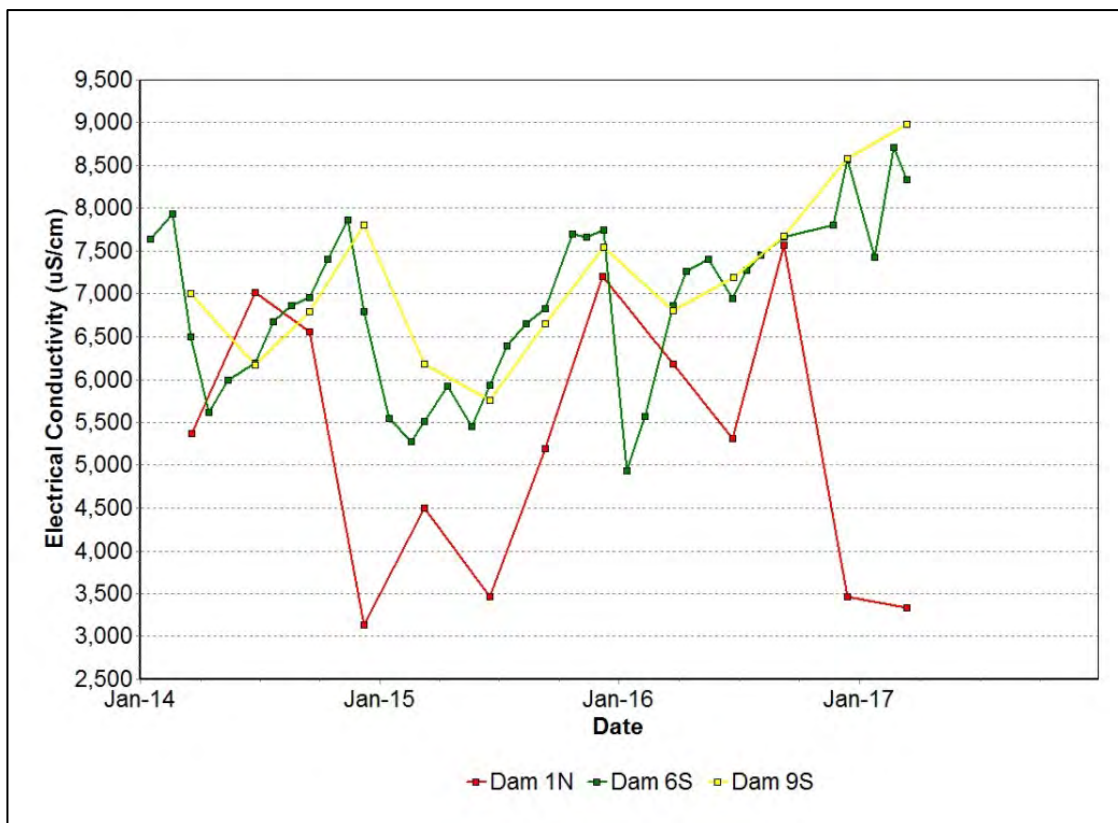
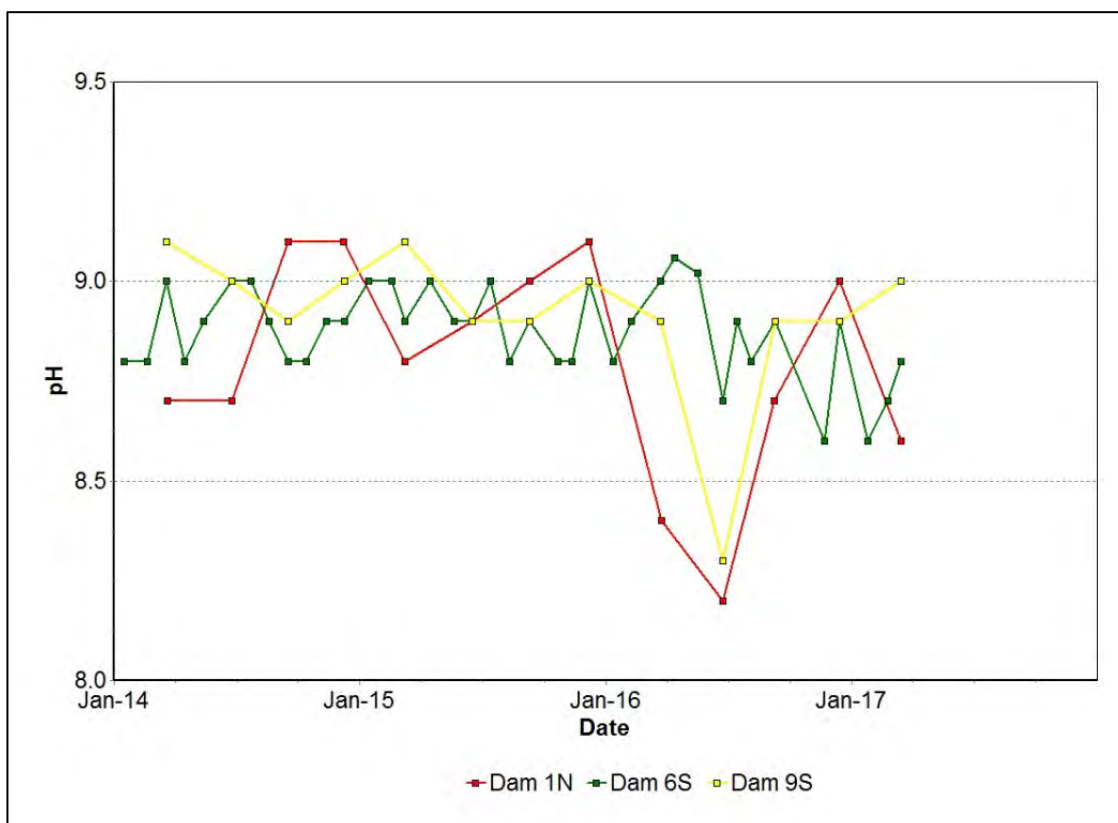
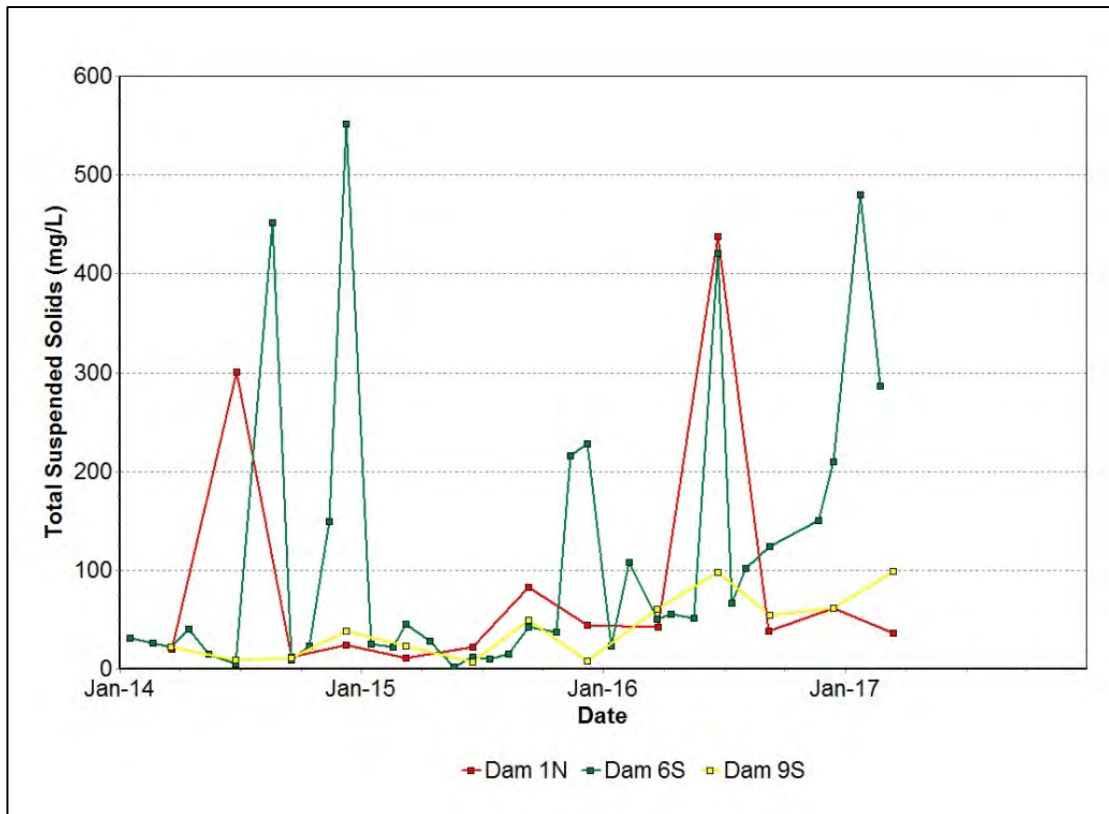
Figure 9 to Figure 11 show the long term surface water trend (2014 – current) within MTW mine dams. Figure 12 to Figure 14 show the long term surface water trend (2014 - current) in surrounding watercourses.

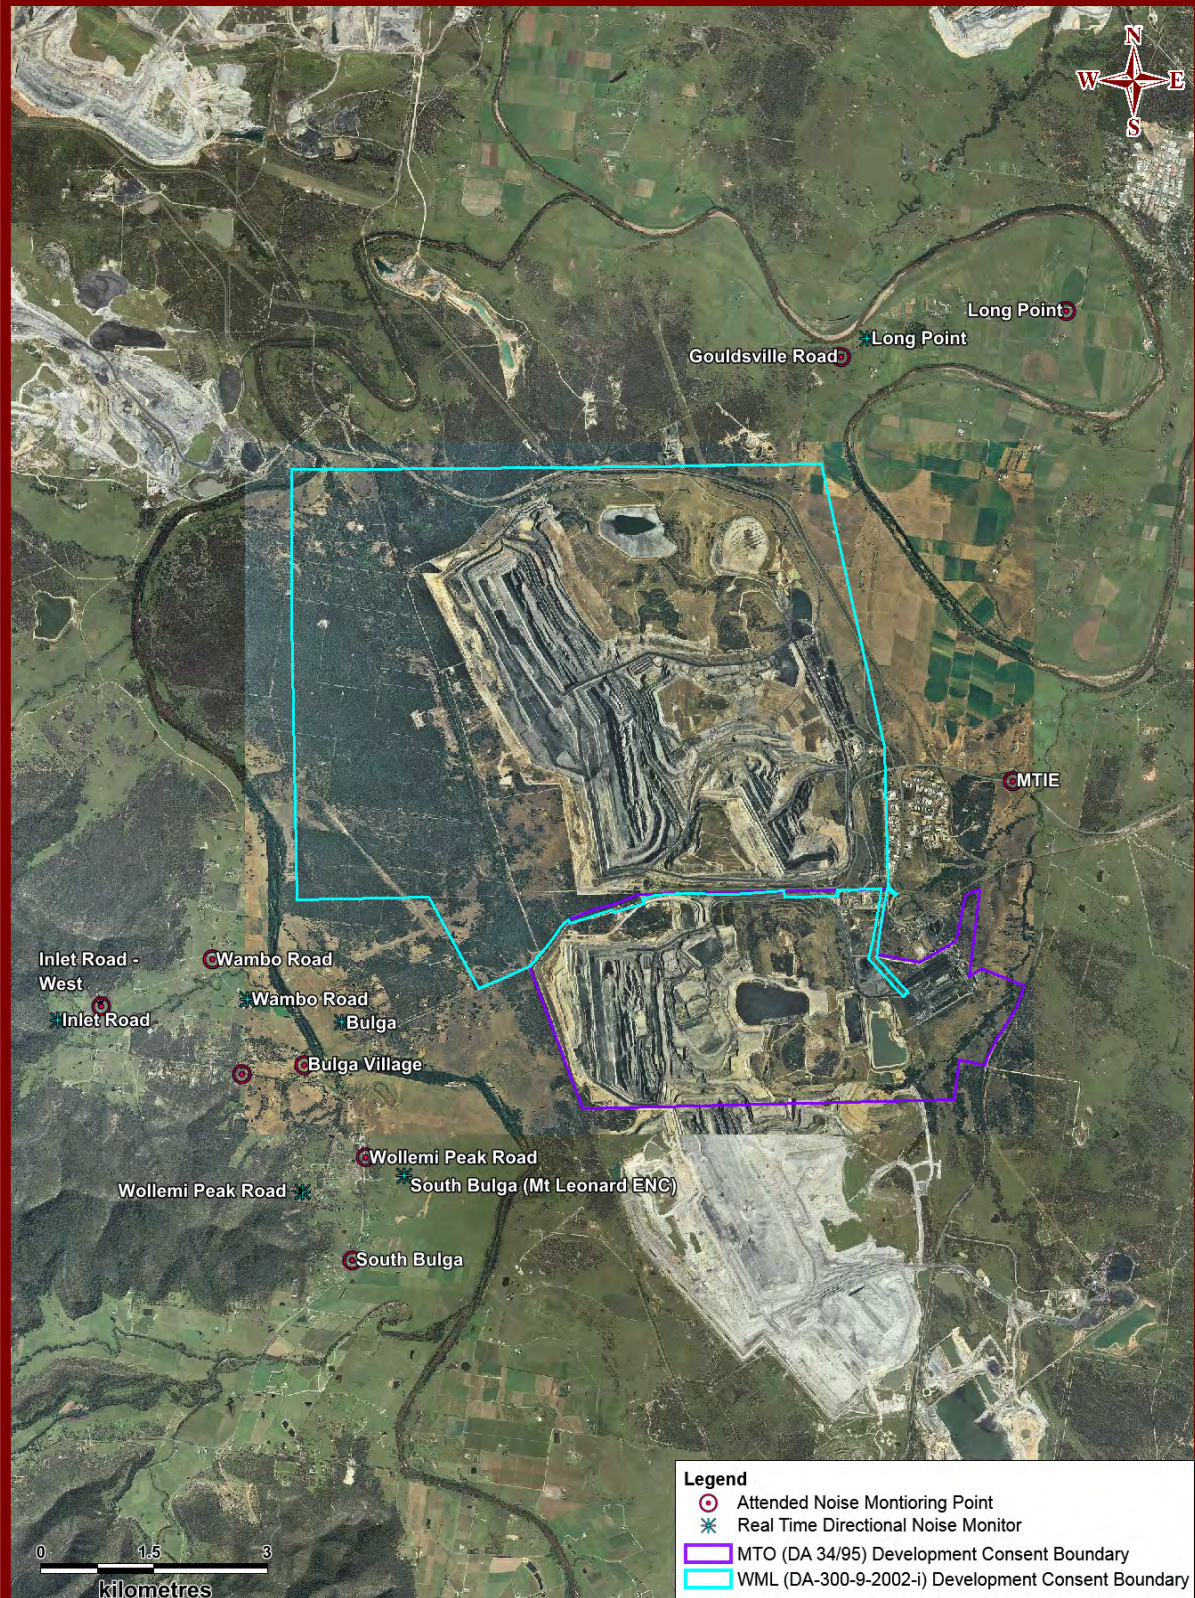
Figure 67: Noise Monitoring Location Plan

**Mount Thorley Warkworth
Noise Monitoring Programme**

Routine attended noise monitoring is carried out in accordance with the MTW Noise Management Plan. A review against EIS predictions will be reported in the Annual Review. The purpose of the noise surveys is to quantify and describe the acoustic environment around the site and compare results with specified limits. Unattended monitoring (real time noise monitoring) also occurs at seven sites surrounding MTW. The attended noise monitoring locations are displayed in Figure 67.
