Mount Thorley Warkworth

Community Consultative Committee (CCC)

Business Papers – August 2017

Materials supplied to members for the meeting on the 14th August 2017.

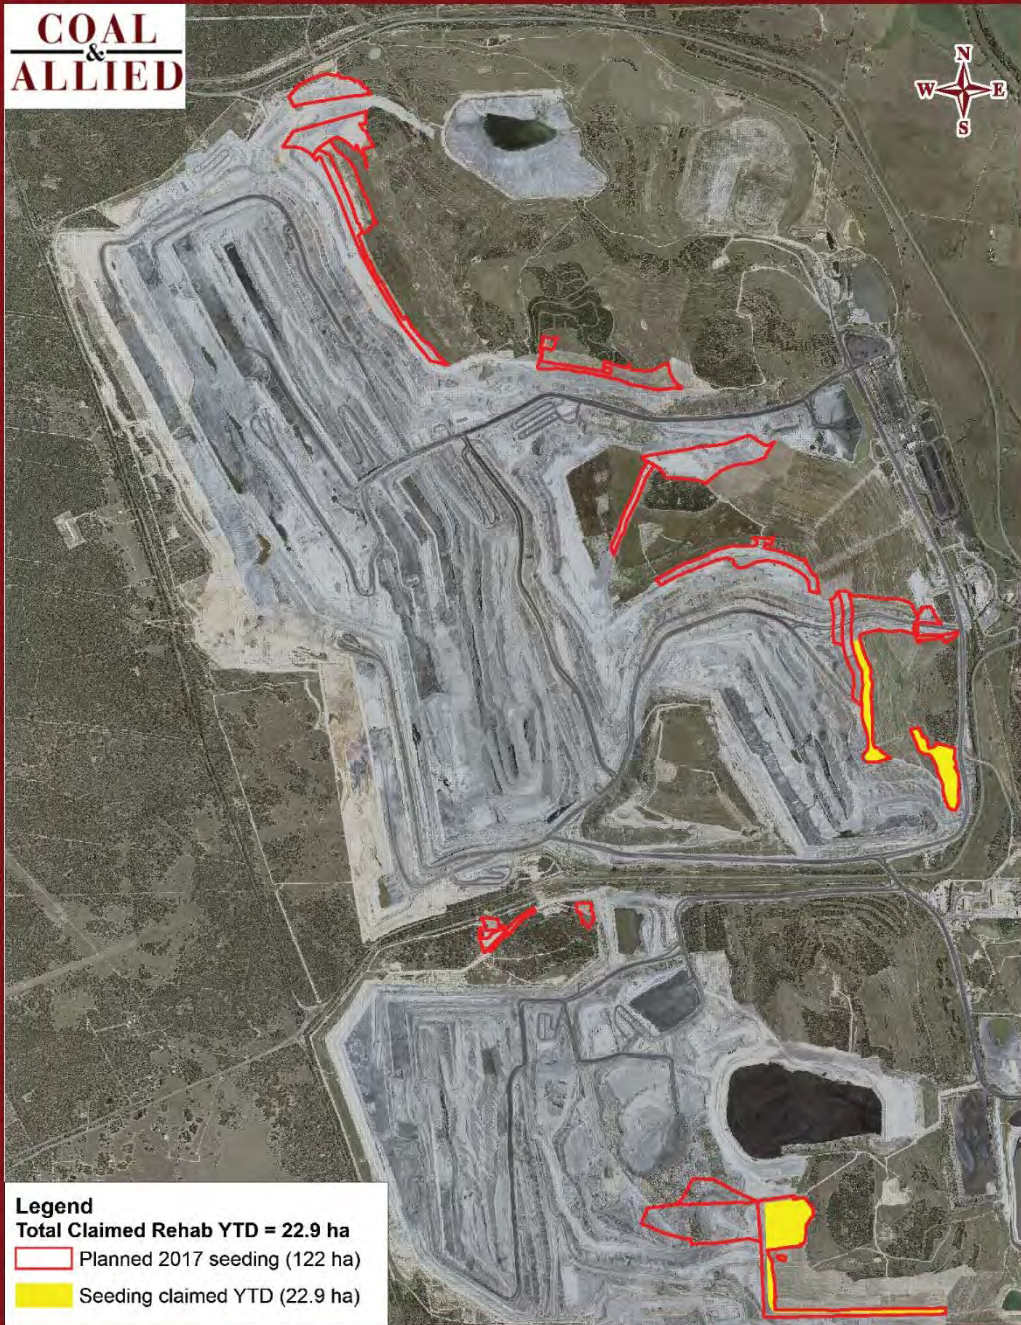
Plan of: Disturbance 2017

Total Claimed Rehab YTD = 22.9 ha

Planned 2017 seeding (122 ha)

Seeding claimed YTD (22.9 ha)

New disturbance was **predominantly in Warkworth's North Pit area** for planned mine progression. A total of 27.5 ha has been disturbed as of the June 30th 2017.

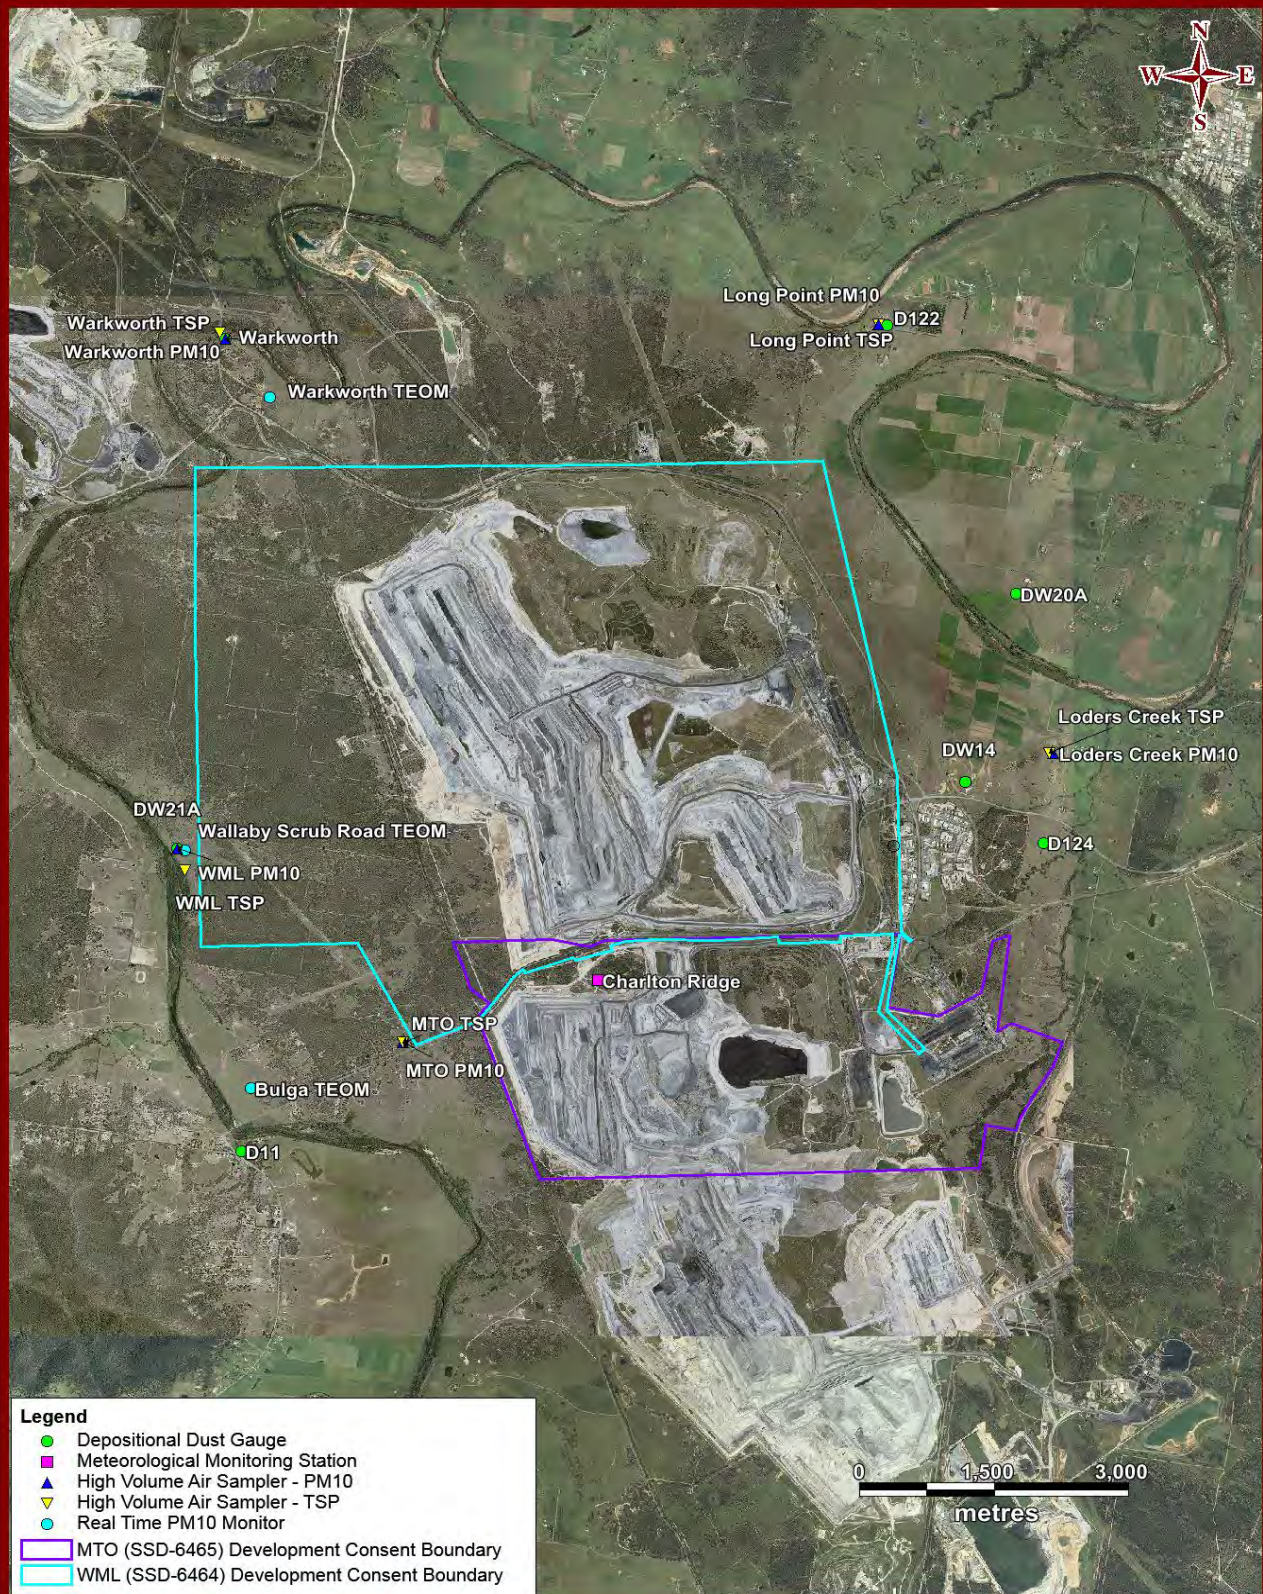
Figure 3: Air Quality Monitoring Locations

Suspended particulates are measured by a network of High Volume Air Samplers (HVAS) measuring Total Suspended Particulates (TSP) and Particulate Matter <10µm (PM₁₀). The location of these monitors can be found in Figure 3. Each HVAS was run for 24 hours on a six-day cycle in accordance with EPA requirements.

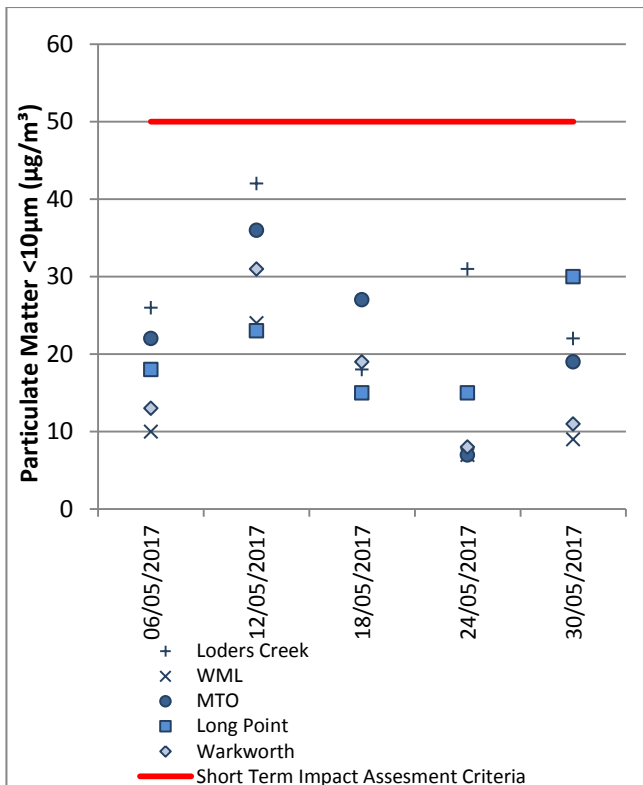
Figure 5 shows the individual PM₁₀ results at each monitoring station against the short term impact assessment criteria of 50µg/m³.

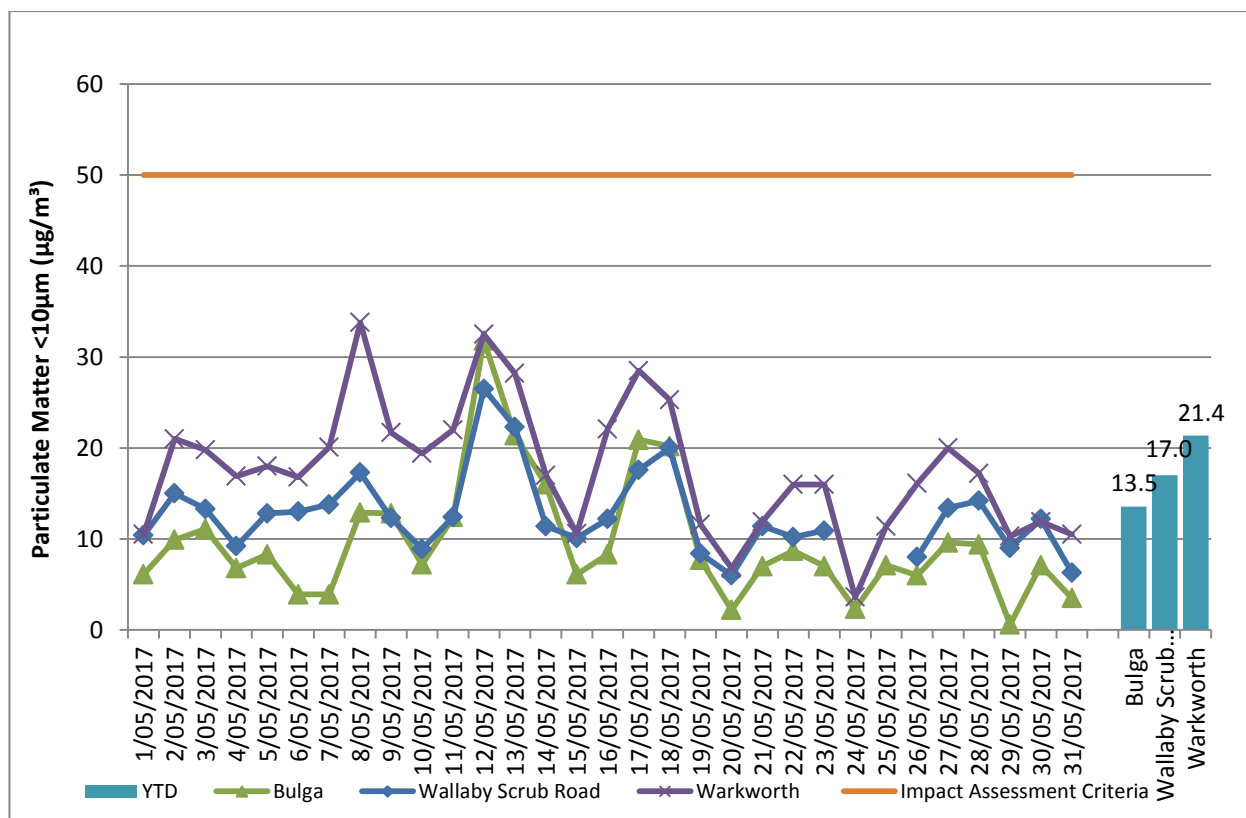
During May, the real time monitoring system generated 46 automated air quality related alerts for elevated PM₁₀ levels.

Figure 8: Real Time PM₁₀ daily 24hr average and annual average – May 2017

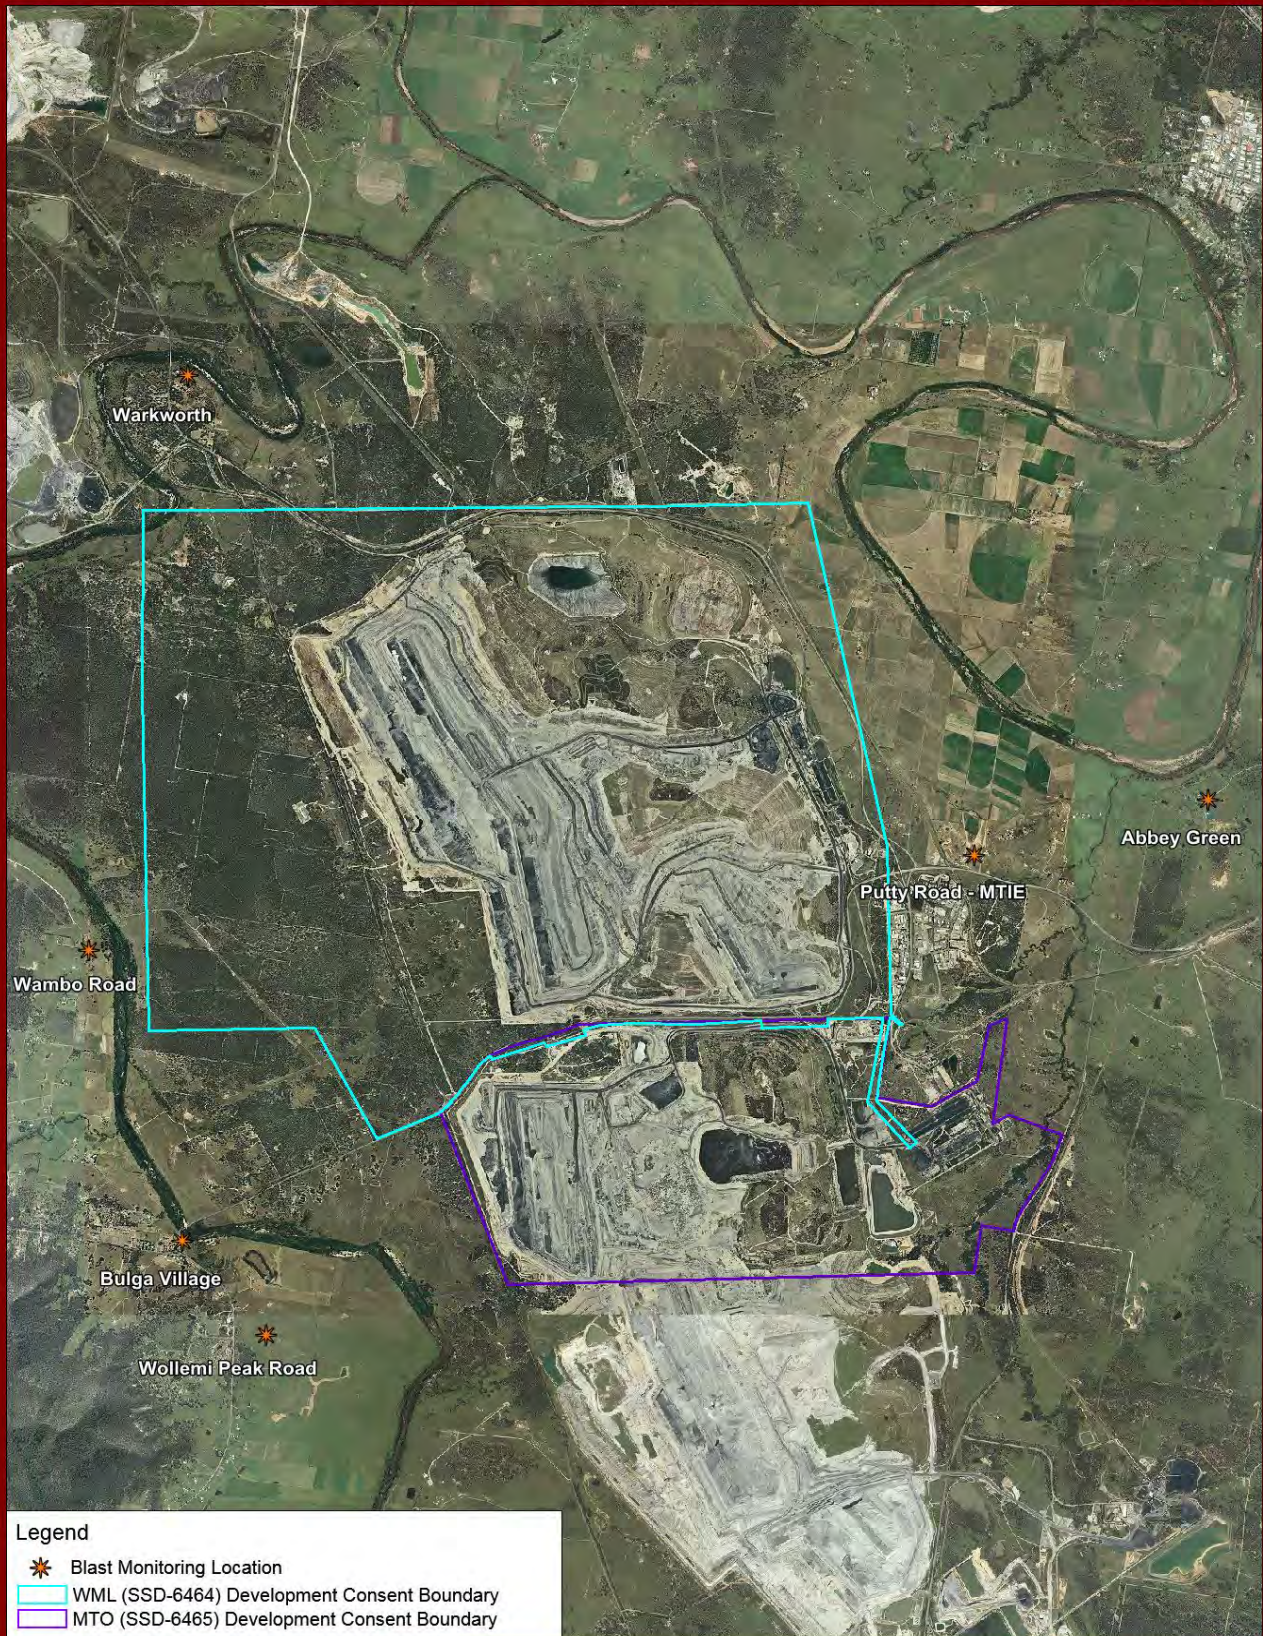
Figure 15: MTW Blast Monitoring Location Plan

**Mount Thorley Warkworth
Blast Monitoring Locations**

The location of these monitors can be found in Figure 15.

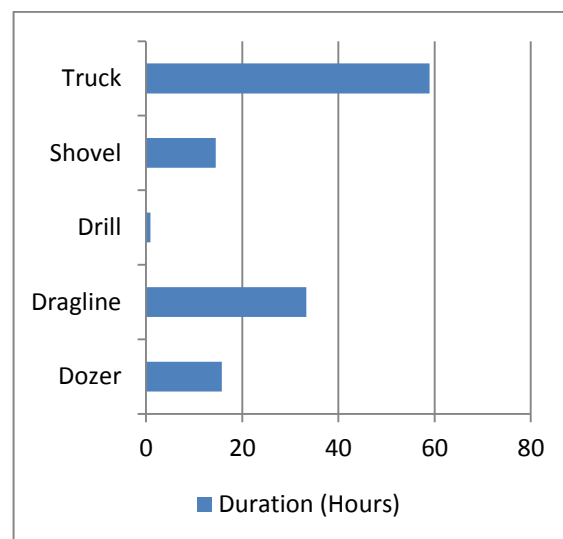
During May, a total of 123.5.0 hours of equipment downtime were logged in response to environmental events such as dust, noise and adverse meteorological conditions. Operational downtime by equipment type is shown in Figure 17.

Figure 17: Operational Downtime by Equipment Type – May 2017

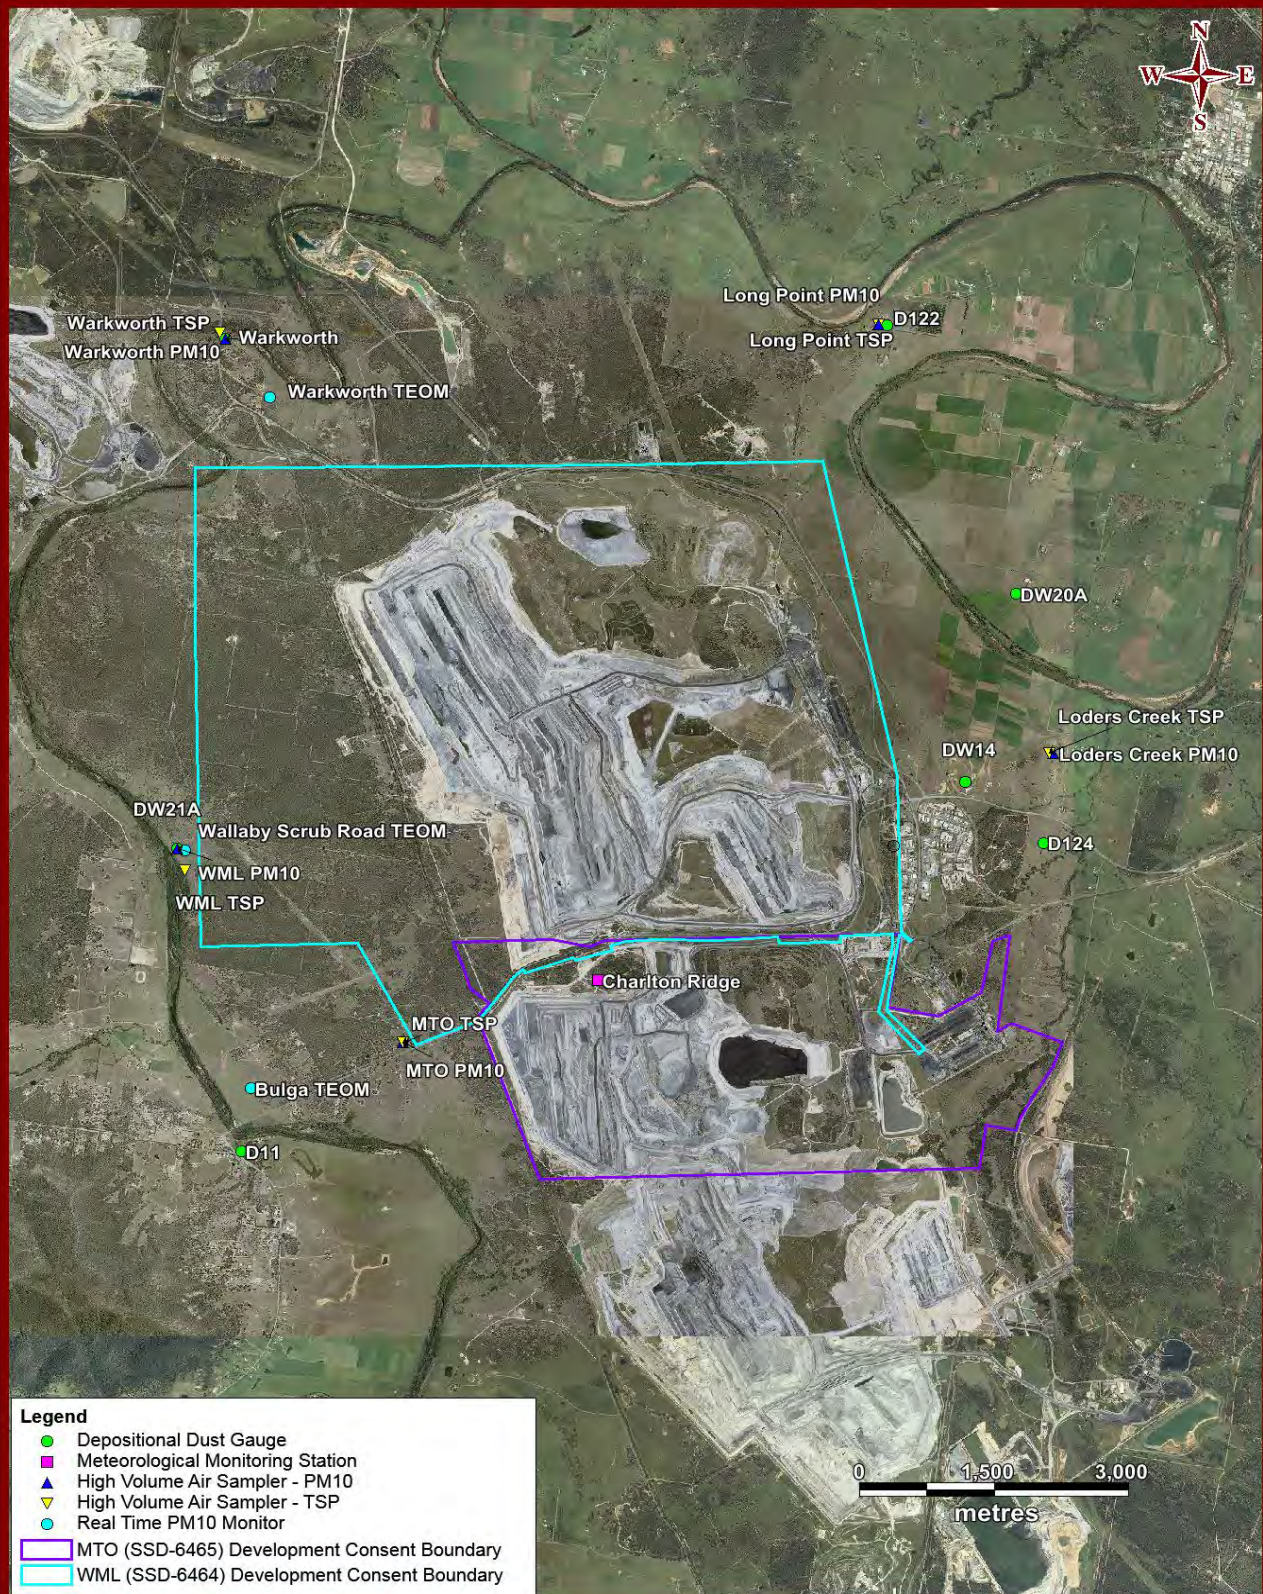
Figure 3: Air Quality Monitoring Locations

Suspended particulates are measured by a network of High Volume Air Samplers (HVAS) measuring Total Suspended Particulates (TSP) and Particulate Matter <10µm (PM₁₀). The location of these monitors can be found in Figure 3. Each HVAS was run for 24 hours on a six-day cycle in accordance with EPA requirements.

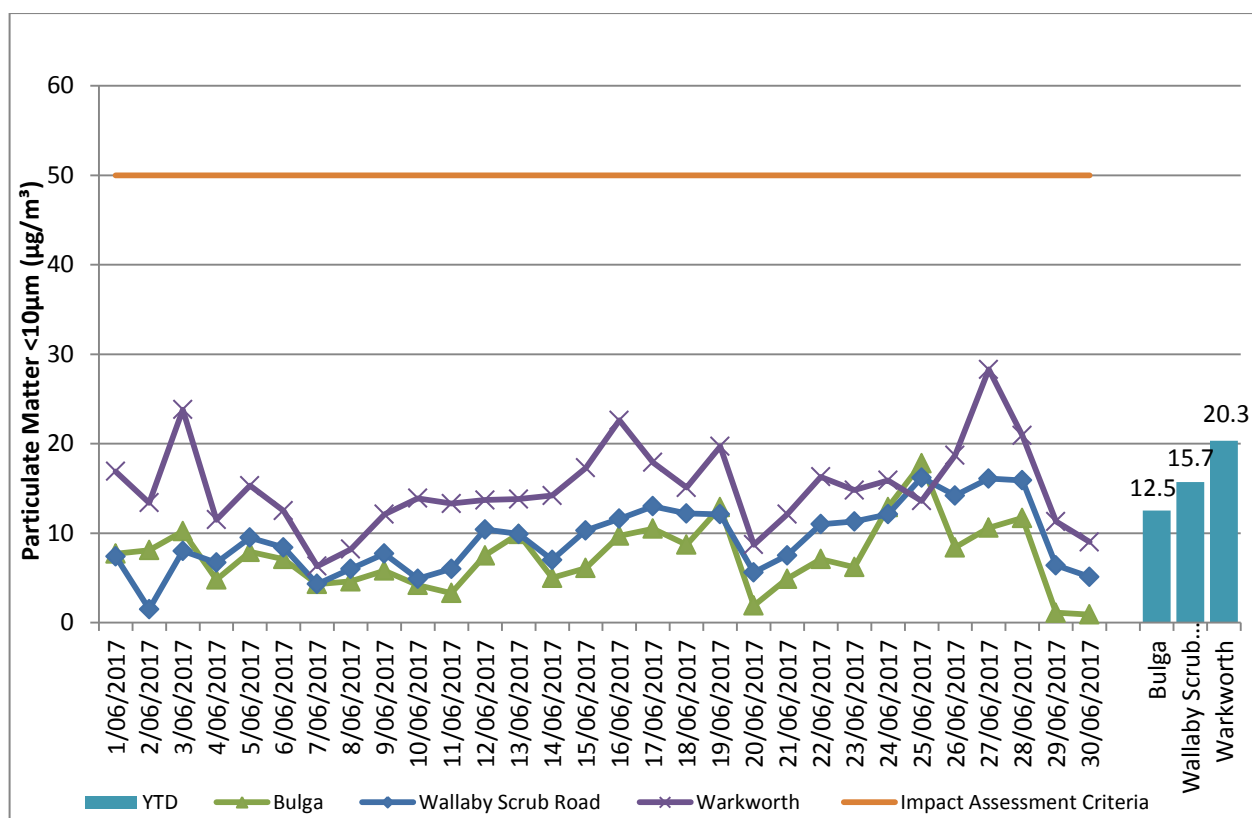
During June, the real time monitoring system did not generate any air quality related alarms.

Figure 8: Real Time PM₁₀ 24hr average and Year-to-date average – June 2017

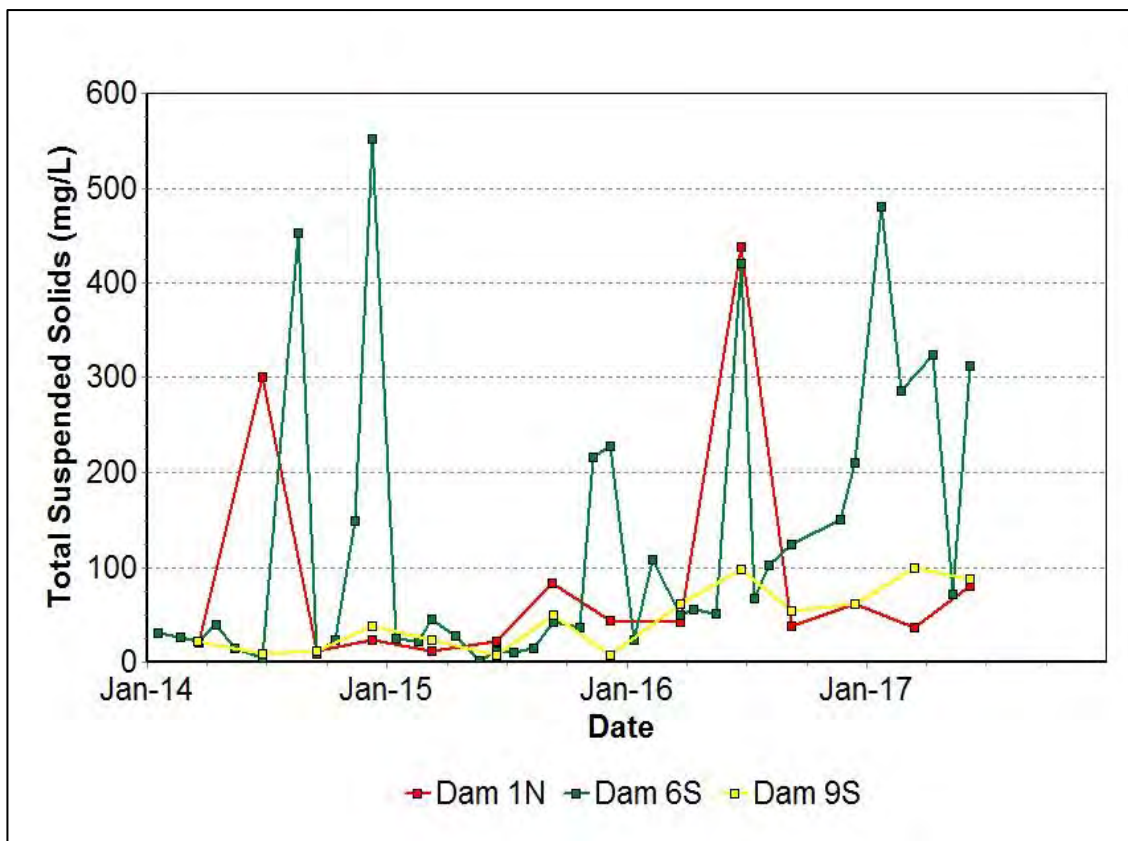
Figure 11: Site Dams Total Suspended Solids Trend 2014 – Current

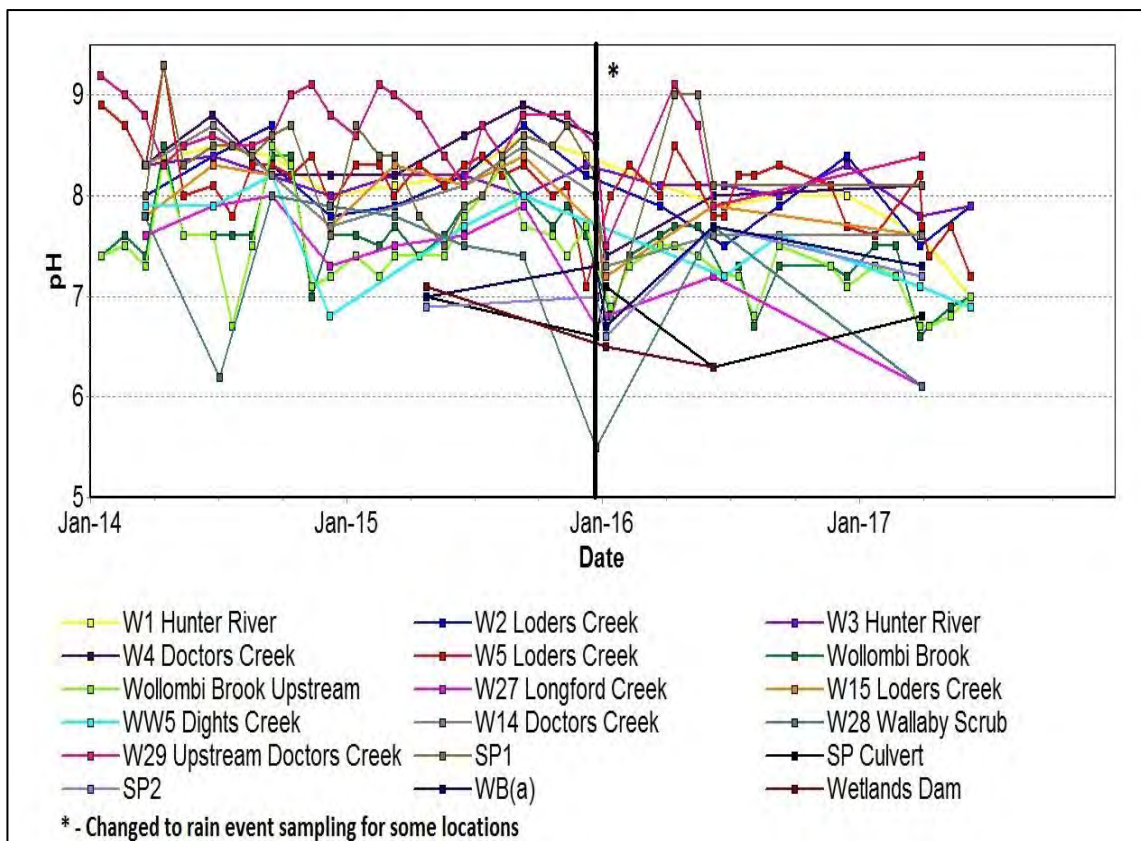
Figure 13: Watercourse pH Trend 2014 – Current

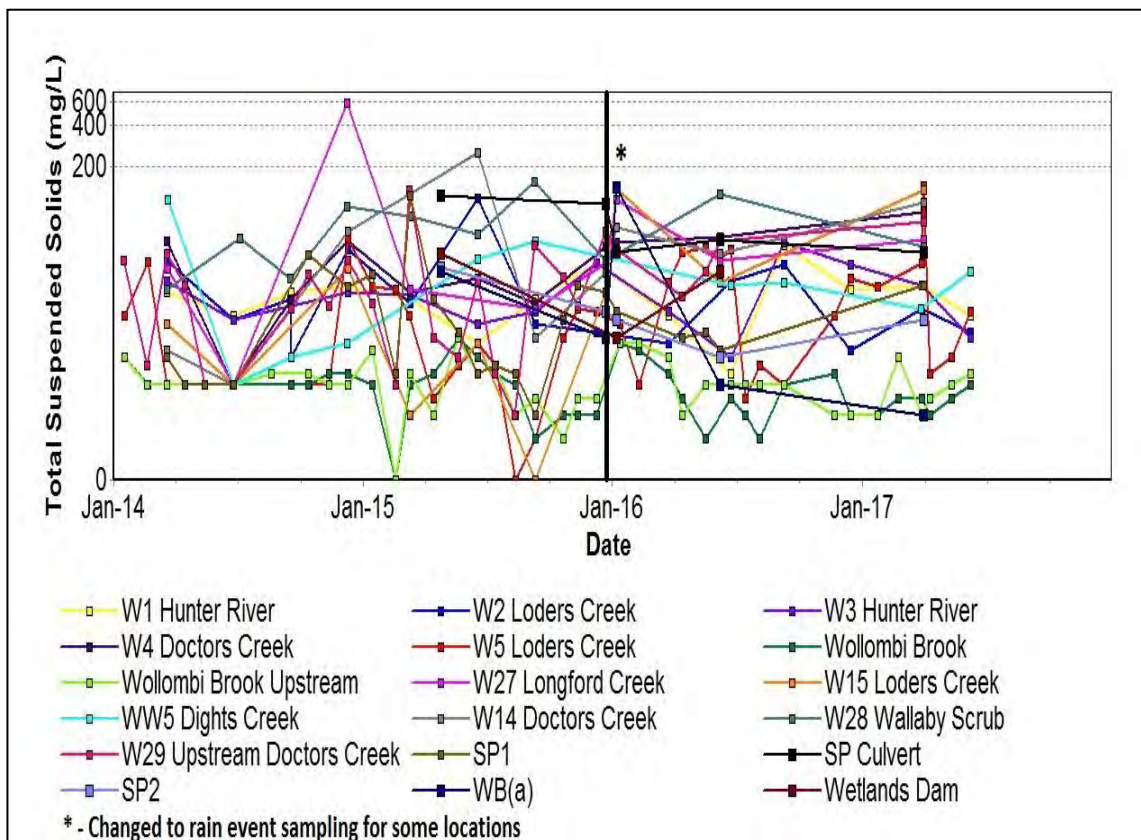
Figure 14: Watercourse Total Suspended Solids Trend 2014 – Current

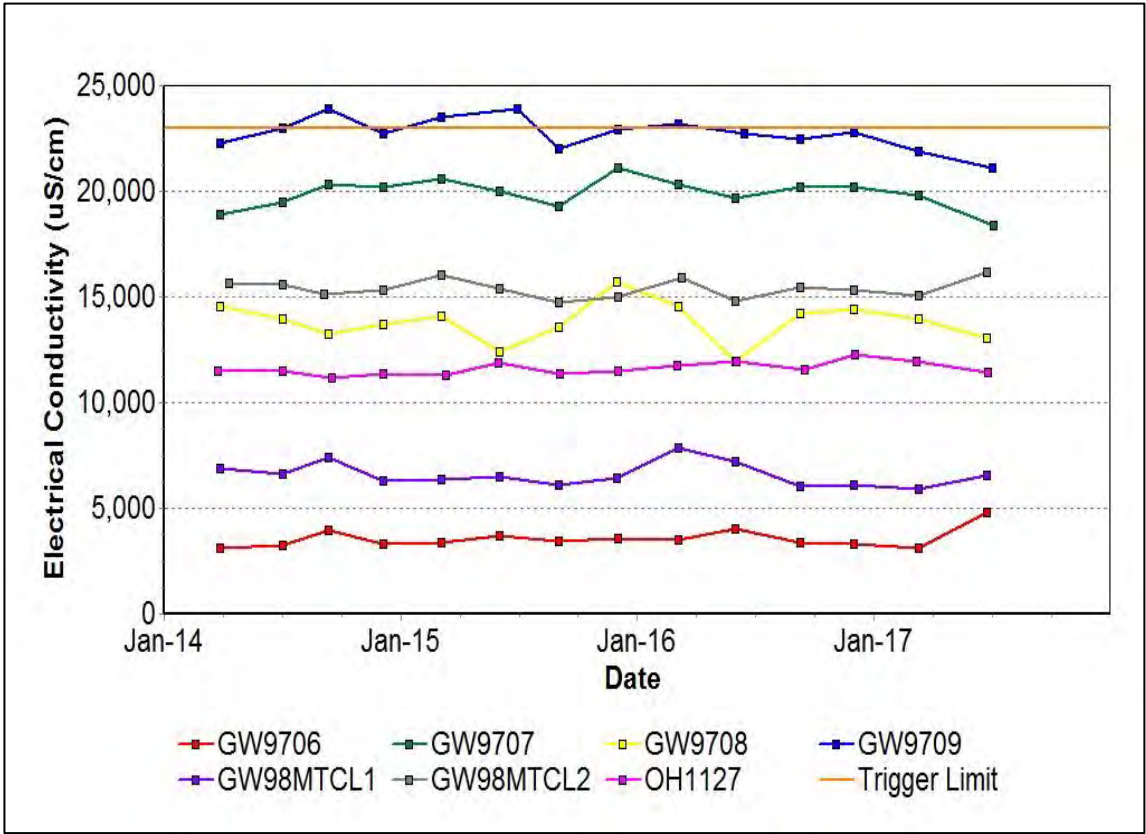
Figures 16 to 58 show the long term water quality trends (2014 – current) for groundwater bores monitored at MTW.

Figure 16: Bayswater Seam Electrical Conductivity Trend – June 2017
