# Mount Thorley Warkworth

## Monthly Environmental Report

### August 2017

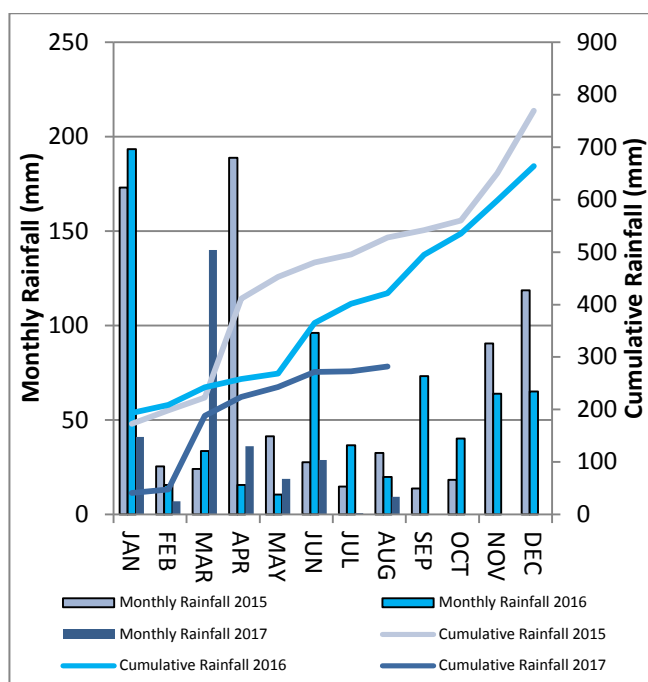
**Figure 1: Rainfall Trend YTD**

Rainfall for the period is summarised in Table 1, the year-to-date trend and historical trend are shown in Figure 1.

2017	Monthly Rainfall (mm)	Cumulative Rainfall (mm)
August	9.4	282.0

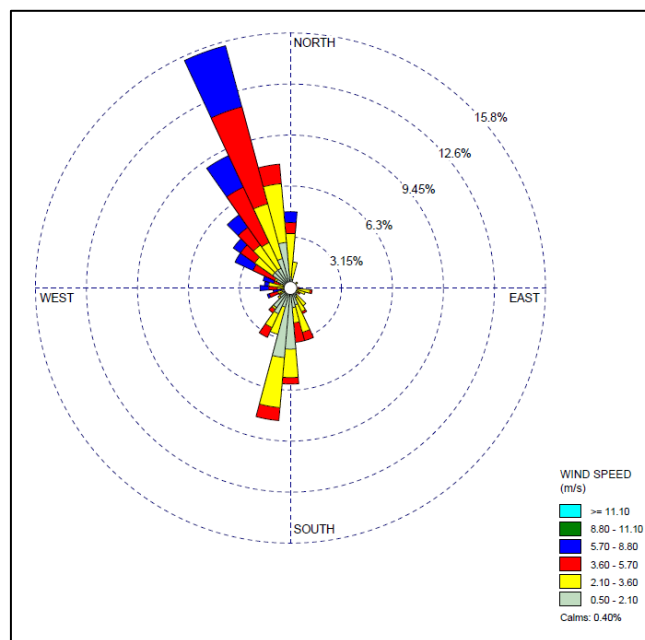
**Figure 2: Charlton Ridge Wind Rose – August 2017**

Winds from the North-West were dominant throughout the reporting period as shown in Figure 2.

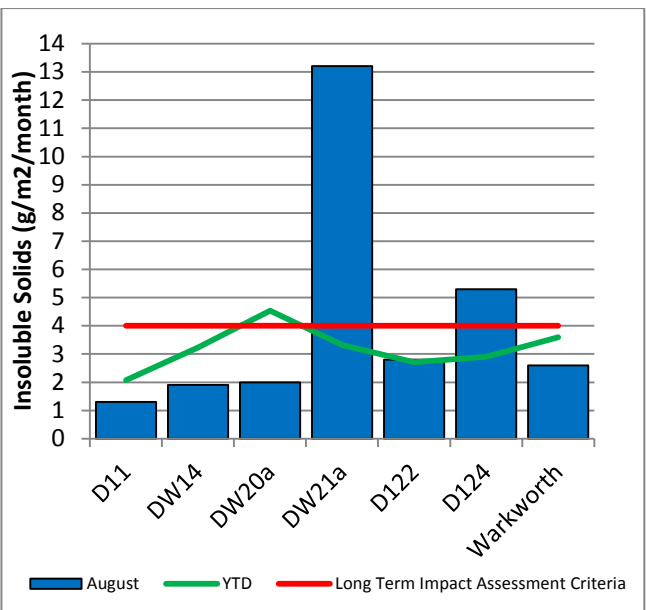
**Figure 4: Depositional Dust – August 2017**

Figure 4 displays insoluble solids results from depositional dust gauges during the reporting period compared against the year-to-date average and the annual impact assessment criteria.

During the reporting period the DW21a and D124 monitors recorded a monthly result above the long term impact assessment criteria of 4.0 g/m<sup>2</sup> per month. Field notes associated with DW21a and D124 confirm the presence of insects and bird droppings. As such the results are considered contaminated and will be excluded from calculation of the annual average.

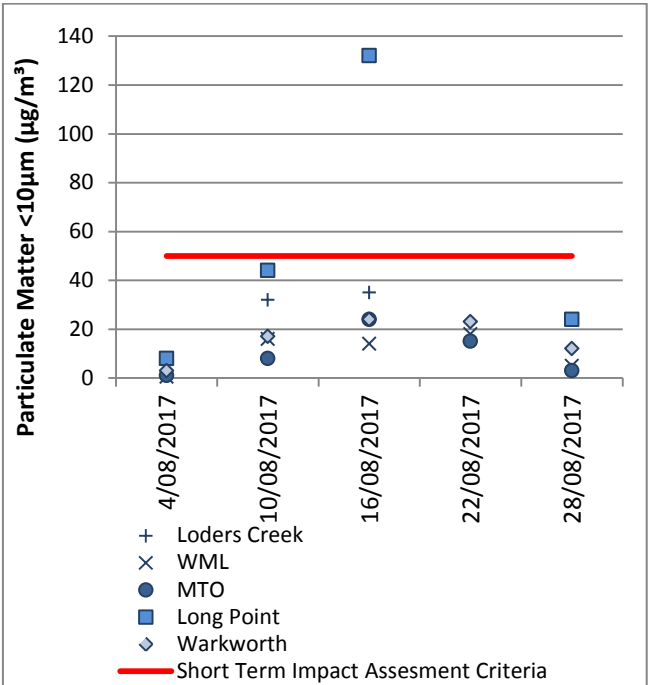
**Figure 5: Individual PM<sub>10</sub> Results – August 2017**

Figure 5 shows the individual PM<sub>10</sub> results at each monitoring station against the short term impact assessment criteria of 50µg/m<sup>3</sup>.

On 16/08/2017 the Long Point HVAS PM<sub>10</sub> unit recorded a result of 132µg/m<sup>3</sup>, which is greater than the short term (24hr) PM<sub>10</sub> impact assessment criteria.

Investigation determined that the wind direction was not from MTW's angle of influence at Long Point on the 16<sup>th</sup> of August. Accordingly, no further action is required.

Data was not available on 22/08/2017 and 28/08/2017 at Loders Creek and on 22/08/2017 at Long Point HVAS due to technical issues.

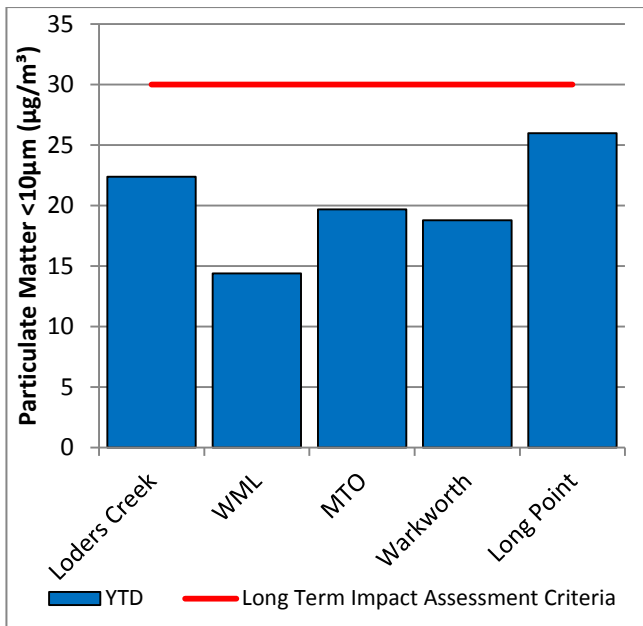
**Figure 6: Annual Average PM<sub>10</sub> – August 2017**

Figure 6 shows the annual average PM<sub>10</sub> results against the long term impact assessment criteria.

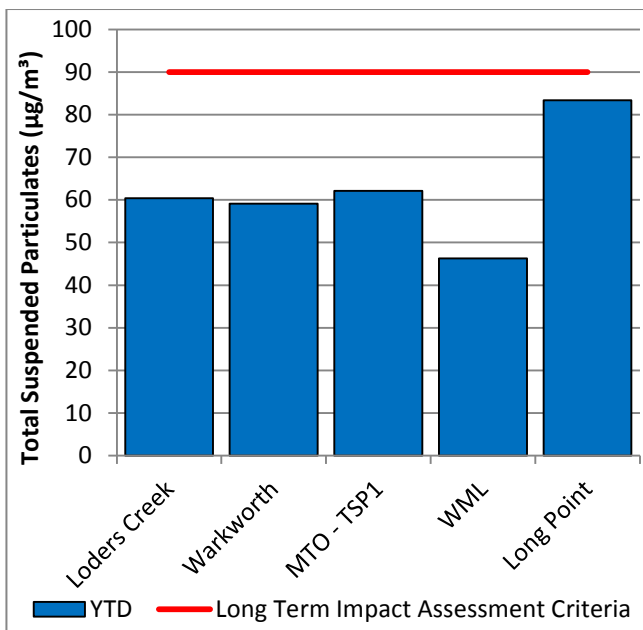
**Figure 7: Annual Average Total Suspended Particulates – August 2017**

Figure 7 shows the annual average TSP results compared against the long term impact assessment criteria of 90µg/m<sup>3</sup>.

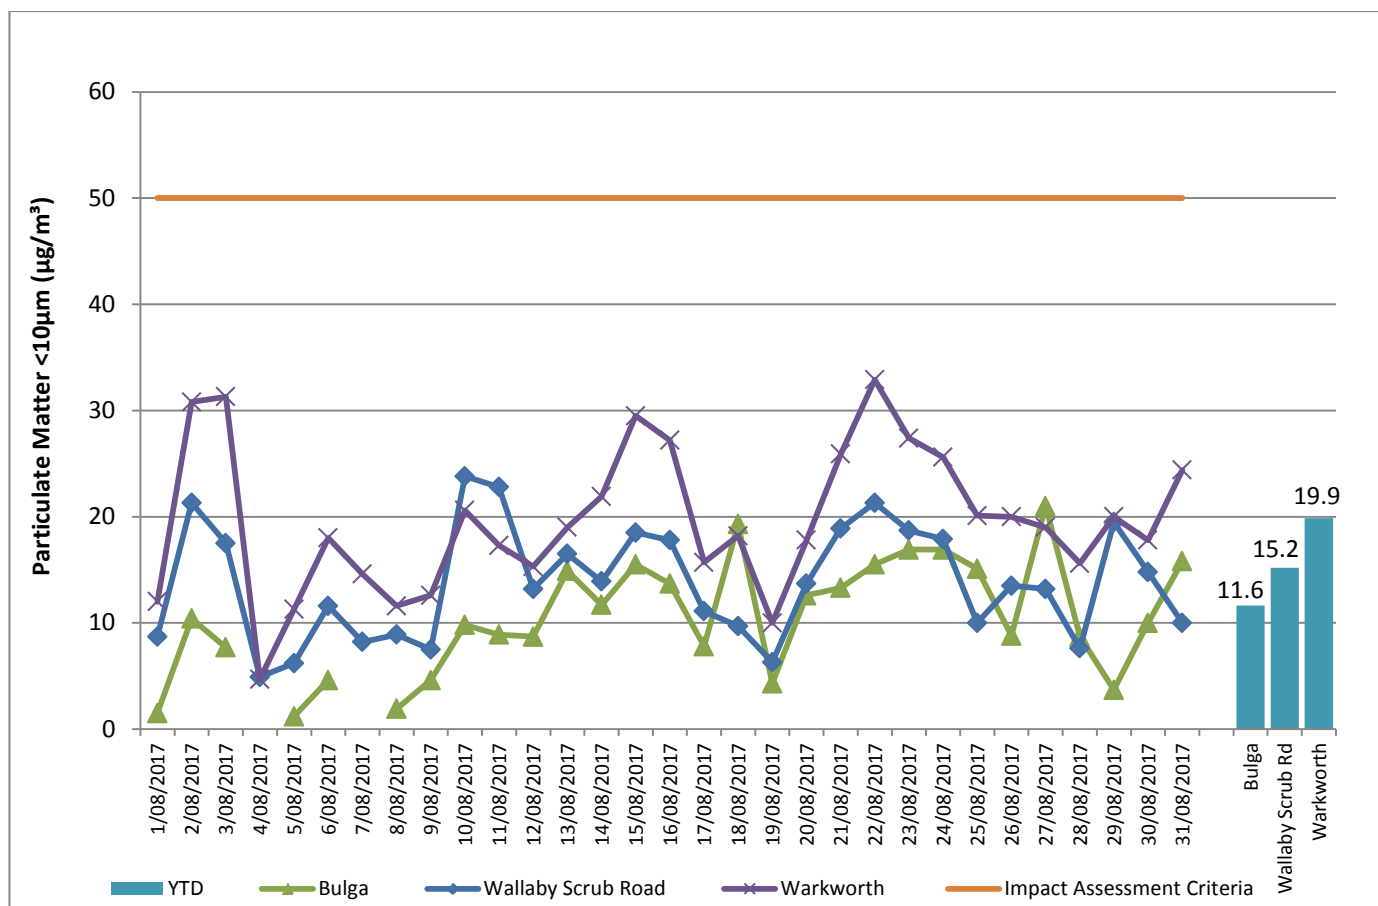
**Figure 8: Real Time PM<sub>10</sub> daily 24hr average and annual average – August 2017**

Results for real time dust sampling are shown in Figure 8, including the daily 24 hour average PM<sub>10</sub> result and the annual PM<sub>10</sub> average.

Data was not available on 4<sup>th</sup> and 7<sup>th</sup> August 2017 (Bulga) due to technical issues.

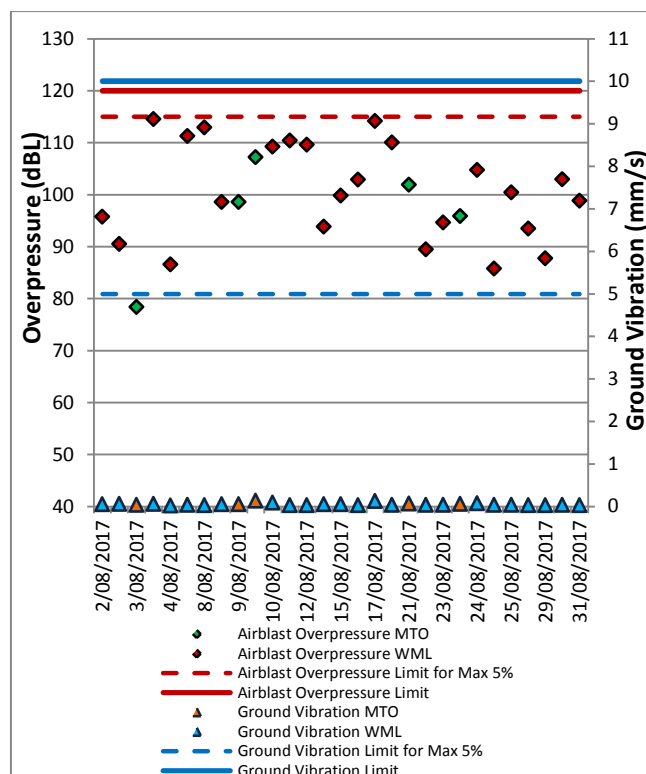
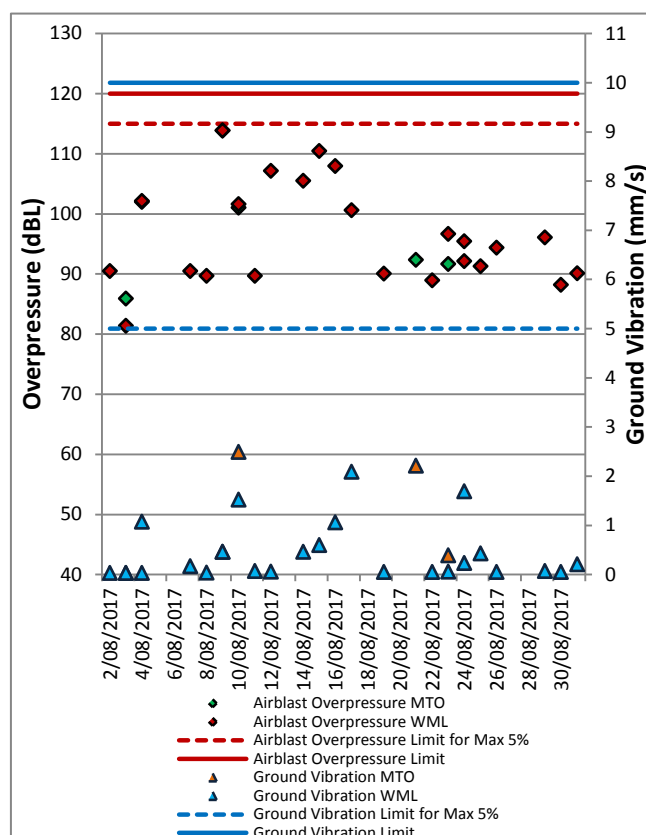
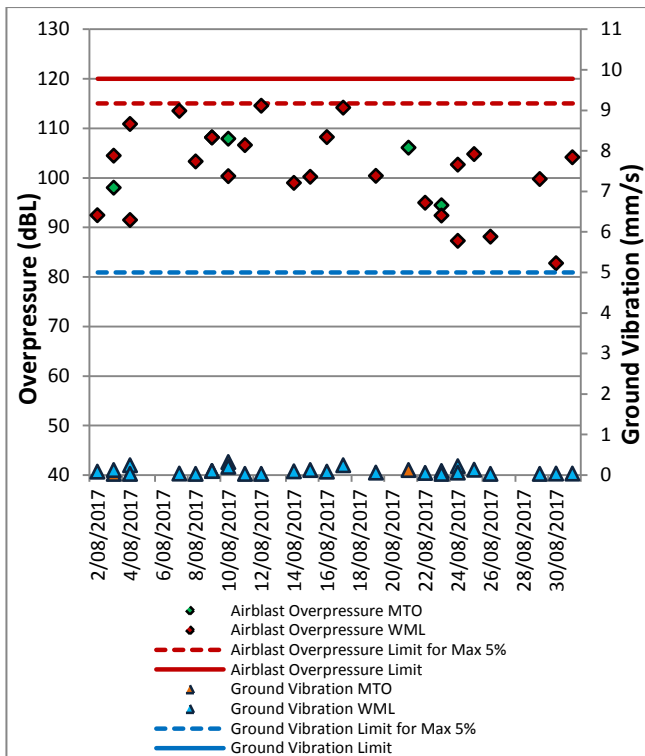
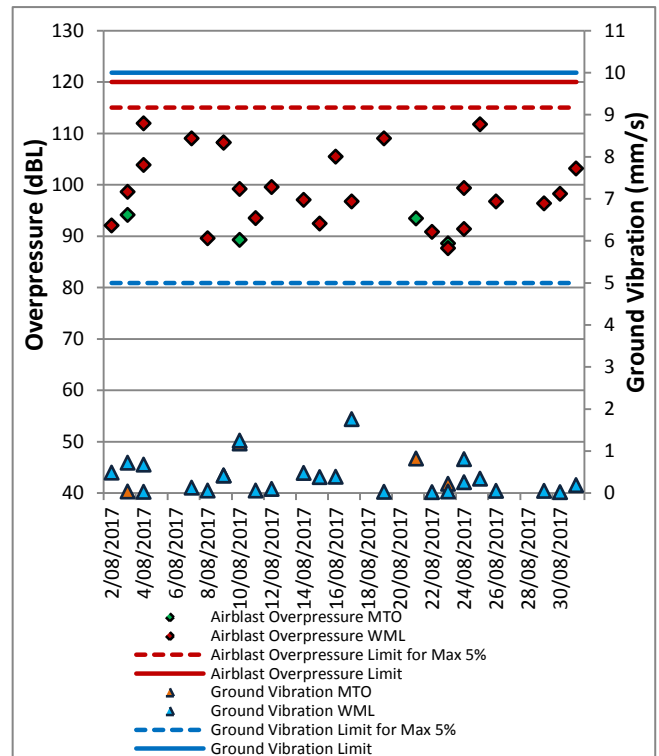
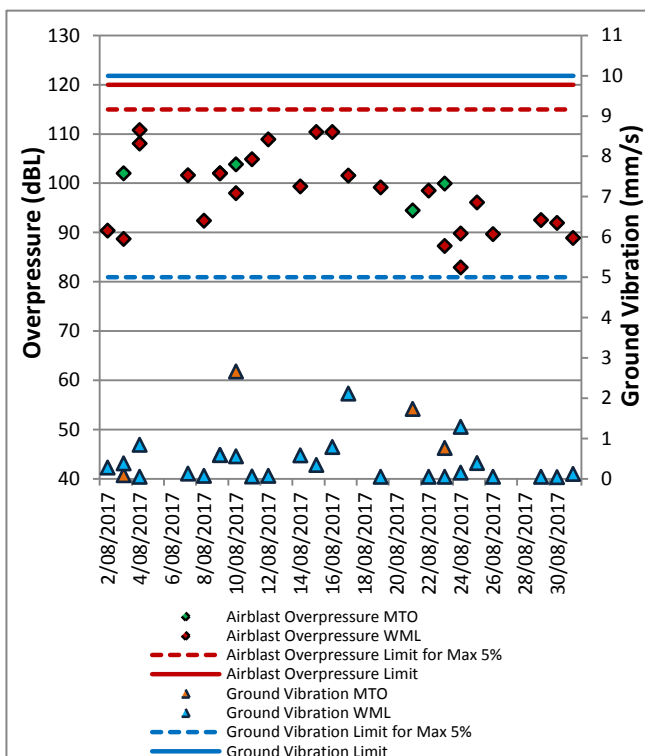
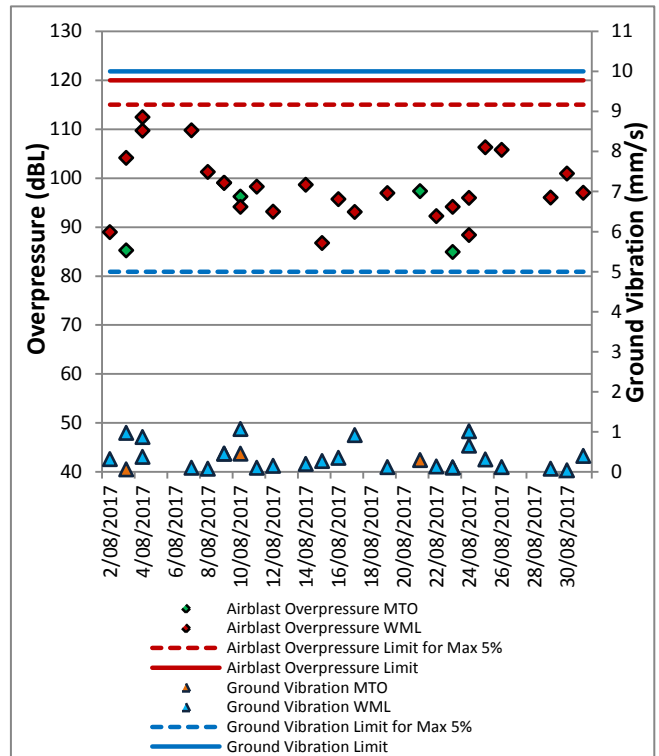
During August 2017, 29 blasts were initiated at MTW. Figure 9 to Figure 14 show the blast monitoring results for the reporting period against the impact assessment criteria. The criteria are summarised in Table 2.

During the reporting period no blasts exceeded the 115 dB(L) 5% threshold for airblast overpressure or 5mm/s 5% threshold for ground vibration.

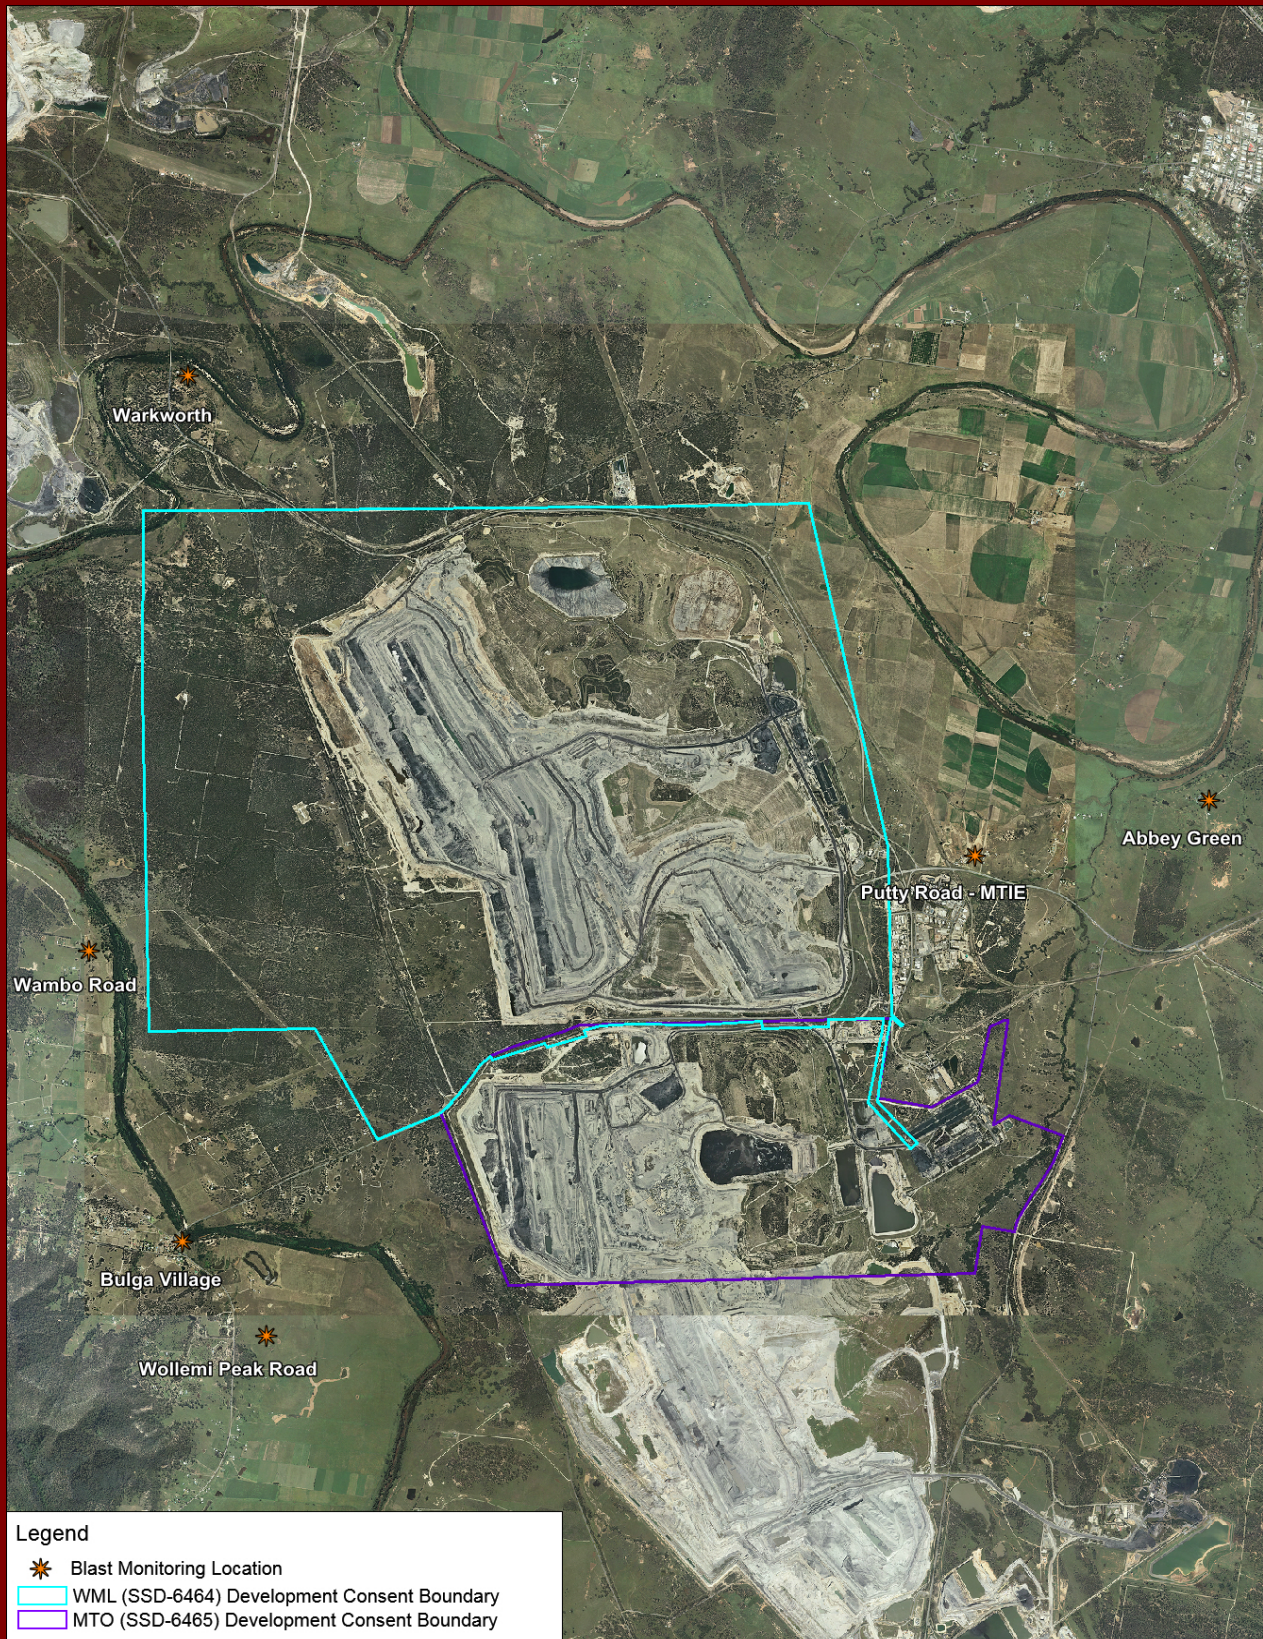
**Figure 15: MTW Blast Monitoring Location Plan**

MTW have a network of six blast monitoring units. These are located at nearby privately owned residences and function as regulatory compliance monitors.

The location of these monitors can be found in Figure 15.

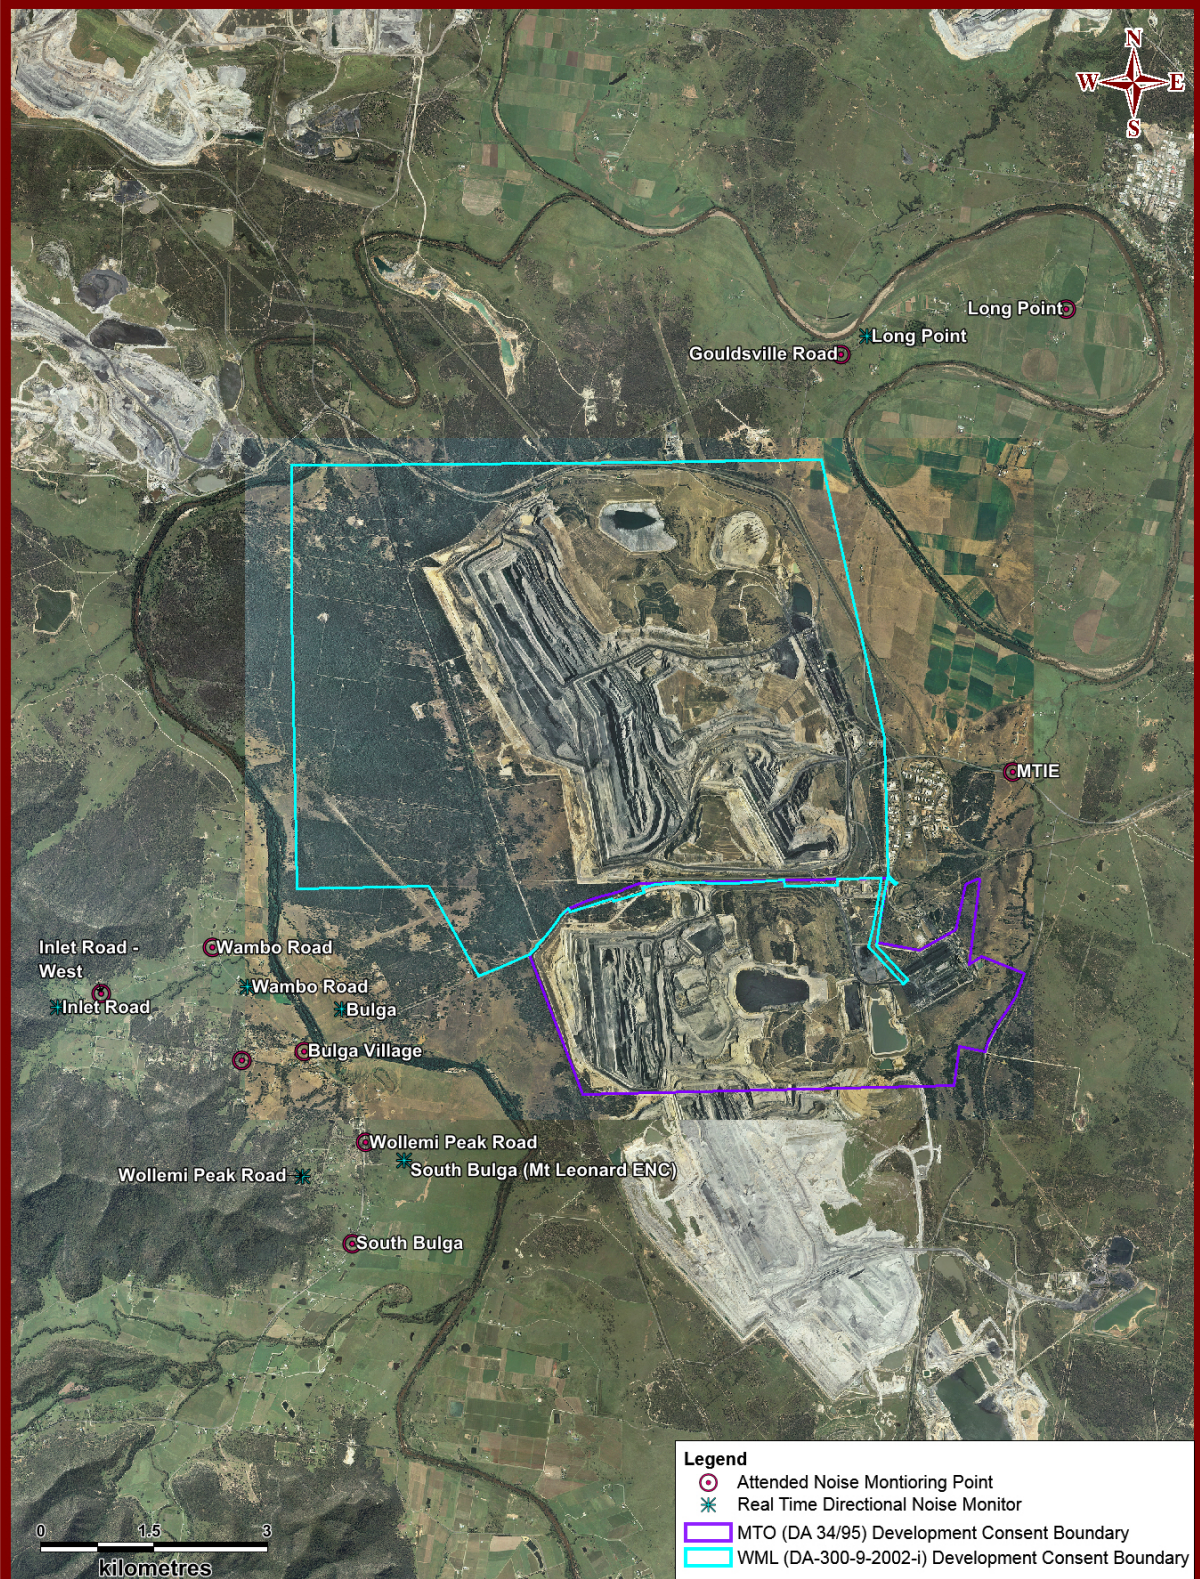
**Figure 16: Noise Monitoring Location Plan**

Routine attended noise monitoring is carried out in accordance with the MTW Noise Management Plan. A review against EIS predictions will be reported in the Annual Review. The purpose of the noise surveys is to quantify and describe the acoustic environment around the site and compare results with specified limits. Real time noise monitoring also occurs at nine sites surrounding MTW. Noise monitoring locations are displayed in Figure 16.

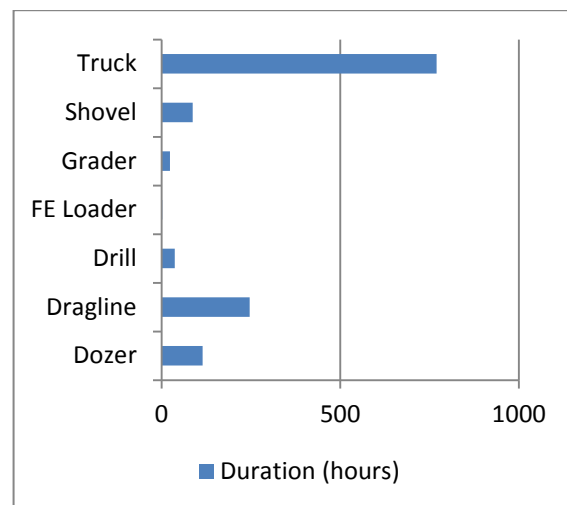
**Figure 17: Operational Downtime by Equipment Type – August 2017**

During August, a total of 1283.2 hours of equipment downtime was logged in response to environmental events such as dust, noise and adverse meteorological conditions. Operational downtime by equipment type is shown in Figure 17.

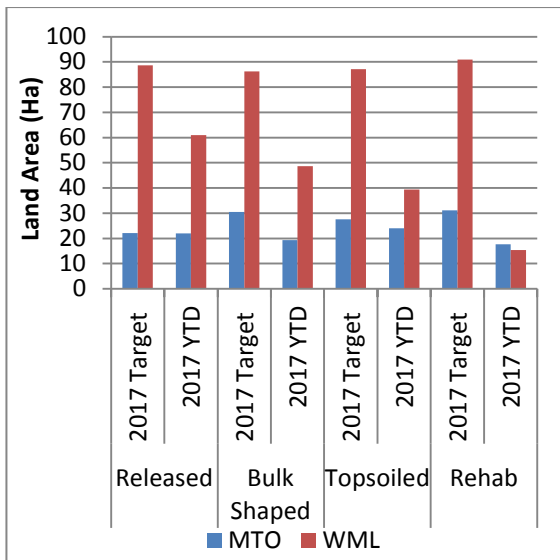
**Figure 18: Rehabilitation YTD - August 2017**

During August, 21.04 Ha of land was released, 8.20 Ha of land was bulk shaped, 22.96 Ha of land was topsoiled, 9.51 Ha of land was composted and 5.23 Ha of land was rehabilitated.
