# Monthly Environmental Monitoring Report

Yancoal Mt Thorley Warkworth

November 2017

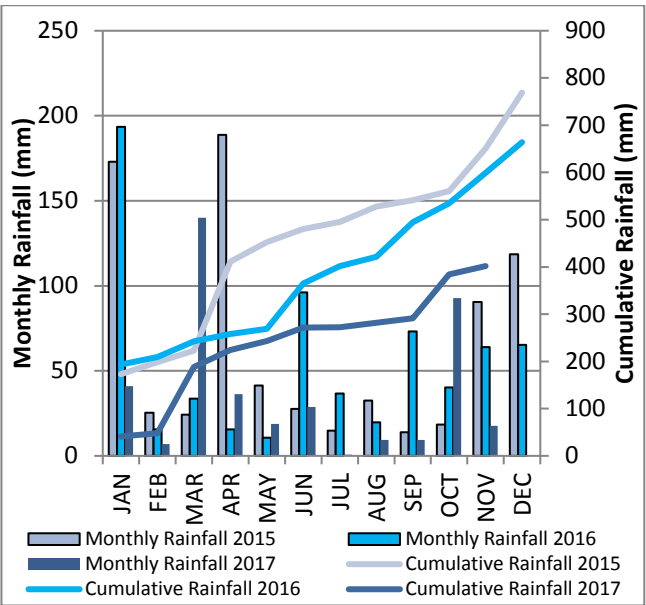
Figure 1: Rainfall Trend YTD

Rainfall for the period is summarised in Table 1, the year-to-date trend and historical trend are shown in Figure 1.

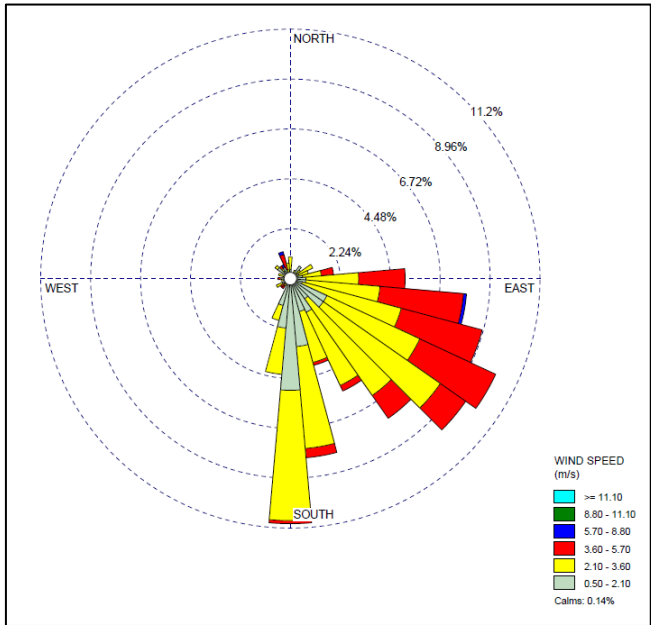
Figure 2: Charlton Ridge Wind Rose – November 2017

Winds from the South – West were dominant throughout the reporting period as shown in Figure 2.

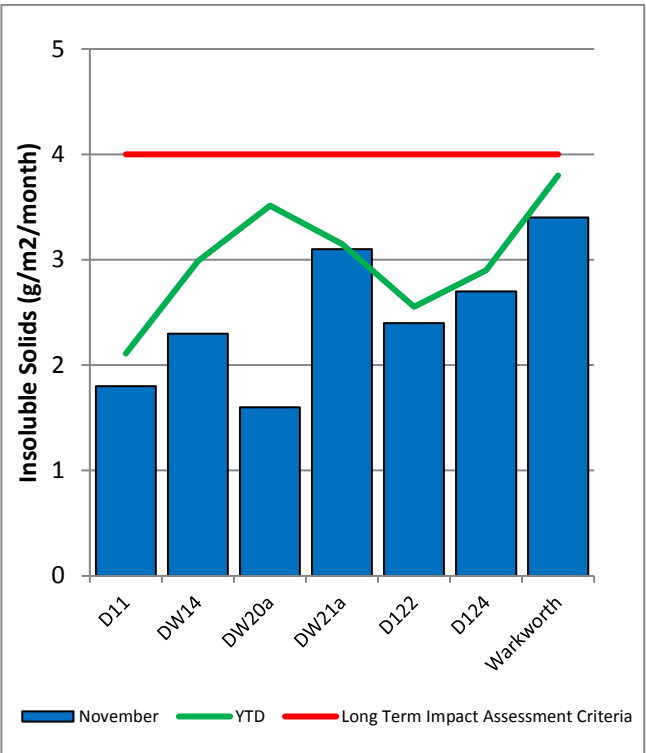
Figure 4: Depositional Dust – November 2017

To monitor regional air quality, MTW operates and maintains a network of seven depositional dust gauges, situated on private and mine owned land surrounding MTW.

Figure 4 displays insoluble solids results from depositional dust gauges during the reporting period compared against the year-to-date average and the annual impact assessment criteria.

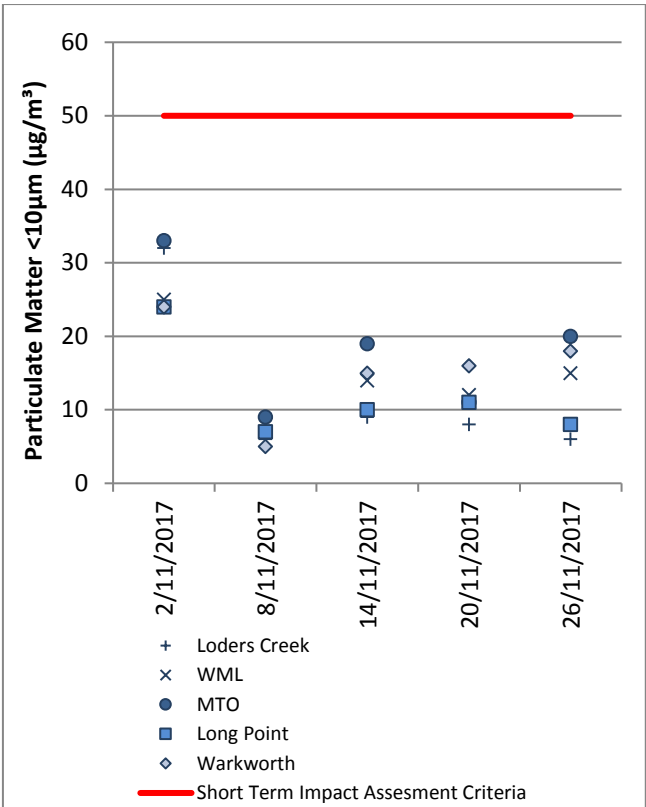
Figure 5: Individual PM<sub>10</sub> Results – November 2017

Figure 5 shows the individual PM<sub>10</sub> results at each monitoring station against the short term impact assessment criteria of 50µg/m<sup>3</sup>.

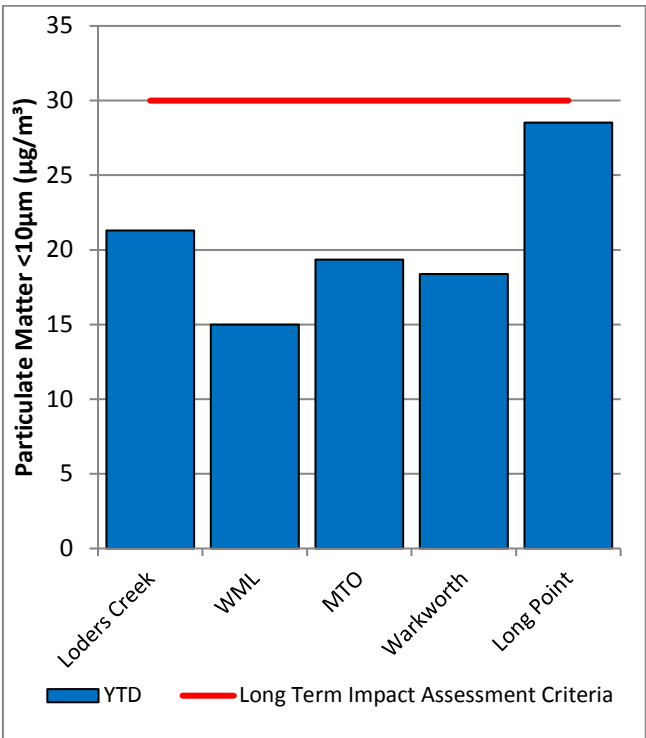
Figure 6: Annual Average PM<sub>10</sub> – November 2017

Figure 6 shows the annual average PM<sub>10</sub> results against the long term impact assessment criteria.

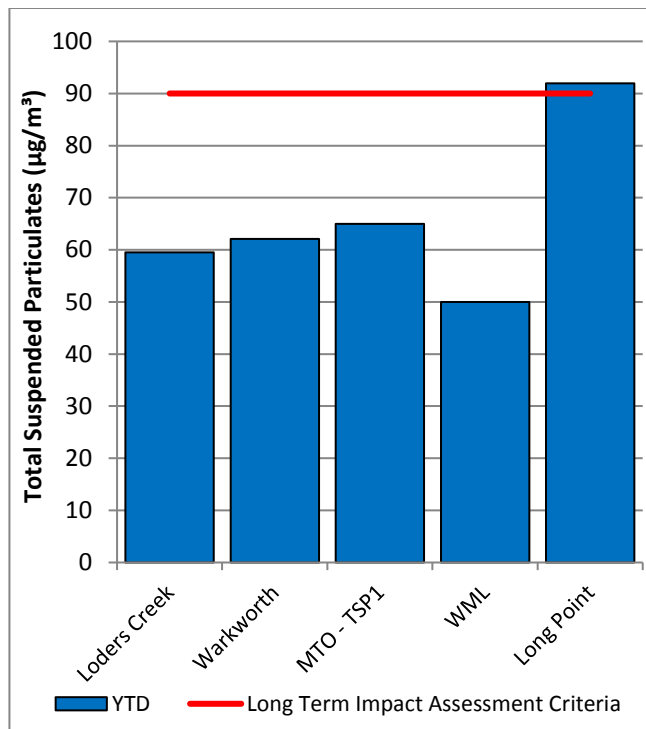
Figure 7: Annual Average Total Suspended Particulates – November 2017

Figure 7 shows the annual average TSP results compared against the long term impact assessment criteria of  $90\mu\text{g}/\text{m}^3$ .

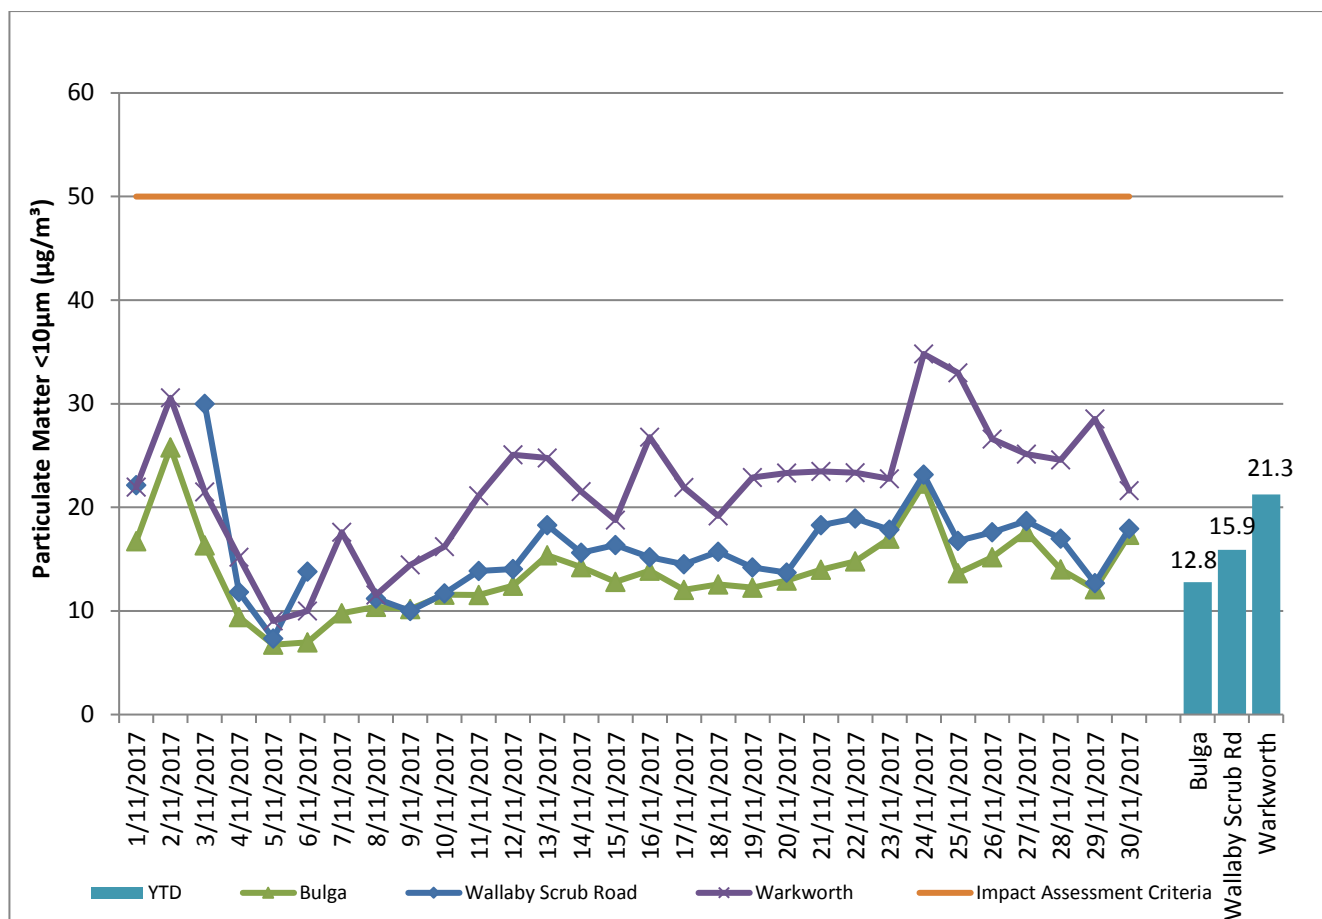
Figure 8: Real Time PM<sub>10</sub> daily 24hr average and annual average – November 2017

Results for real time dust sampling are shown in Figure 8, including the daily 24 hour average  $\text{PM}_{10}$  result and the annual  $\text{PM}_{10}$  average.

Data was not available on the 2<sup>nd</sup> and 6<sup>th</sup> November 2017 at the Wallaby Scrub Road monitor due to equipment malfunction resulting in erroneous data.

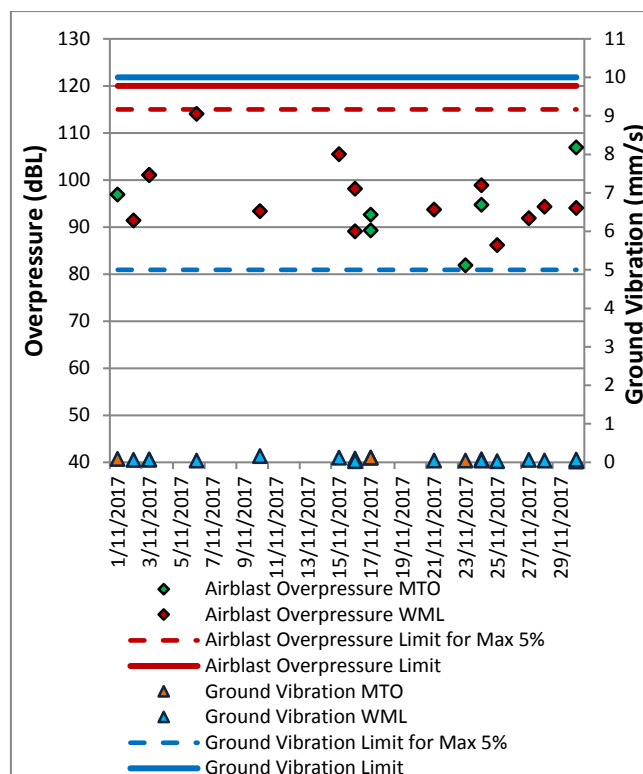
**Figure 9: Abbey Green Blast Monitoring Results – November 2017**

During November 2017, 20 blasts were initiated at MTW. Figure 9 to Figure 14 show the blast monitoring results for the reporting period against the impact assessment criteria. The criteria are summarised in Table 2.

During the reporting period no blasts exceeded the 115 dB(L) 5% threshold for airblast overpressure or 5mm/s 5% threshold for ground vibration.

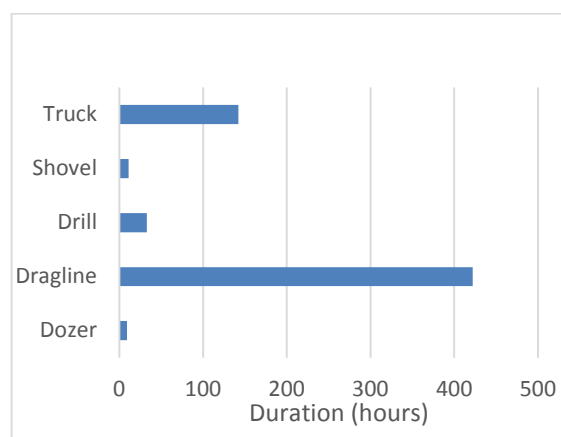
**Figure 17: Operational Downtime by Equipment Type – November 2017**

During November, a total of 617 hours of equipment downtime was logged in response to environmental events such as dust, noise and adverse meteorological conditions. Operational downtime by equipment type is shown in Figure 17.

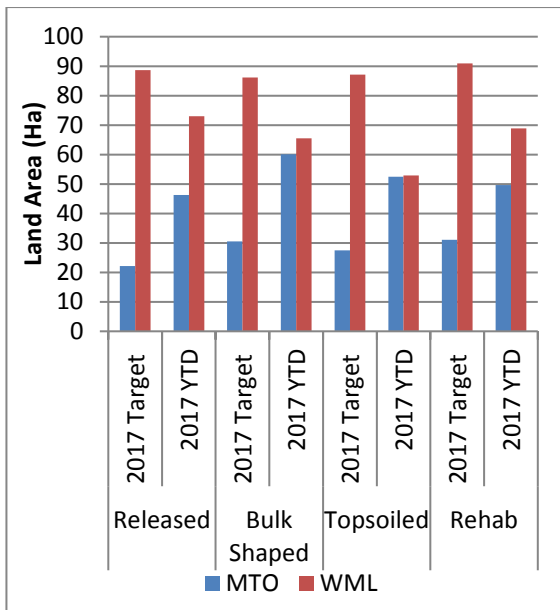
Figure 18: Rehabilitation YTD - November 2017

During November, 14.8 Ha of land was released, 18.6 Ha of land was bulk shaped, 15.5 Ha of land was topsoiled, 22.6 Ha of land was composted and 55.7 Ha of land was rehabilitated.
