# **Monthly Environmental Monitoring Report**

**Yancoal Mt Thorley Warkworth**

**December 2017**

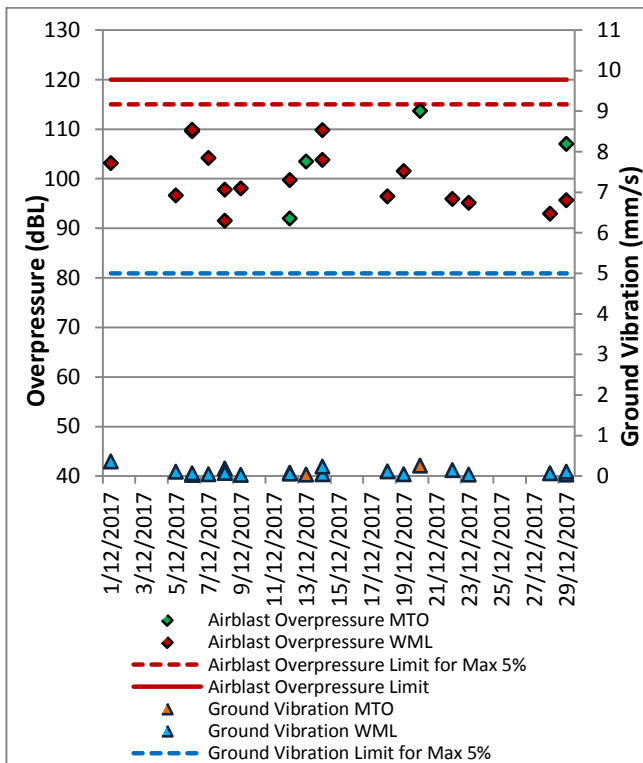
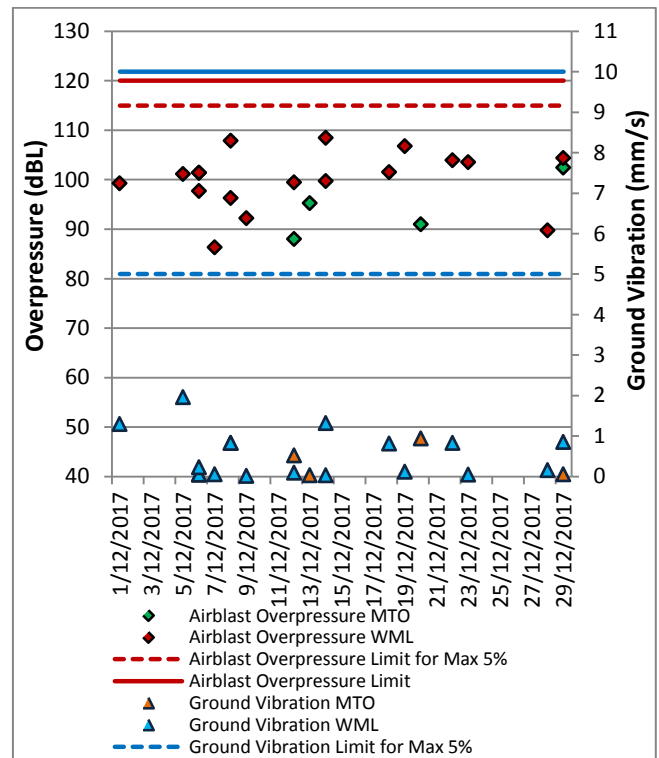
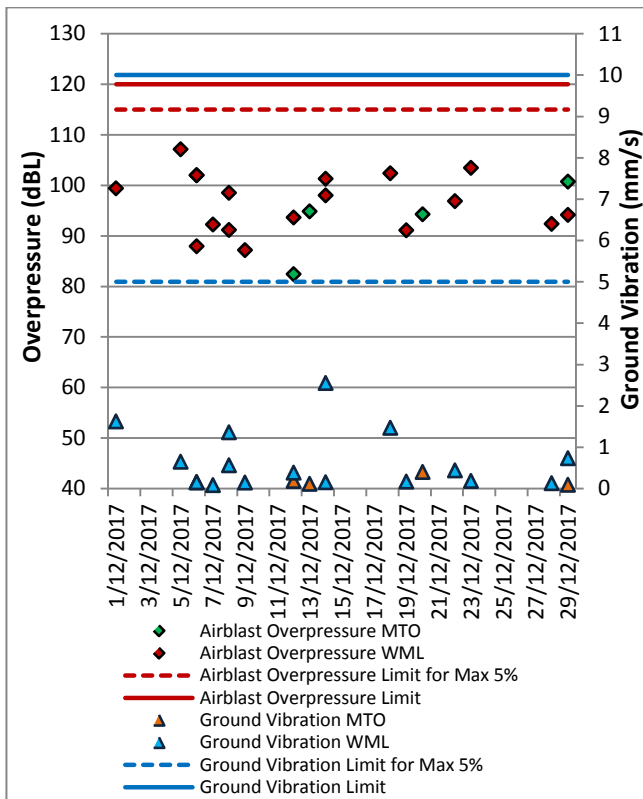
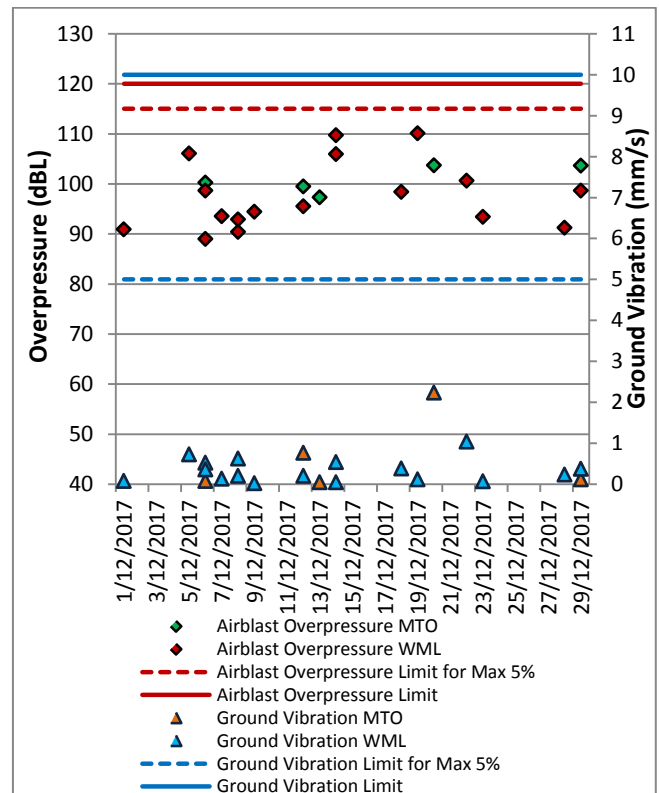
During December 2017, 22 blasts were initiated at MTW. Figure 60 to Figure 65 show the blast monitoring results for the reporting period against the impact assessment criteria. The criteria are summarised in Table 4.

During the reporting period no blasts exceeded the 115 dB(L) 5% threshold for airblast overpressure or 5mm/s-5% threshold for ground vibration

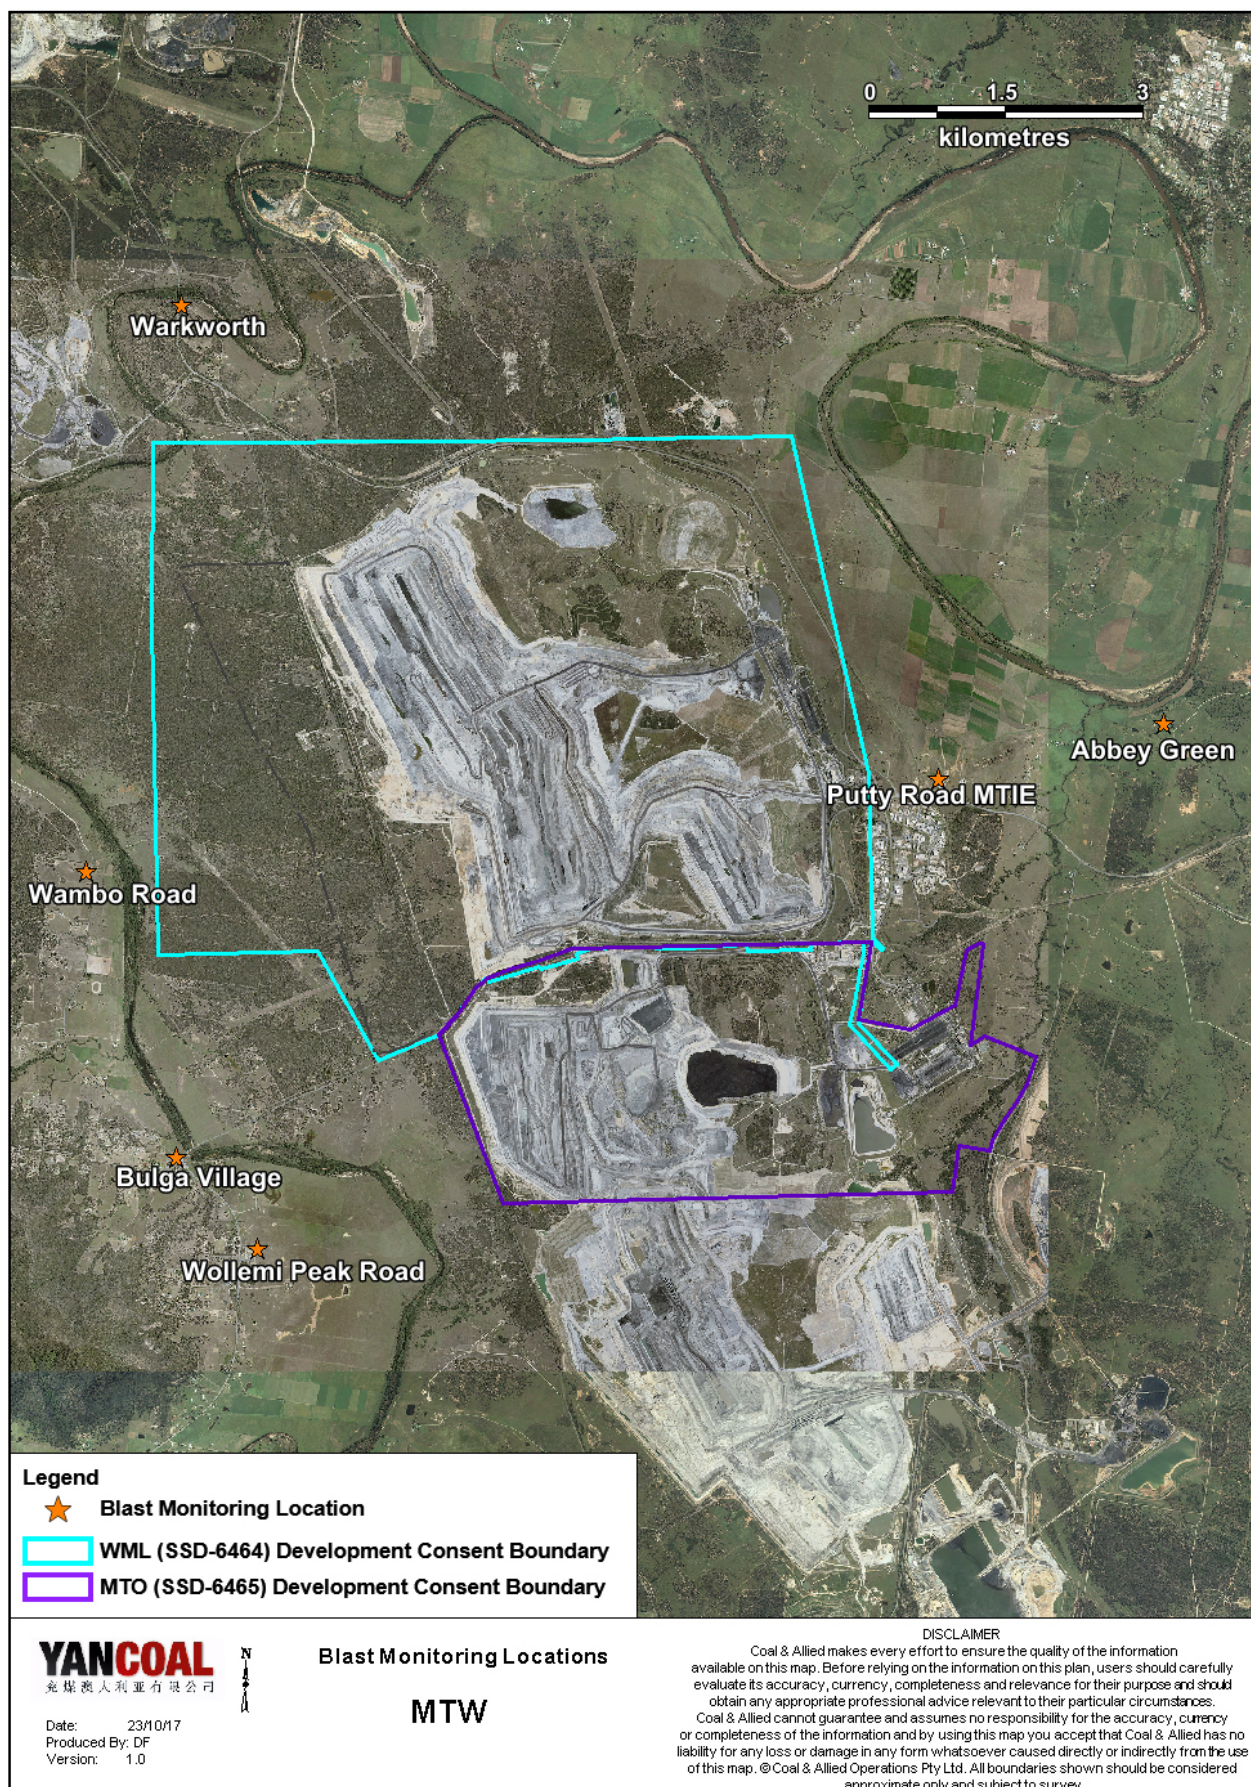
Figure 66: Blast and Vibration Monitoring Location Plan

MTW have a network of six blast monitoring units. These are located at nearby privately owned residences and function as regulatory compliance monitors.

The location of these monitors can be found in Figure 66.

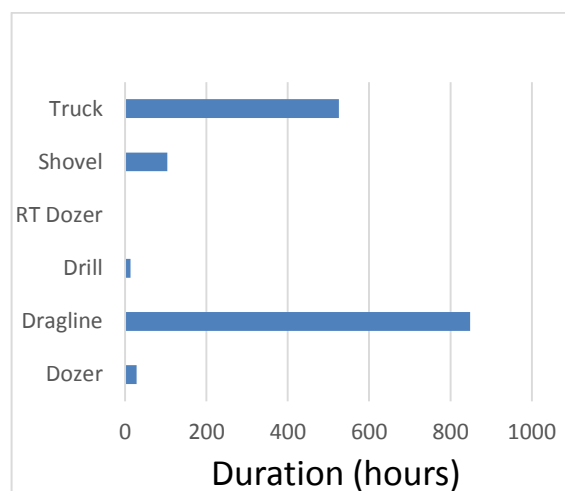
**Figure 68: Operational Downtime by Equipment Type – December 2017**

During December a total of 1520 hours of equipment downtime was logged in response to environmental events such as dust, noise and elevated wind impacts. Operational downtime by equipment type is shown in Figure 68.

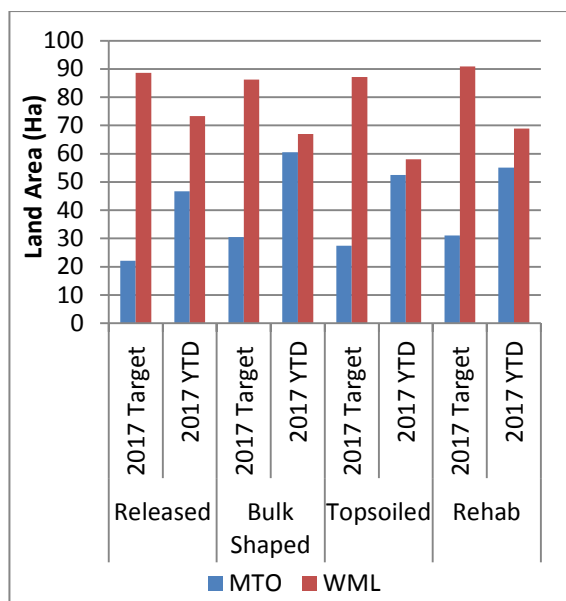
Figure 69: Rehabilitation YTD - December 2017

During December, 0.8Ha of land was released, 2.0Ha was bulk shaped, 5.2Ha was top soiled, 2.8Ha was composted and 5.5Ha was rehabilitated. Year-to-date progress can be viewed in Figure 69
