Mount Thorley Warkworth

Community Consultative Committee (CCC)

**Business Papers – February 2018**

# Monthly Environmental Monitoring Report

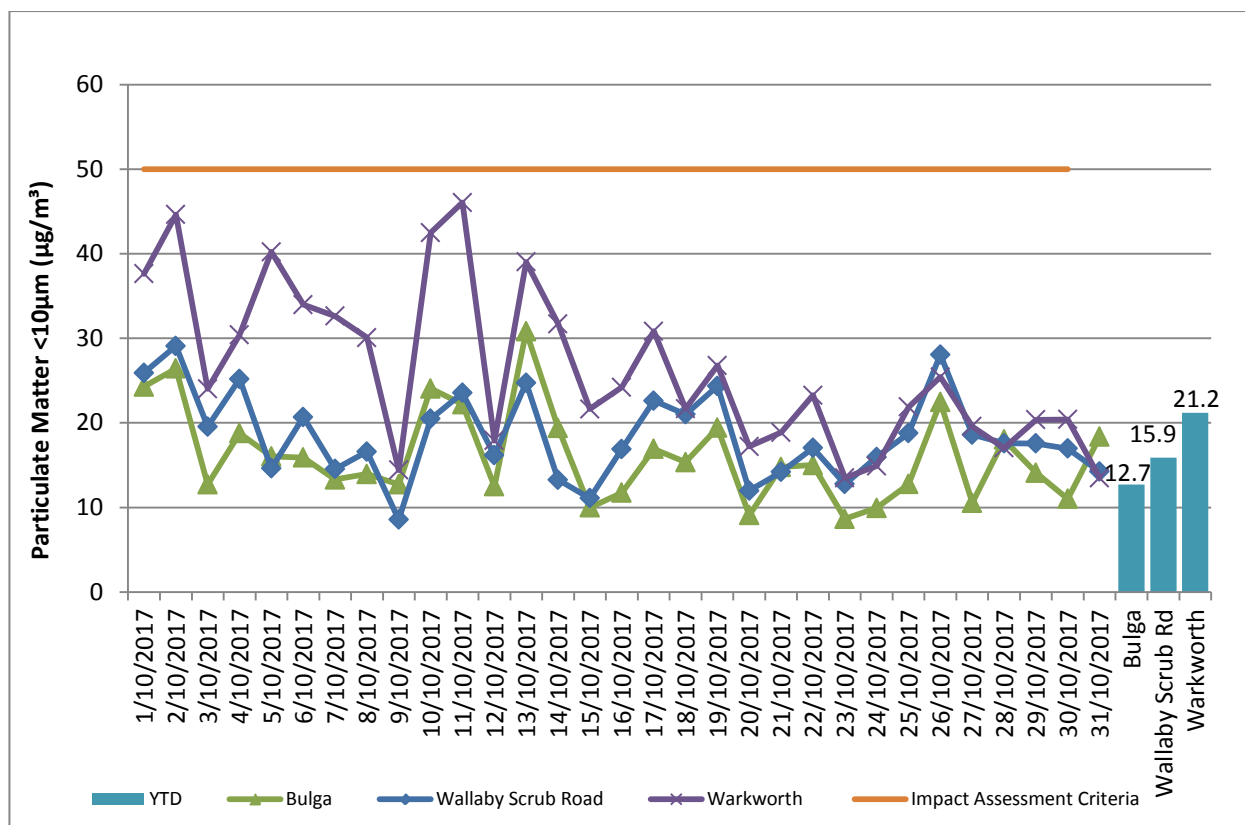
Figure 8: Real Time PM<sub>10</sub> daily 24hr average and annual average – October 2017

During October, the real time monitoring system generated 143 automated air quality related alerts, including 11 alerts for adverse meteorological conditions and 132 alerts for elevated PM<sub>10</sub> levels.

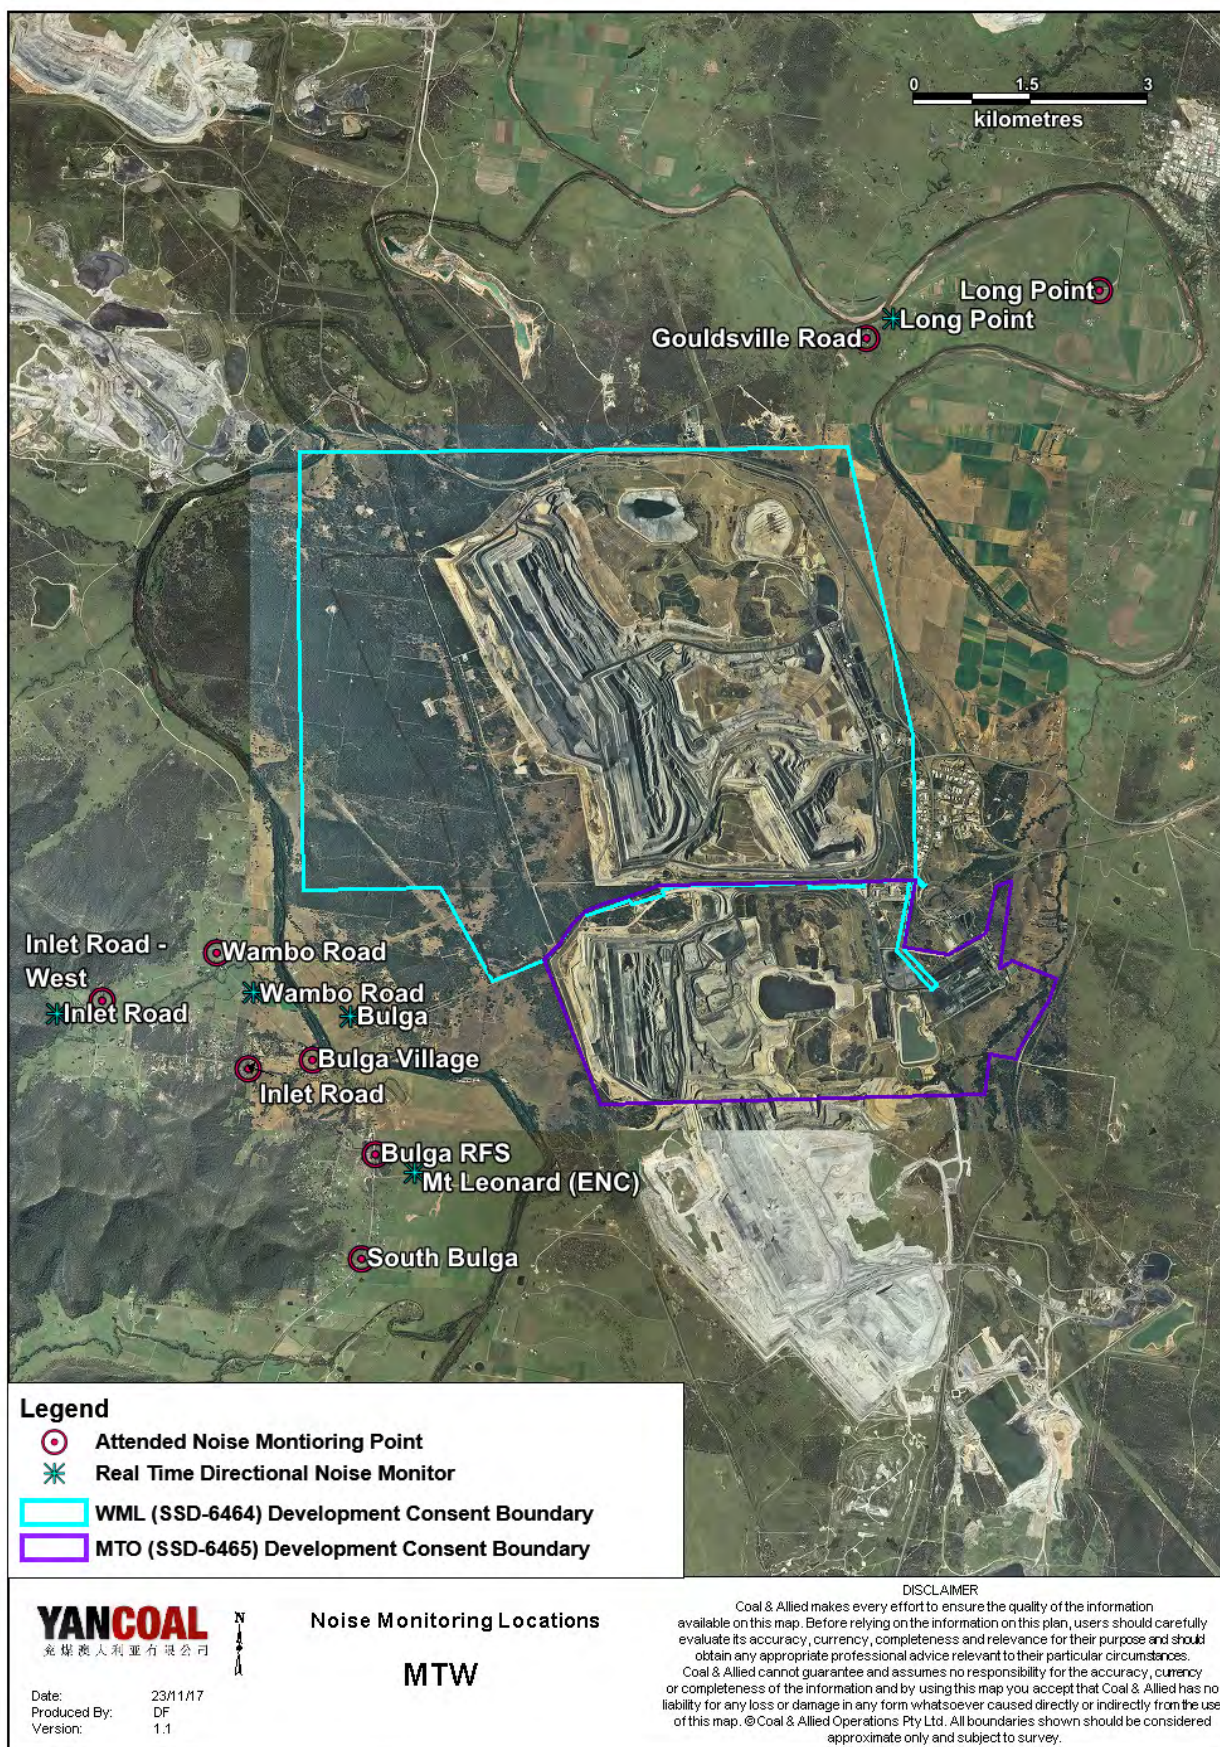
Figure 16: Noise Monitoring Location Plan

Routine attended noise monitoring is carried out in accordance with the MTW Noise Management Plan. A review against EIS predictions will be reported in the Annual Review. The purpose of the noise surveys is to quantify and describe the acoustic environment around the site and compare results with specified limits. Real time noise monitoring also occurs at nine sites surrounding MTW. Noise monitoring locations are displayed in Figure 16.

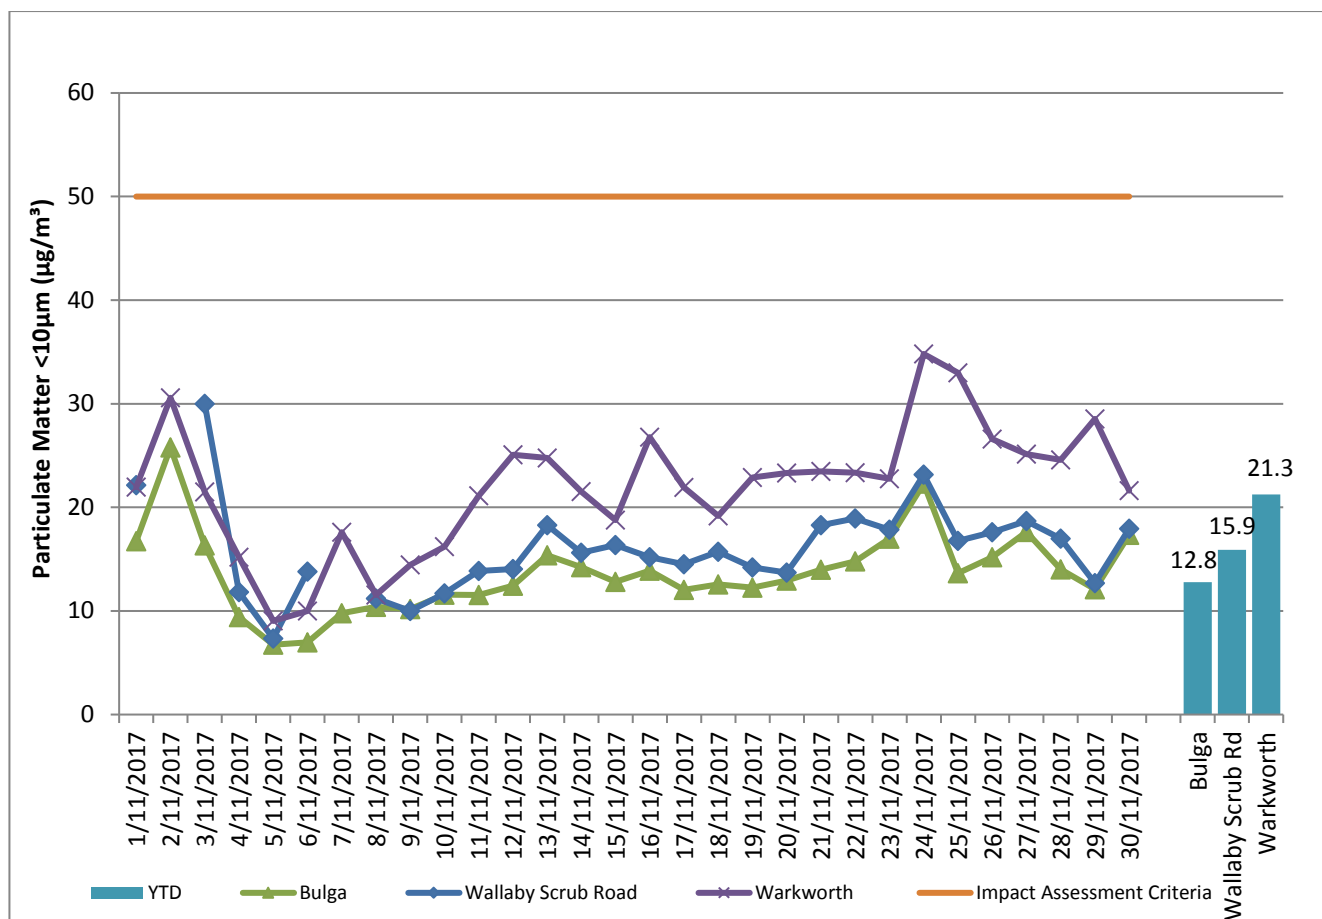
Figure 8: Real Time PM<sub>10</sub> daily 24hr average and annual average – November 2017

During November, the real time monitoring system generated 47 automated air quality related alerts, including 1 alert for adverse meteorological conditions and 46 alerts for elevated  $\text{PM}_{10}$  levels.

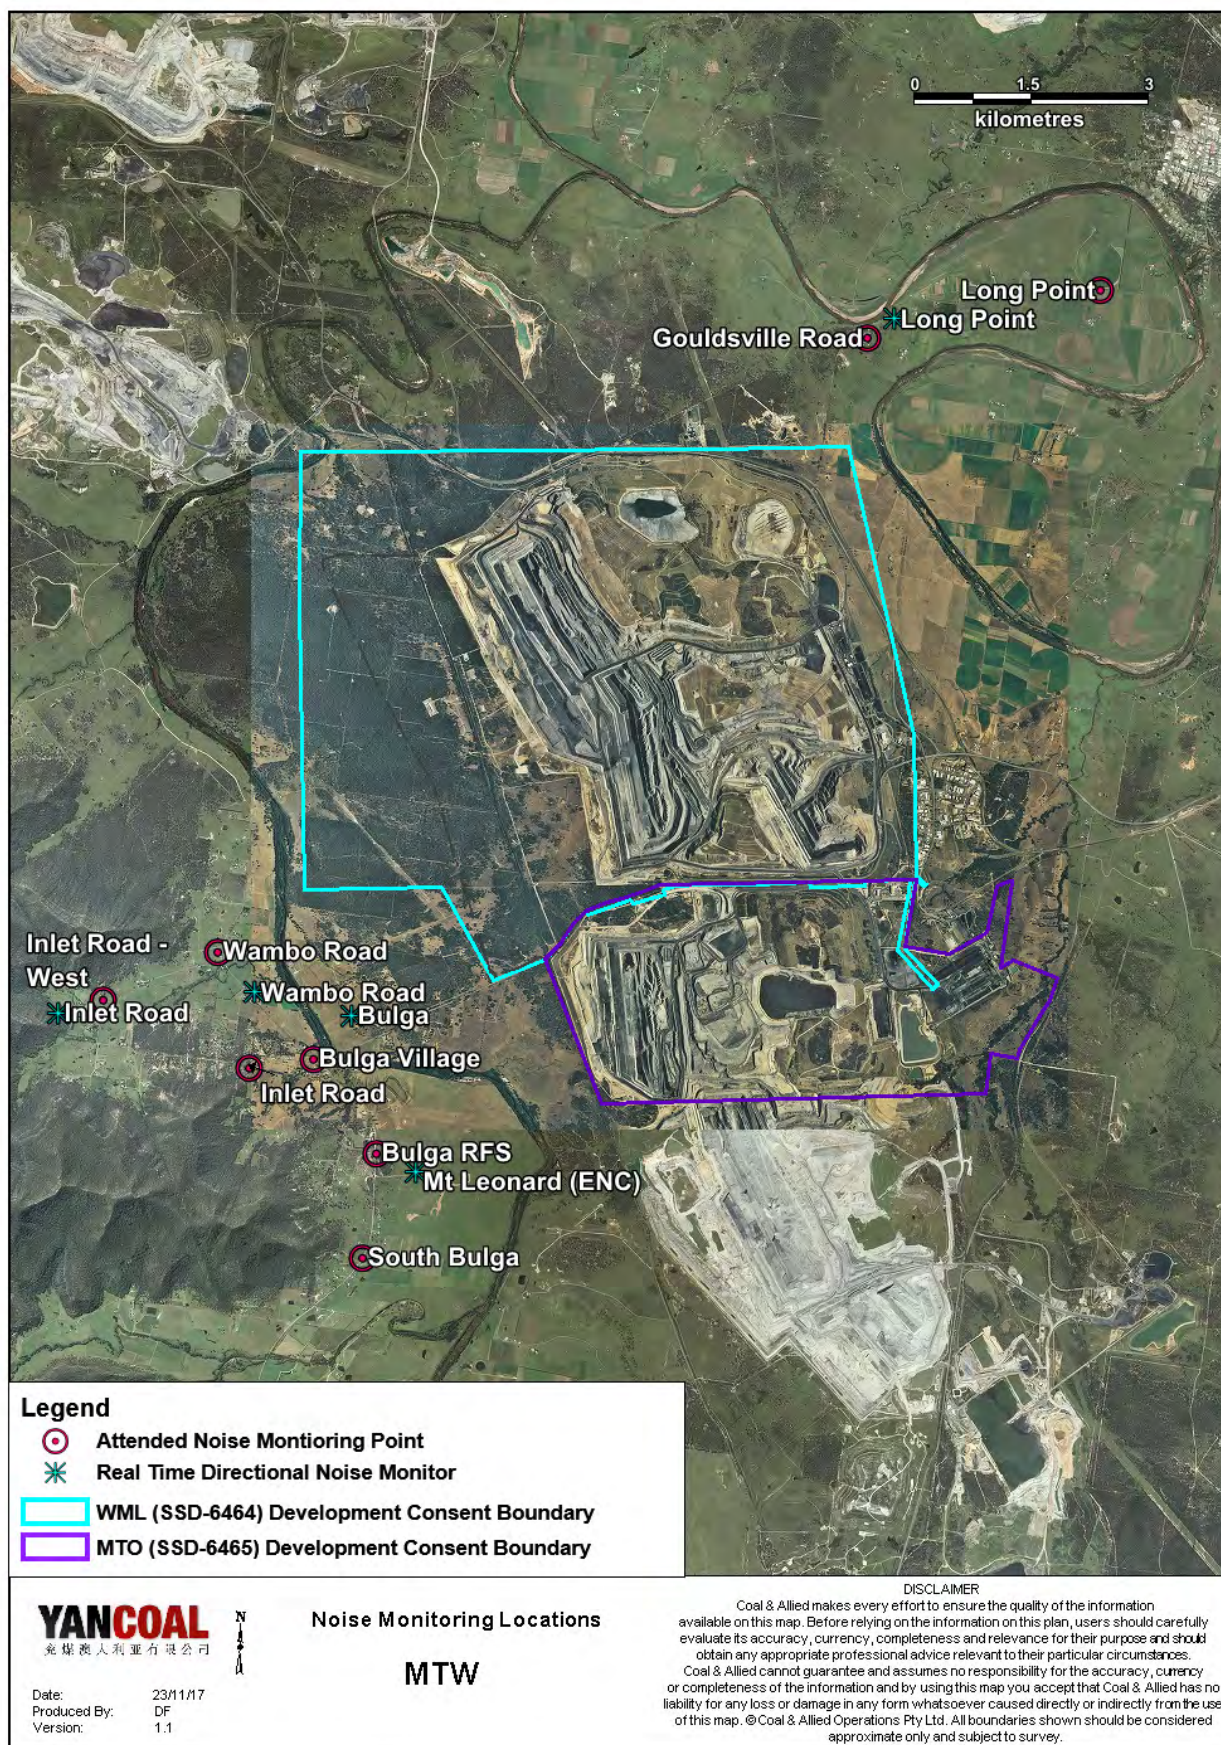
Figure 16: Noise Monitoring Location Plan

Routine attended noise monitoring is carried out in accordance with the MTW Noise Management Plan. A review against EIS predictions will be reported in the Annual Review. The purpose of the noise surveys is to quantify and describe the acoustic environment around the site and compare results with specified limits. Real time noise monitoring also occurs at nine sites surrounding MTW. Noise monitoring locations are displayed in Figure 16.

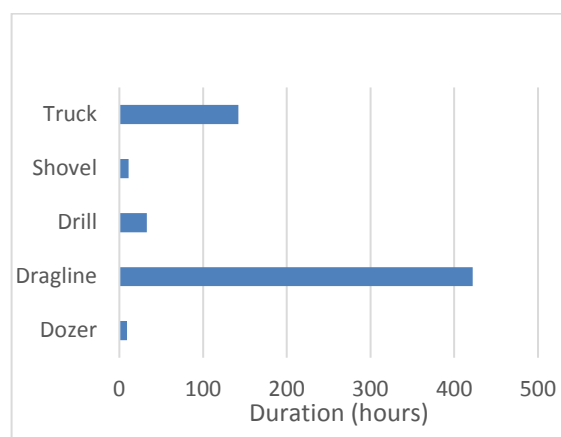
**Figure 17: Operational Downtime by Equipment Type – November 2017**

During November, a total of 617 hours of equipment downtime was logged in response to environmental events such as dust, noise and adverse meteorological conditions. Operational downtime by equipment type is shown in Figure 17.

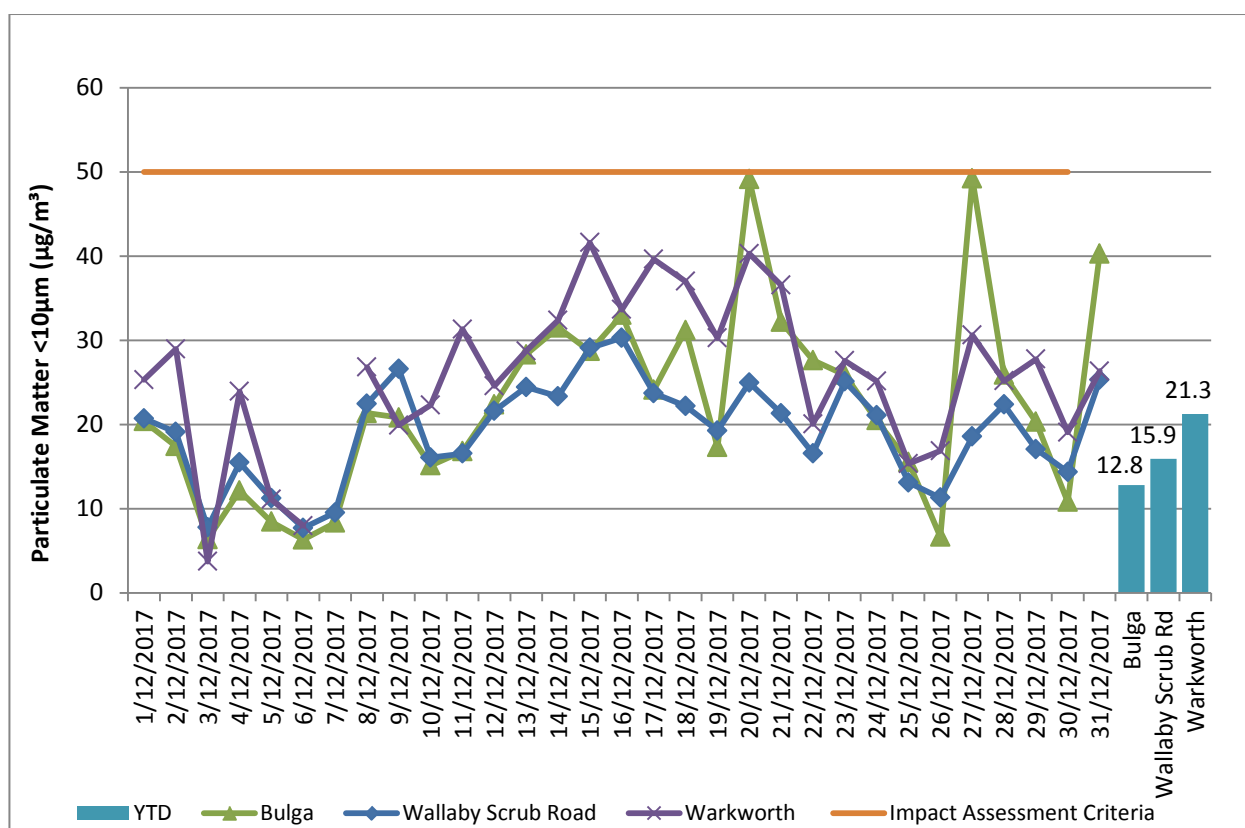
Figure 8: Real Time PM<sub>10</sub> 24hr average and Year-to-date average – December 2017

During December, the real time monitoring system generated 118 automated air quality related alerts, including 11 alerts for adverse meteorological conditions and 107 alerts for elevated PM<sub>10</sub> levels.

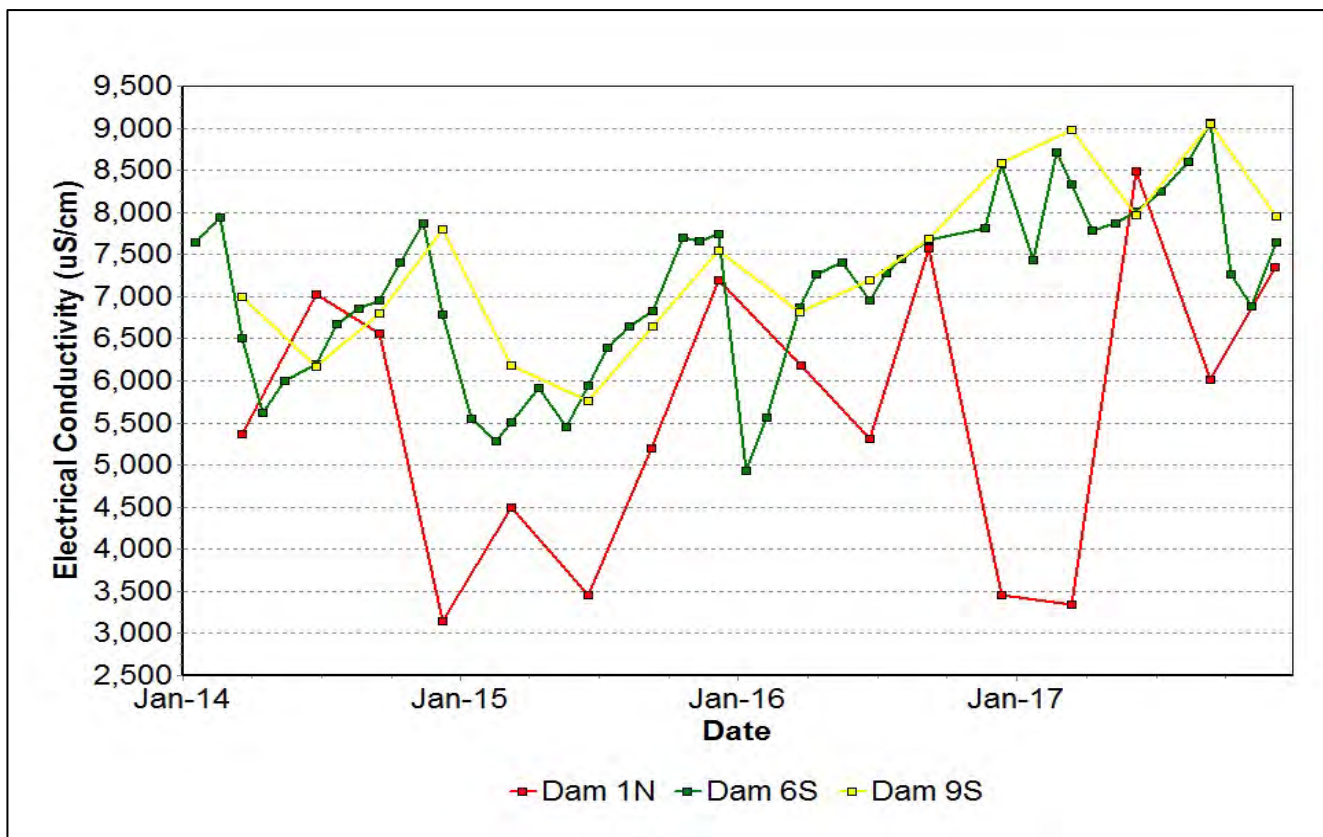
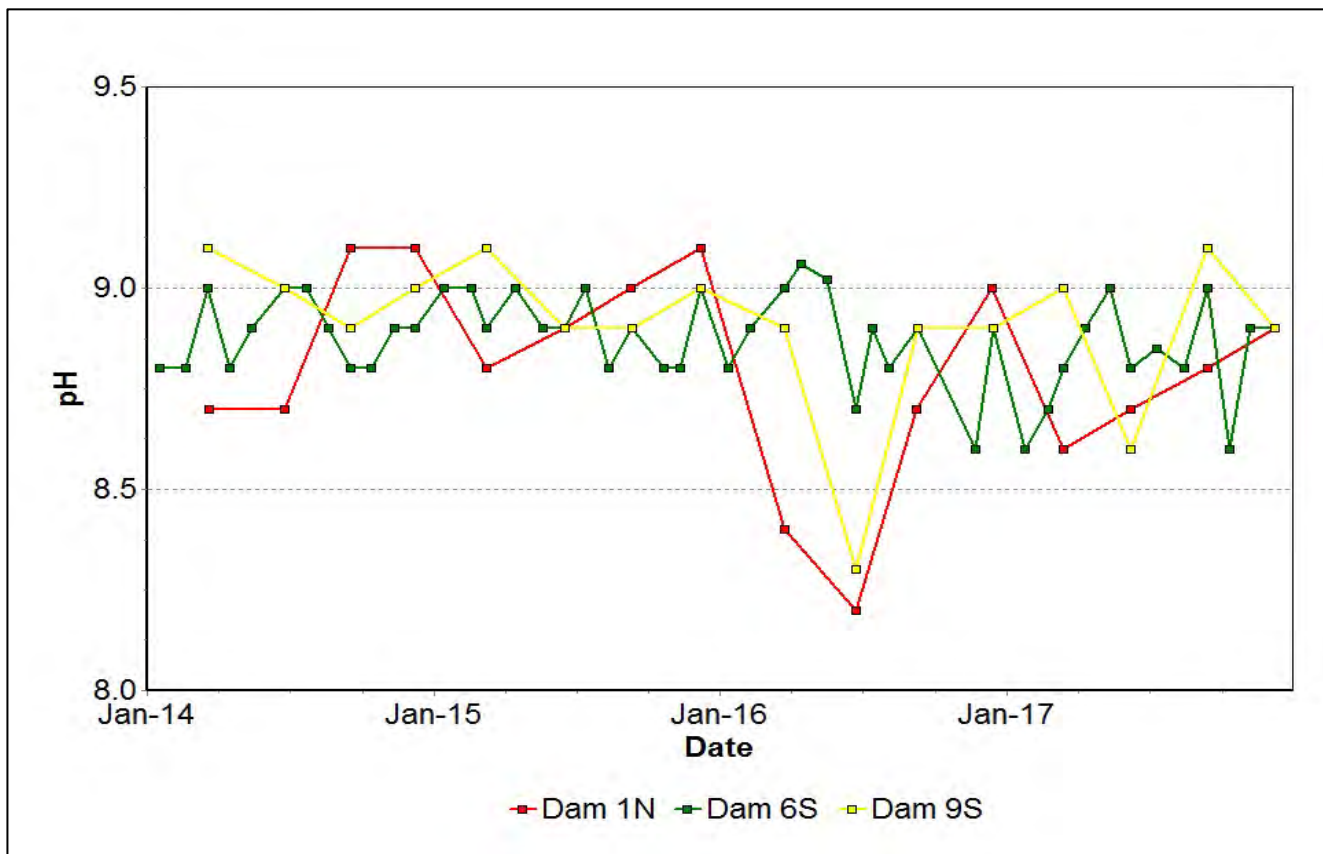
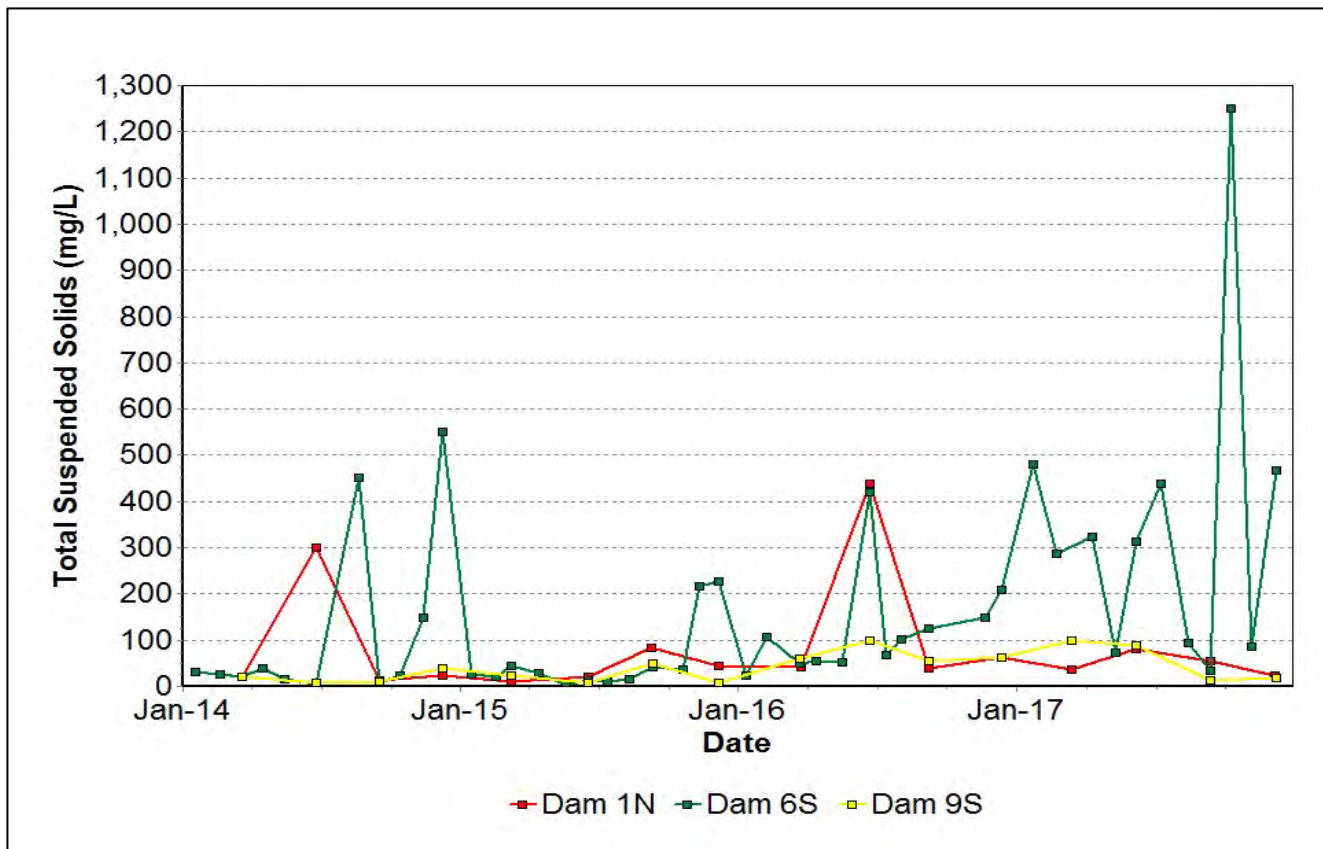
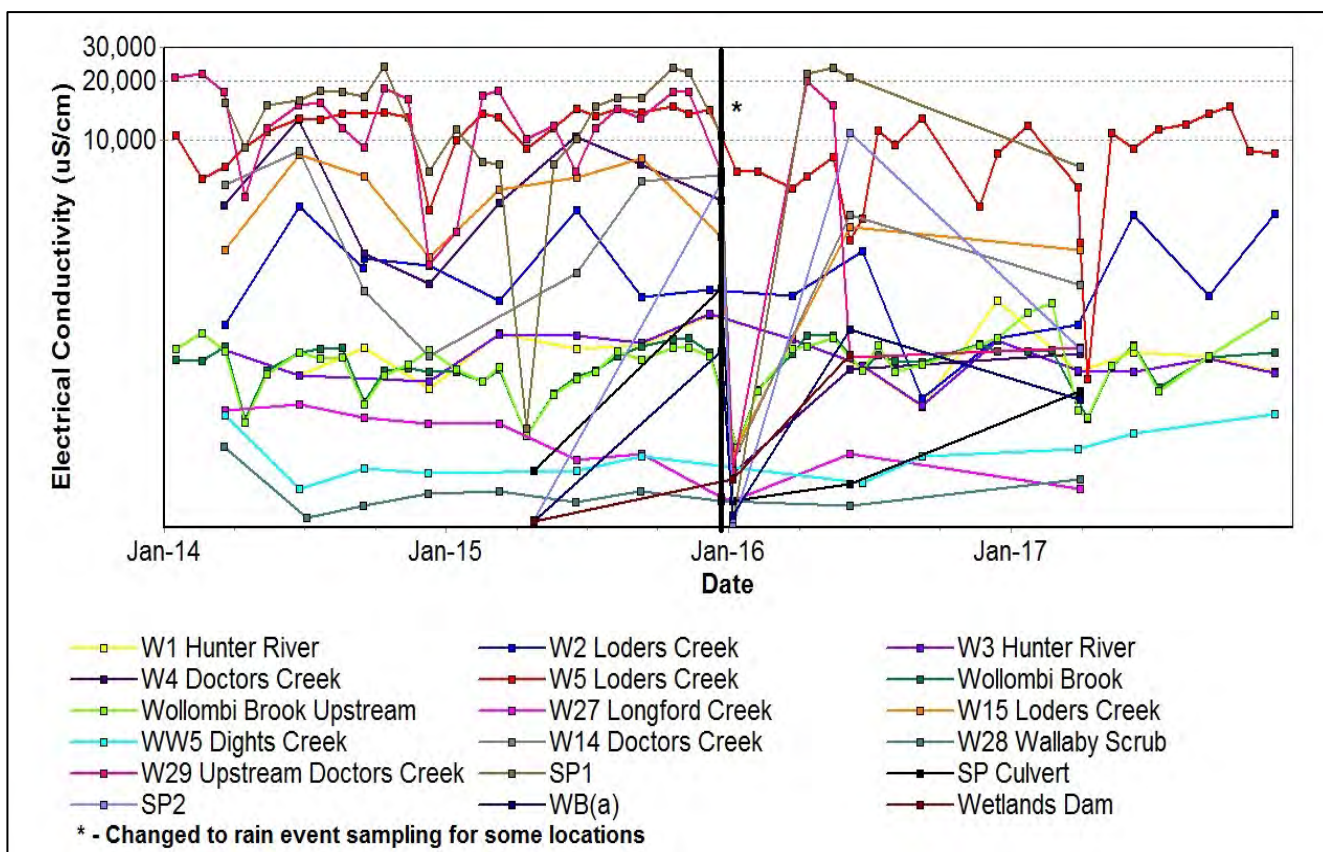
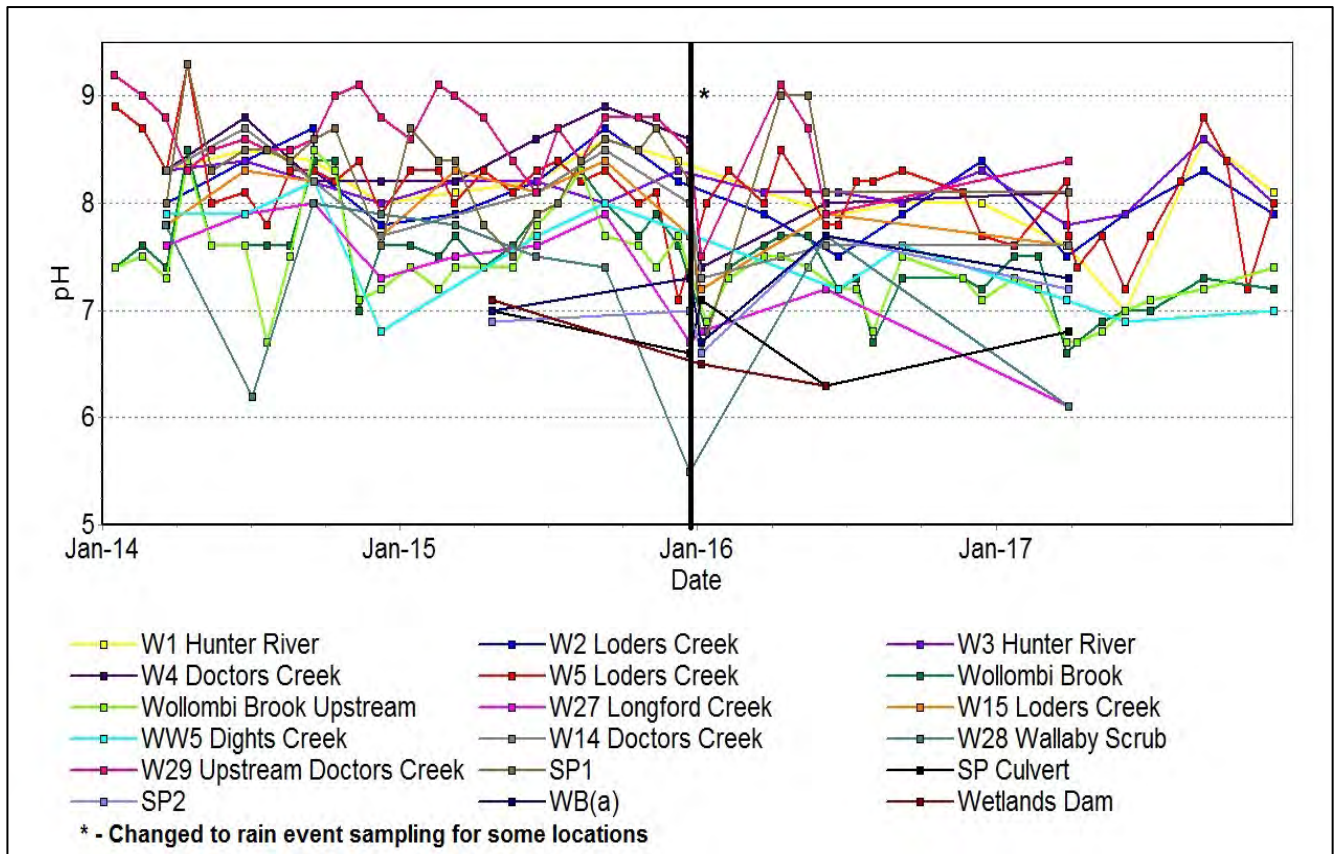
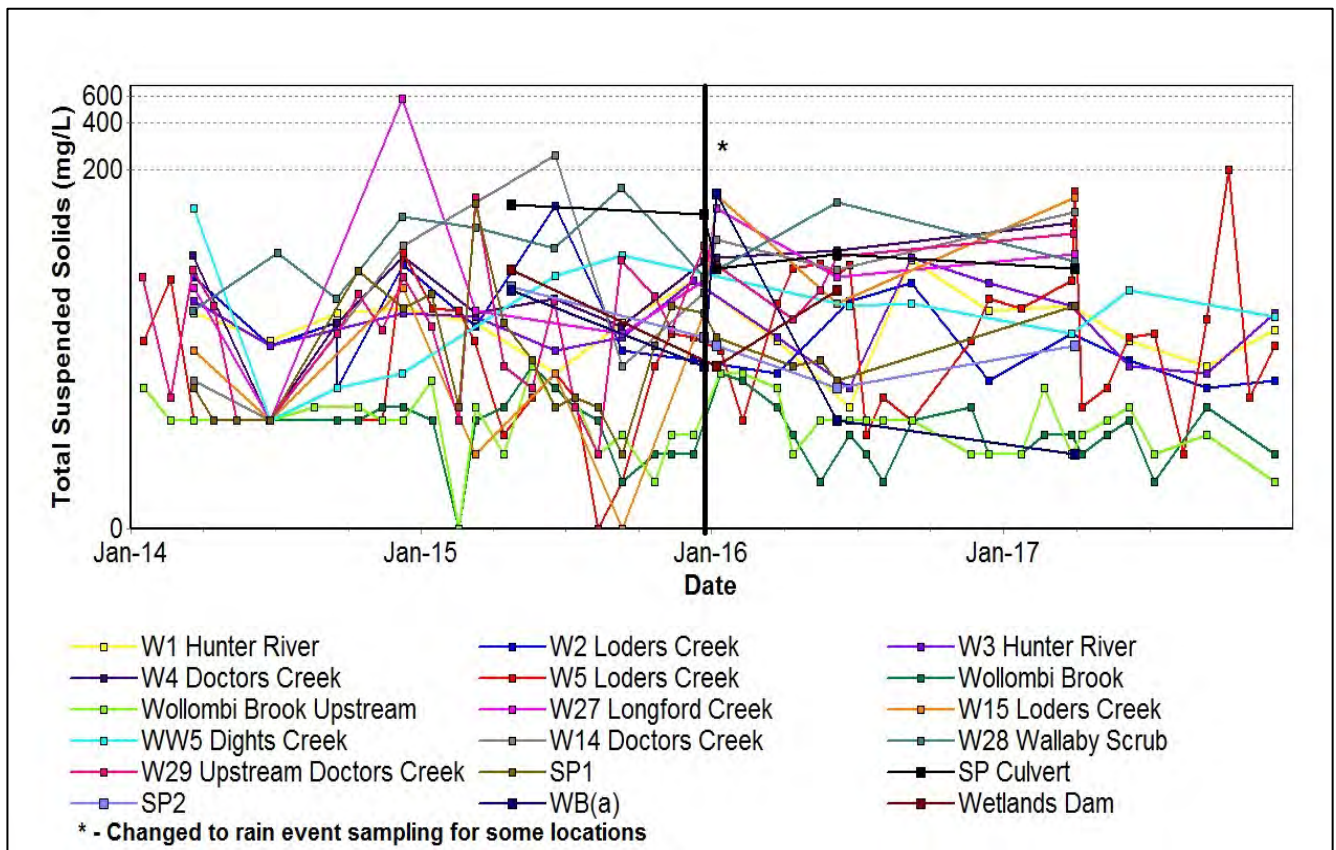
Figure 9 to Figure 11 show the long term surface water trend (2014 – current) within MTW mine dams. Figure 12 to Figure 14 show the long term surface water trend (2014 - current) in surrounding watercourses.

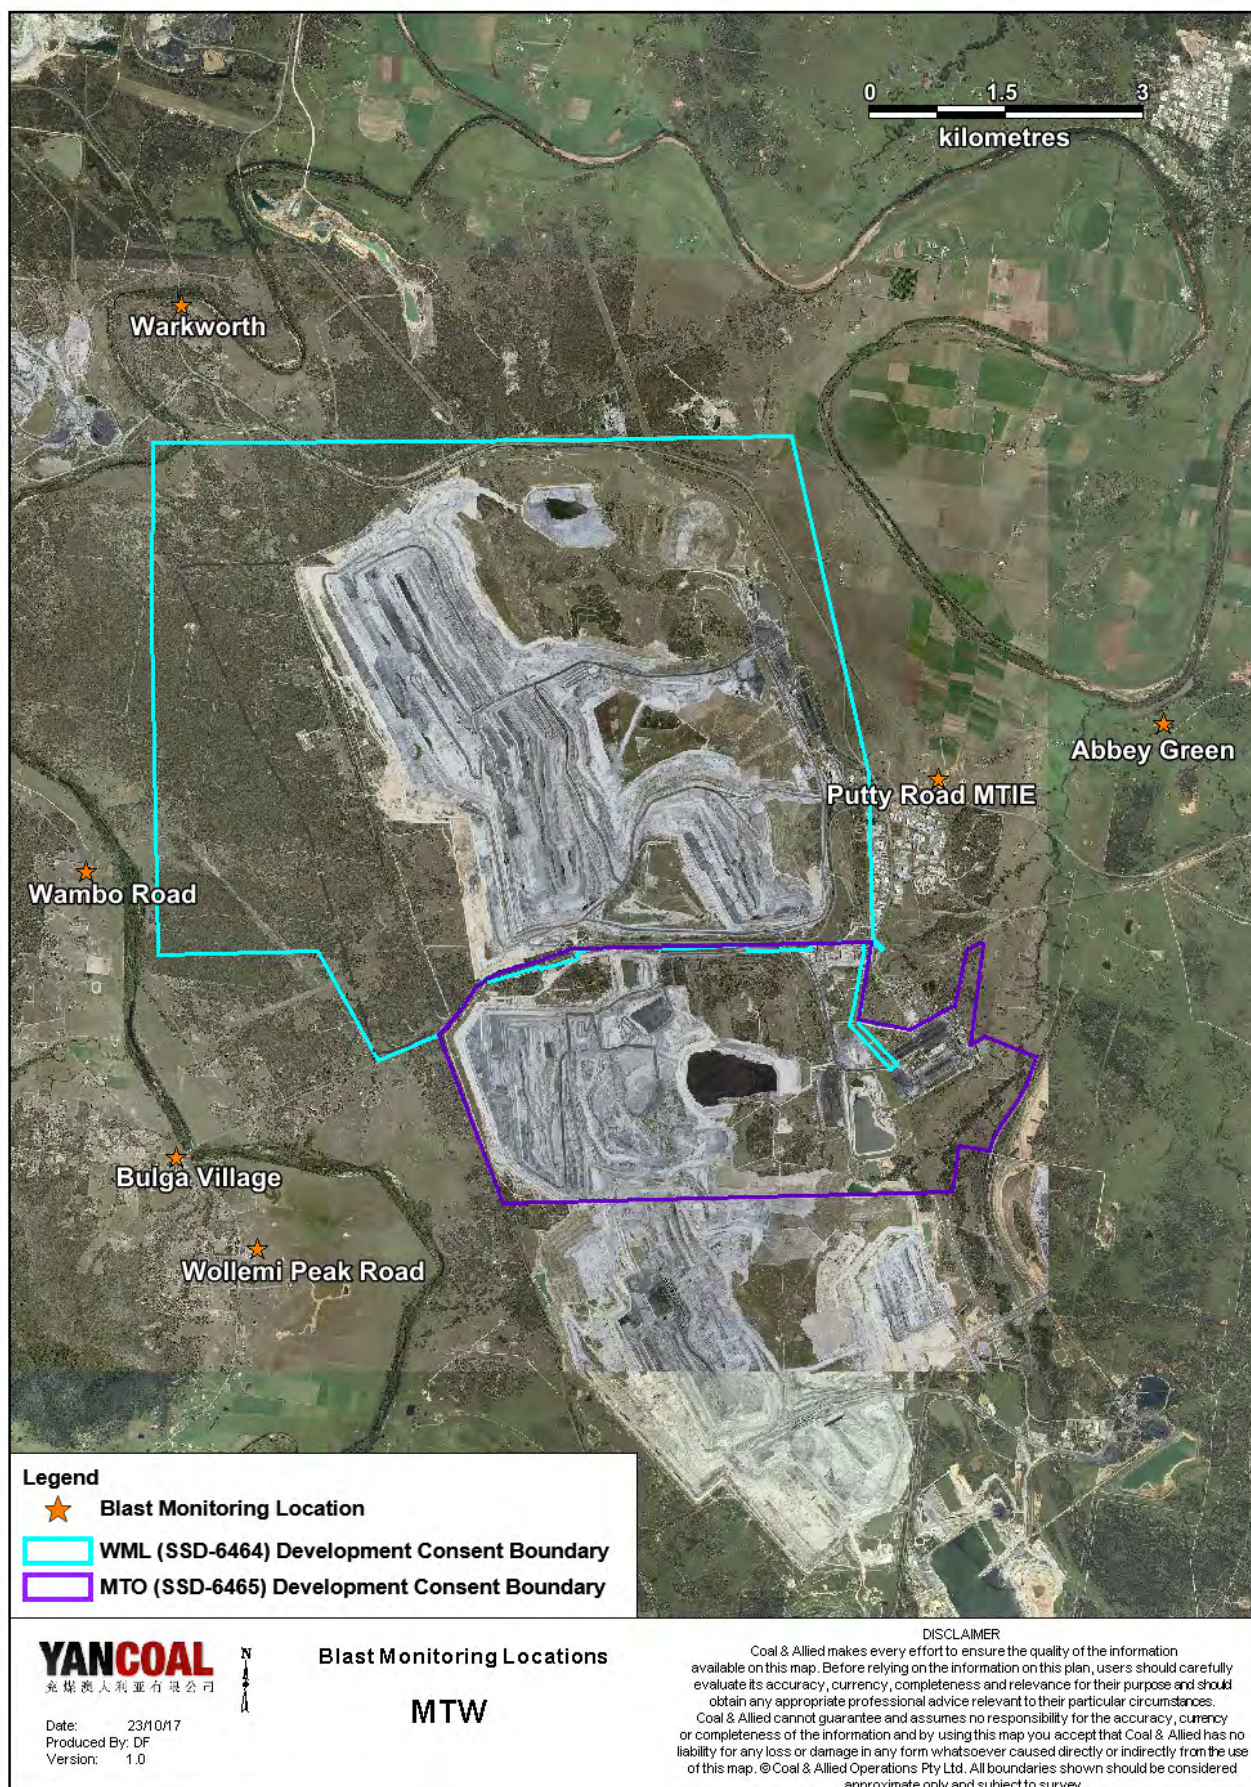
Figure 66: Blast and Vibration Monitoring Location Plan

The location of these monitors can be found in Figure 66.

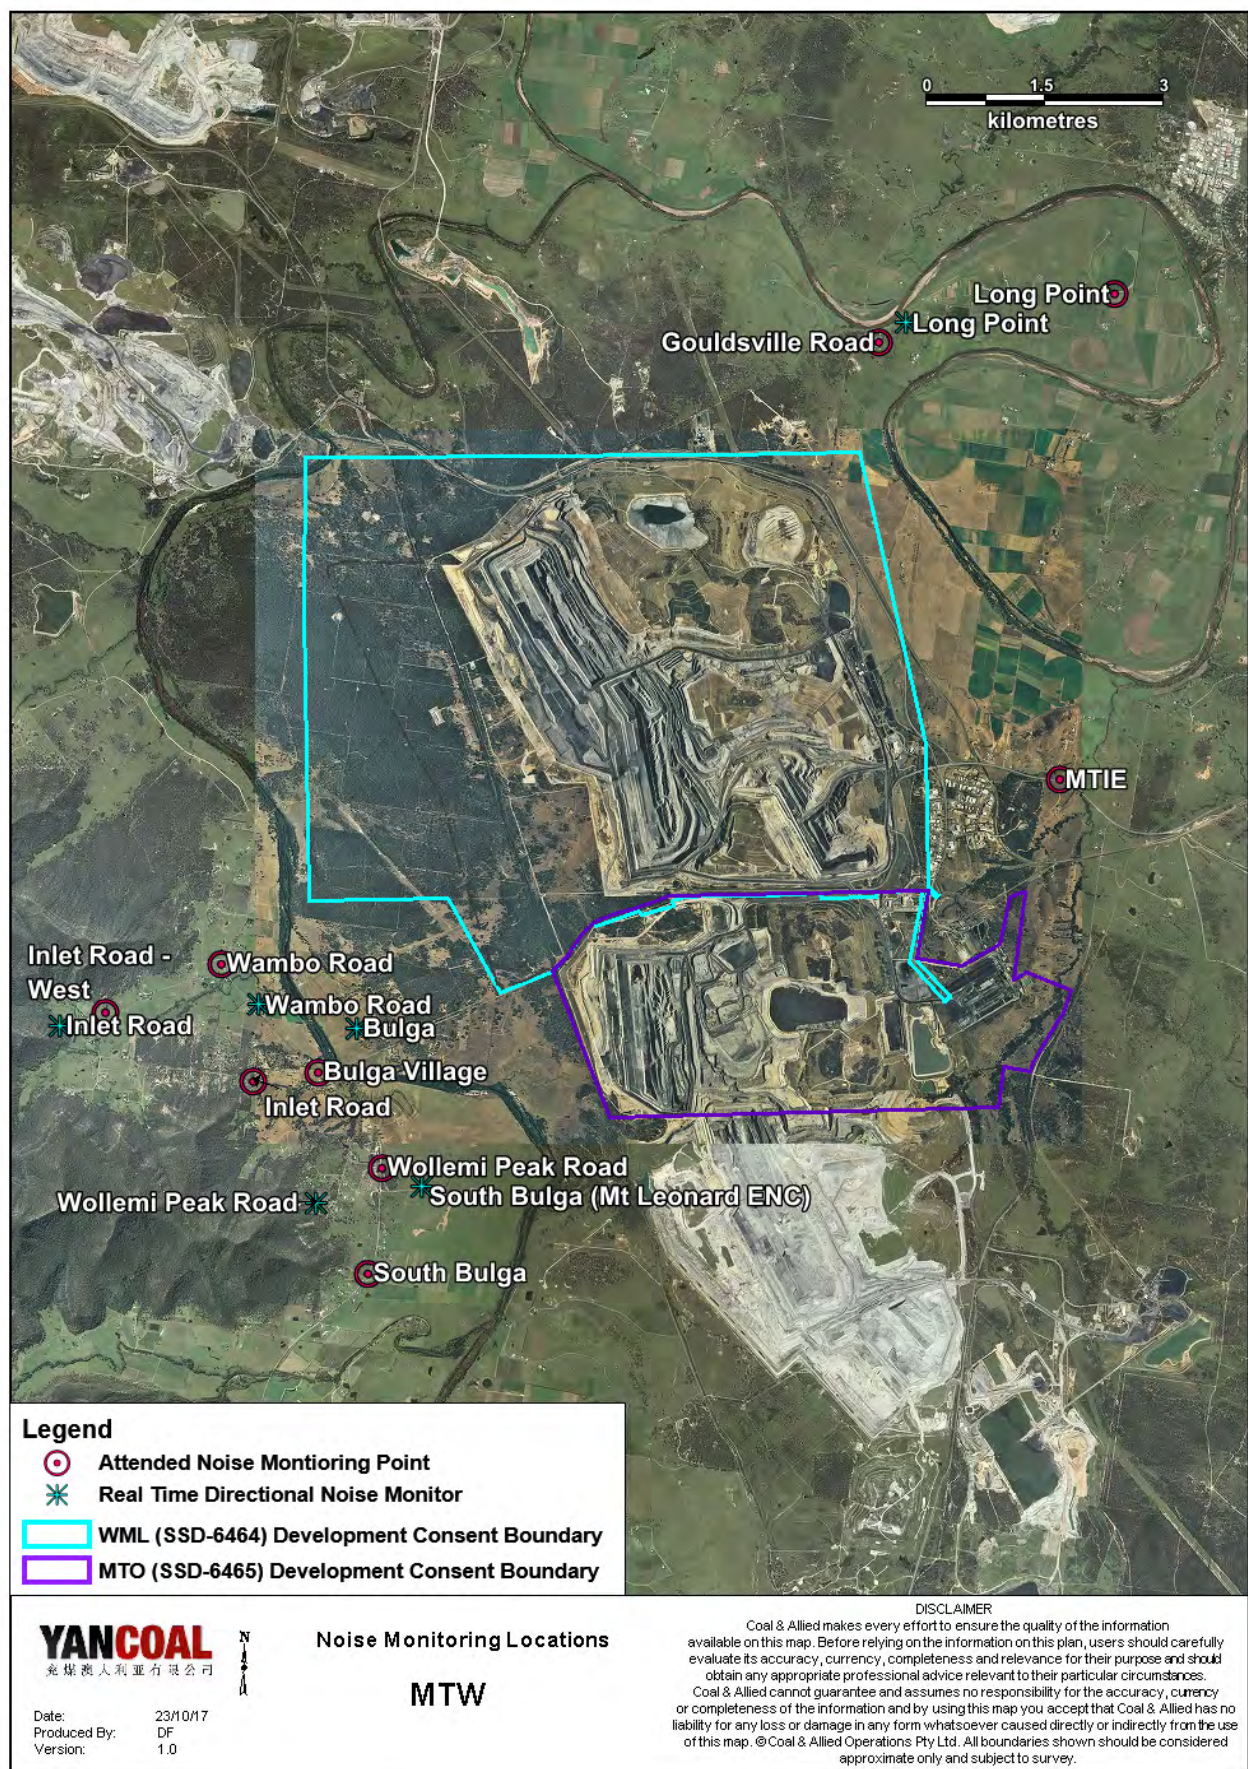
Figure 67: Noise Monitoring Location Plan

Routine attended noise monitoring is carried out in accordance with the MTW Noise Management Plan. A review against EIS predictions will be reported in the Annual Review. The purpose of the noise surveys is to quantify and describe the acoustic environment around the site and compare results with specified limits. Unattended monitoring (real time noise monitoring) also occurs at five sites surrounding MTW. The attended noise monitoring locations are displayed in Figure 67.
