Mount Thorley Warkworth

2015 Annual Environmental Review

March 2016

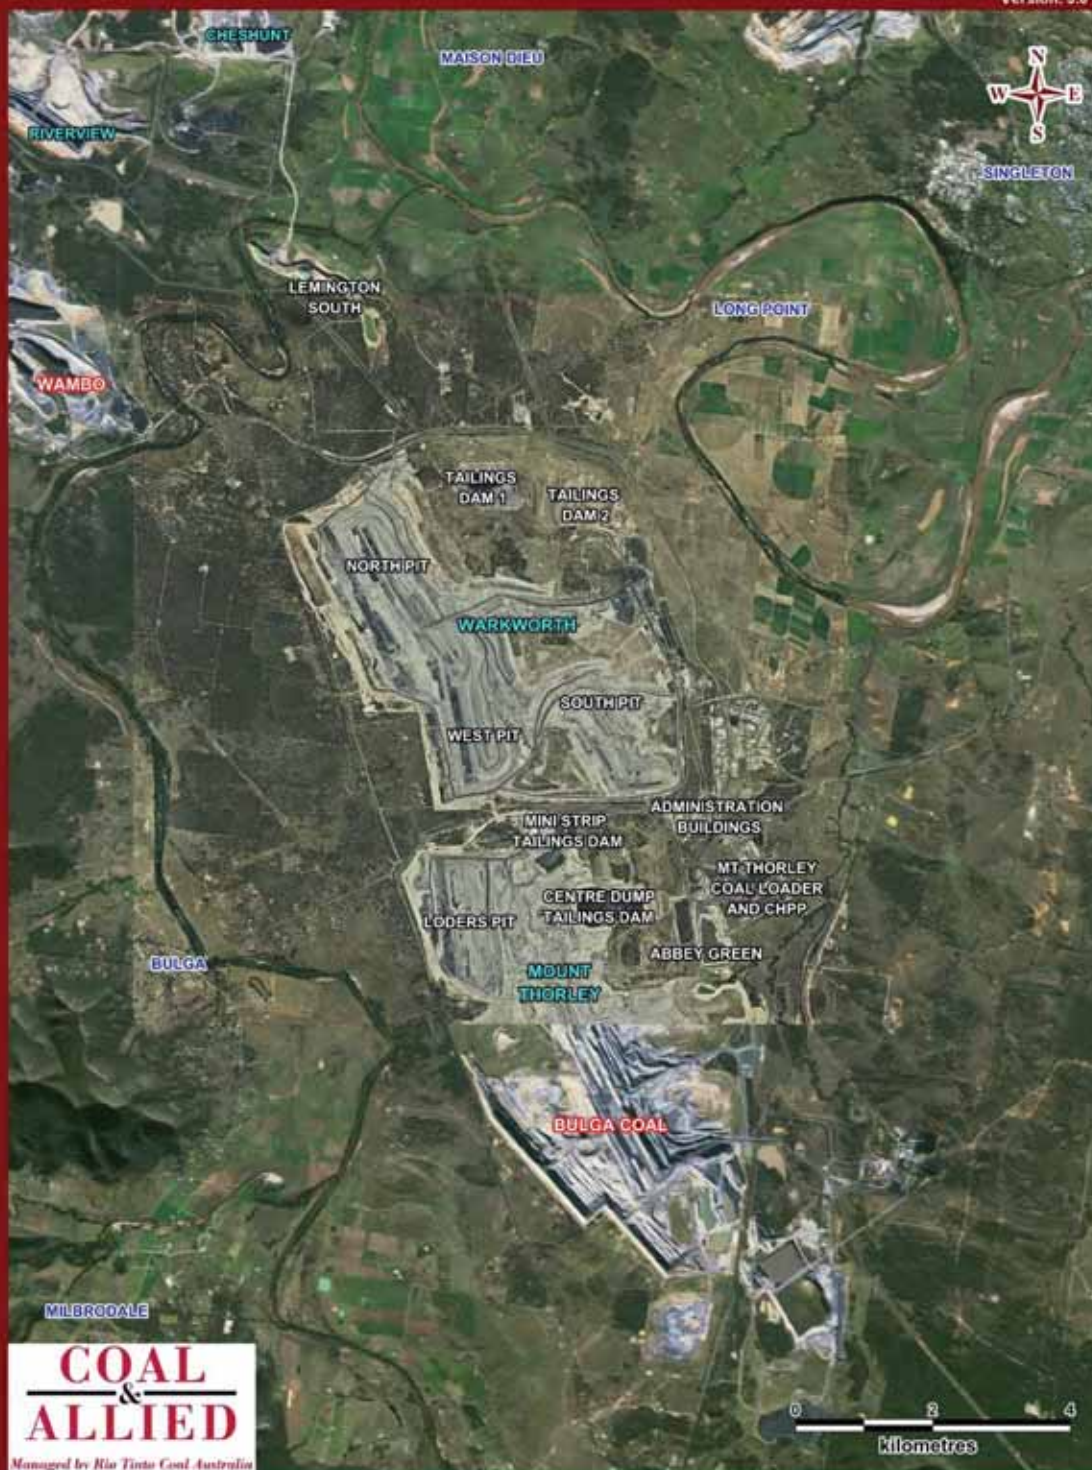
Figure 1: MTW Site Layout and Locality Plan

MTW is located in an area adjacent to other coal mines (Figure 1). Other industry in the locality includes: the Mount Thorley Industrial Estate; the Dyno Nobel Facility; Steggles Quarantine Facility; and the Redbank Power Station (currently not in operation). Other surrounding land uses predominantly consist of a military base and agriculture. The villages of Bulga and Warkworth are located to the southwest and northwest of MTW operations respectively.

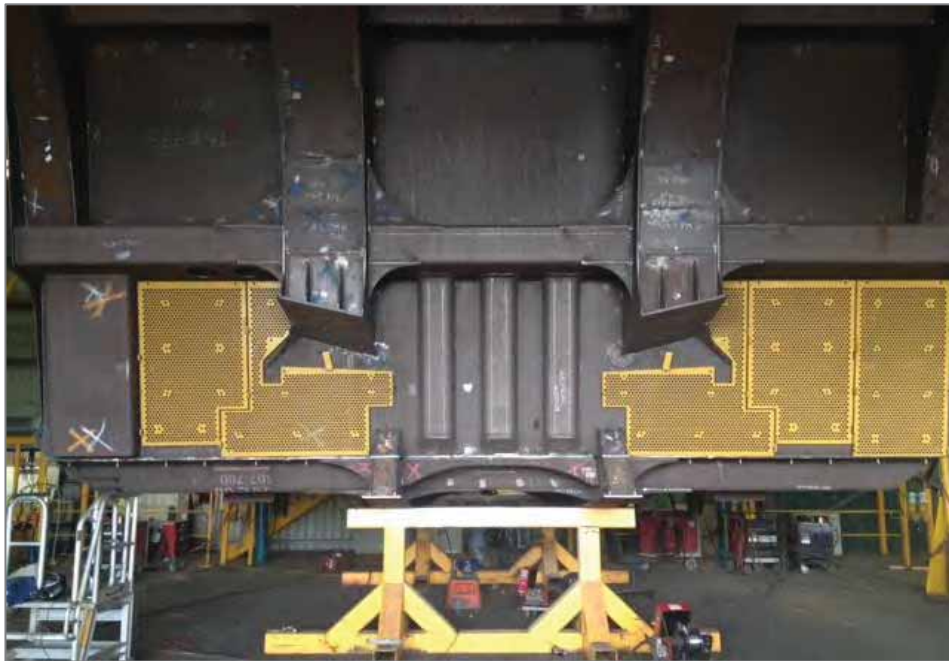
Figure 3: 795 body panel retention fitted to Truck 437.

Figure 3 shows the body panels fitted to a tray of a Caterpillar 795F truck.

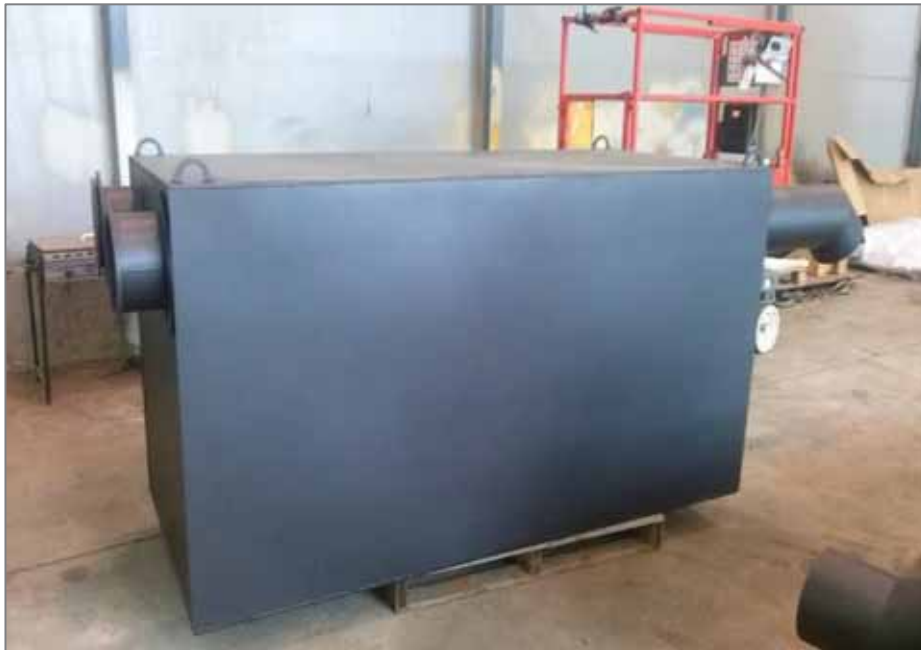
Figure 4: New exhaust silencer which was fitted to Truck 407.

- Full refurbishment of sound media;
 - Engine enclosures
 - Louvres etc
- New exhaust system; and
- Axel box blower hose attenuation

Figure 4 shows a new exhaust silencer which dampens noise associated with the engine exhaust system.

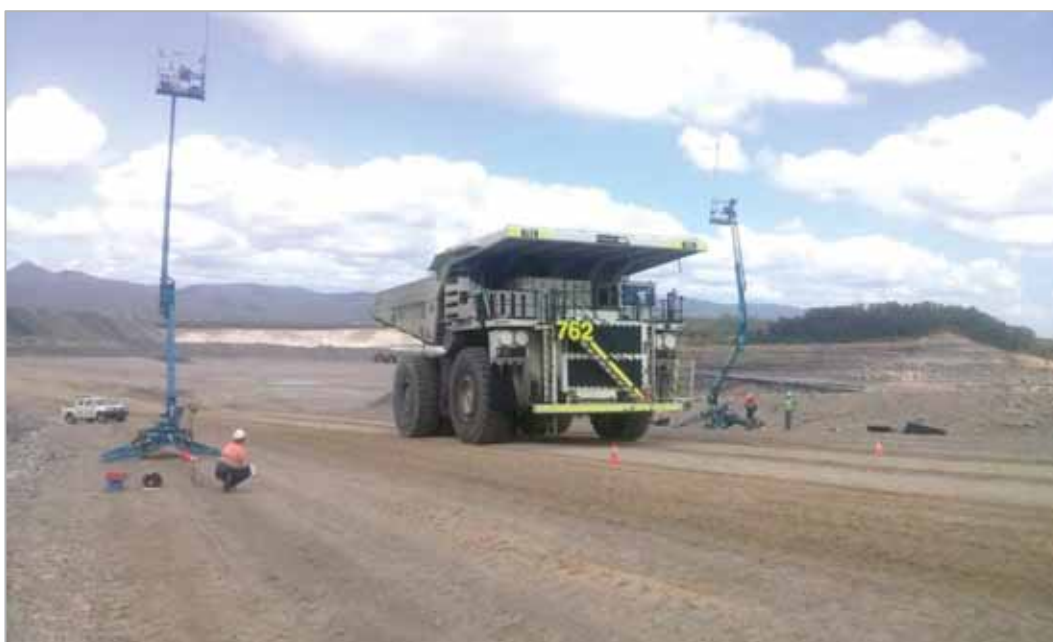
Figure 5 - Sound Power Screening being performed on Truck 762 following installation of sound attenuation components

In addition to visual inspections, MTW implements a Sound Power Level (SWL) screening program to assess the sound power outputs of individual pieces of equipment (Figure 5). Following completion of the sound attenuation program (scheduled to be completed at the end of 2016); sound power level testing will be undertaken on 33% of the attenuated haul fleet each year.

Forty-Four sound power level assessments were undertaken, across a total of 33 pieces of attenuated equipment in 2015.

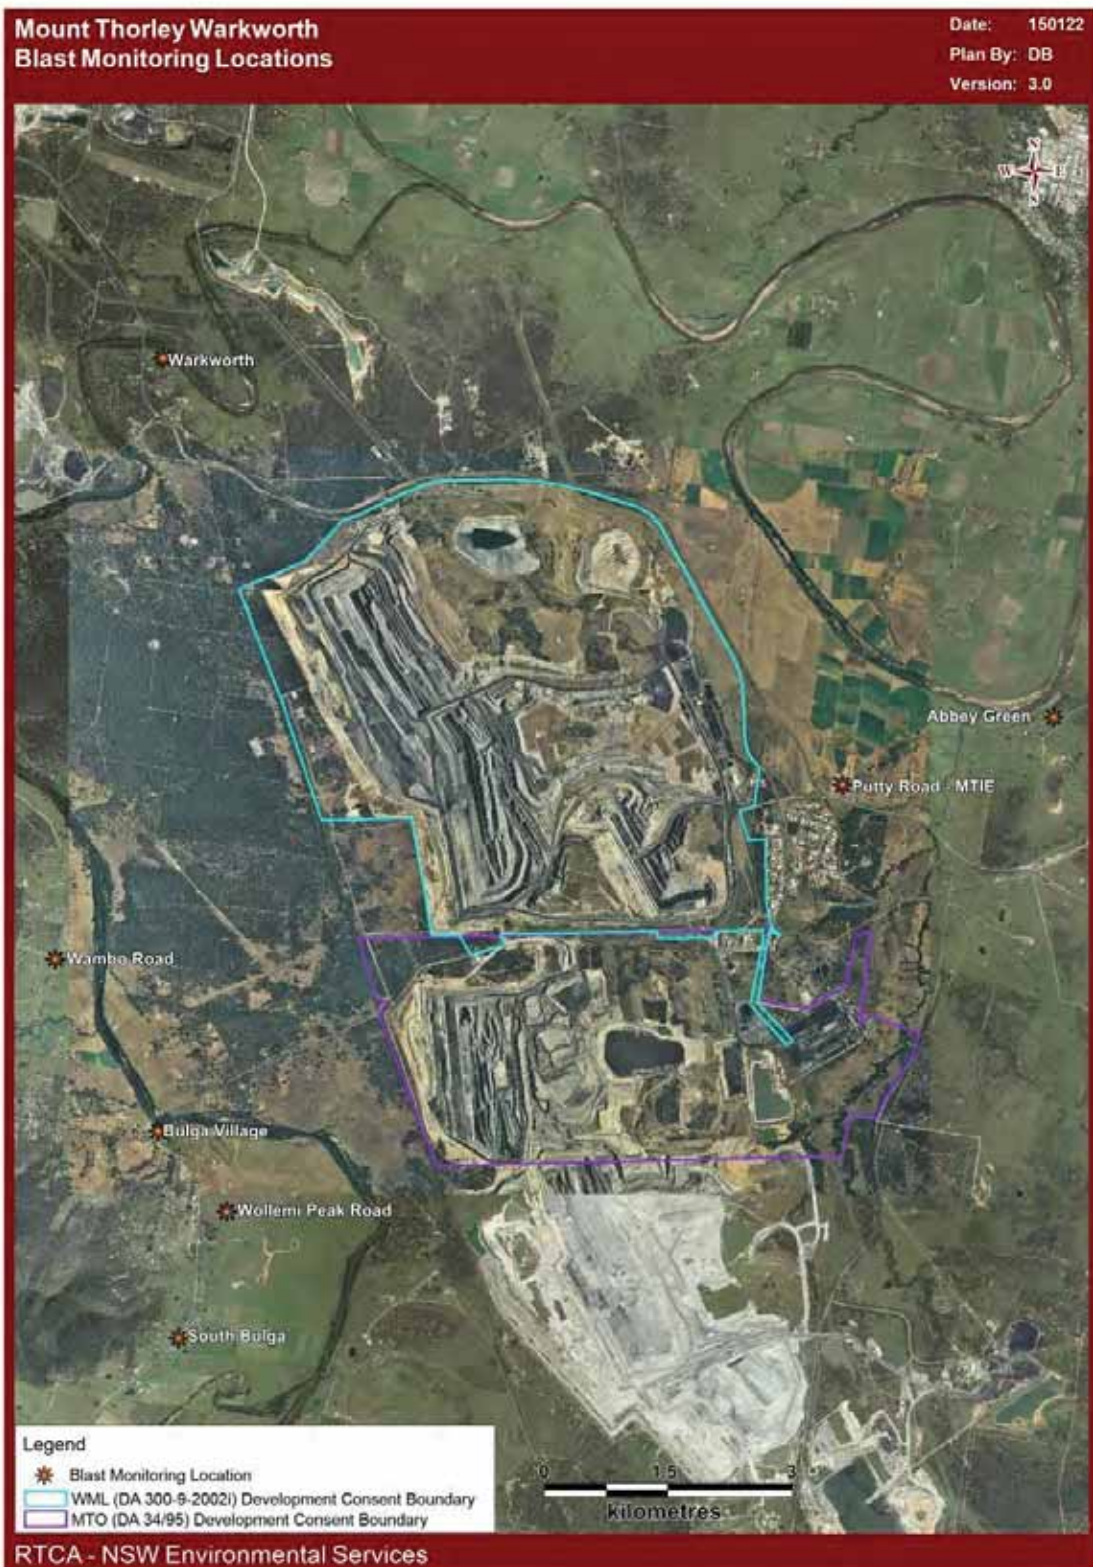
Figure 6: Blast Monitoring Locations

- Abbey Green (Abbey Green Station, Putty Road, Glenridding);
- Bulga Village (Wambo Road, Bulga);
- Mount Thorley Industrial Estate (known as MTIE - Putty Road, Mount Thorley)
- Wambo Road (Wambo Road, Bulga);
- Warkworth Village (former Warkworth Public School, Warkworth); and
- Wollemi Peak Road (intersection of Putty & Wollemi Peak Roads, Bulga).

The South Bulga monitoring location (Putty Road, Bulga) was decommissioned in April 2015 in consultation with the DP&E Singleton compliance office and local residents.

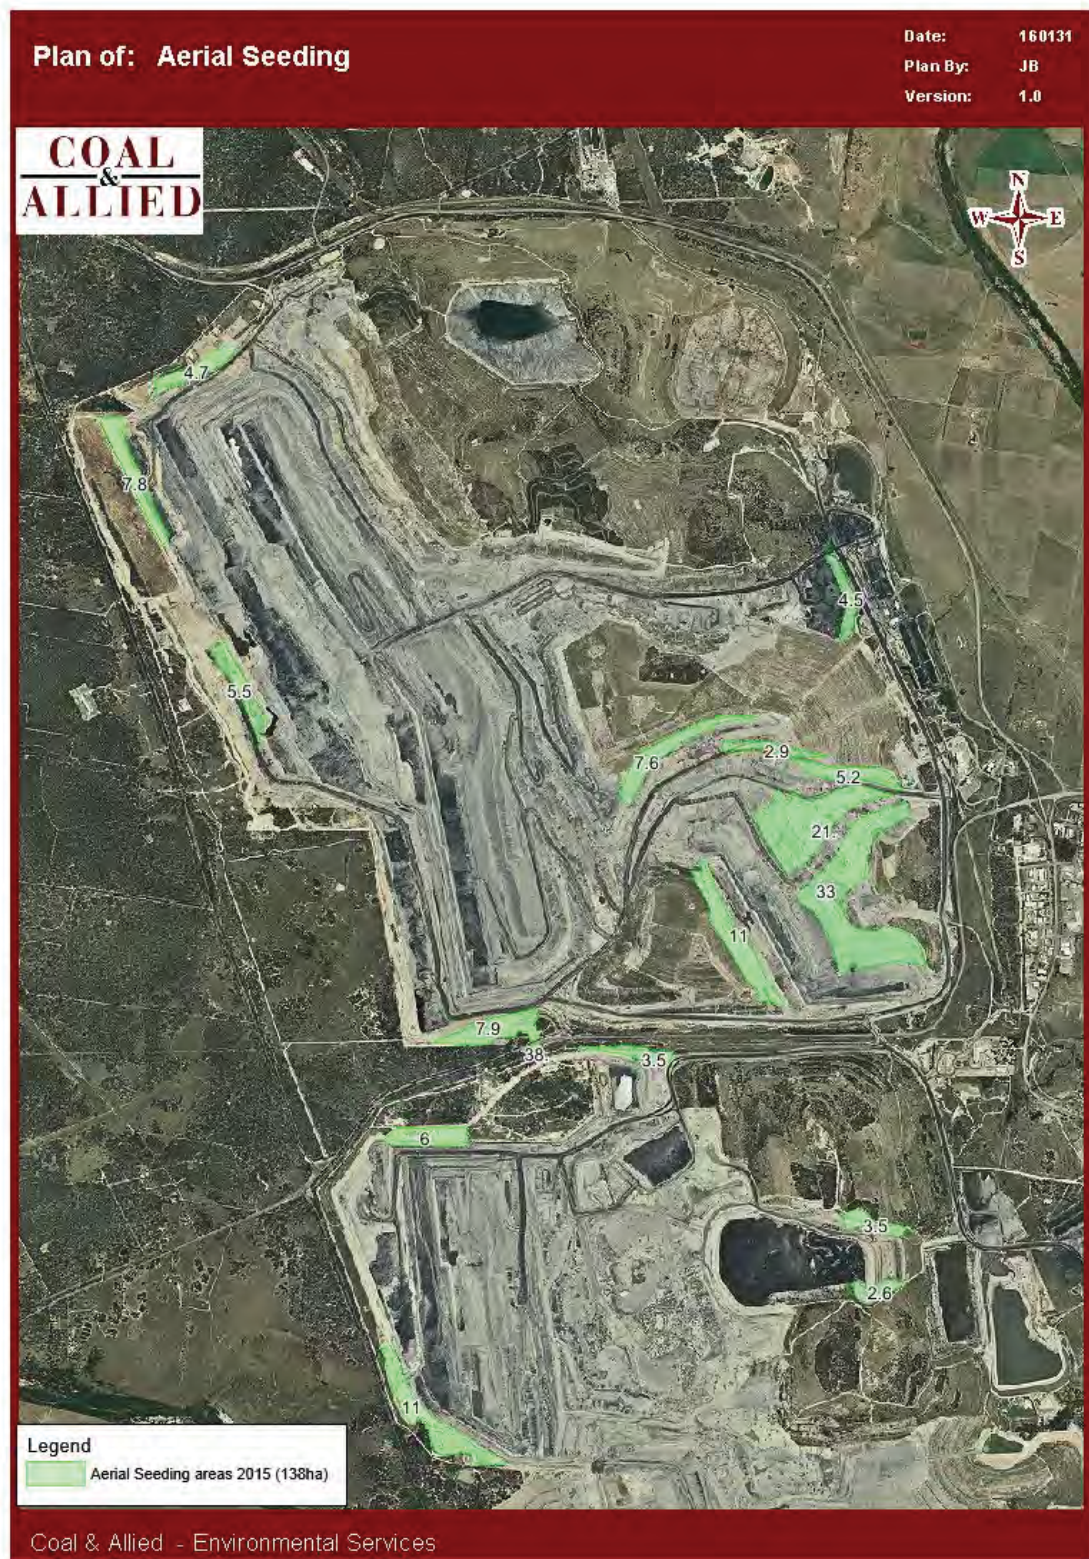
Figure 15: 2015 Aerial Seeding Areas

Aerial Seeding was undertaken in early May 2015 by a fixed wing aircraft to provide temporary cover to areas exposed to wind generated dust and erosion at MTW. Waste dumps and exposed areas were selected for seeding if they were not planned to be disturbed within six months. The 138 hectares of area seeded included waste dumps and ahead of mining disturbance (see Figure 15). All areas were seeded using an exotic pasture grass and legume mix suitable for autumn sowing. The seed mix was revised slightly from previous years to reduce the number of species to those which were most successful from previous years. A starter fertiliser was mixed with the seed prior to loading to provide sufficient nutrients for plant growth.

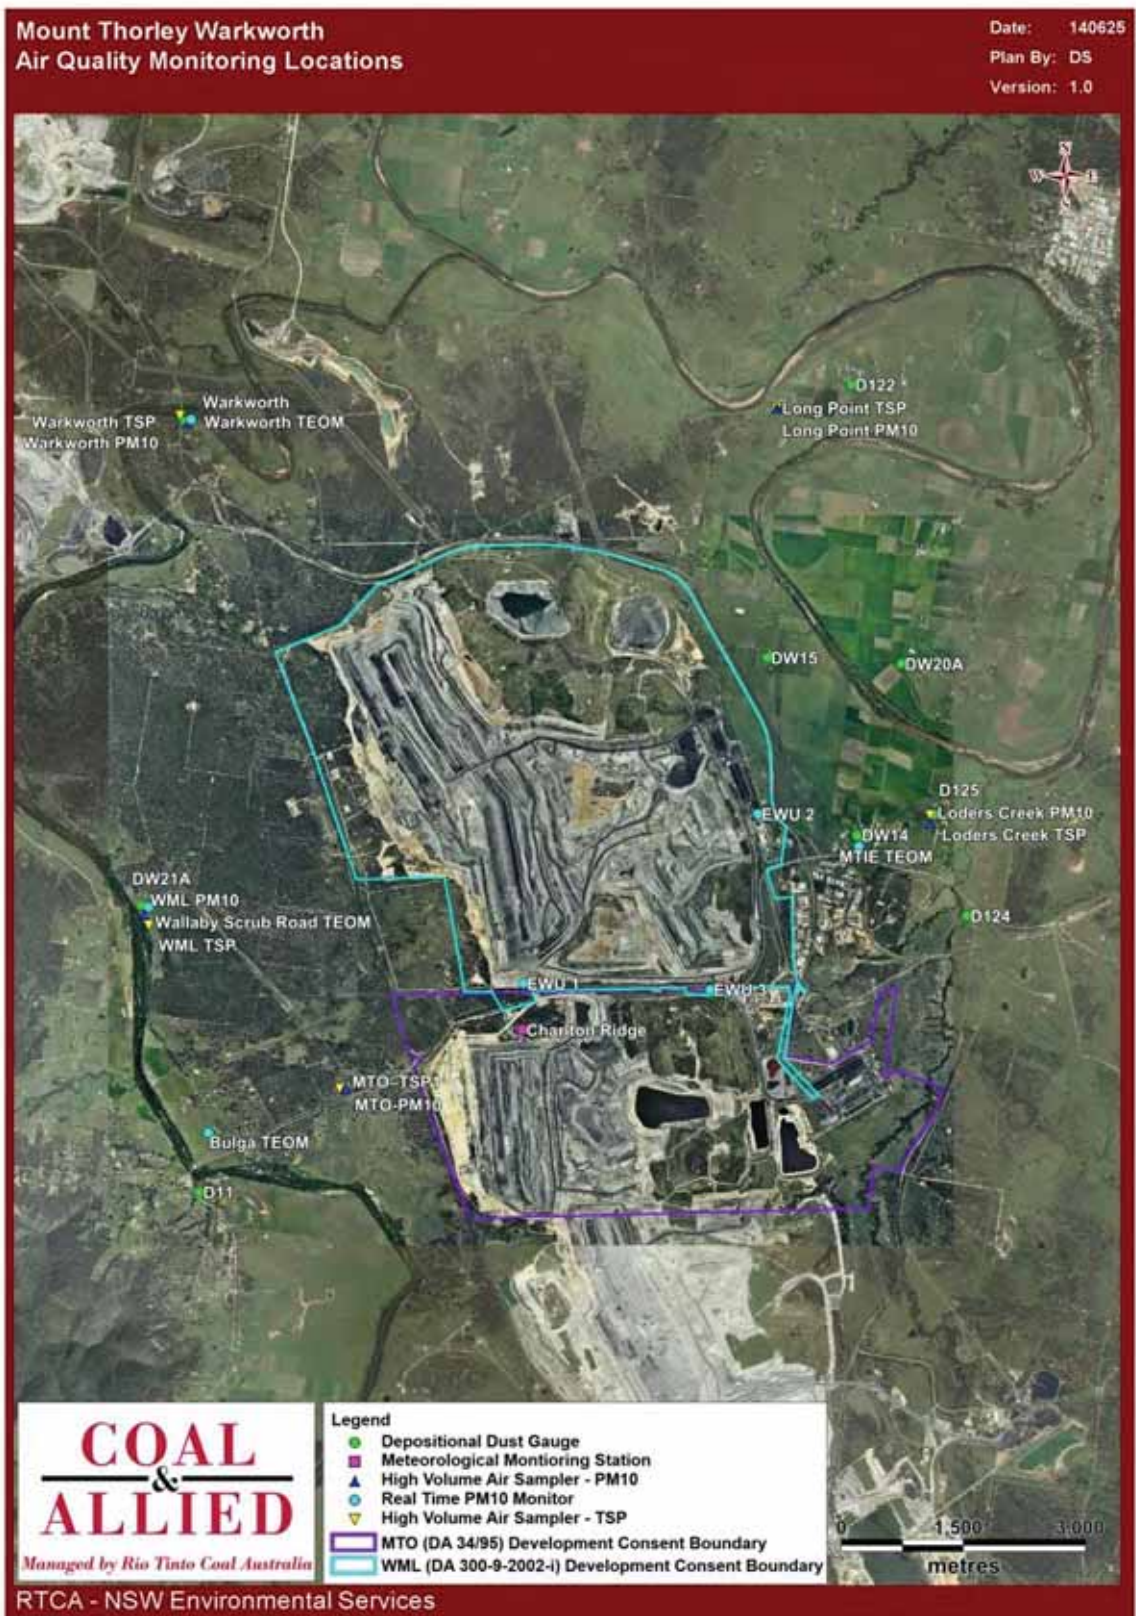
Figure 16: Air and Meteorological Monitoring Locations MTW 2015

Air quality monitoring at MTW is undertaken in accordance with the MTW Air Quality Monitoring Programme and protocol for evaluating non-compliances ([http://www.riotinto.com/documents/MTW Air Quality and Greenhouse Gas Management Plan.pdf](http://www.riotinto.com/documents/MTW_Air_Quality_and_Greenhouse_Gas_Management_Plan.pdf)). The monitoring network comprises an extensive array of monitoring equipment which is utilised to assess performance against the relevant conditions of MTW's approvals. Air quality monitoring locations are shown in Figure 16. During 2015, MTW complied with all short term and annual average air quality criteria.

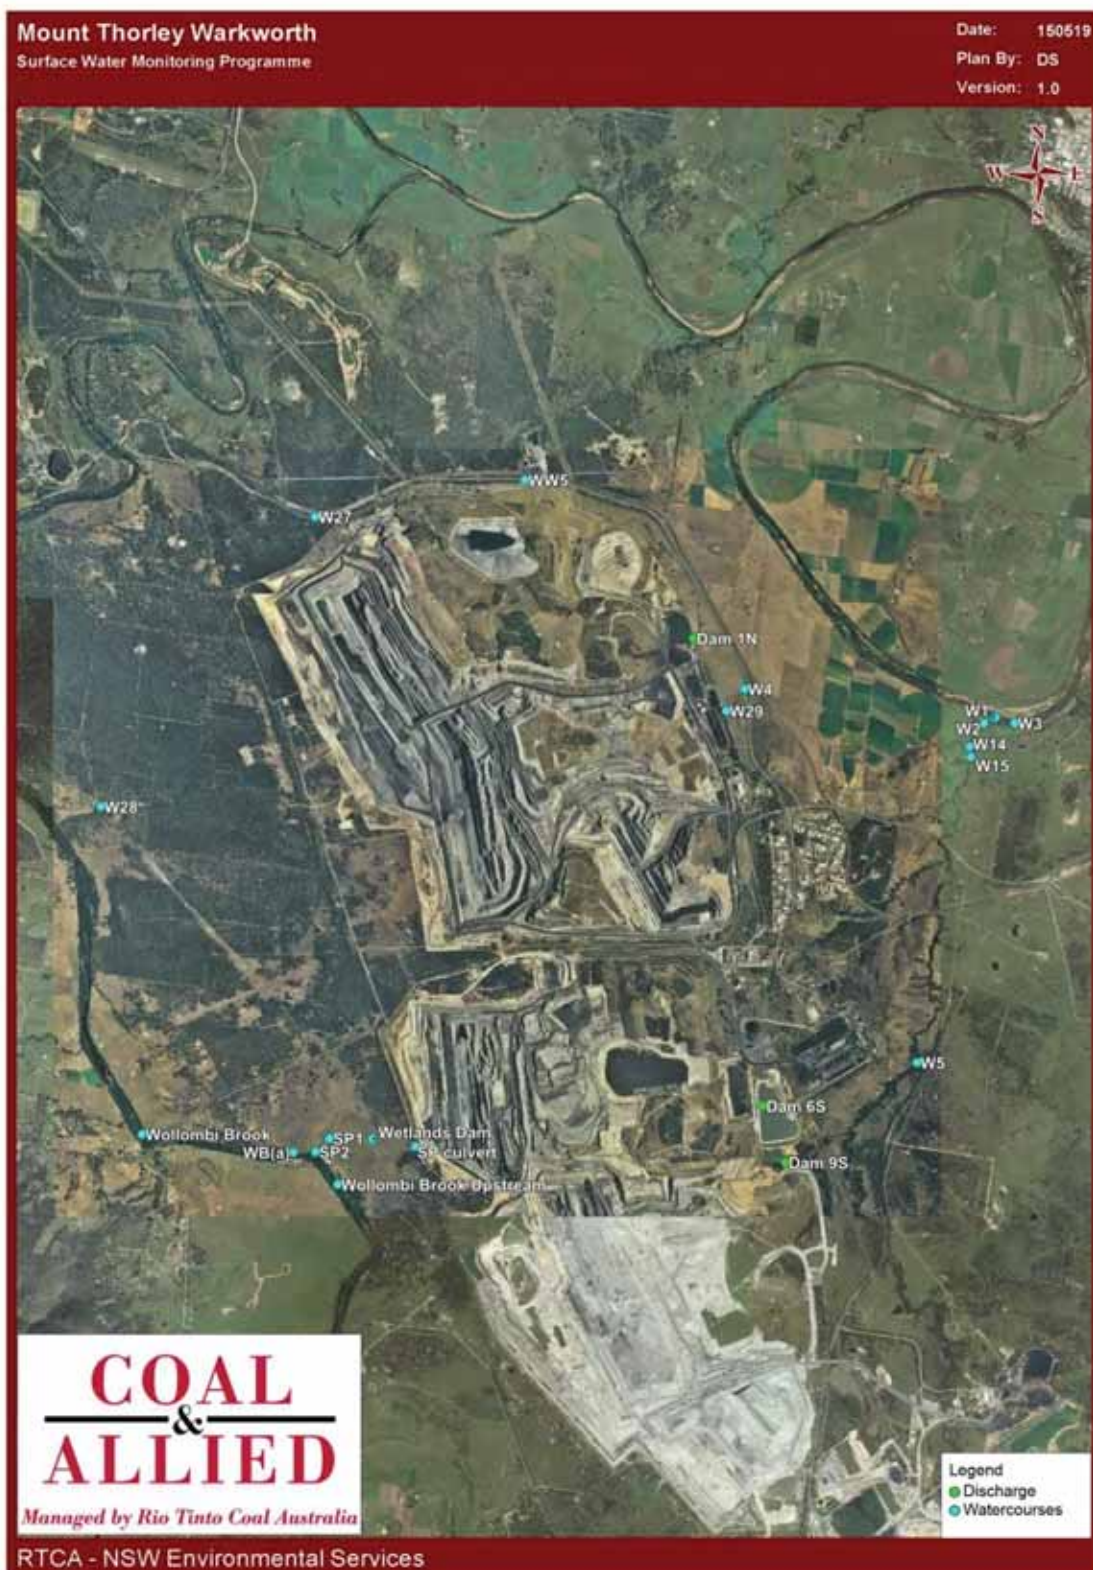
Figure 29: Surface Water Monitoring Points

Surface water monitoring activities continued in 2015 in accordance with the MTW Water Management Plan and MTW Surface Water Monitoring Programme. MTW maintains a network of surface water monitoring sites located at site dams and surrounding natural watercourses, see Figure 29. Water quality monitoring is undertaken to verify the effectiveness of the water management system onsite, and to identify the emergence of potentially adverse effects on surrounding watercourses. Primary water storage dams are monitored routinely to verify the quality of mine water, used in coal processing, dust suppression, and other day to day activities around the mine.

Surface water monitoring data review involves a comparison of measured pH, EC and TSS results against internal trigger values which have been derived from the historical data set. The response to measured excursions outside the trigger limits is detailed in the MTW Water Management Plan.

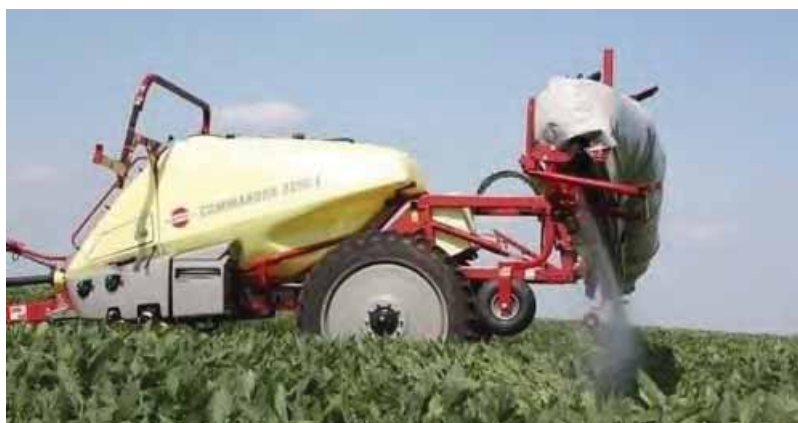
Figure 76: Photo showing a spray rig boom fitted with air-assist shroud.

An air-assisted boom sprayer will be trialled to control weeds on rehabilitation areas and topsoil stockpiles. The spray nozzles are enclosed within a shroud and air is used to direct the herbicide out through the bottom of the shroud and onto the target weeds (see Figure 76). The air-assist design helps to minimise spray drift onto off-target areas and results in better leaf coverage with herbicide for a more effective kill of target species.

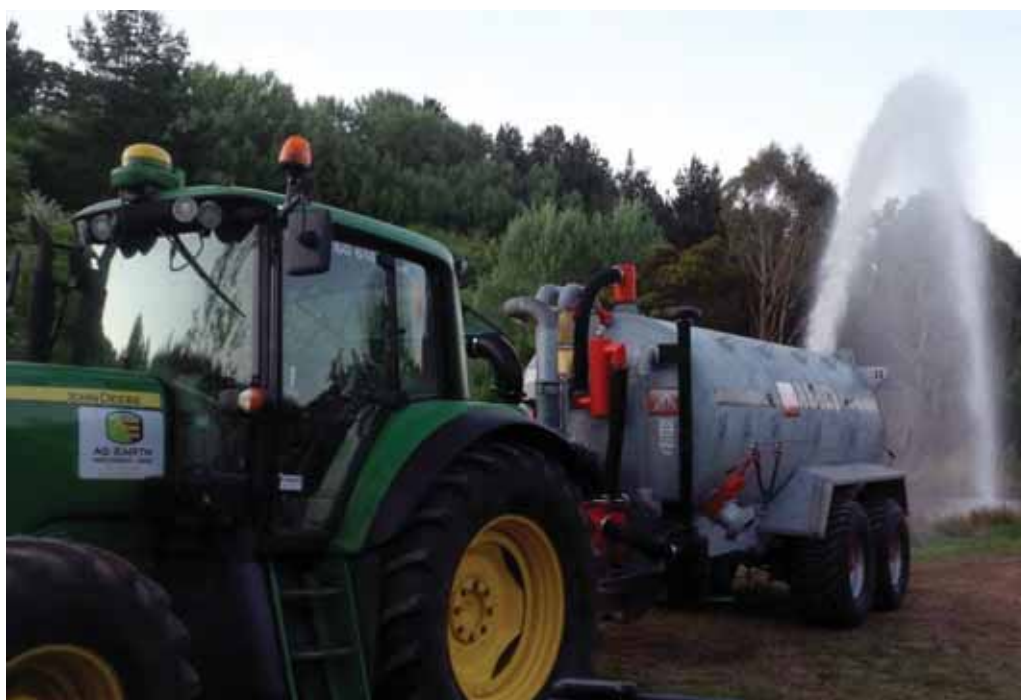
The focus for trials of spoil/compost as a growth medium replacement for topsoil will be on seeding methods that are suitable to be used on a rough spoil surface. The germination results from a spoil/compost trial at Wilton, where the surface was cleared of rock using rock windrowing and rock picking in preparation for using the direct-drill seeder, were not as impressive as previous trials where a rough spoil surface had been maintained. During 2016, a tanker will be trialled for hydroseeding spoil/compost areas with native seed mixes. The tanker can discharge the water/seed mixture through either splash plates fitted to the rear of the tanker; or through a water cannon that can be controlled from the cab of the tractor.

Figure 77: Photo showing discharge capabilities of sludge tanker that will be trialled for hydroseeding rehabilitation areas.

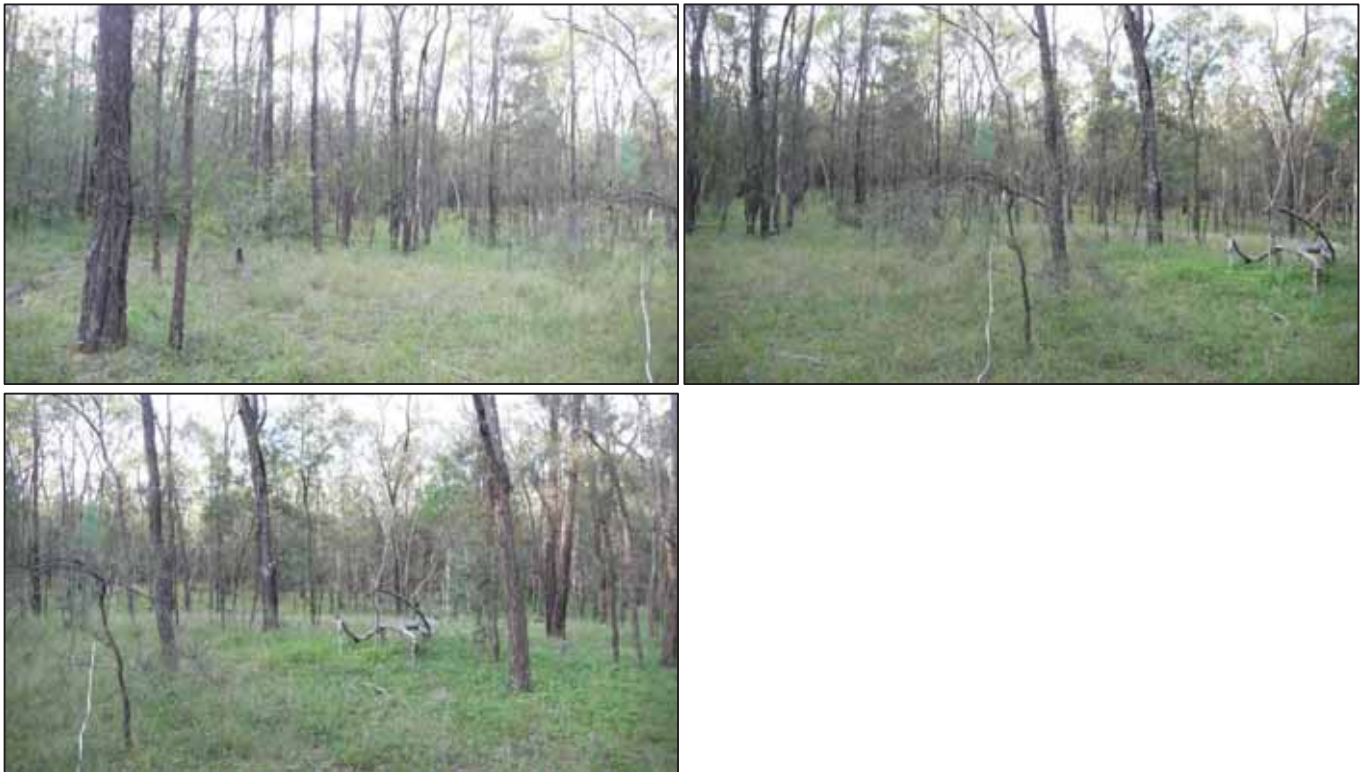
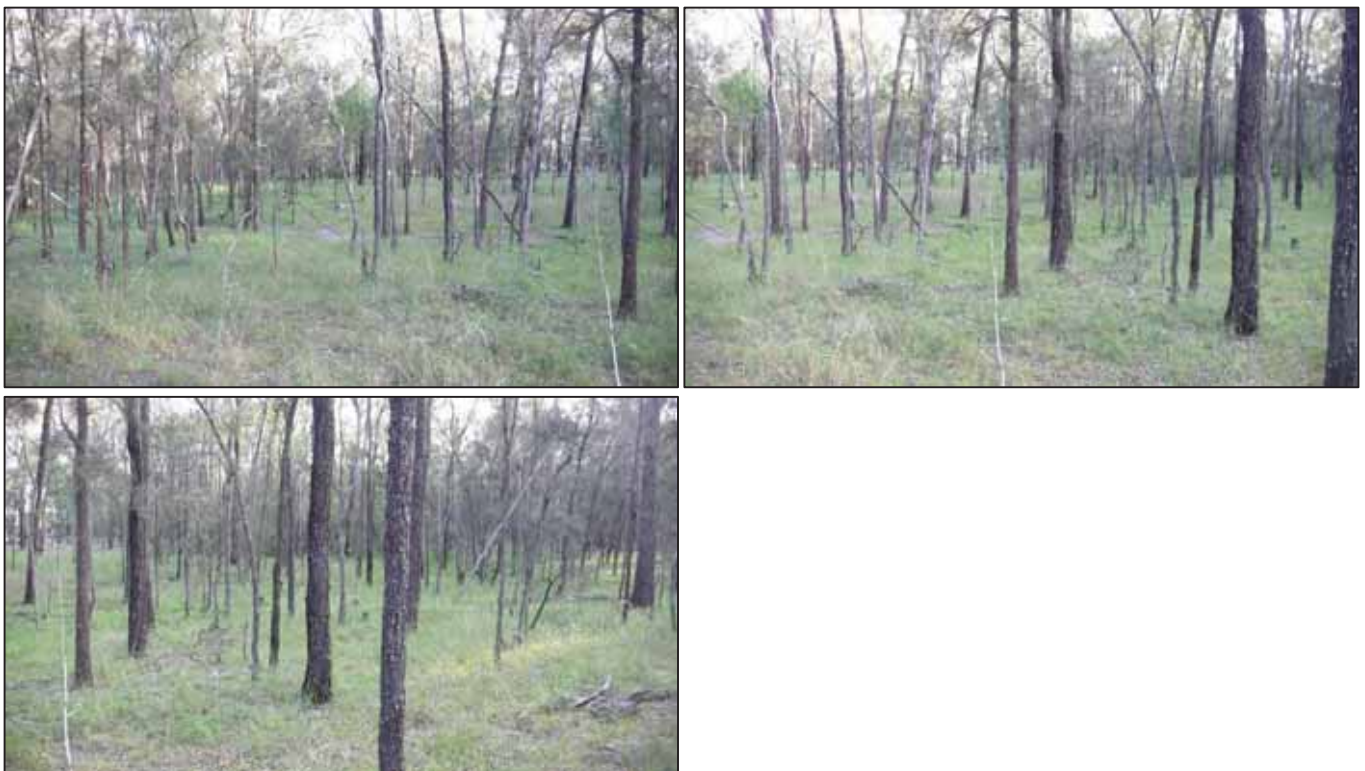
Site photographs at Warkworth Grey Box 02 (left to right)

No damage from fire activity was observed at the site.

No access tracks, or evidence of trail bikes or foot traffic was observed at the site.

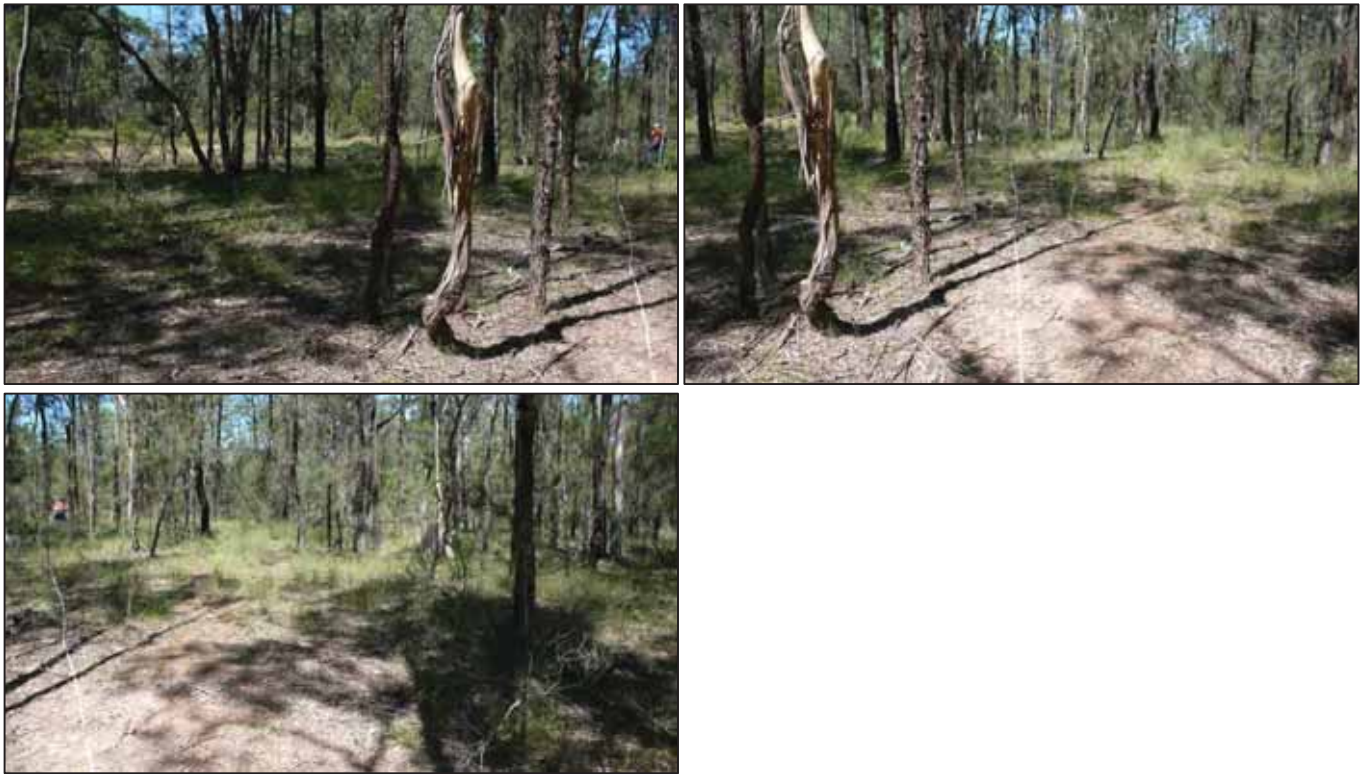
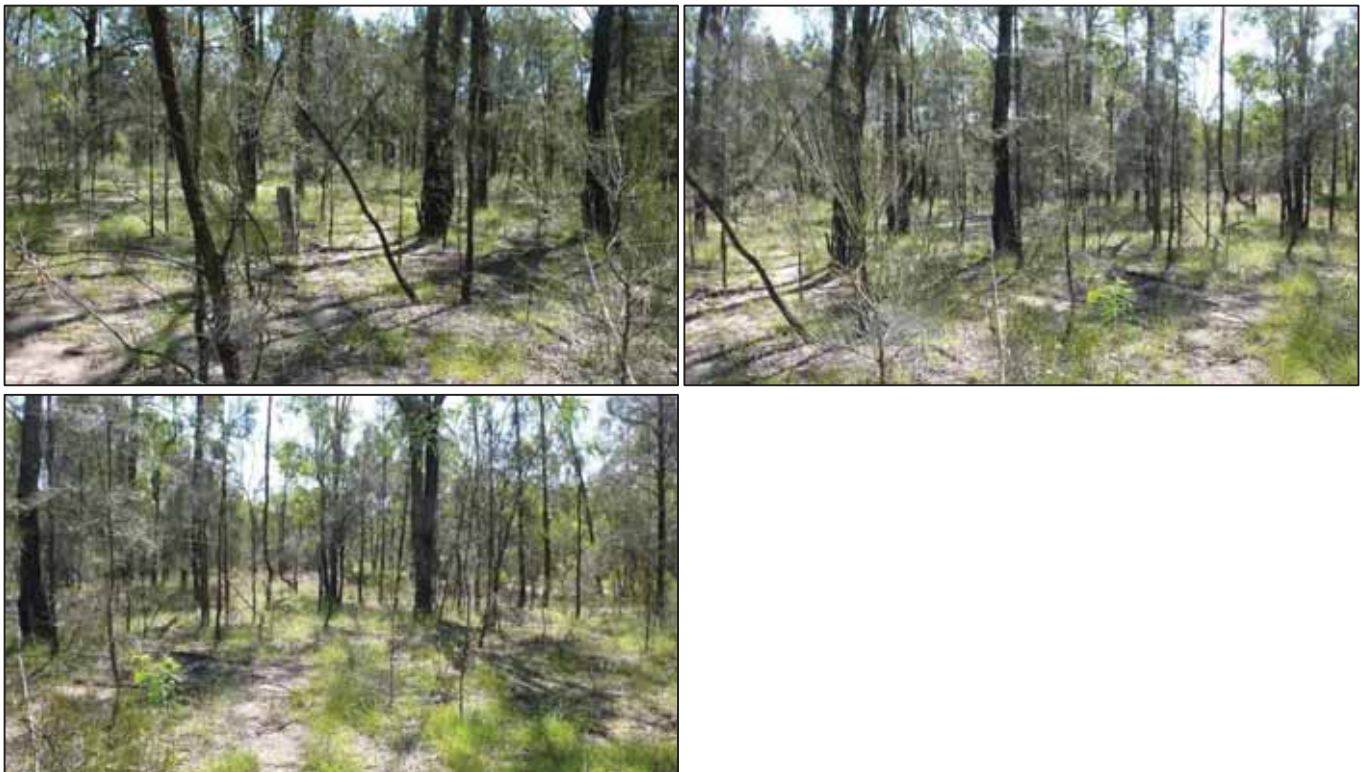
Site photographs at Warkworth Grey Box 03 (left to right)

No damage from fire activity was observed at the site.

No access tracks, or evidence of trail bikes or foot traffic was observed at the site.

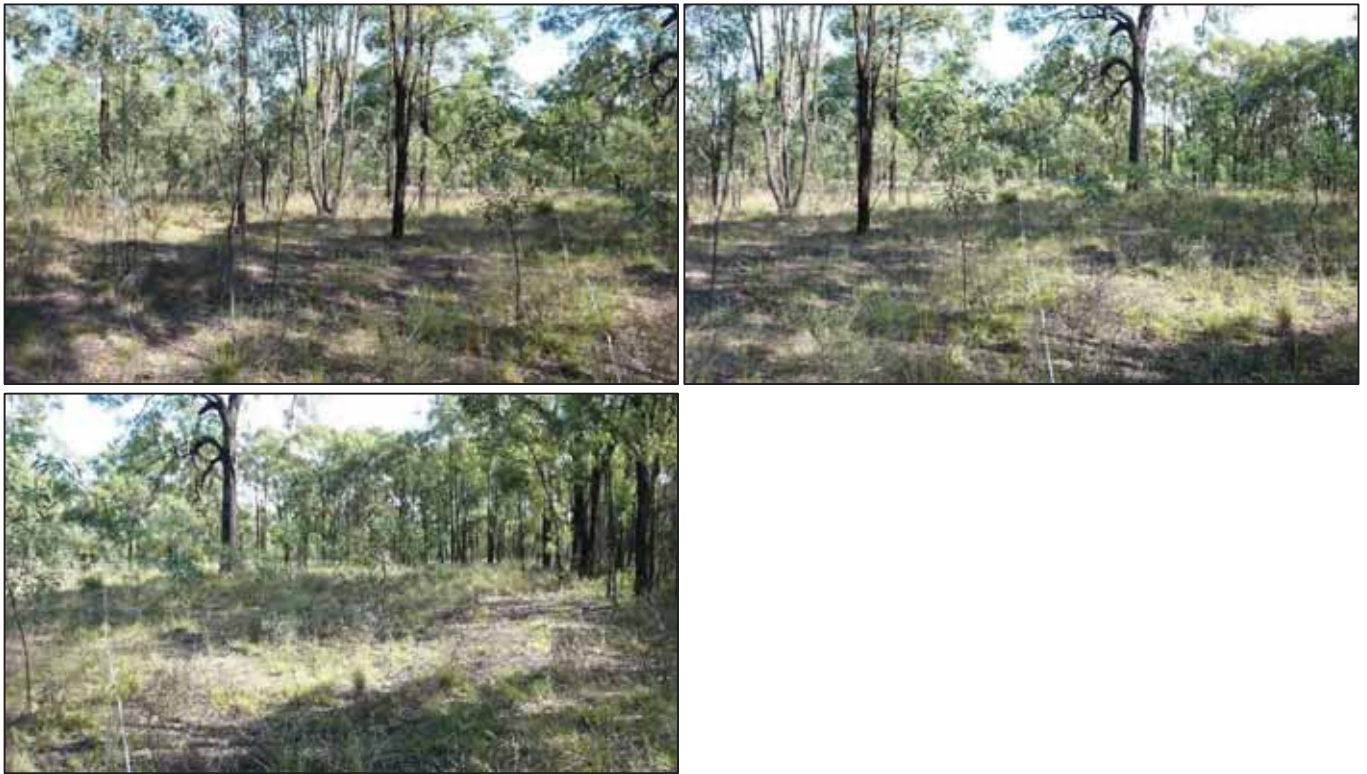
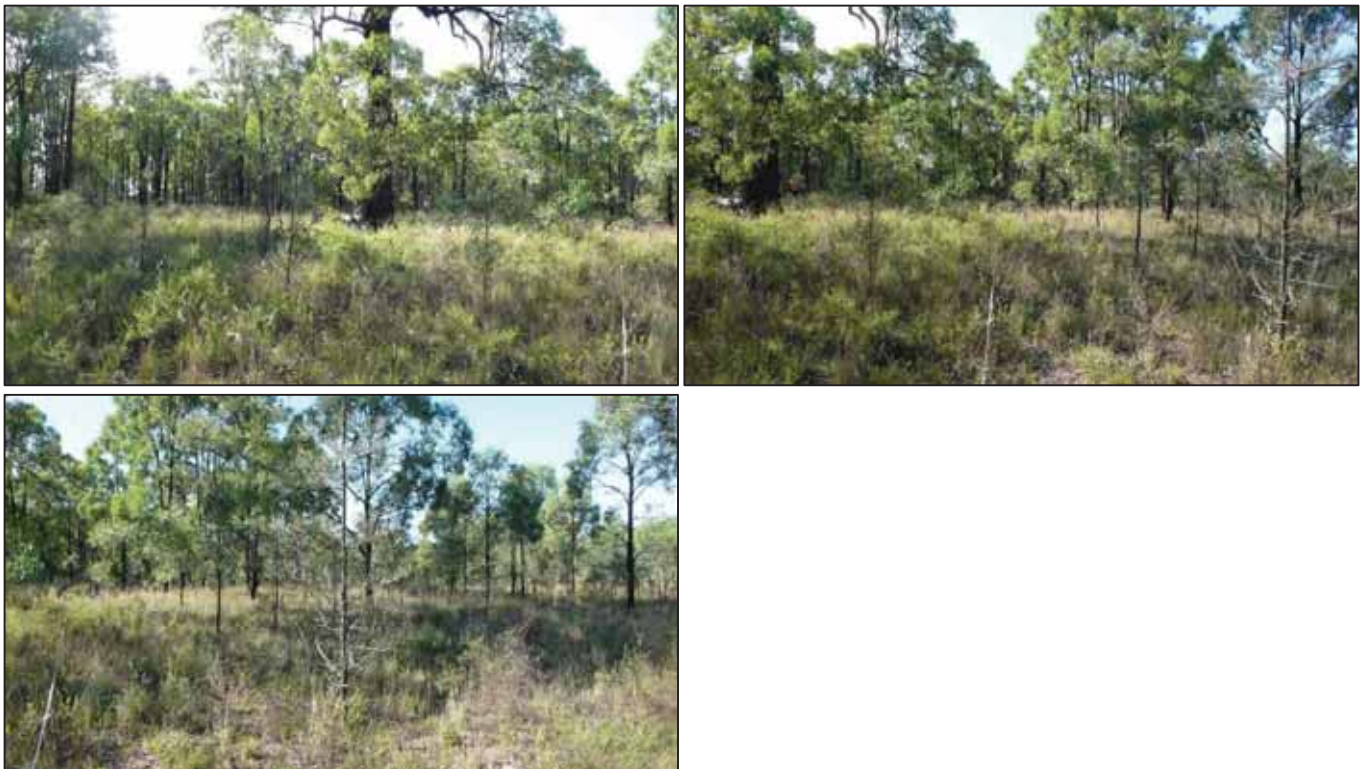
Site photographs at Warkworth Grey Box 04 (left to right)

Disturbance present at the site consisted of few weed species. Weeds recorded include *Melinus repens*, *Eragrostis curvula*, *Opuntia* spp., *Bidens pilosa* and *Senecio madagascariensis*.

No damage from fire activity was observed at the site.

No access tracks, or evidence of trail bikes or foot traffic was observed at the site.

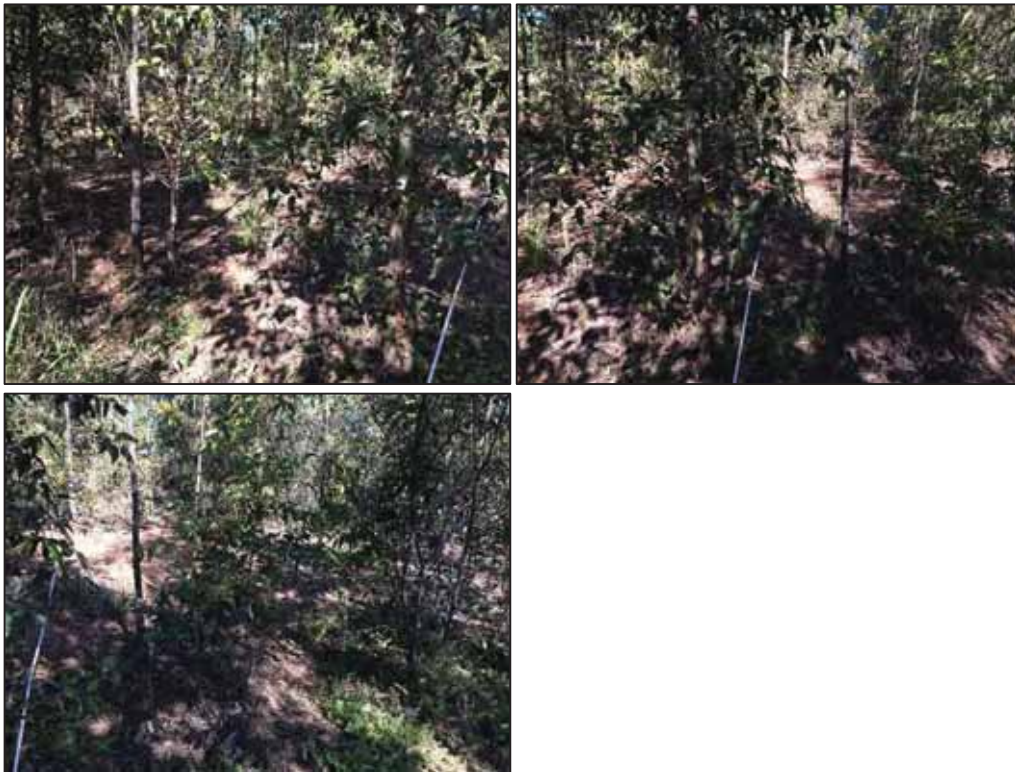
Site photographs at HVOCAR2009-01 (left to right)

Disturbance present at the rehabilitation site consisted mainly of weeds, and grazing by macropods. No evidence of fire was observed in the rehabilitation area. No areas containing rubbish were observed.

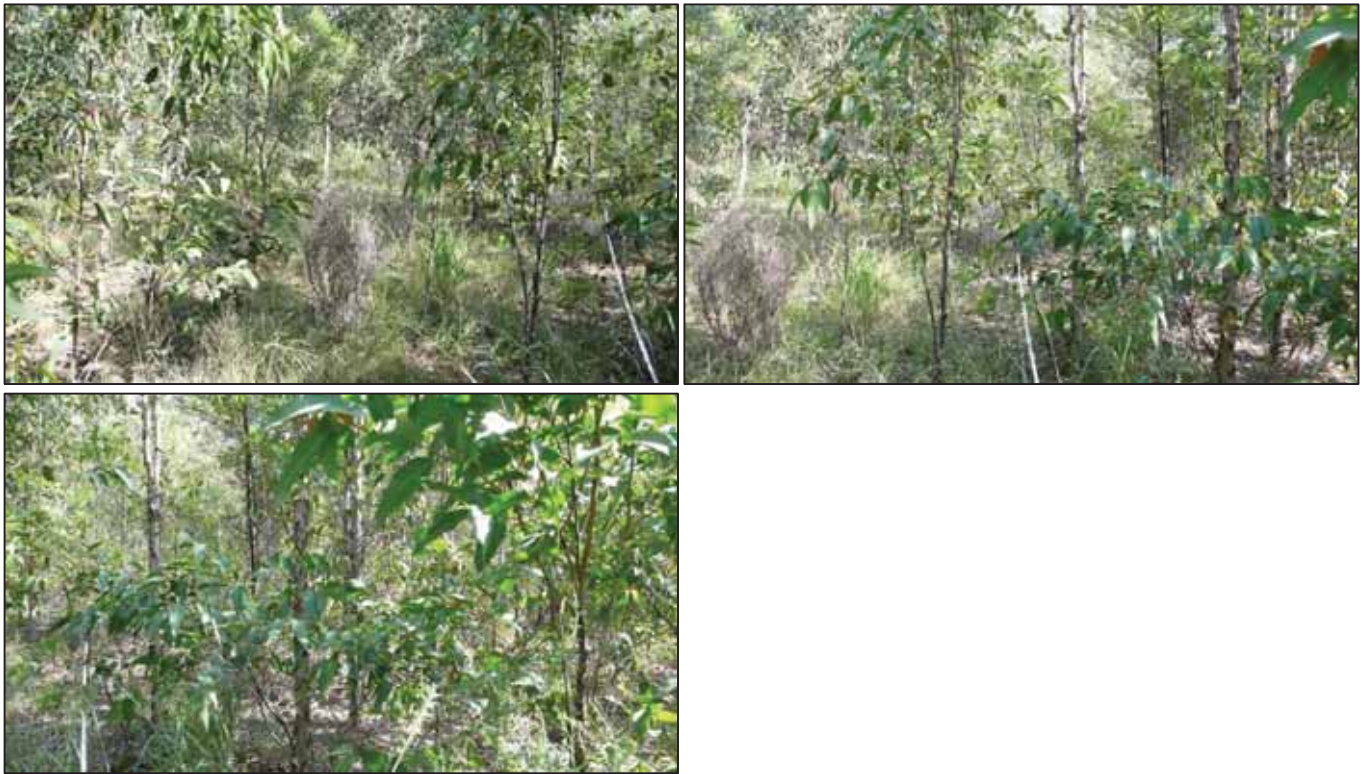
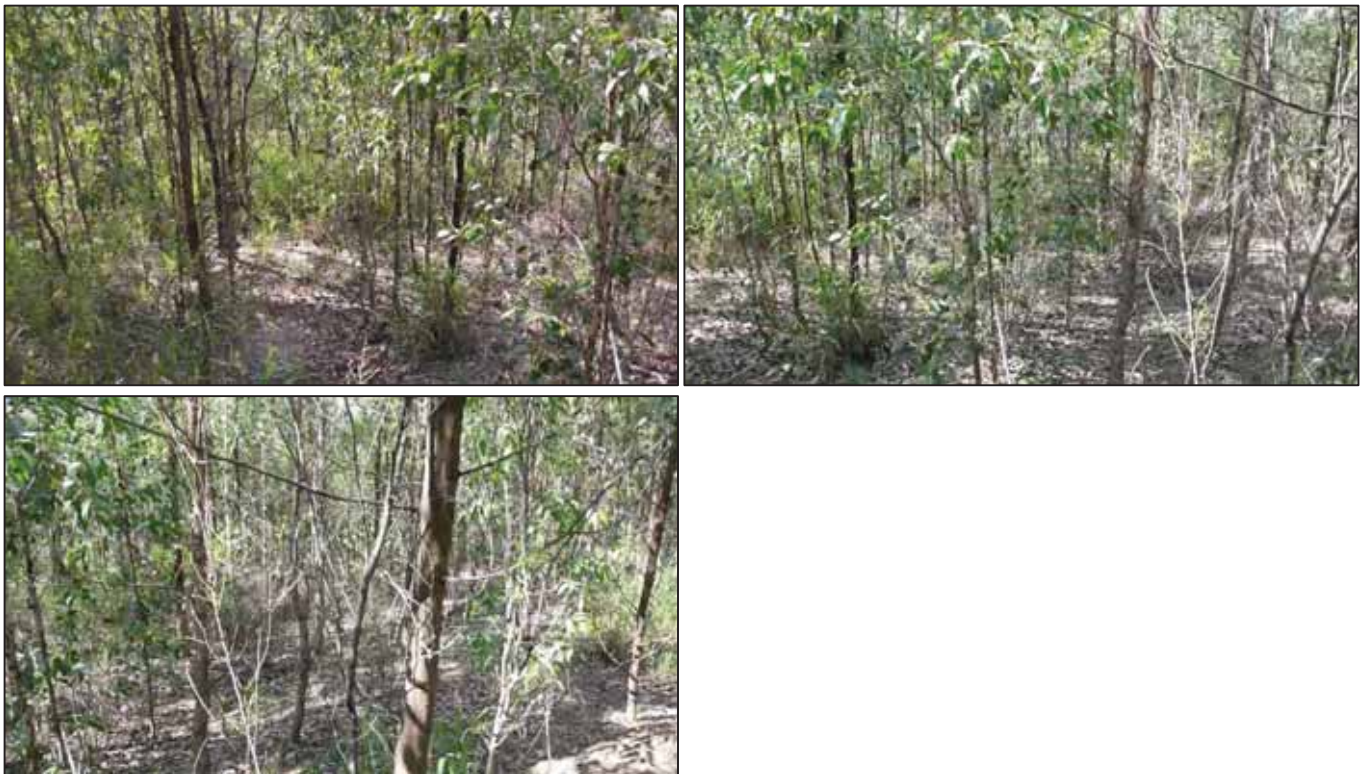
Site photographs at HVOWES2008-01 (left to right)

Disturbance present at the rehabilitation site consisted mainly of weeds, and grazing by macropods. No evidence of fire was observed in the rehabilitation area. No areas containing rubbish were observed.
