Mount Thorley Warkworth

2015 Annual Environmental Review

March 2016

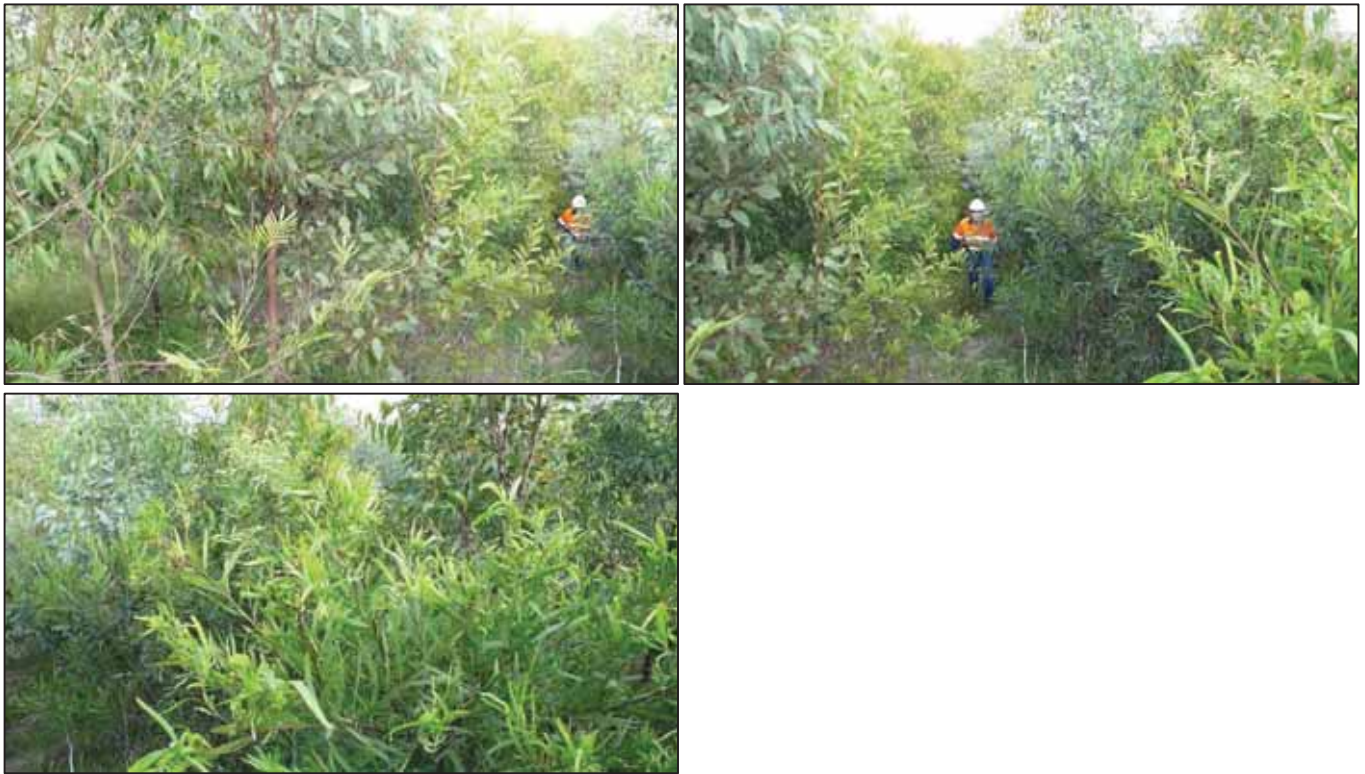
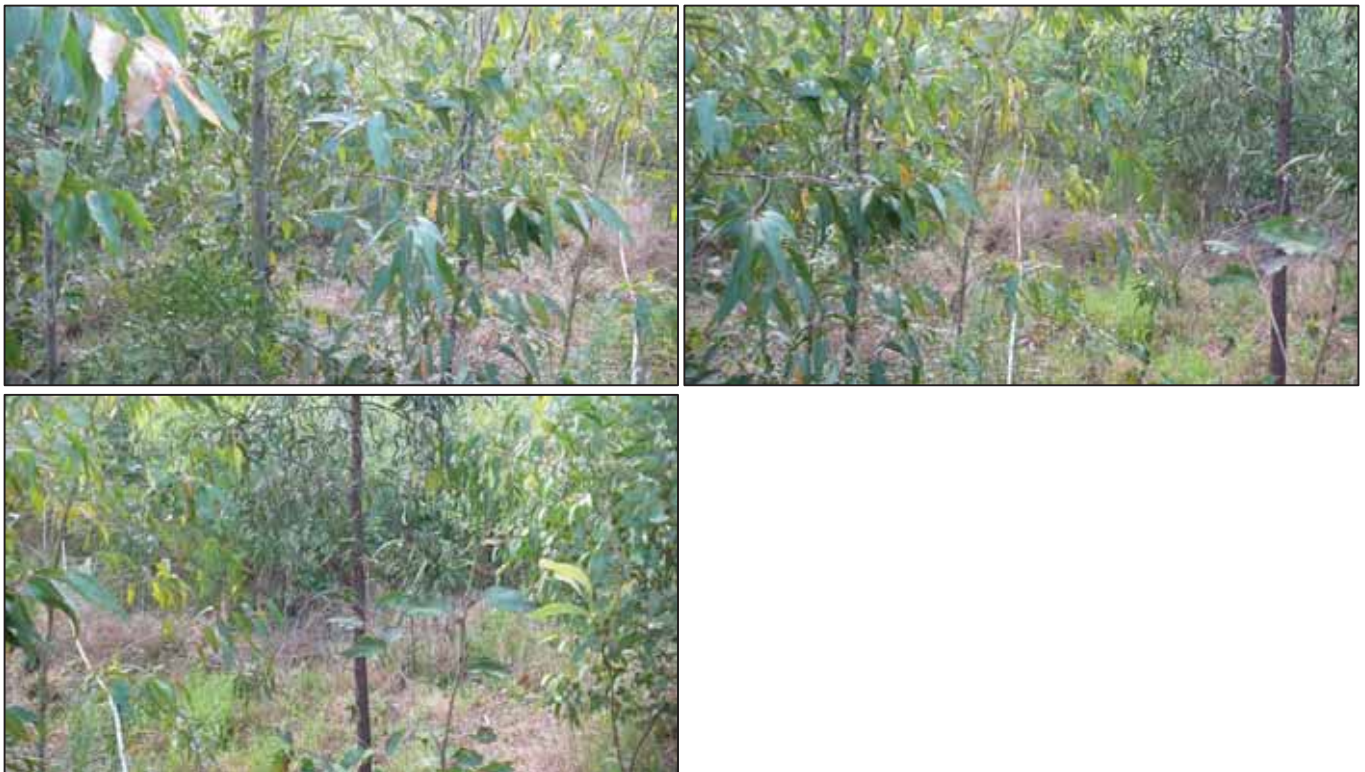
Site photographs at HVOWES2011-01 (left to right)

Disturbance present at the site consisted mainly of weeds, and grazing by macropods. No evidence of fire was observed in the rehabilitation area. No areas containing rubbish were observed.

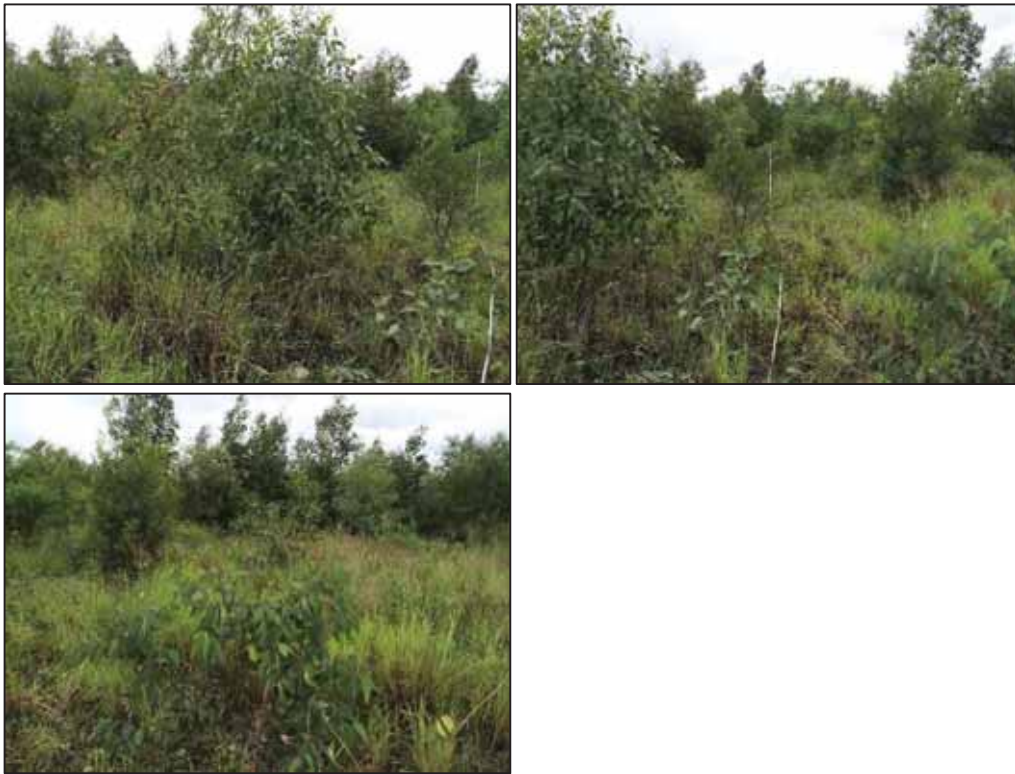
Site photographs at MTWCDC2011-01 (left to right)

Disturbance present at the site consisted mainly of weeds, and grazing by macropods. No evidence of fire was observed in the rehabilitation area. No areas containing rubbish were observed.

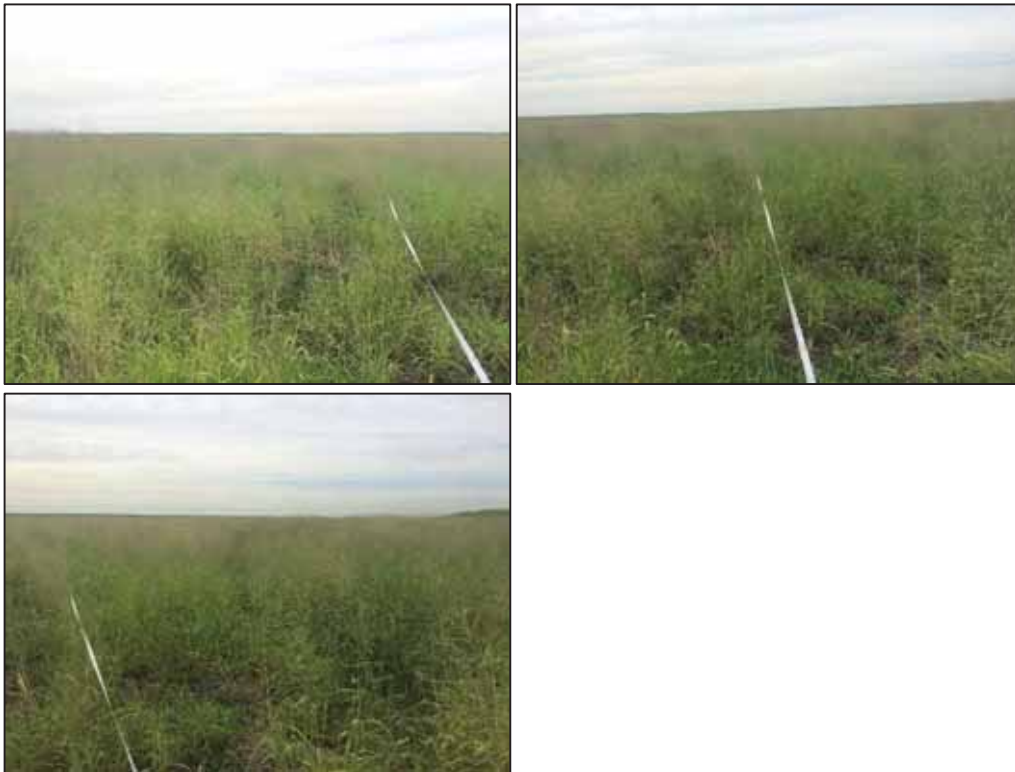
Site photographs at HVORIV2013-01 (left to right)

Disturbance present at rehabilitation site HVORIV2013-01 consisted mainly of weeds, and grazing by macropods. No evidence of fire was observed in the rehabilitation area. No areas containing rubbish were observed.

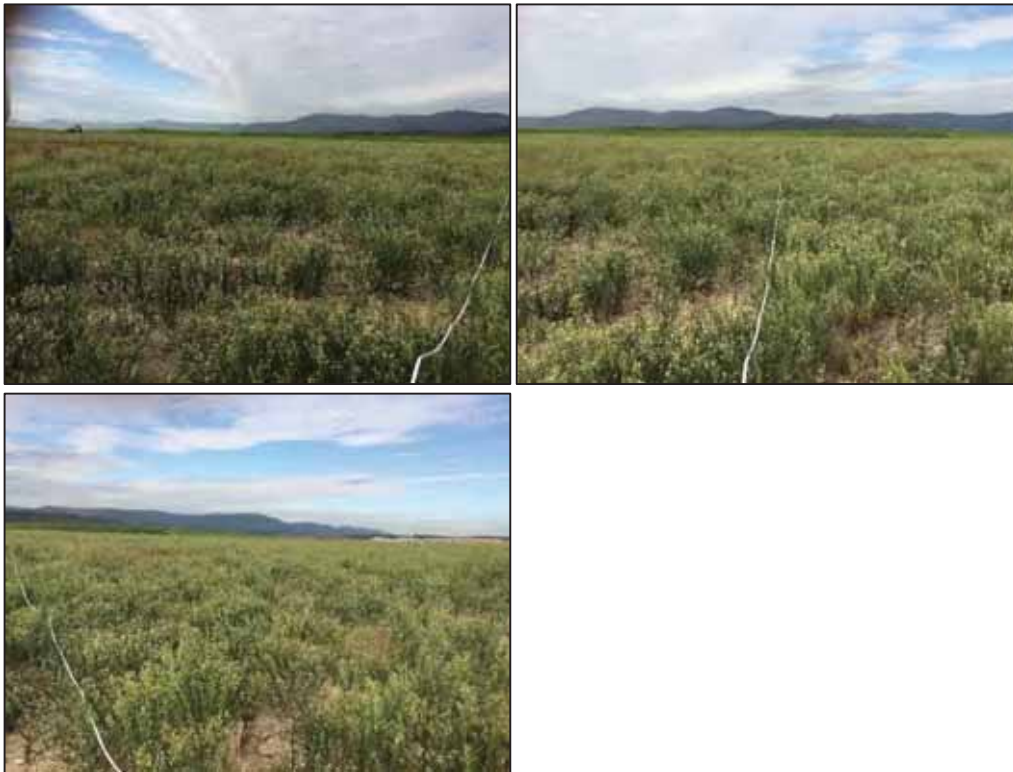
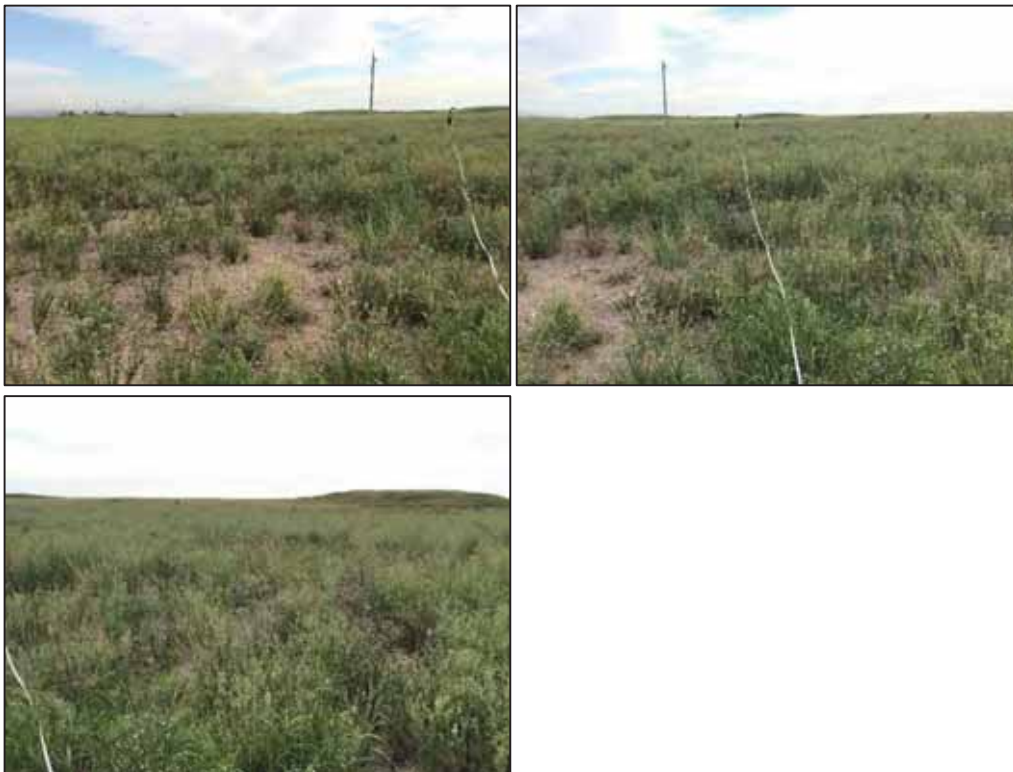
Site photographs at HVORIV2014-01 (left to right)

HVORIV2014-01 rehabilitation area occurs on a combination of spoil and compost at HVO West. The rehabilitation site is dominated by *Conyza bonariensis*. Other species include *Chloris gayana*, *Bidens pilosa*, *Bothriochloa macra*, *Galenia pubescens*, *Plantago lanceolata*, *Senecio mada gascariensis*, *Gomphocarpus fruticosus*, *Panicum maximum*, *Plantago lanceolata*, *Nicotiana glauca* and *Solanum nigrum*. It should be noted that a number of regenerating eucalypts (thin leaves – likely *E. crebra*), and small acacias and *Enchylaena tomentosa* were also recorded regenerating in the plot.

Disturbance present at rehabilitation site HVORIV2014-01 consisted mainly of weeds, and grazing by macropods. No evidence of fire was observed in the rehabilitation area. No areas containing rubbish were observed.

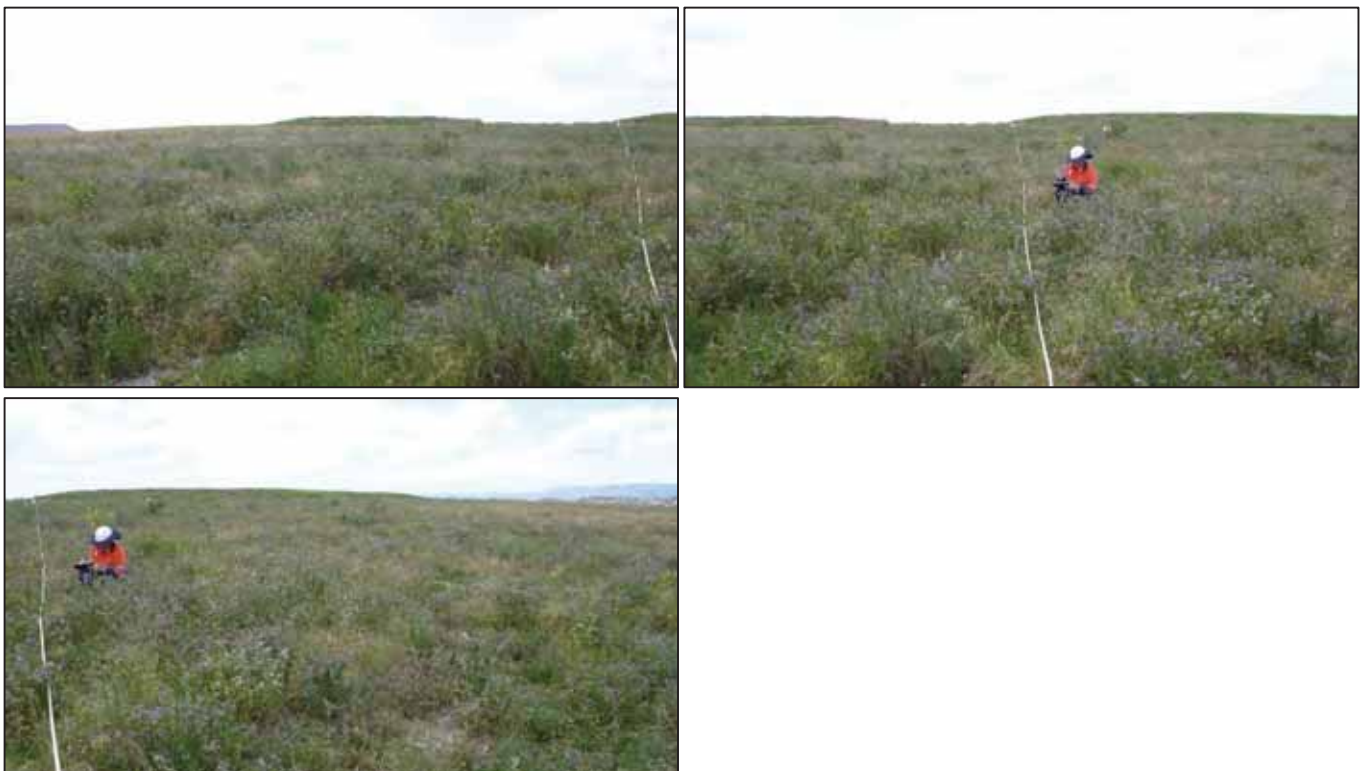
Site photographs at HVOWES2013-01 (left to right)

A number of eucalypts were observed within the rehabilitation area. It is likely that the eucalypts regenerating included *Eucalyptus crebra* and *Corymbia maculata*.

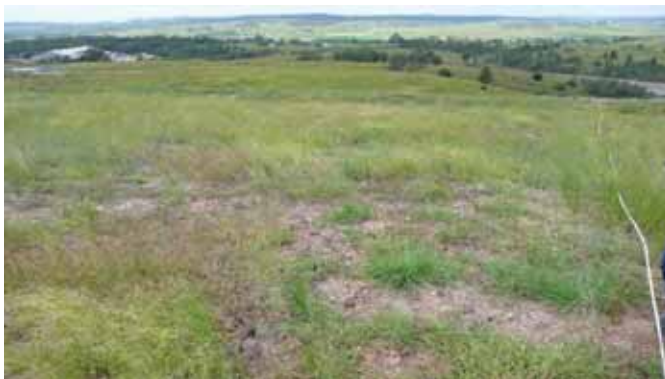
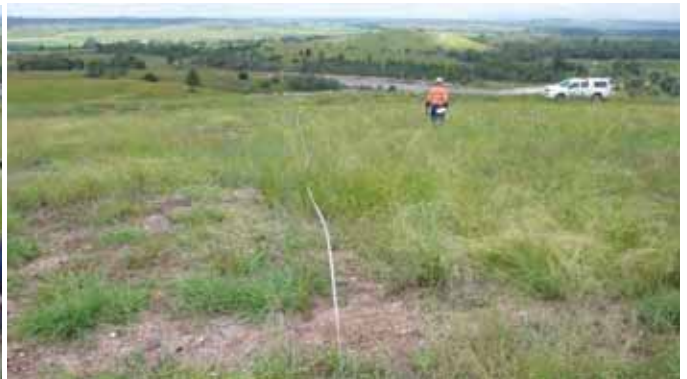
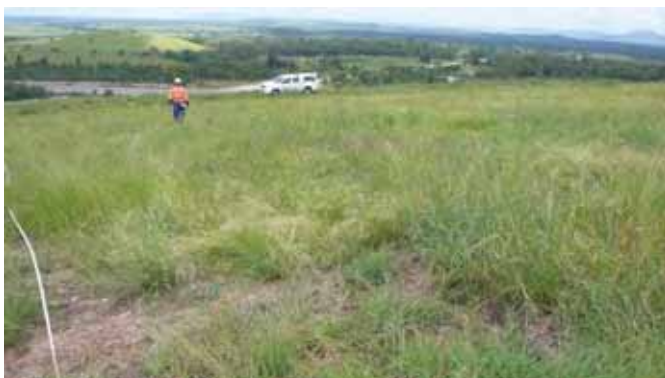
Site photographs at HVOCAR2014-01 (left to right)

Disturbance present at rehabilitation site HVOCAR2014-01 consisted mainly of weeds, and grazing by macropods. No evidence of fire was observed in rehabilitation area. No areas containing rubbish were observed.

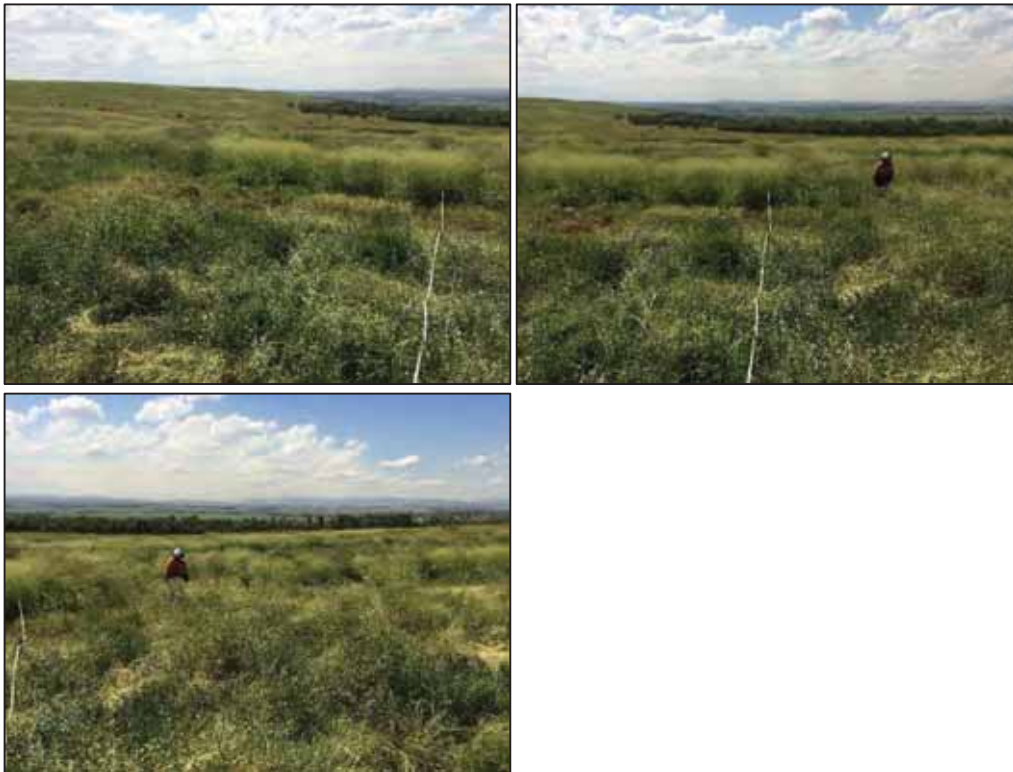
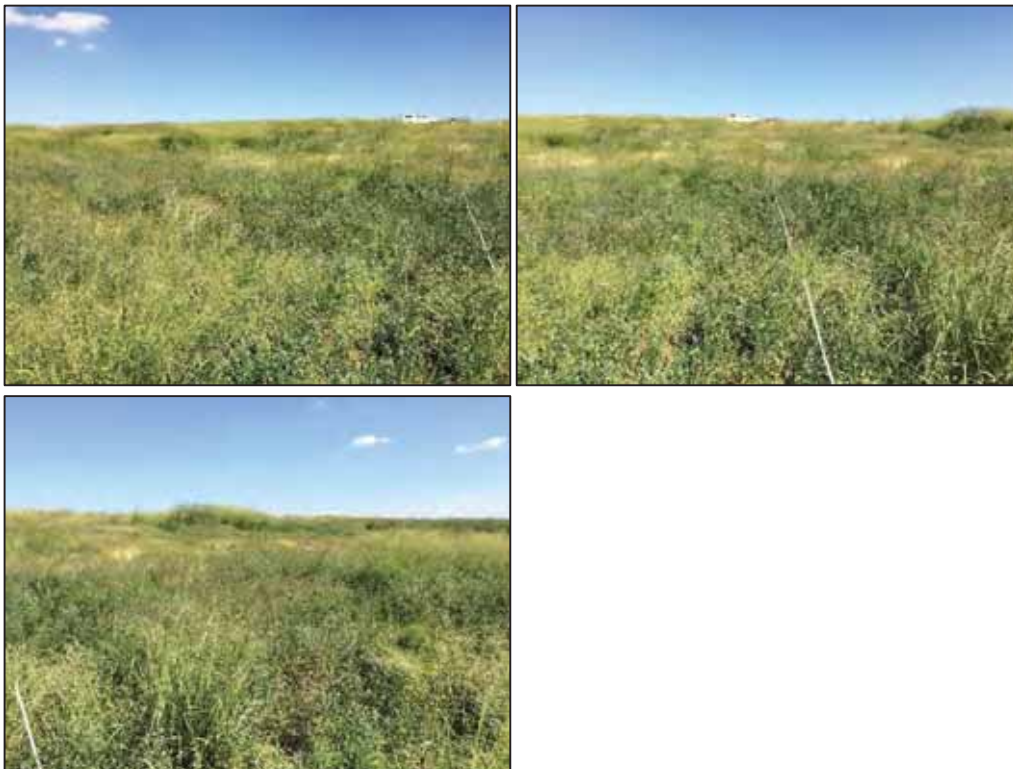
Site photographs at HVOCHE2012-01 (left to right)

Disturbance present at rehabilitation site HVOCHE2012-01 consisted mainly of weeds, and grazing by macropods. No evidence of fire was observed in the rehabilitation area. No areas containing rubbish were observed.

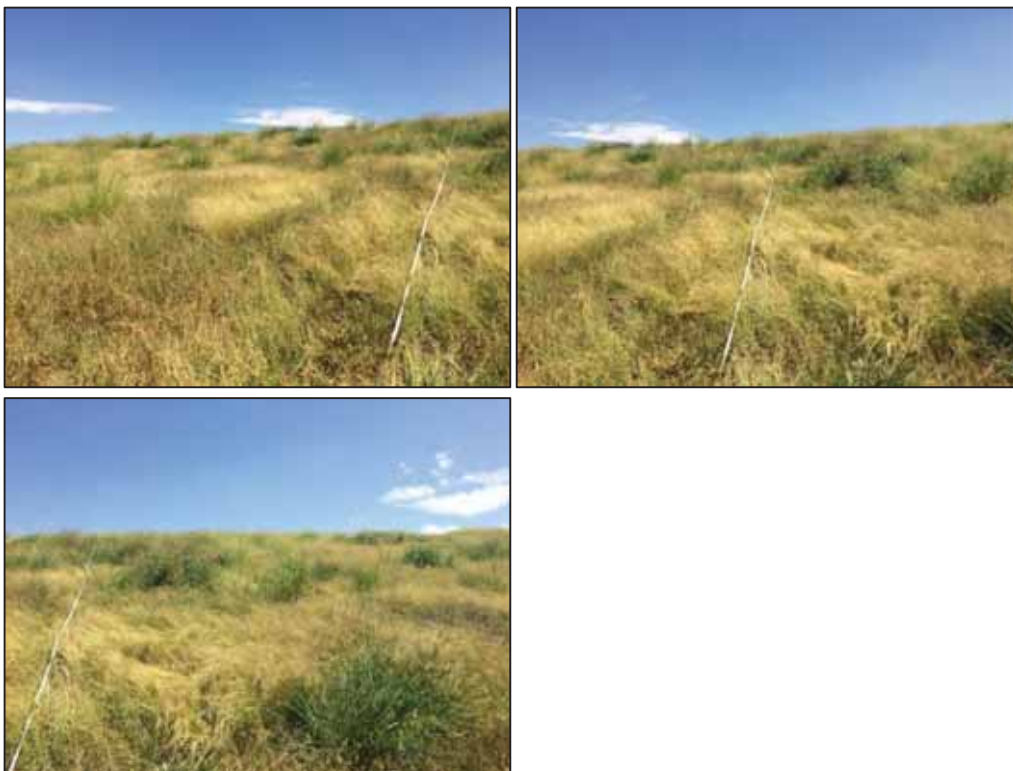
Site photographs at HVOCHE2013-01 (left to right)

Disturbance present at rehabilitation site HVOCHE2013-01 consisted mainly of weeds, and grazing by macropods. No evidence of fire was observed in the rehabilitation area. No areas containing rubbish were observed.

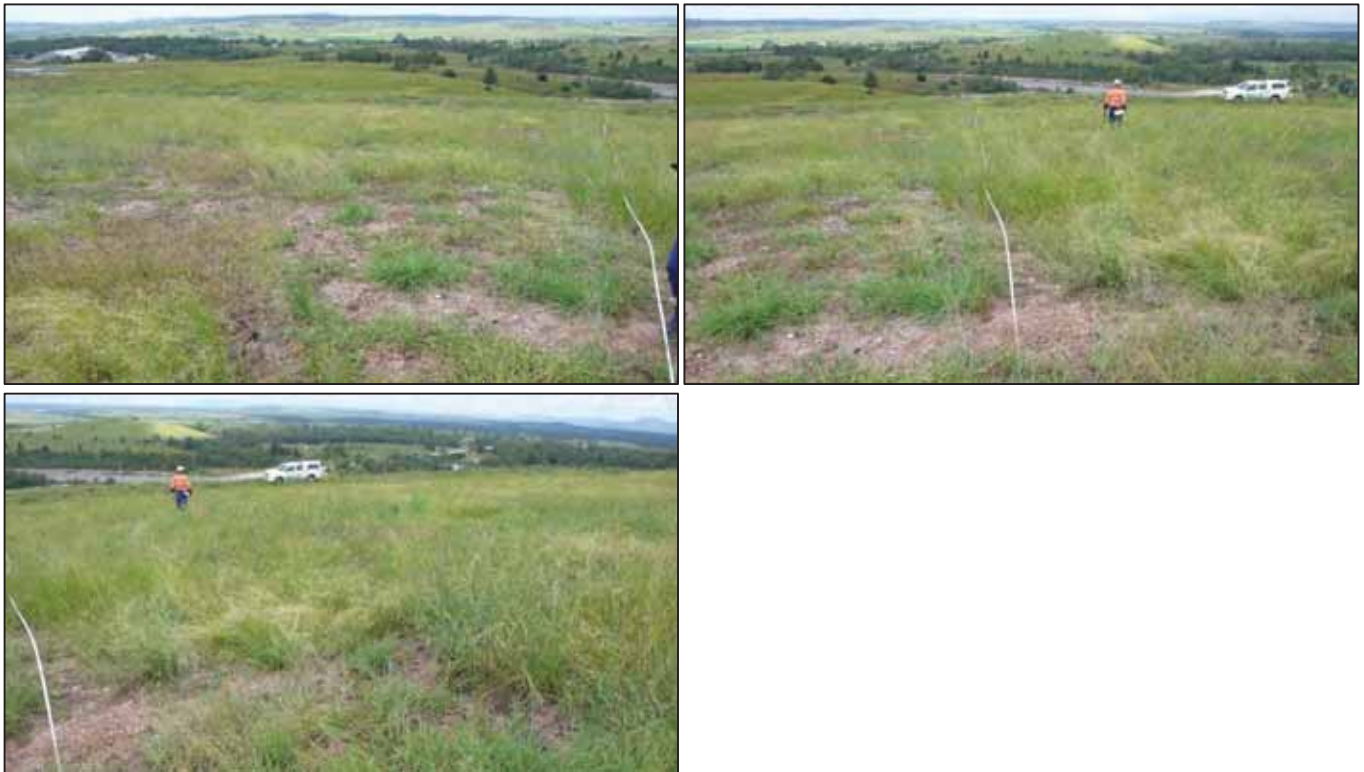
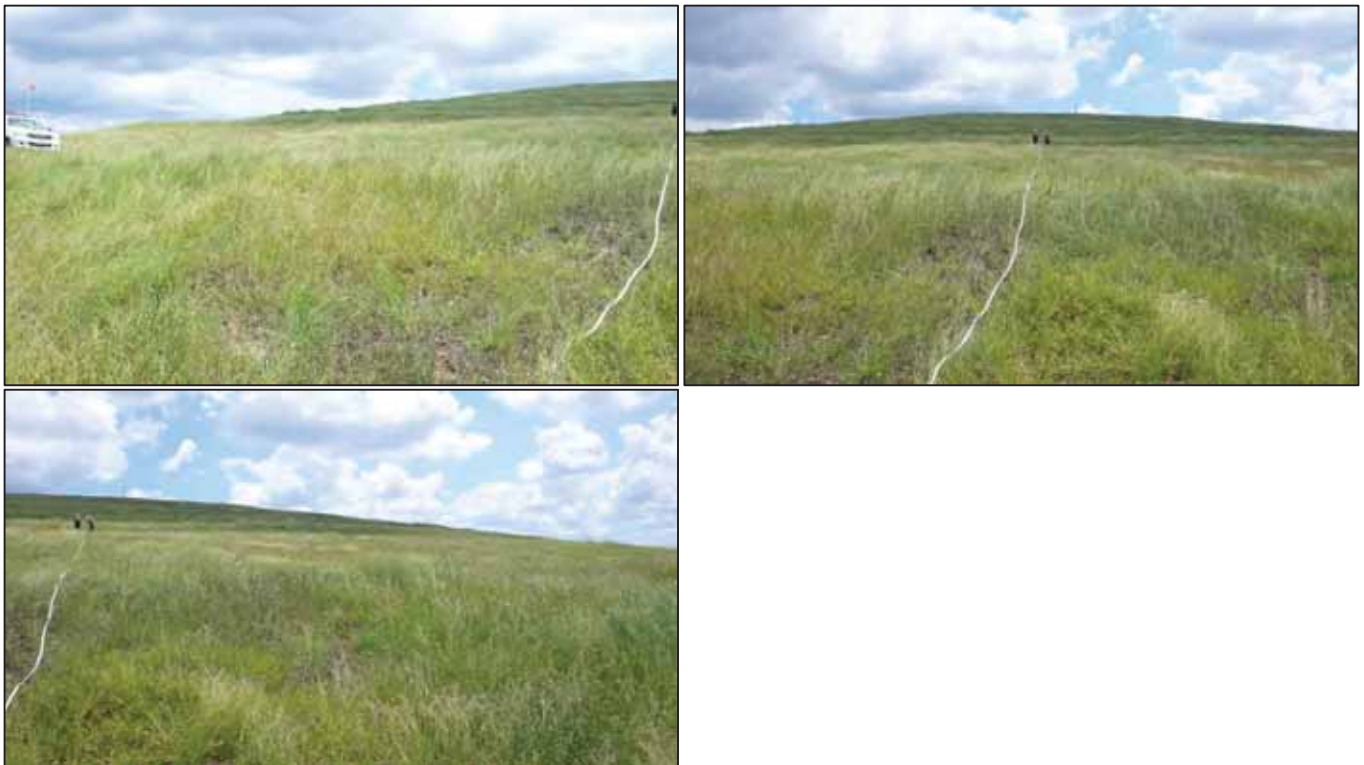
Site photographs at HVOCHE2014-01 (left to right)

Disturbance present at rehabilitation site HVOCHE2014-01 consisted mainly of weeds, and grazing by macropods. No evidence of fire was observed in the rehabilitation area. No areas containing rubbish were observed.

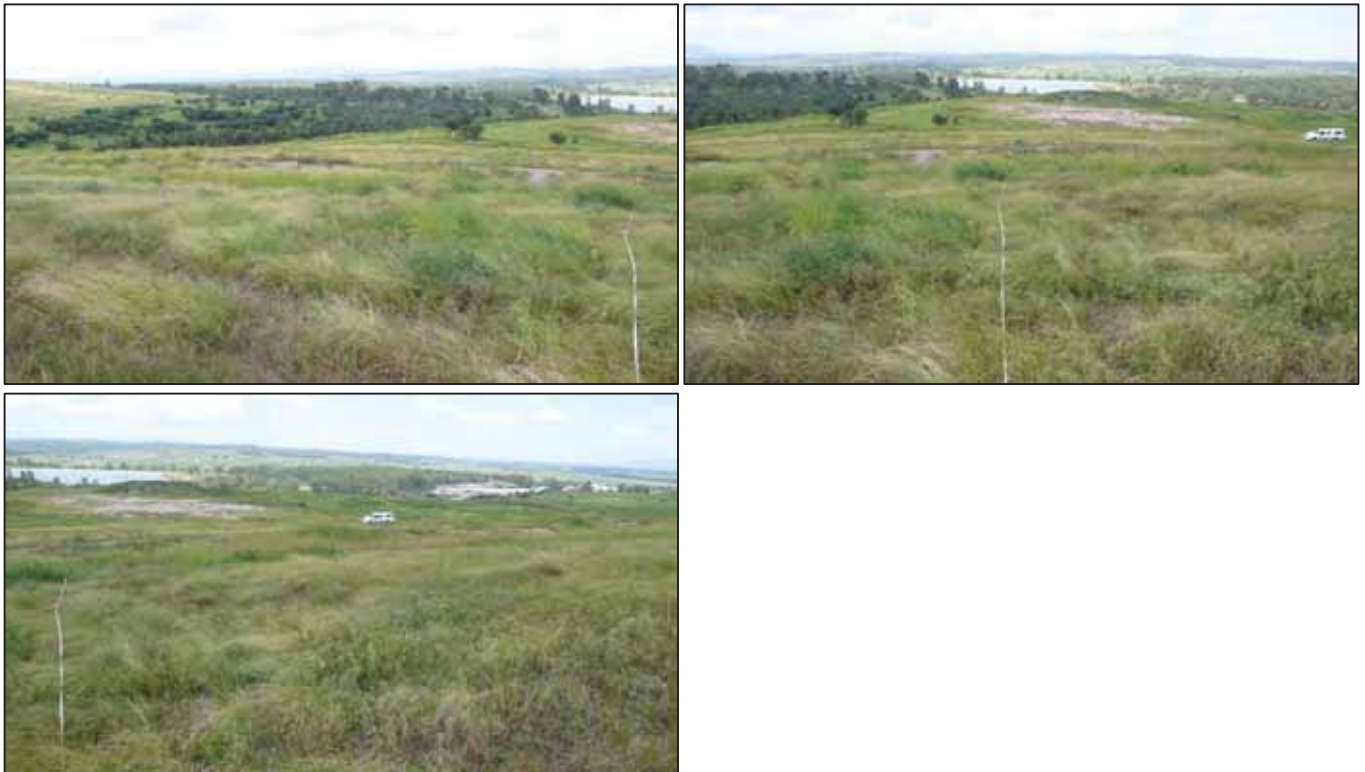
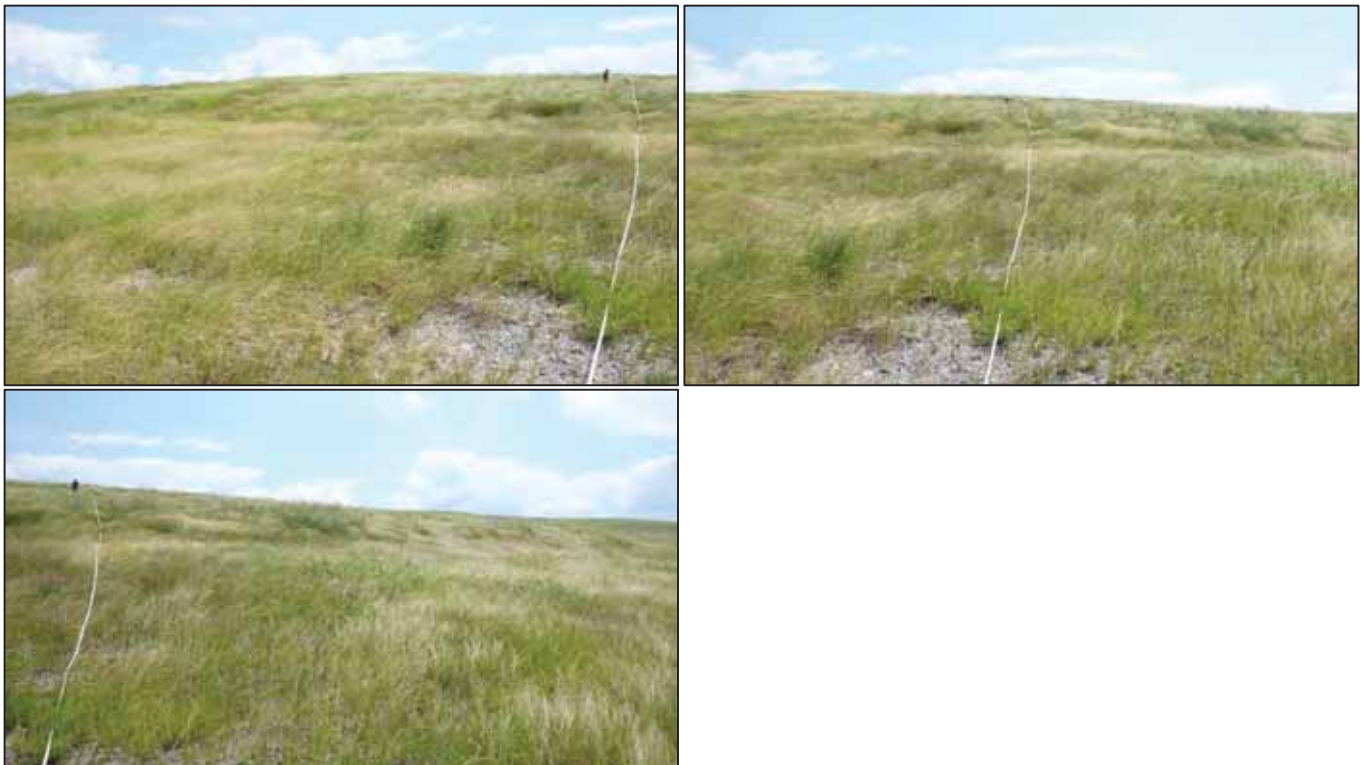
Site photographs at HVOCHE2012-03 (left to right)

Disturbance present at rehabilitation site HVOCHE2012-03 consisted mainly of weeds, and grazing by macropods. No evidence of fire was observed in the rehabilitation area. No areas containing rubbish were observed.

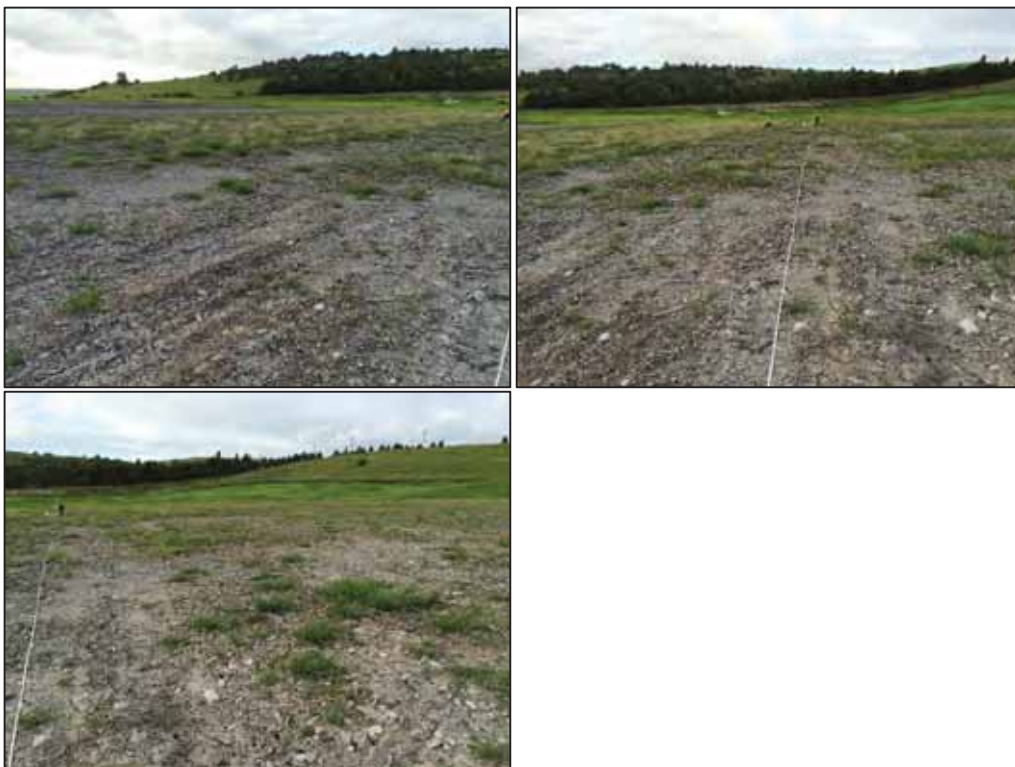
Site photographs at MTWTDI2015-01 (left to right)

Disturbance present at rehabilitation site MTWTDI2015-01 consisted mainly of weeds, and grazing by macropods. No evidence of fire was observed in the rehabilitation area. No areas containing rubbish were observed.

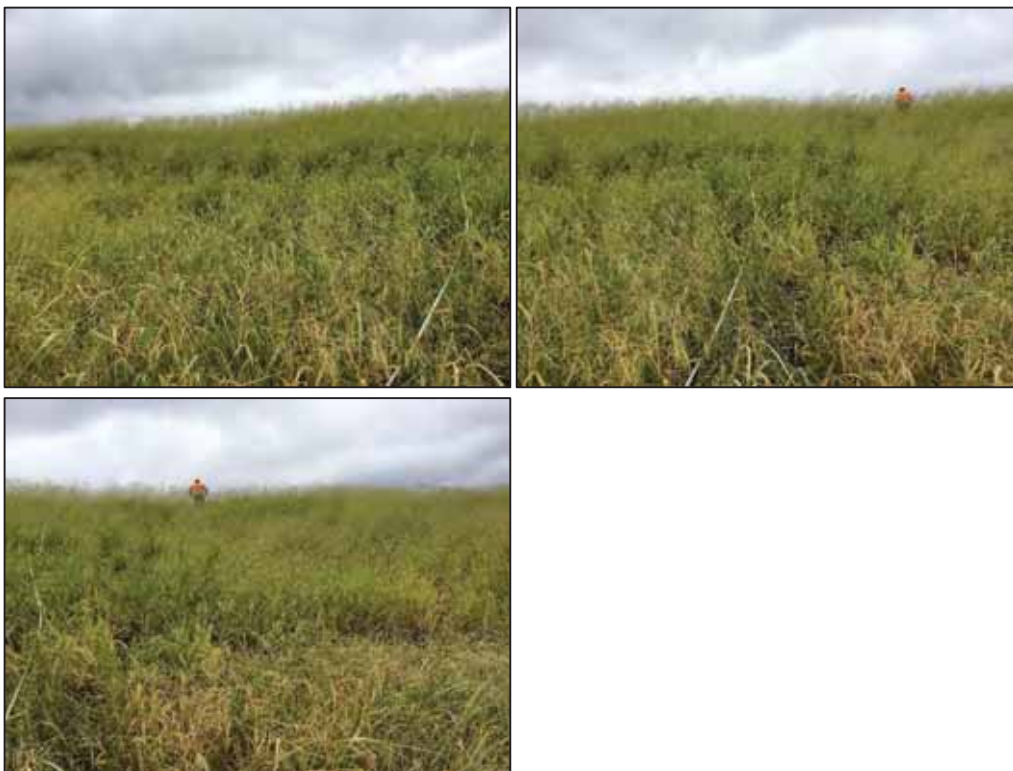
Site photographs at MTWSPN2014-01 (left to right)

Disturbance present at rehabilitation site MTWSPN2014-01 consisted mainly of weeds, and grazing by macropods. No evidence of fire was observed in the rehabilitation area. No areas containing rubbish were observed.

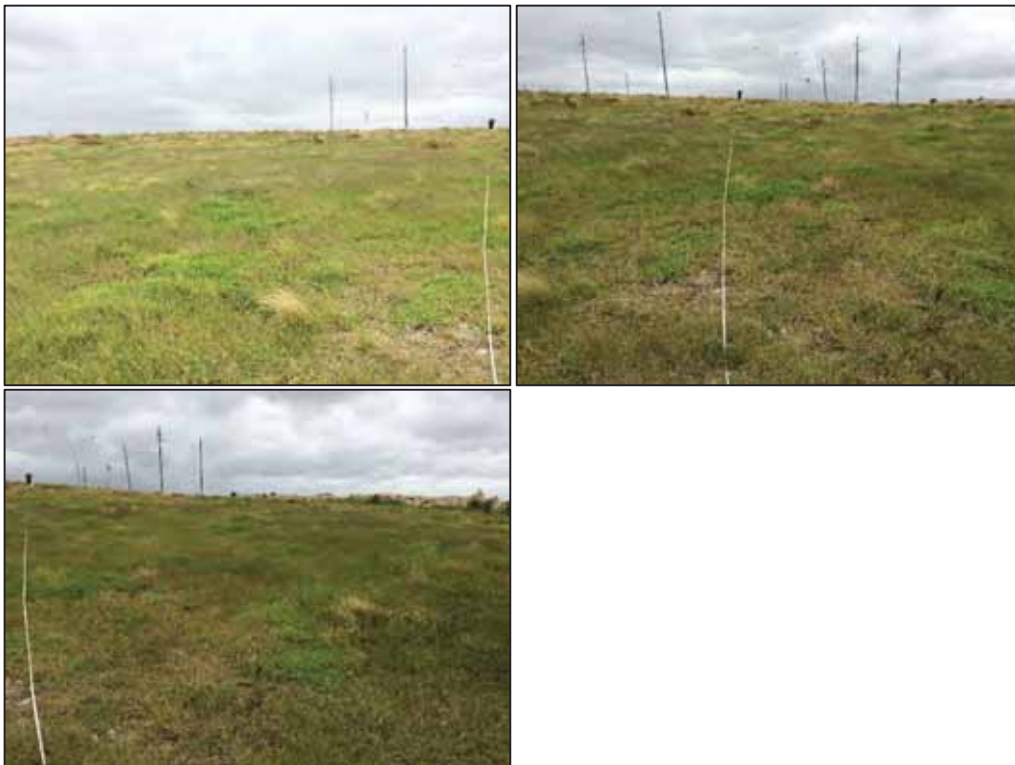
Site photographs at MTWNP2014-0 (left to right)

Disturbance present at rehabilitation site MTWNP2014-03 consisted mainly of weeds, and grazing by macropods. No evidence of fire was observed in the rehabilitation area. No areas containing rubbish were observed.

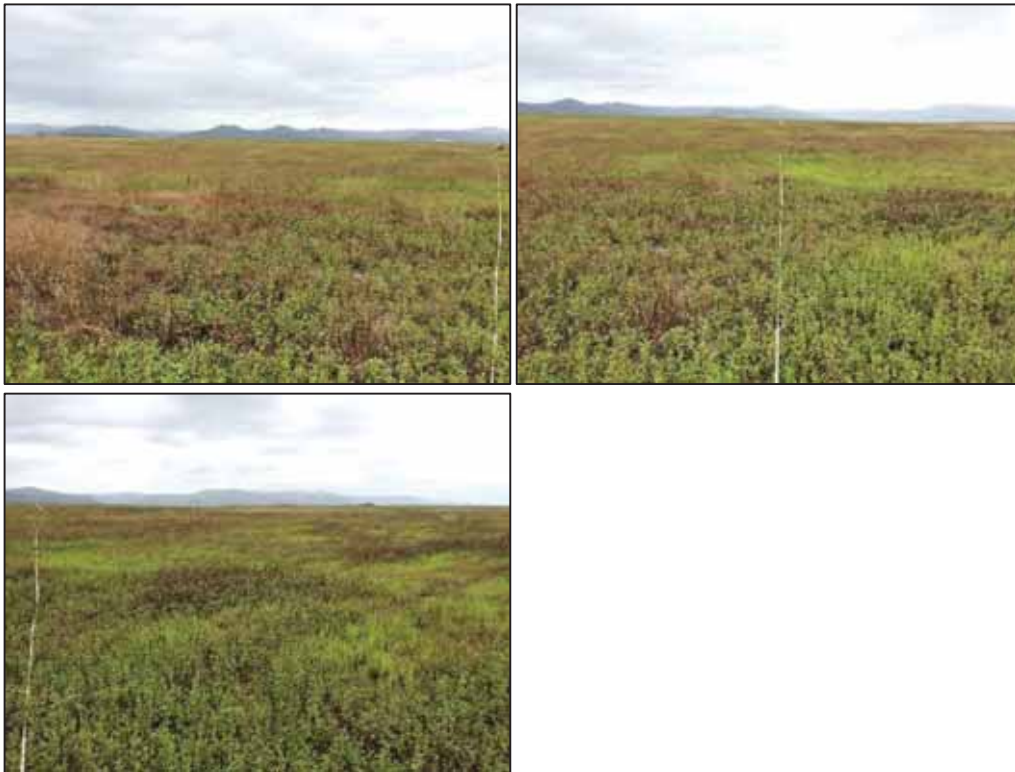
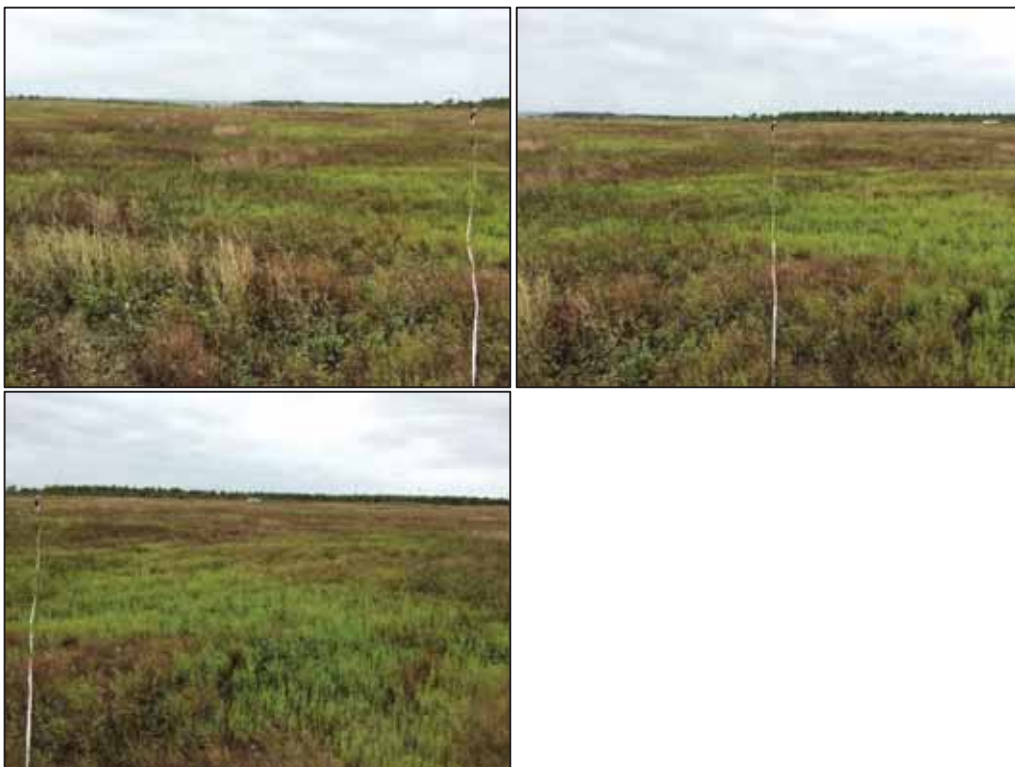
Site photographs at MTWNP2013-01 (left to right)

Disturbance present at rehabilitation site MTWNP2013-01 consisted mainly of weeds, and grazing by macropods. No evidence of fire was observed in the rehabilitation area. No areas containing rubbish were observed.

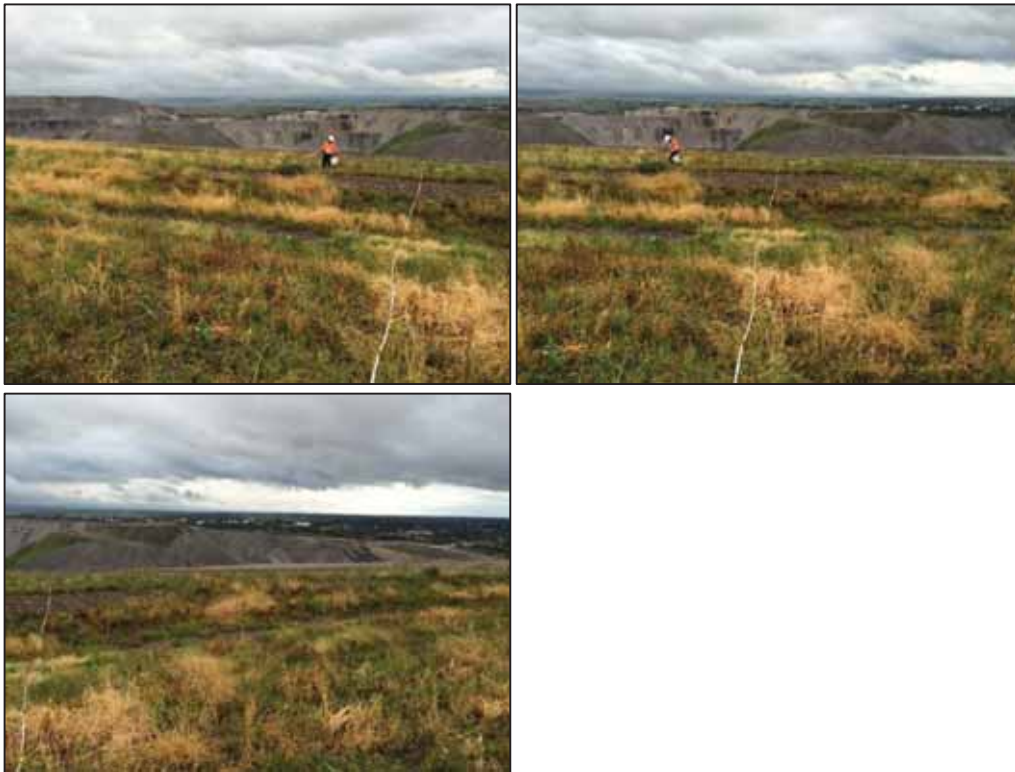
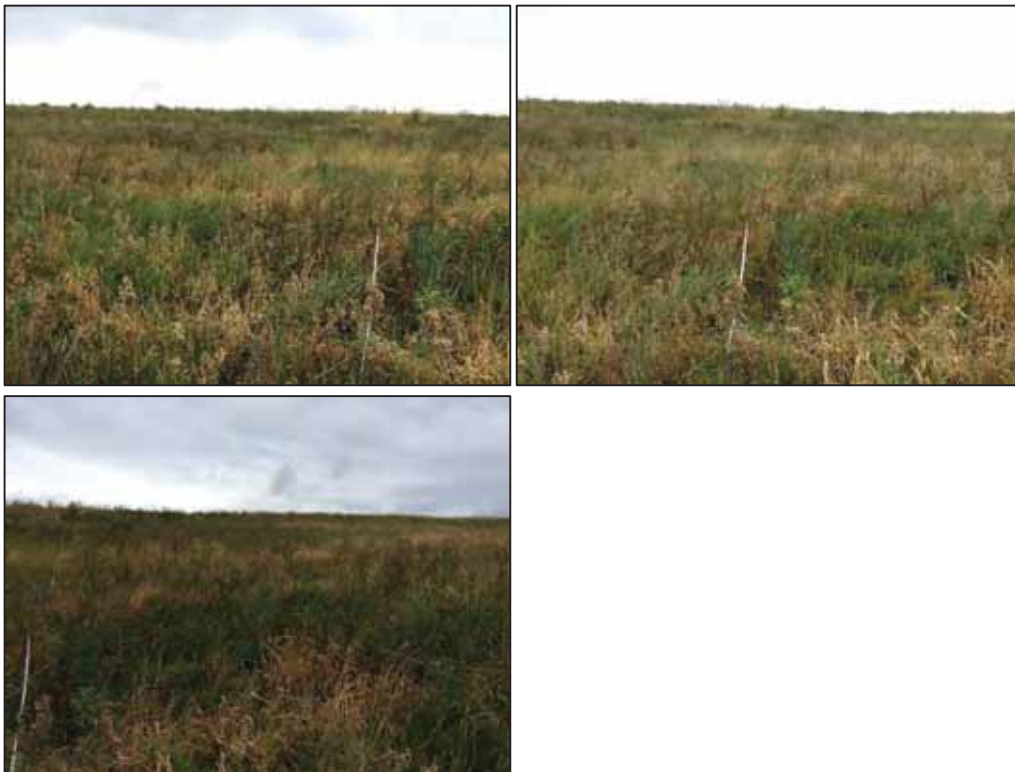
Site photographs at MTWWDL2014-01 (left to right)

Disturbance present at rehabilitation site MTWWDL2014-01 consisted mainly of weeds, and grazing by macropods. No evidence of fire was observed in the rehabilitation area. No areas containing rubbish were observed.

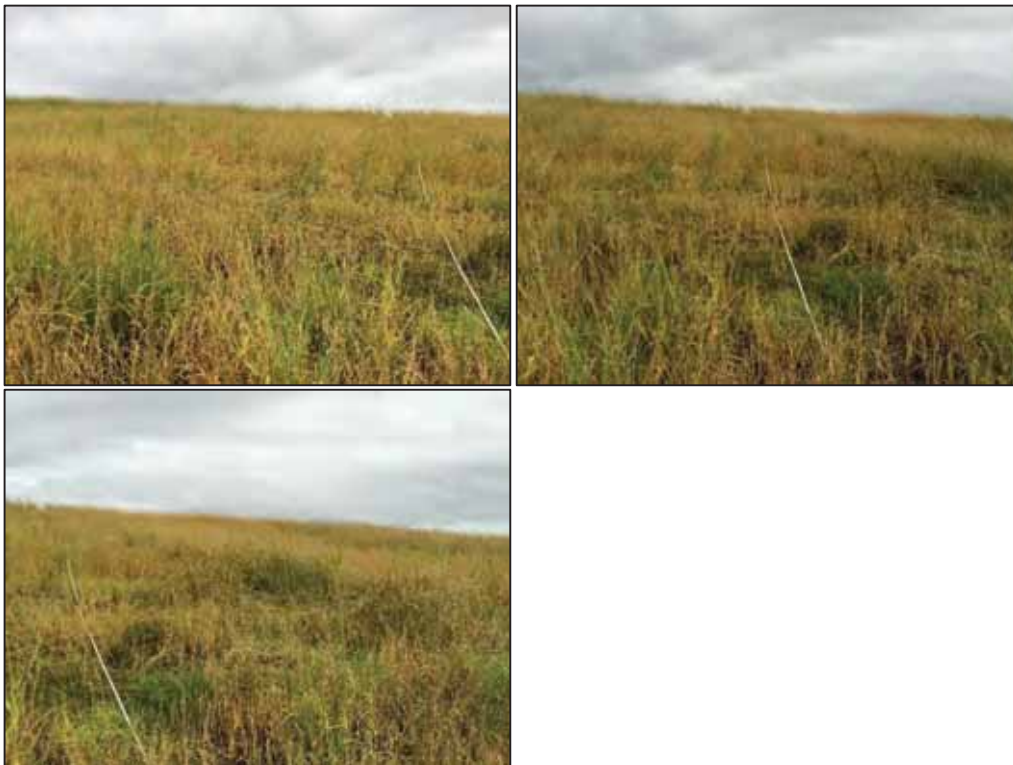
Site photographs at MTWWDL2014-02 (left to right)

Disturbance present at rehabilitation site MTWWDL2014-02 consisted mainly of weeds, and grazing by macropods. No evidence of fire was observed in the rehabilitation area. No areas containing rubbish were observed.

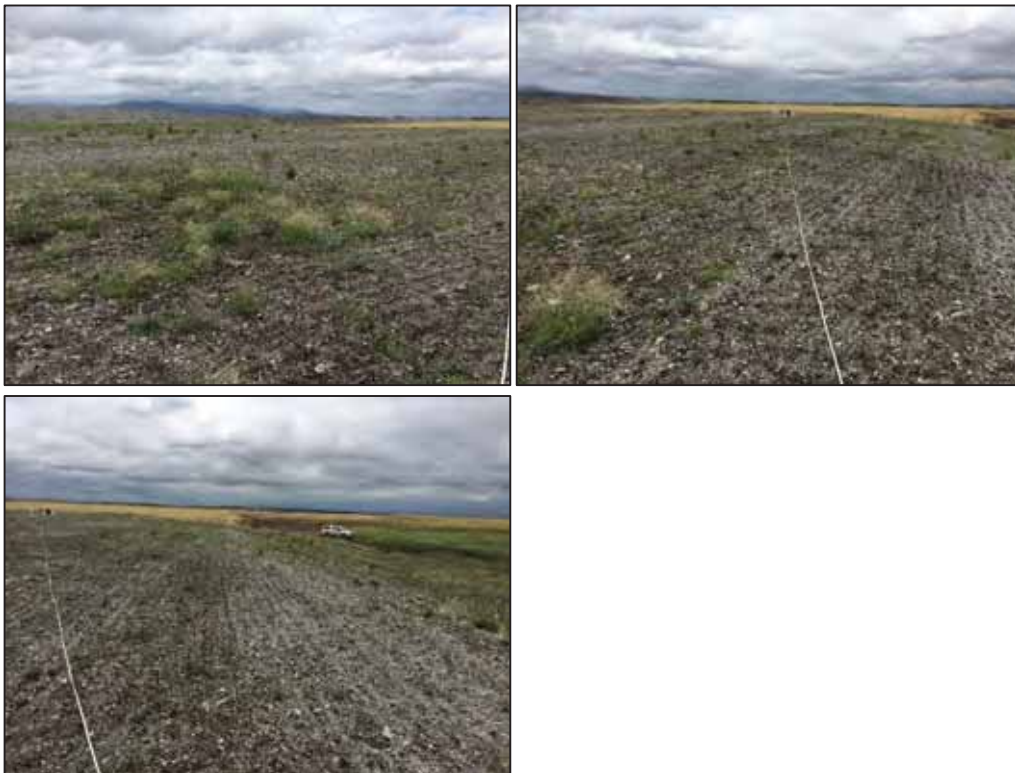
Site photographs at MTWCDD2015-01 (left to right)

MTWCDD2015-01 rehabilitation area occurs on a combination of spoil and compost at Mount Thorley-Warkworth. The rehabilitation site was dominated by the following introduced species: *Conyza bonariensis*, *Chloris gayana*, *Echinochloa crus-gali*, *Senecio madagascariensis*, *Solanum nigrum* and *Panicum maximum*. Native species included *Eriochloa pseudoastritrica*, *Austrodanthonia spp.*, *Einadia nutans*, *Austrostipa scabra*, *Bothriochloa macra* and *Chloris truncata*.

It should be noted that a number of Eucalypts were regenerating in the area. Most of these are likely *Eucalyptus crebra* due to their narrow leaves.

Disturbance present at rehabilitation site MTWCDD2015-01 consisted mainly of weeds, and grazing by macropods. No evidence of fire was observed in the rehabilitation area. No areas containing rubbish were observed.
