Mount Thorley Warkworth

2015 Annual Environmental Review

March 2016

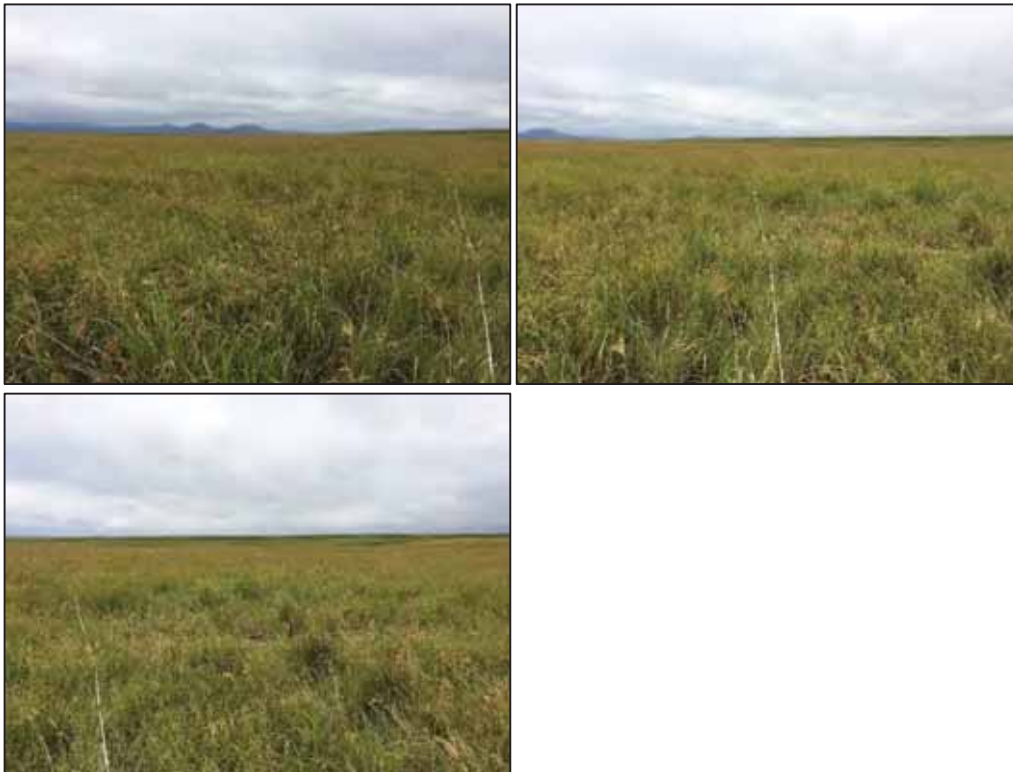
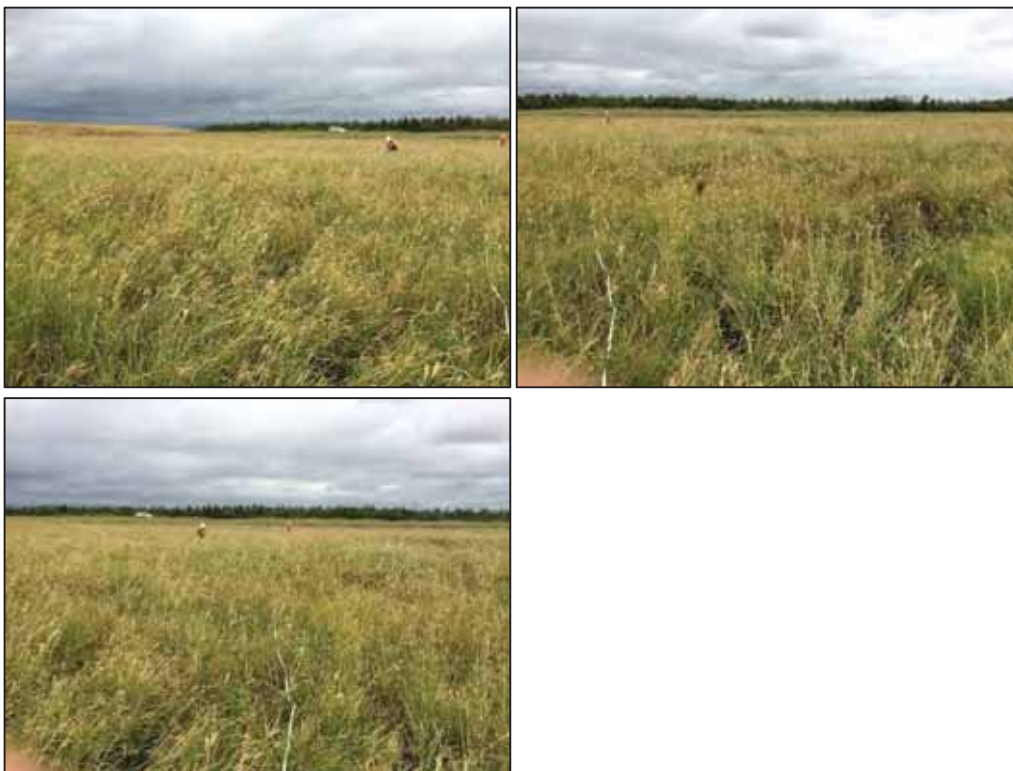
Site photographs at MTWCDD2013-01 (left to right)

Disturbance present at rehabilitation site MTWCDD2013-01 consisted mainly of weeds, and grazing by macropods. No evidence of fire was observed in the rehabilitation area. No areas containing rubbish were observed.
