Mount Thorley Warkworth

2014 Annual Environmental Review

March 2015

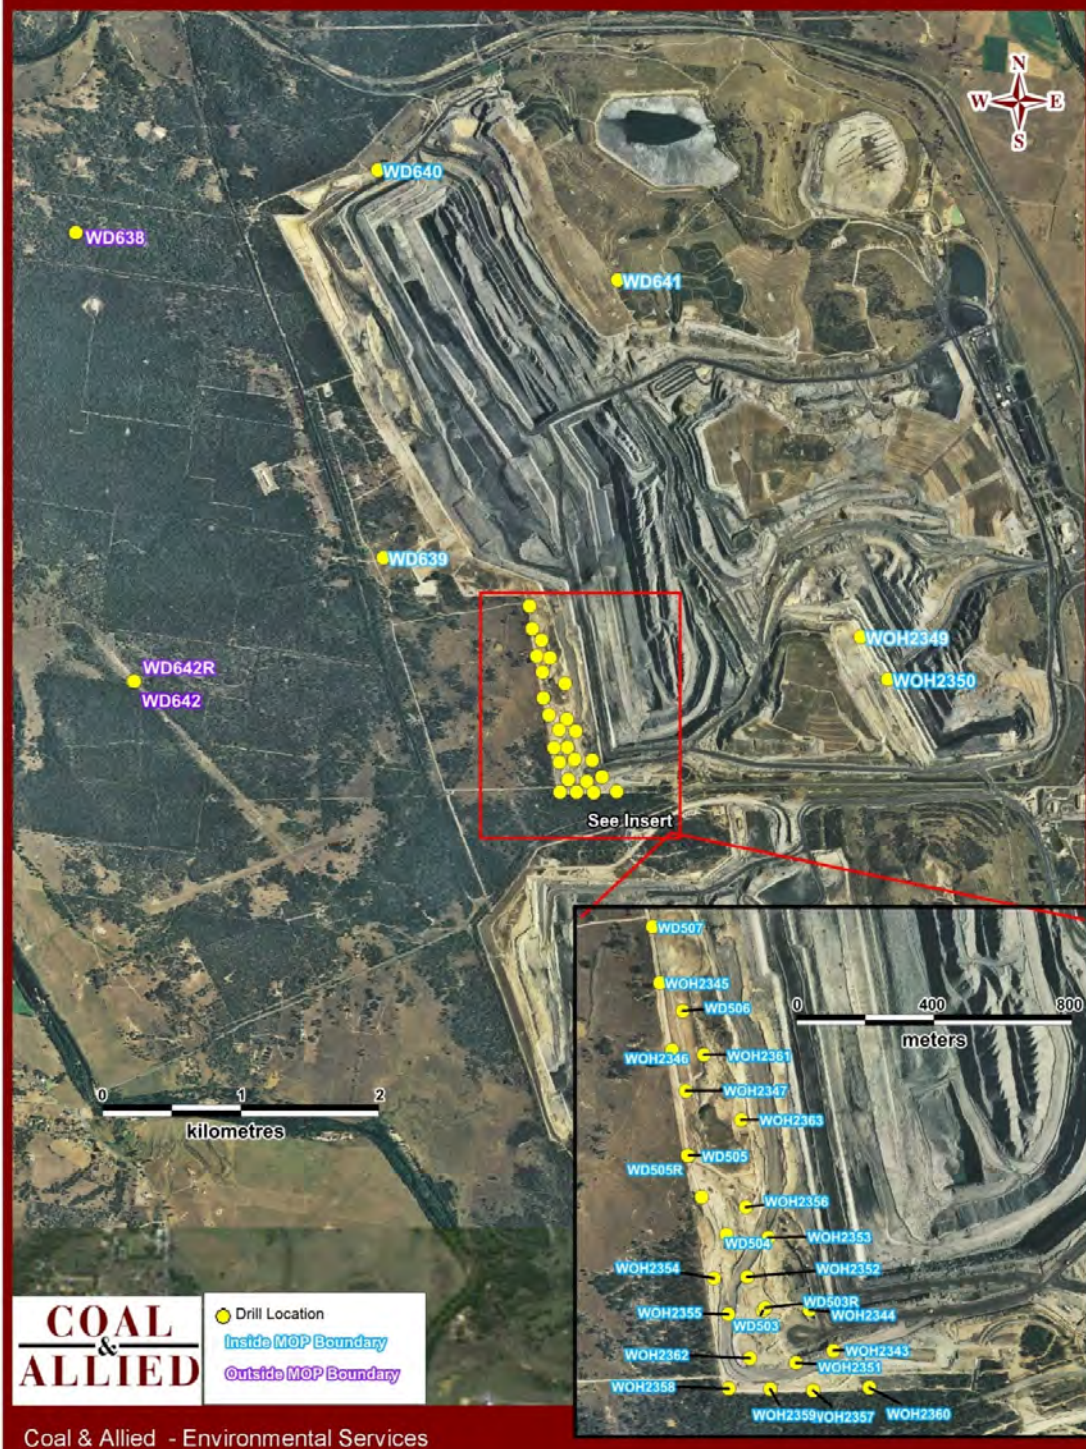
Figure 2: 2014 Drill sites both internal and external to the MOP area

Drilling activity undertaken in 2014 is shown in Figure 2. An example of a drill site before and after drilling is shown in Figure 3 and Figure 4.

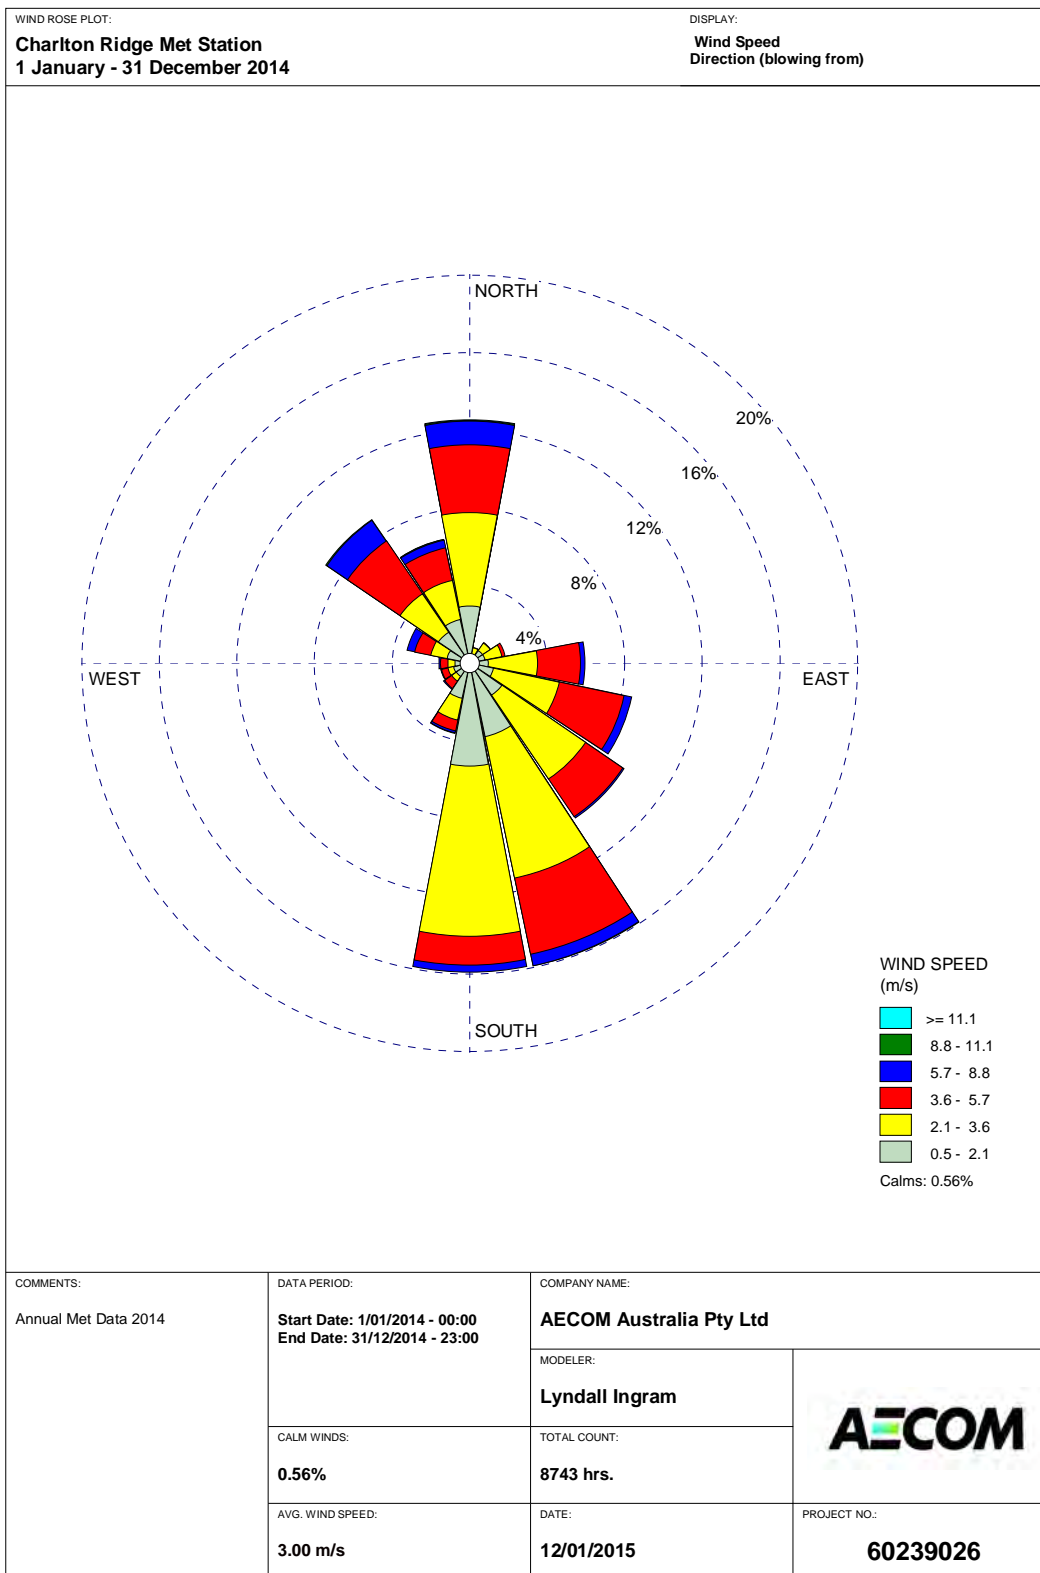
Figure 9: Annual Wind Rose

During 2014 the predominant wind direction at the Charlton Ridge Meteorological Station was from the North and North West (approximately 30% of the time) and from South and South East (approximately 30% of the time). Wind Speeds were strongest from the North (Figure 9).

A summary of monthly temperature, relative humidity, wind speed and solar radiation data recorded at the Charlton Ridge meteorological station is presented in Table 16. The 2014 annual wind rose is presented in Figure 9.

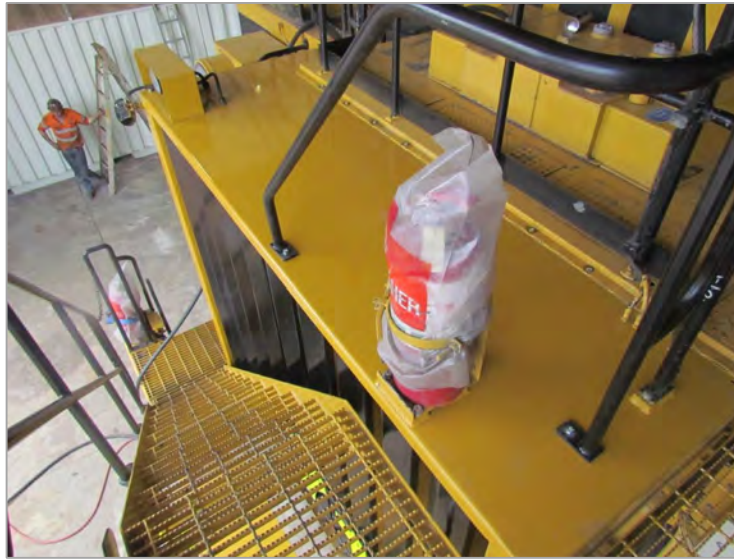
Figure 11 shows a Radiation Splitter which prevents the air escaping above the radiator and instead directing air flow into the radiator increasing efficiency and decreasing noise.

Figure 11 - Top-down view of Radiation Splitter installed on MTW Cat 789C Haul truck

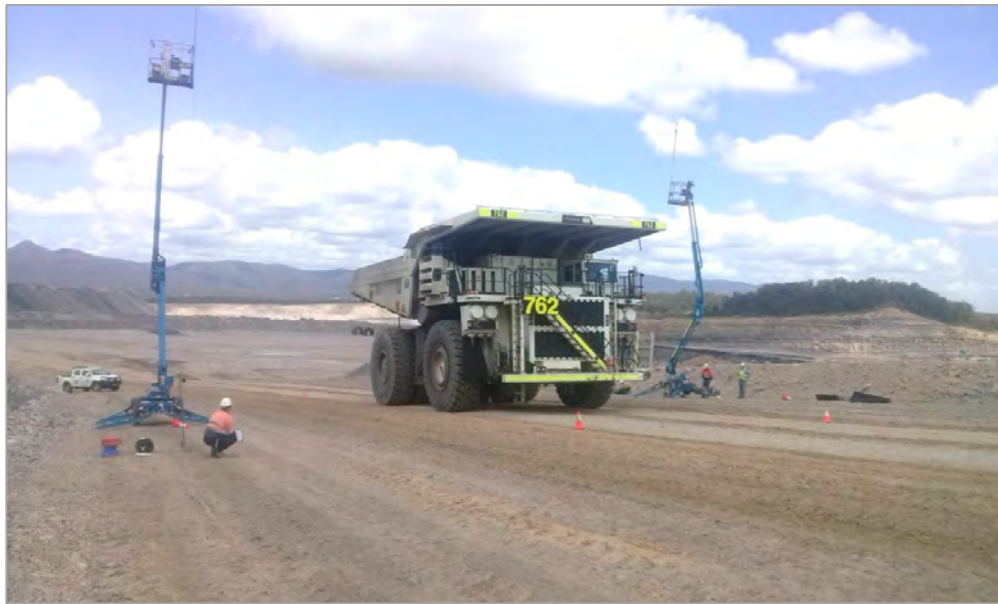
In addition to visual inspections, MTW implements a Sound Power Level (SWL) screening program to assess the sound power outputs of individual pieces of equipment (Figure 12). Sound screening is undertaken on 33% of the attenuated haul fleet each year.

Figure 12 - Sound Power Screening being performed on Truck 762 following installation of sound attenuation components

Thirty three attenuated haul trucks underwent SWL screening in 2014. Additional testing was undertaken to address a shortcoming in the 2013 program (eight trucks tested in 2013).

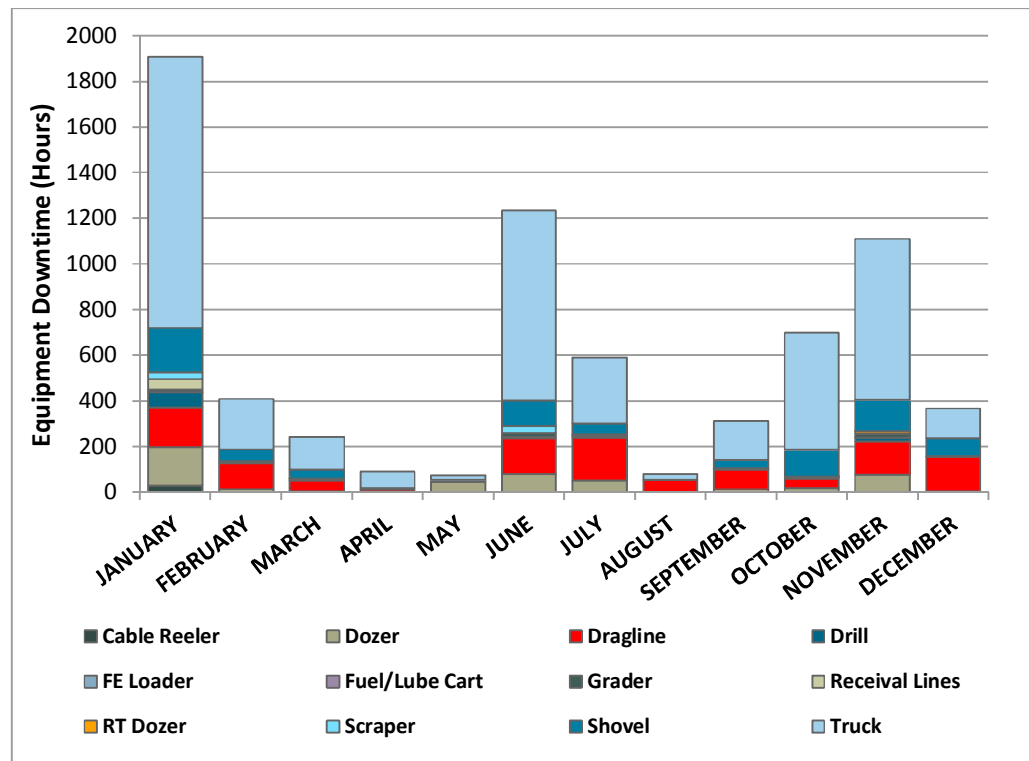
Figure 25: Equipment downtime for dust management by month

510 real-time alarms for air quality and wind conditions were received and acknowledged during 2014. In response 7,110 hours of equipment downtime was recorded due to air quality management. A detailed breakdown of air quality related equipment stoppages (per month, per equipment type) is presented in Figure 25.

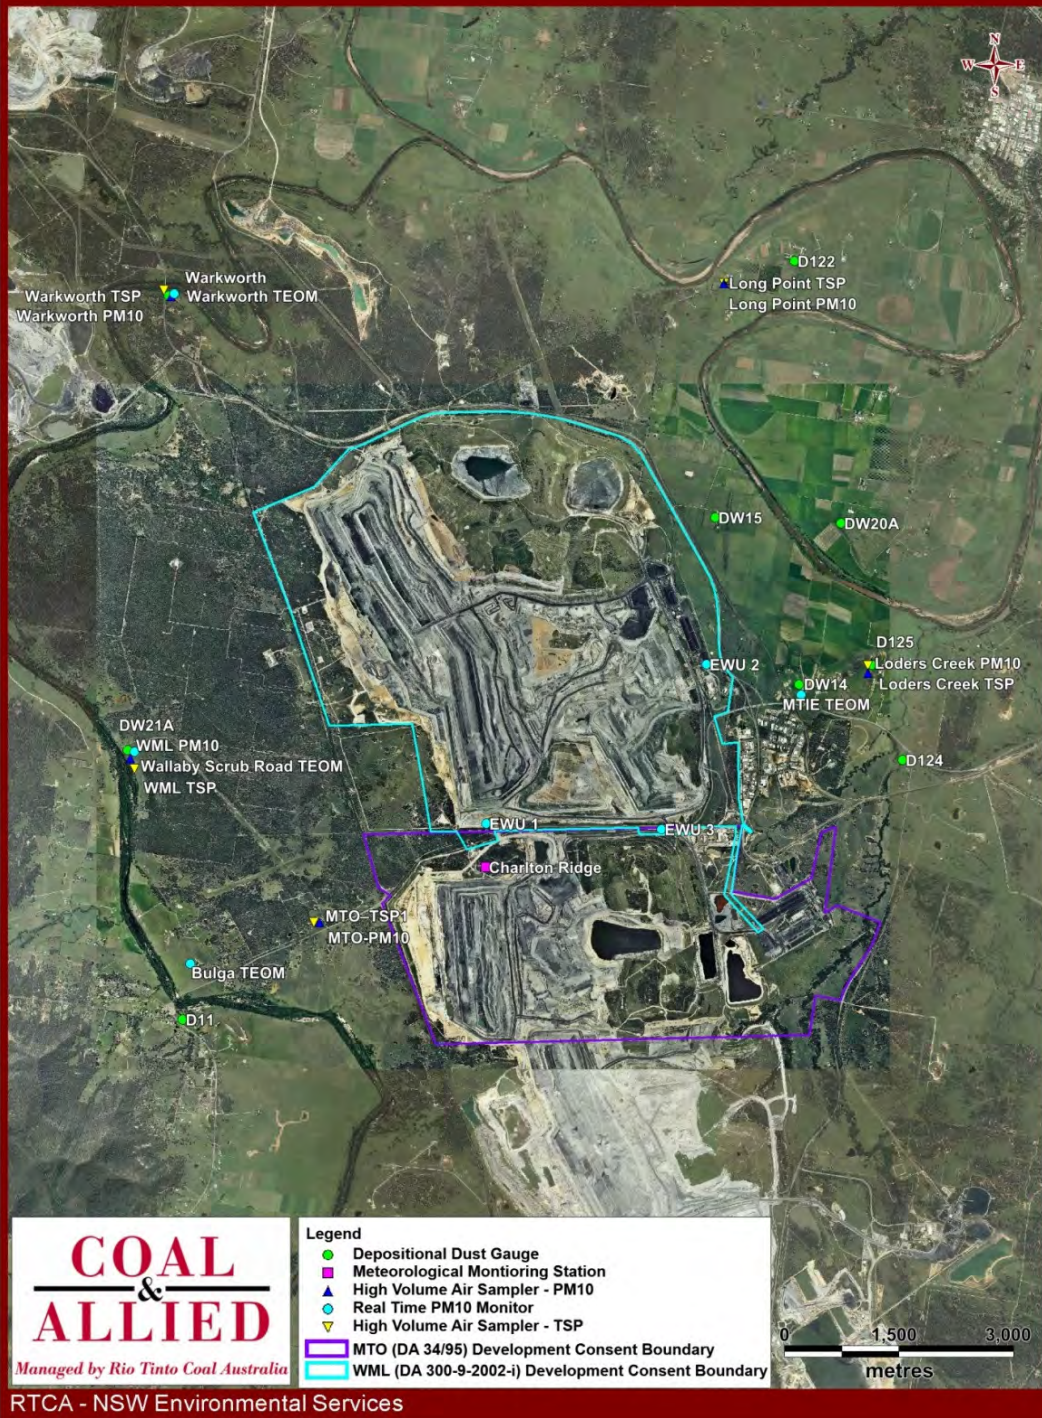
Figure 27: Air and Meteorological Monitoring Locations MTW 2014

Air quality monitoring at MTW is undertaken in accordance with the MTW Air Quality Monitoring Programme and protocol for evaluating non-compliances (available via the Rio Tinto website). The monitoring network comprises an extensive array of monitoring equipment which is utilised to assess performance against the relevant conditions of MTW's approvals. Air quality monitoring locations are shown in Figure 27. During 2014, MTW complied with all short term and annual average air quality criteria.

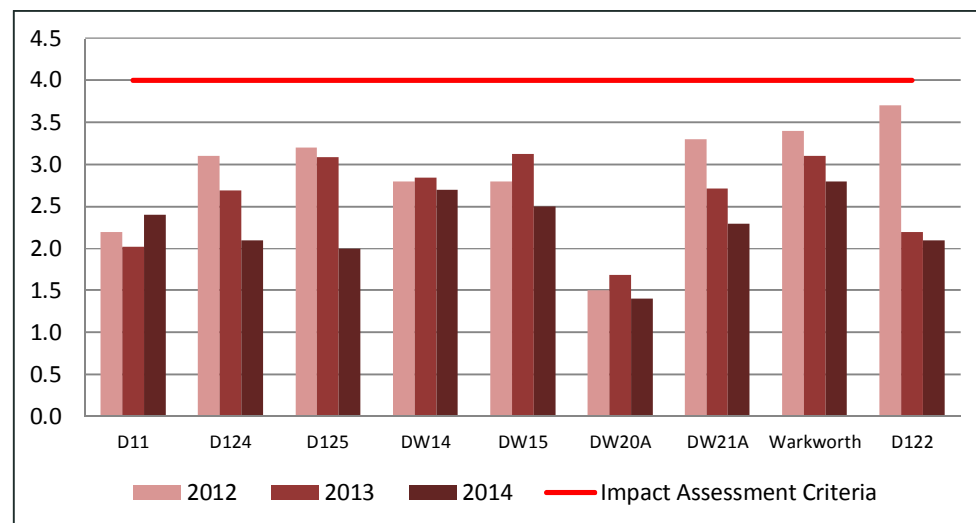
Figure 28: 2014 Depositional Dust results compared against the impact assessment criteria and previous years' results

During 2014, monthly dust deposition rates equal to or greater than the long term impact assessment criteria of 4g/m²/month were recorded at number of sites. Often this is due to contamination of the open sample vessel. Where field observations denote a sample as contaminated (typically with insects, bird droppings or vegetation), the results are excluded from Annual Average compliance assessment. Meteorological conditions and the results of nearby monitors for the sampling period are also considered when determining MTW's level of contribution to any elevated result. Details of excluded results are presented in the relevant MTW Monthly Environmental Monitoring Report.

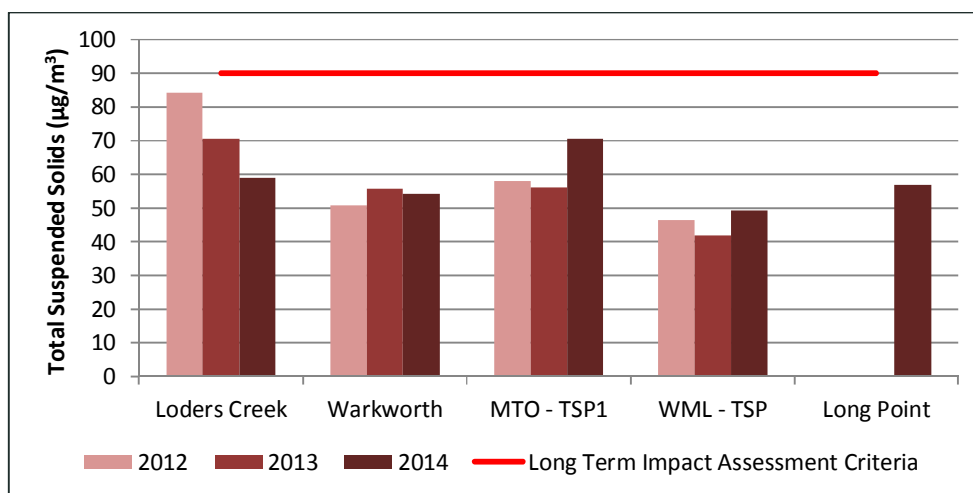
Figure 30: 2014 TSP Annual Average compared against the impact assessment criteria and previous years' results

The annual average TSP concentrations recorded in 2014 are generally consistent with those recorded during previous years (Figure 30), with the exception of the MTO-TSP1 monitoring location which recorded an annual average of 70.61µg/m³. It should be noted that this monitoring location is no longer representative of any privately owned land following land ownership changes in 2014, and is proposed to be relocated to the west in 2015 to ensure the monitoring network records measurements which remain representative of impacts received by neighbouring privately owned lands.

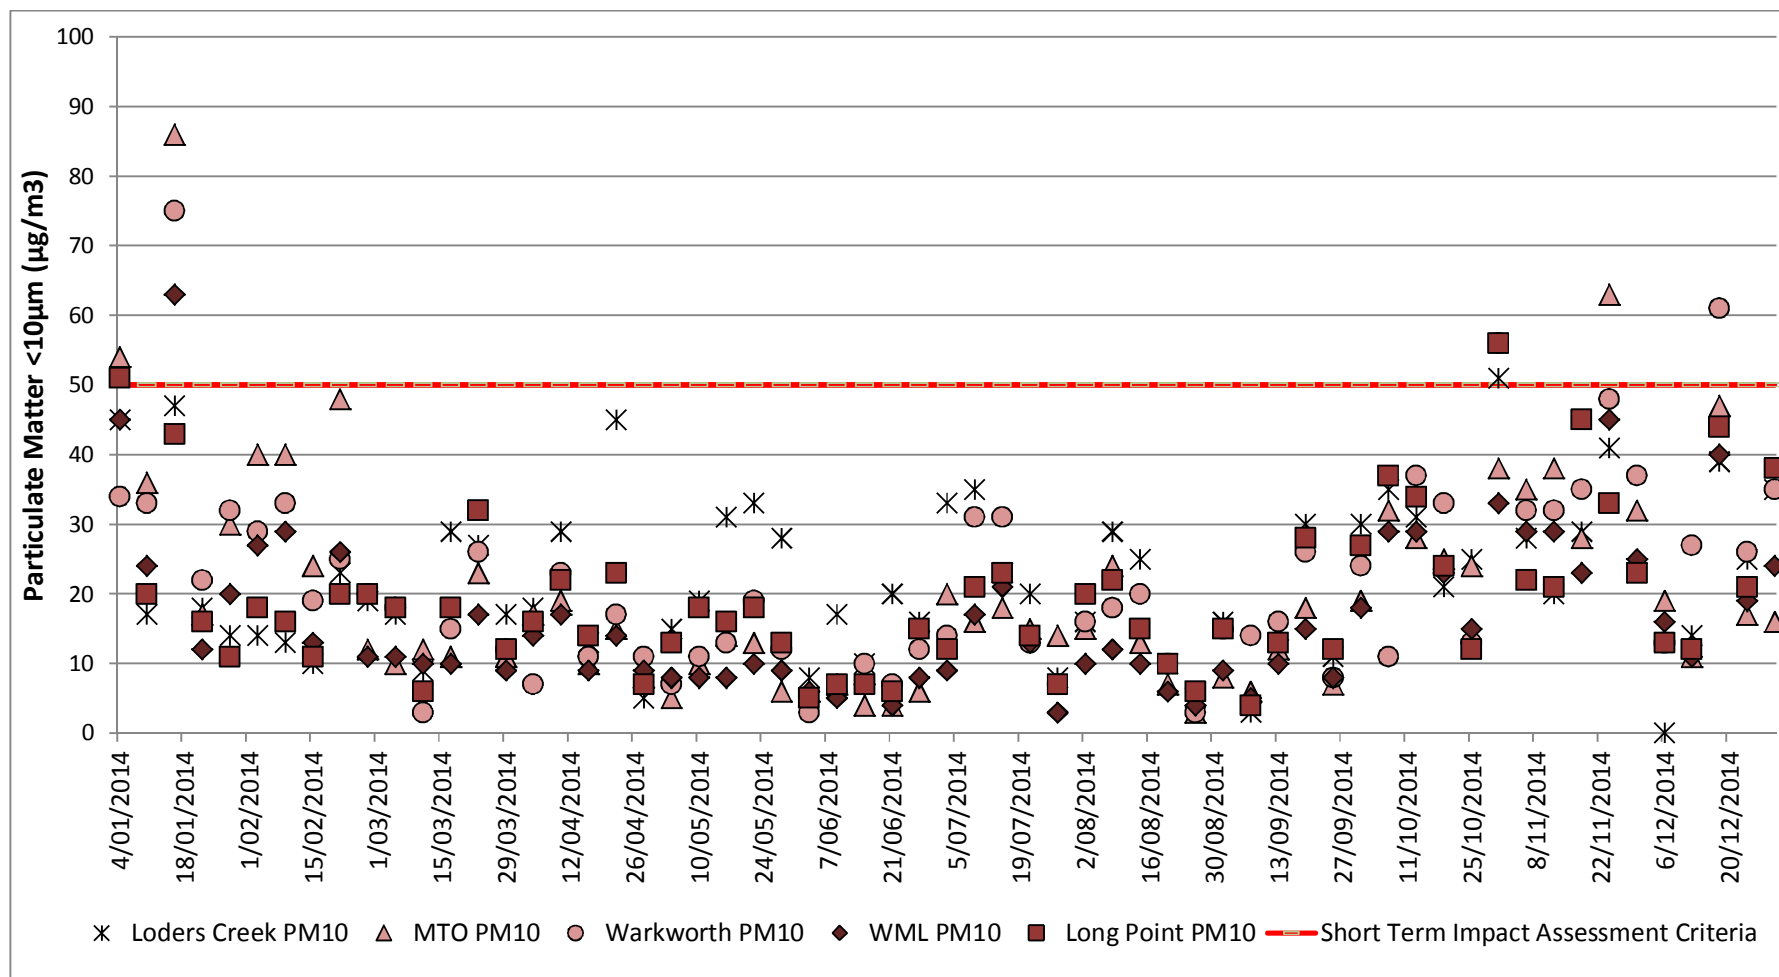
Figure 31: PM10 24hr monitoring results

Monitoring results for 2014 PM₁₀ (24 hour) collected through the High Volume Air Sampler monitoring regime compared against the short term impact assessment criteria is shown in Figure 31. All 24hr average results recorded by MTW's surrounding network of TEOM monitors is presented on a quarterly basis in Figure 31 to Figure 35.

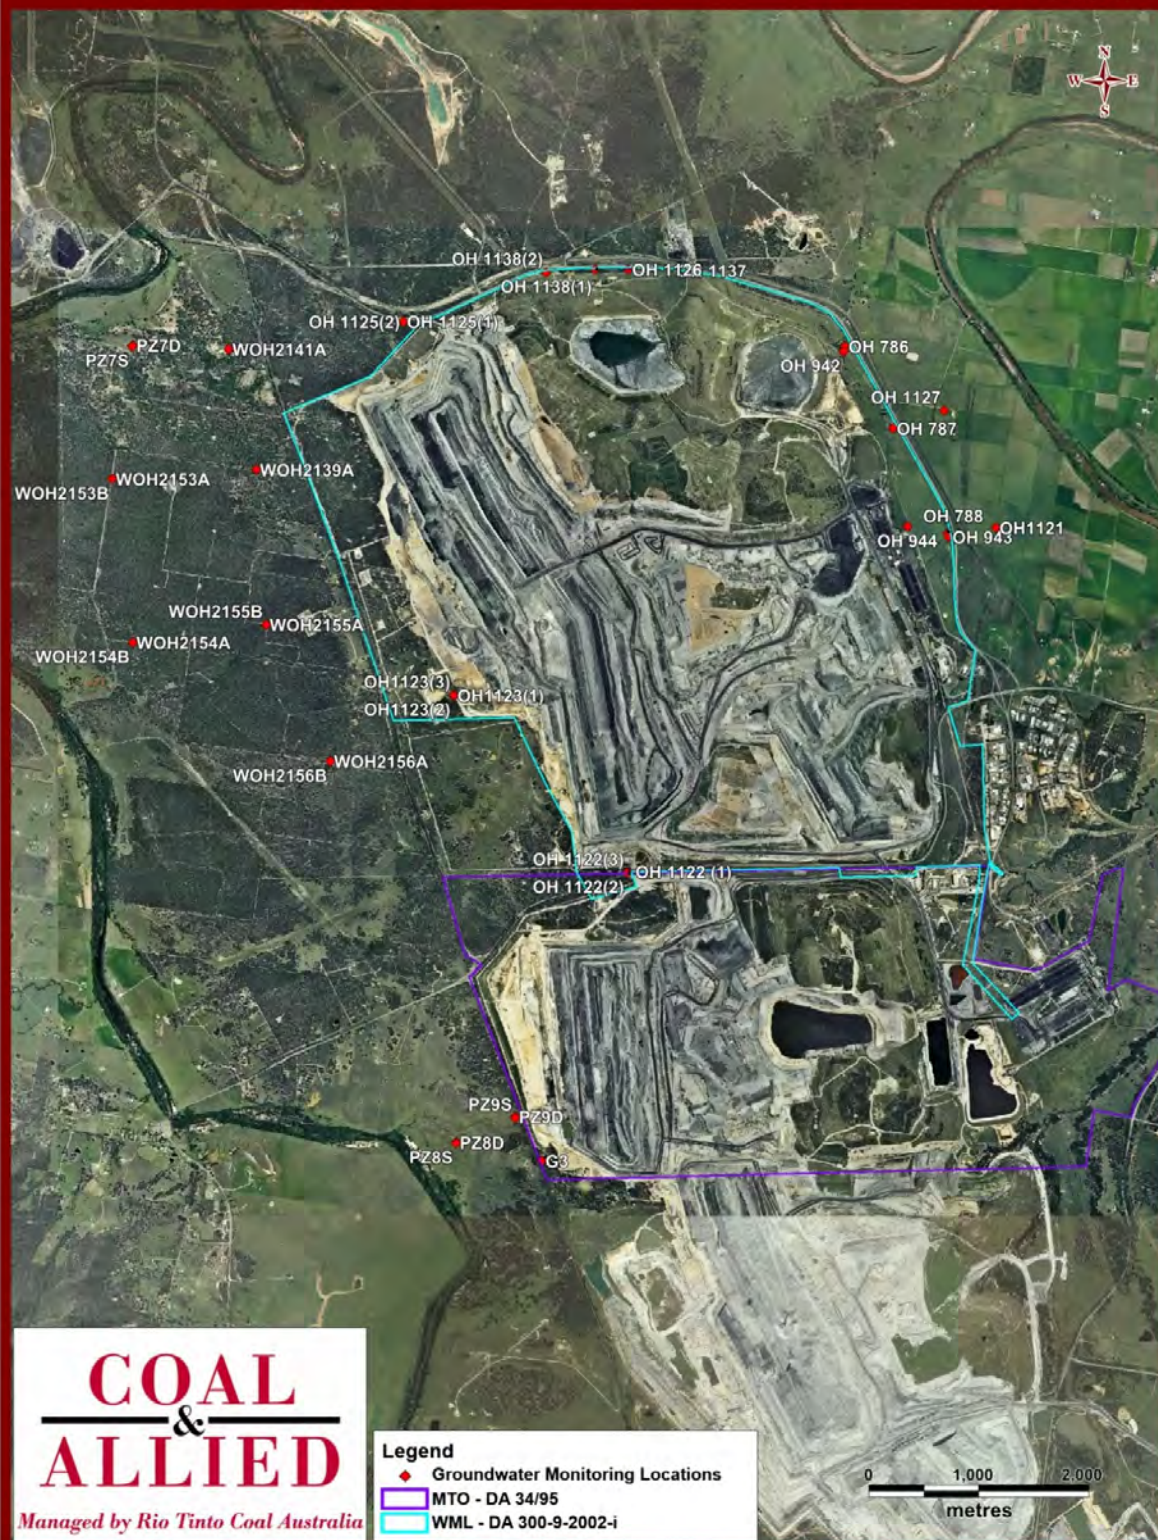
Figure 49: Groundwater Monitoring Network at MTW in 2013

The monitoring locations are shown in Figure 49.

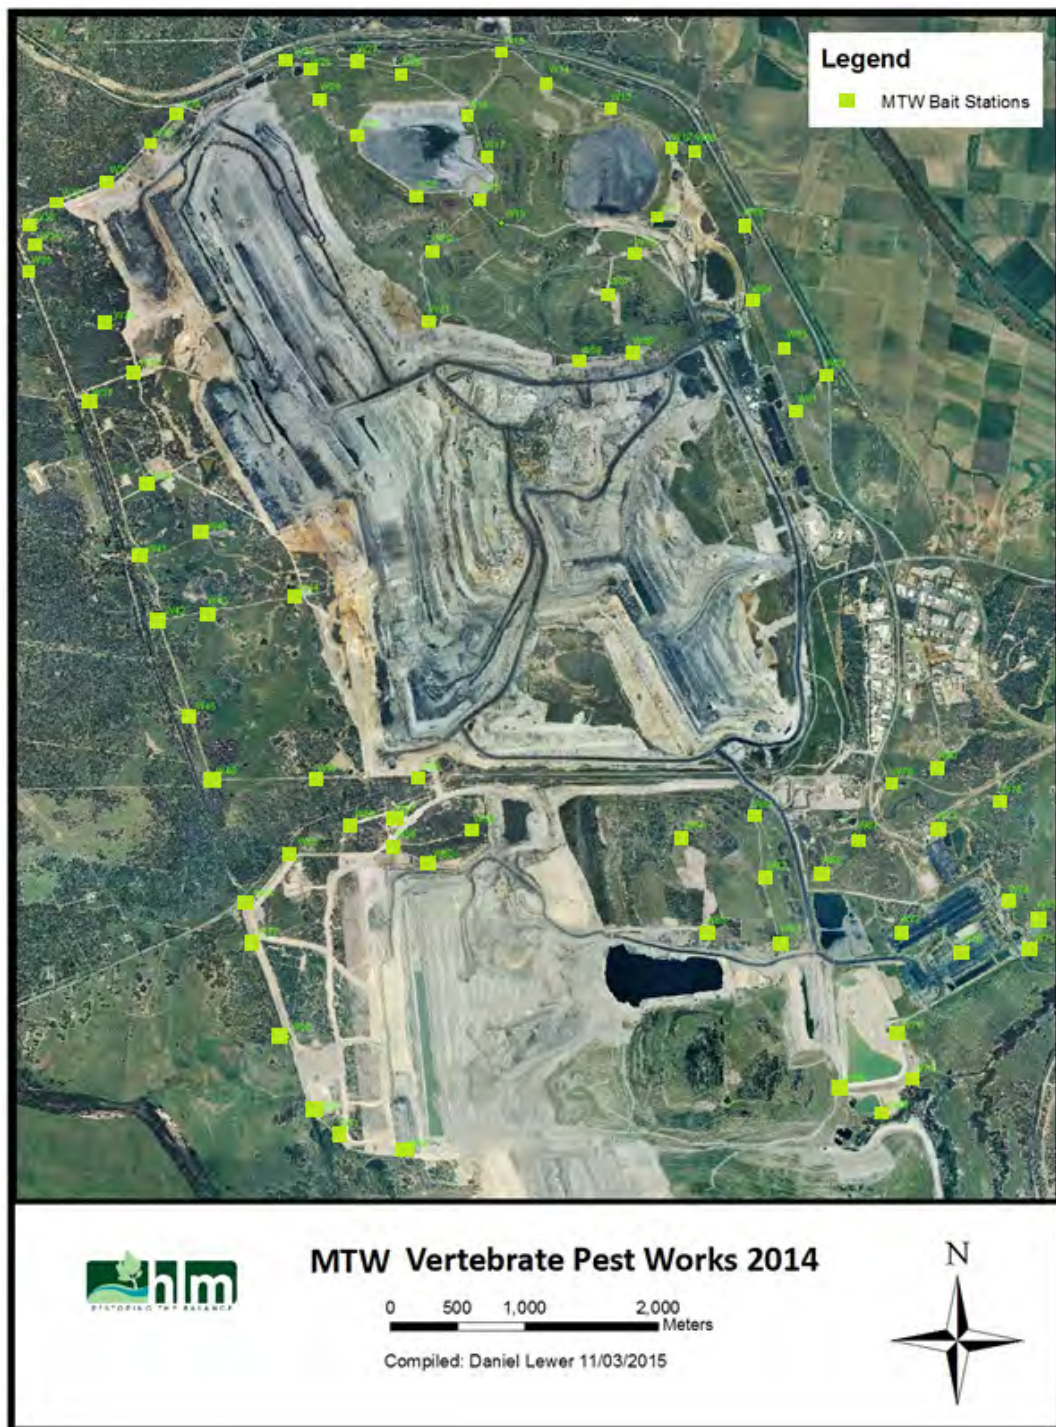
Figure 91: Baiting Station Locations at MTW during the 2014 Control Programs

Winter and Spring baiting in 2014 were extended to a 4 week period in place of the previously conducted 2 week programs in Summer and Autumn to increase exposure times of the programs to the target species. Consistently high fox bait takes during this time supports this 2014 program focus as MTW continues to limit feral pest impacts on its landholdings and surrounding neighbours.

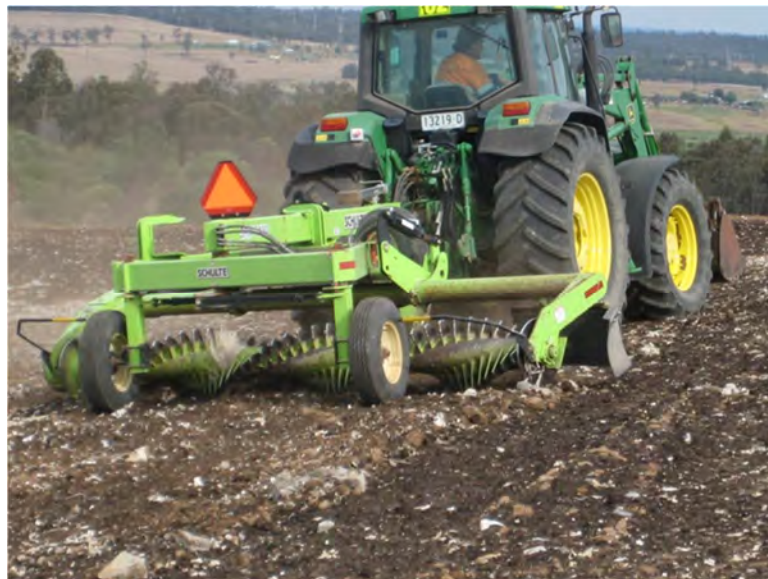
Figure 92: Rock windrower incorporating compost in rehabilitation, Cheshunt Pit HVO

Two agricultural implements have been used to incorporate the compost through the top layer of growth medium. The first of these is a rock windrower (see Figure 92) which is typically used to sweep rocks into a windrow for removal from cropping paddocks. A rock picker is then used to pick up the windrowed rocks. The benefit of using the rock windrower and rock picker is that the soil surface is then free of rocks that would cause difficulties for the direct-drill that is used for sowing. Rock picking and aerating was completed on an as-needs basis during 2014, depending on ground conditions.

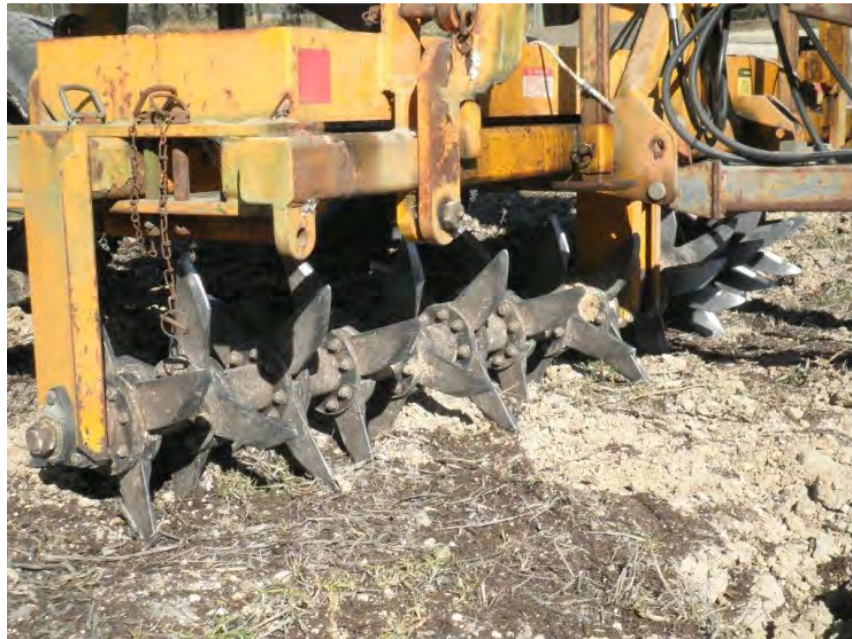
Figure 93: Aerator showing tyne arrangement

the aerator is also useful for breaking up the surface crust and providing a suitable seed bed for sowing. The aerator is also valuable as it does not pull rocks to the surface, as is typical with tyne-style equipment.

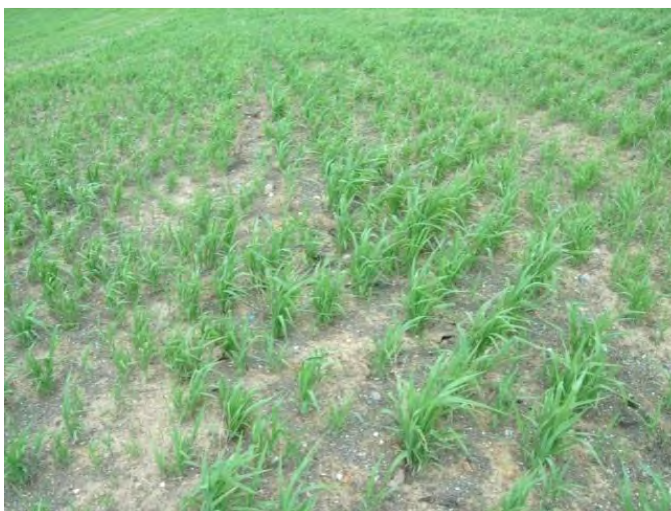
Broadcast spreading of cover crop seed onto a freshly-prepared aerated surface has been found to be most effective in establishing initial cover on slopes. Seedlings that establish in the holes left by the aerator can survive dry conditions because of the improved water harvesting ability of the aerator pattern. Harrows are not used to provide soil coverage after sowing because the seed that falls in the aerator holes is sufficiently buried by the movement of the fresh topsoil by rain and wind. Avoiding the use of harrows is important because they have been found to smooth out the aerator pattern and produce a slick surface less able to harvest water and more prone to erosion (see Figure 94 and Figure 95).

Figure 95: An area which has been aerated (not harrowed), showing healthy cover crop establishment in the aerator pattern

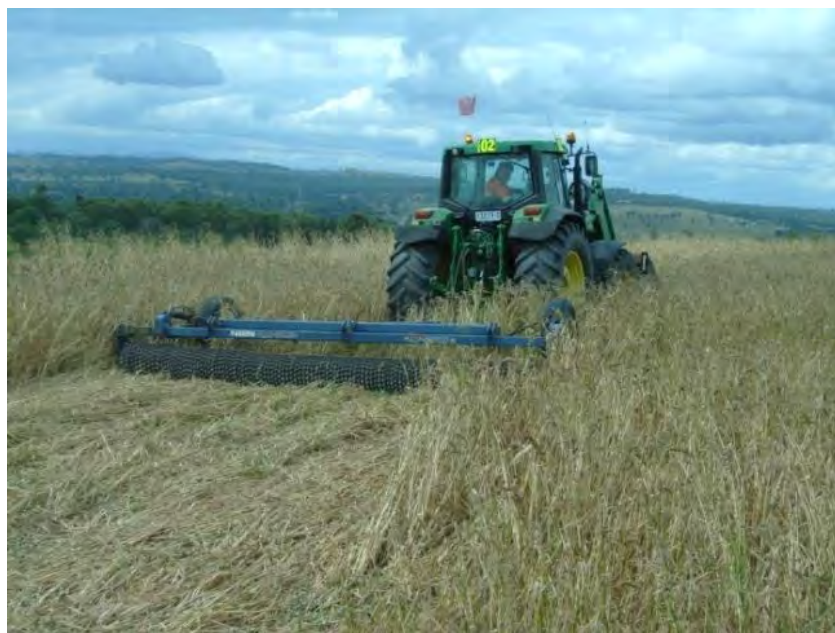
Figure 96: Crop rolling the millet cover crop on to the surface

Rolling the crop onto the surface rather than slashing/mulching the stubble was preferred because it leaves a more stable “attached” mulch (i.e. mulch still attached to roots) rather than small pieces of stubble which would be more prone to being washed or blown off the soil surface. Rehabilitation areas with the rolled cover crop on the surface have been found to be very stable and resistant to the effects of both wind and water erosion.

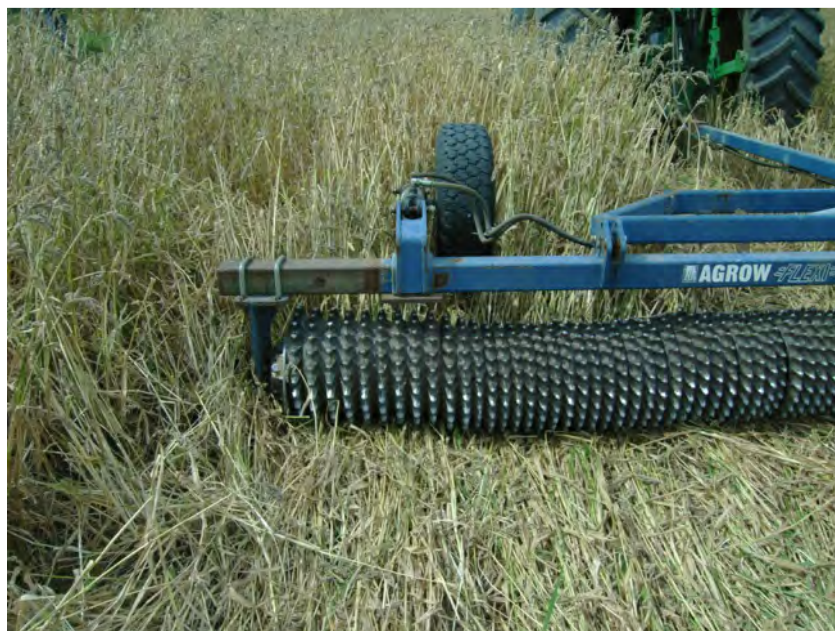
One of the aims of using sacrificial cover crops is to provide additional opportunities for weed control prior to sowing long term seed mixes. An issue that presented in 2013 was the difficulty of targeting small weed plants growing under a knee-high cover crop due to the high levels of herbicide spray interception on the standing cover crop. The solution that was adopted was the use of a flexiroller to flatten the cover crop on the surface and allow the weeds to poke up through the flattened stubble (see Figure 96 and Figure 97). The weeds are then exposed for effective herbicide spraying with a boom spray.

Figure 97: The flexiroller is made up of individual rings which allow it to conform to the surface contours

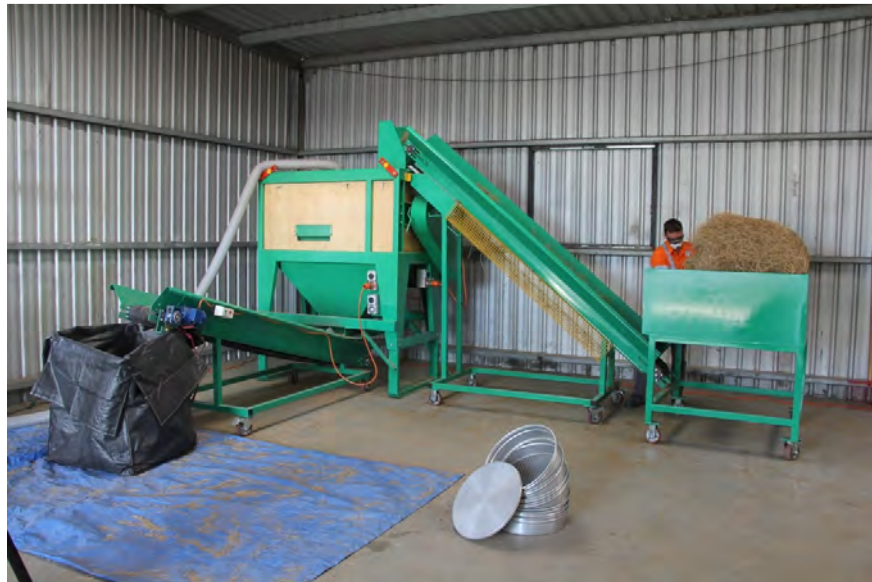
Trials have been undertaken in 2014 by native grass seed contractors using custom-designed machinery to improve the flowability of the native seed through the direct-drill seeder. These trials have used a combination of threshers, sieves and shaker tables to separate the seed from the awn and floret appendages, and remove stalk (Figure 98). Further refinement of these processes will be undertaken during 2015 to produce native seed mixes that are more suitable for direct-drilling and potentially suitable for broadcast seeding through air seeding equipment.

Figure 98: Native grass seed thresher used to process harvested seed into a form suitable for the direct-drill seeder.

The native grass seed box on the direct-drill is equipped with agitators to keep the seed mix from bridging and pick-wheels to help pull seed down into metering points. Despite this the initial trials showed the native grass seed was still causing some blockages during seeding. Further processing of the native grass seed mix, by putting it through a garden style mulcher, was needed to reduce blockages. A commercial thresher was used for processing seed in 2014. This machine uses stiff brushes and sieves to process the seed in order to improve the flowability of the seed mix through the direct-drill. The use of the thresher rather than the garden mulcher reduces potential damage to seed caused by spinning mulcher blades.

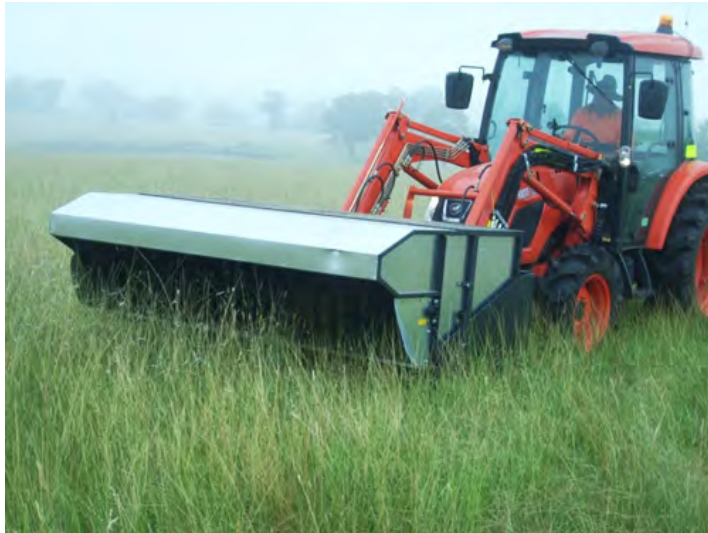
Figure 99 shows the native grass seed harvesting implement used on Coal & Allied Properties and Figure 100 shows the harvested seed being dried prior to going into storage.

Figure 99: Native grass seed harvesting at a Coal & Allied owned property near Muswellbrook.

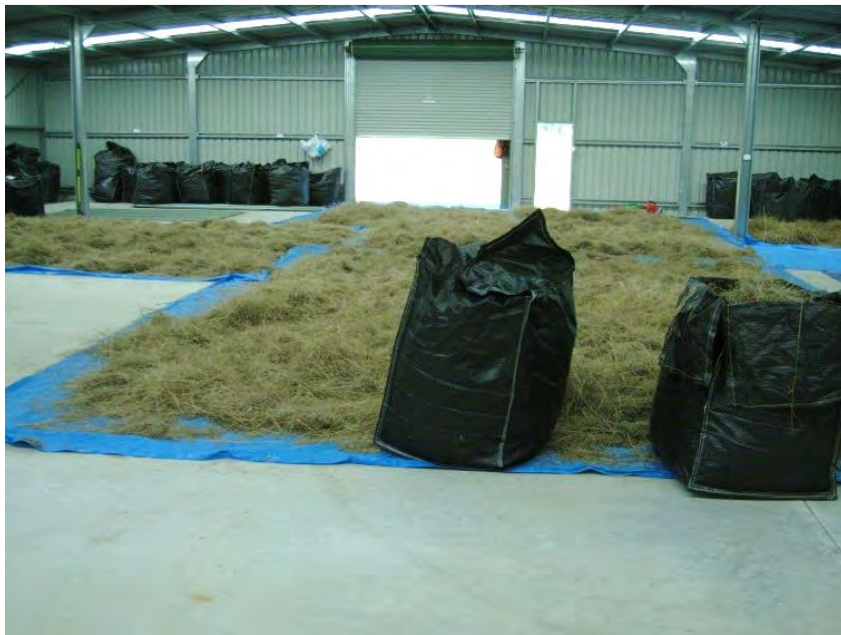
Figure 100: Harvested native grass seed material being dried before storage.

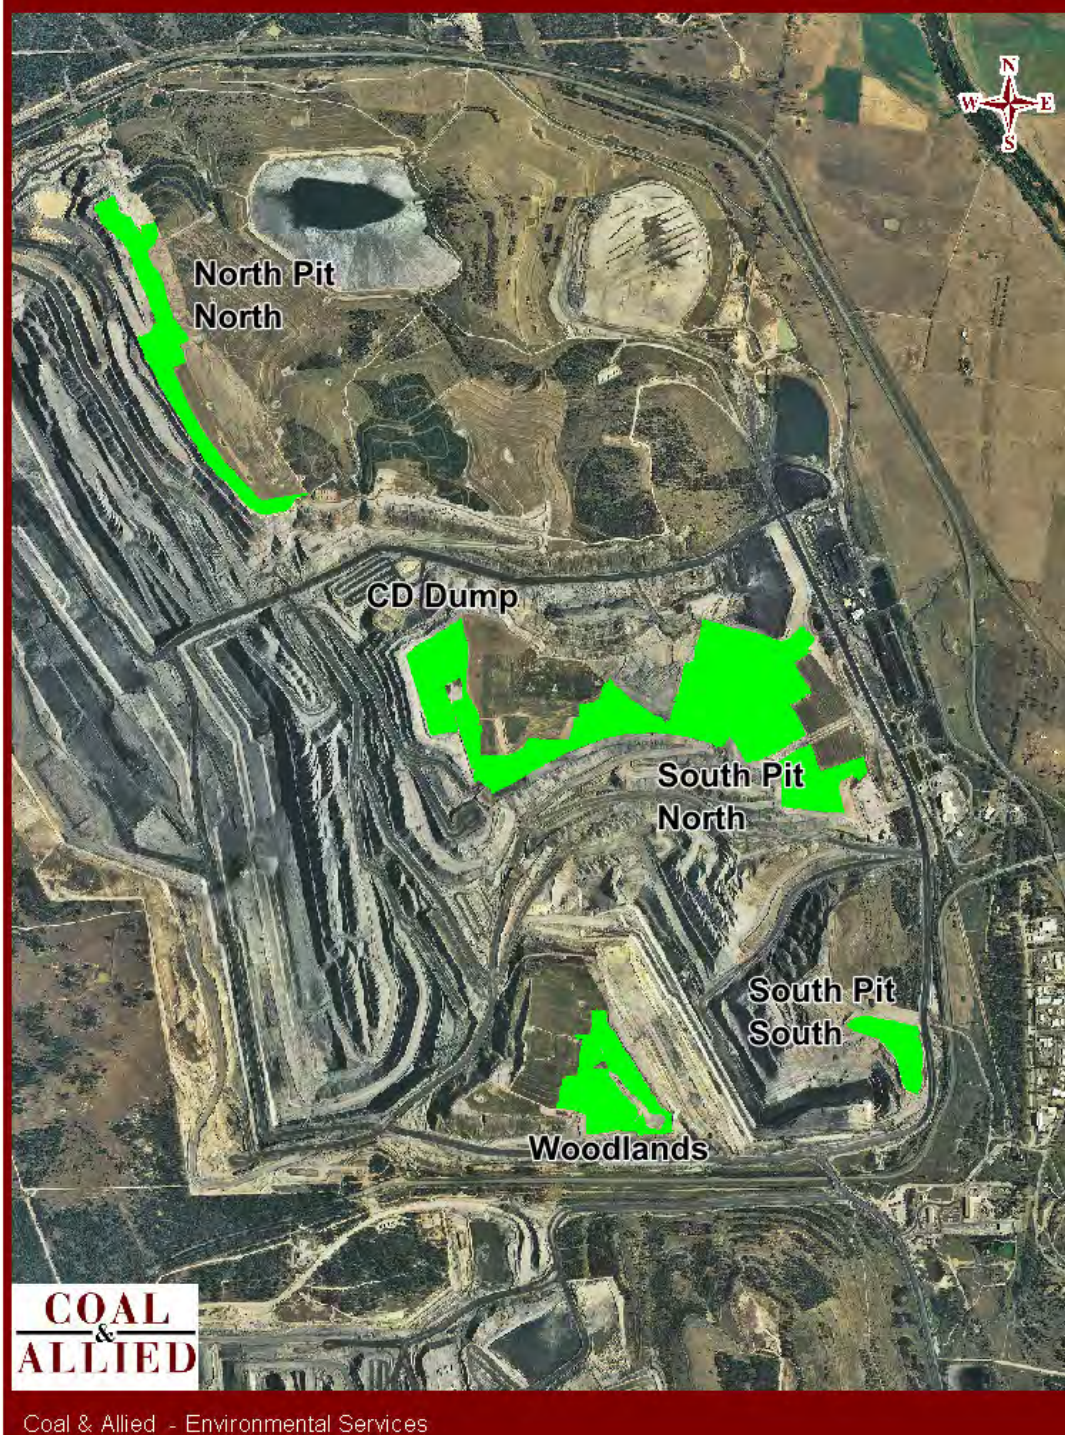
Figure A: Rehabilitation Areas 2014

**Plan of: Actual Rehabilitation Progress
compared to EIS Projection**
