Mount Thorley Warkworth

2014 Annual Environmental Review

March 2015

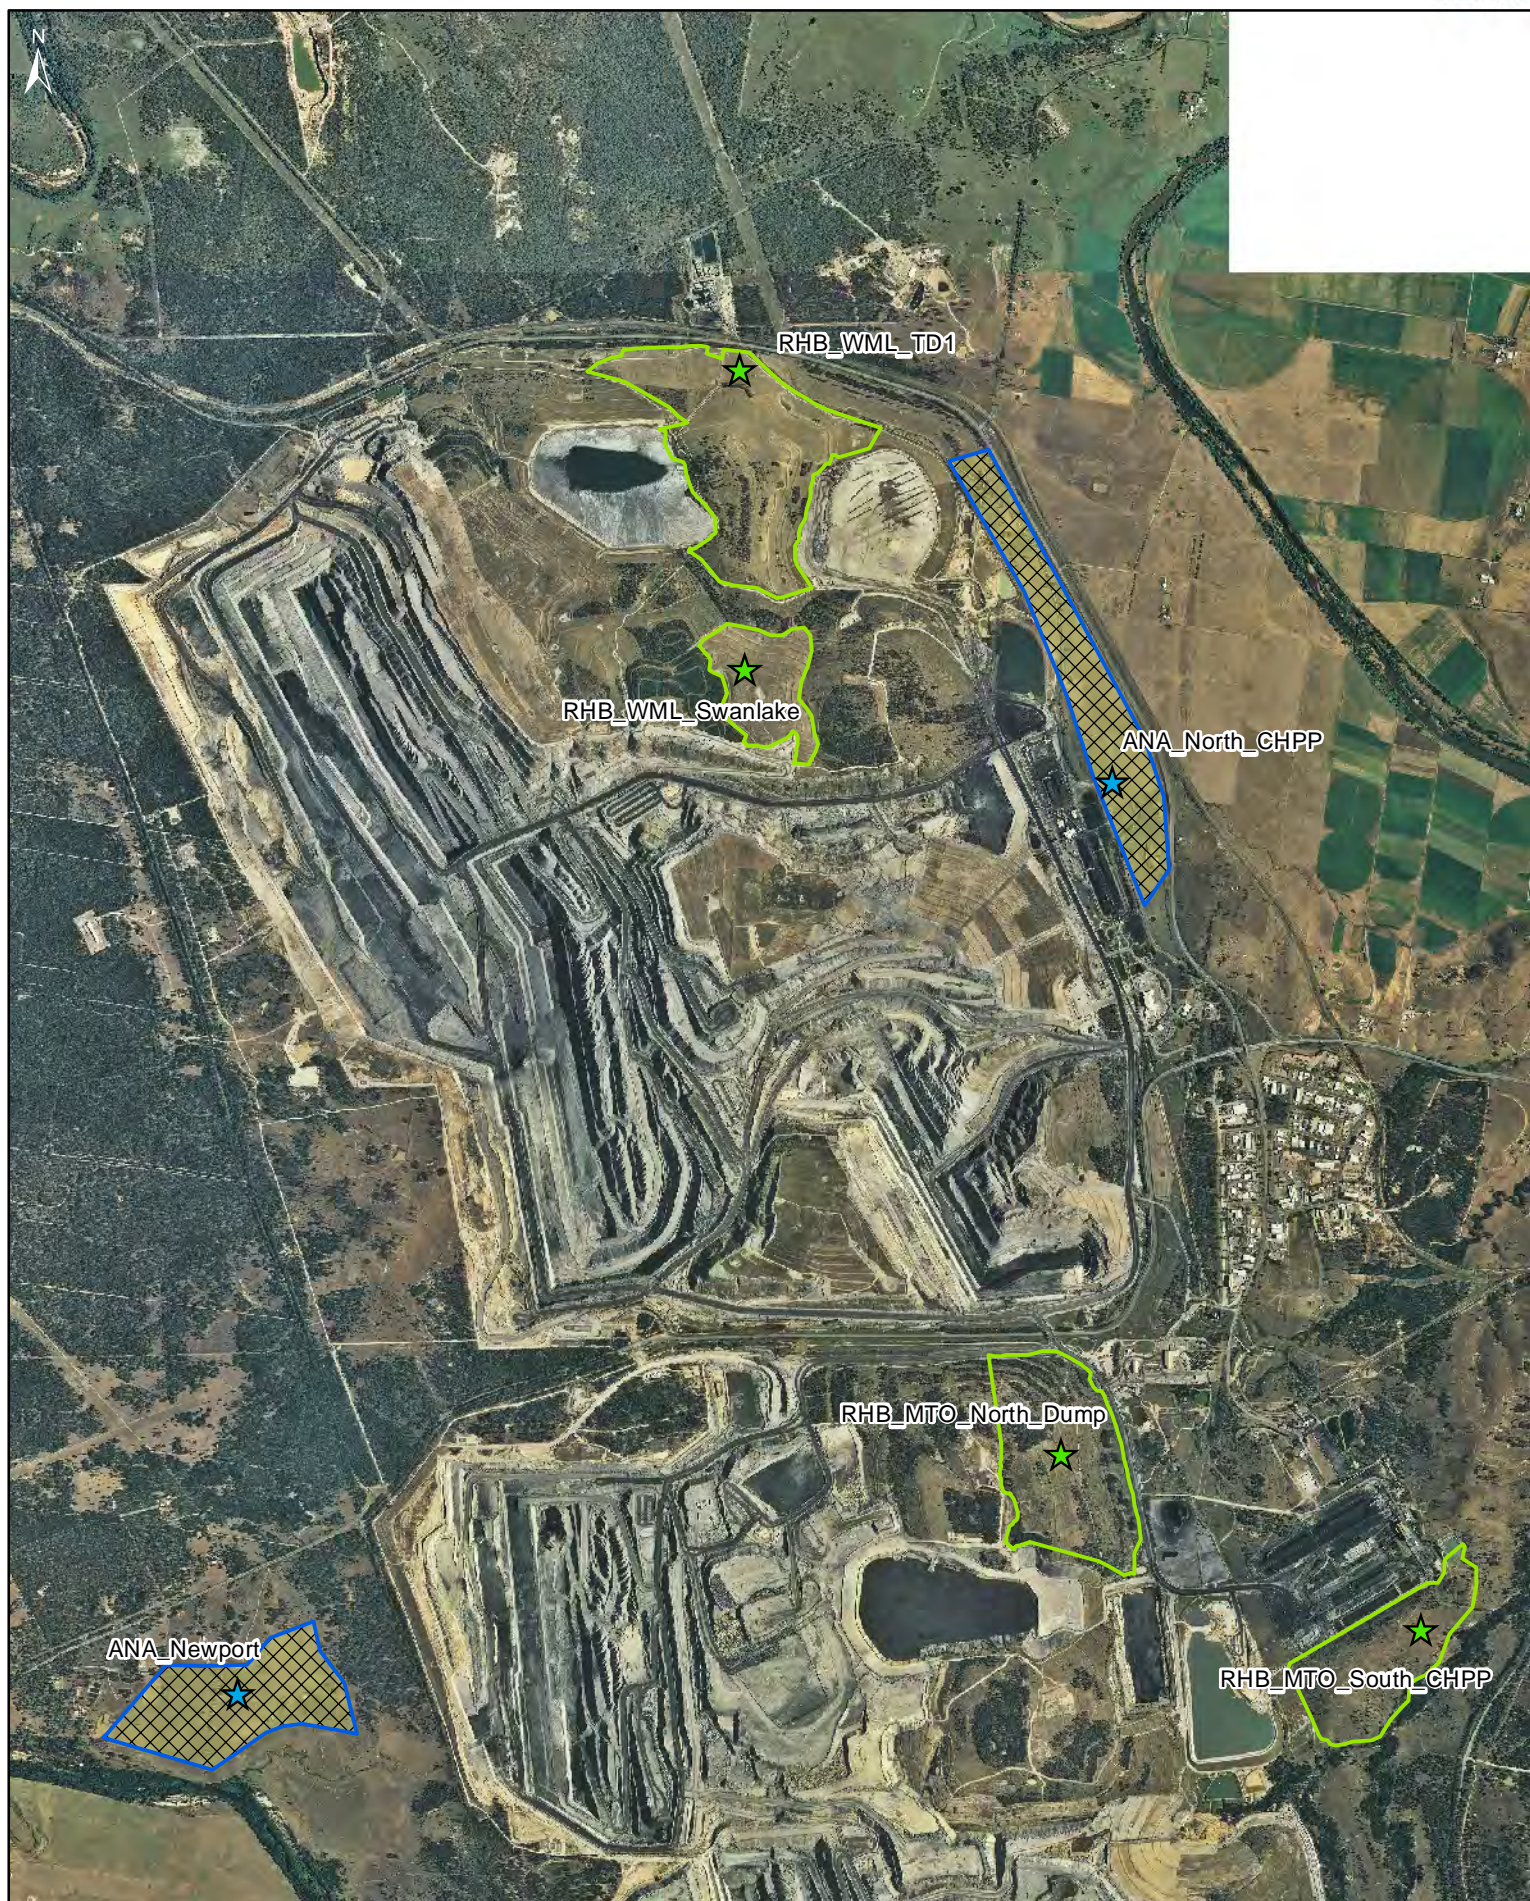
Fig. 1a

Figure 1 a (for HVO sites) and Figure 1 b (for MTW sites). For each rehabilitation monitoring site, the location of the LFA monitoring transect and of the Botanal study polygon are presented in Figure 2 a.

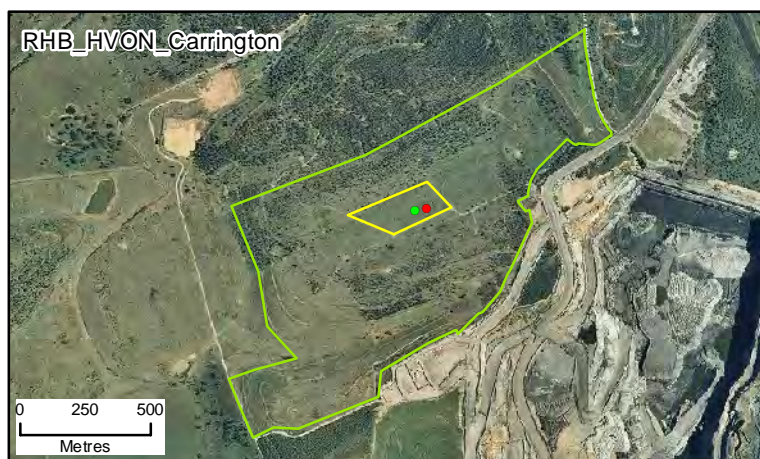
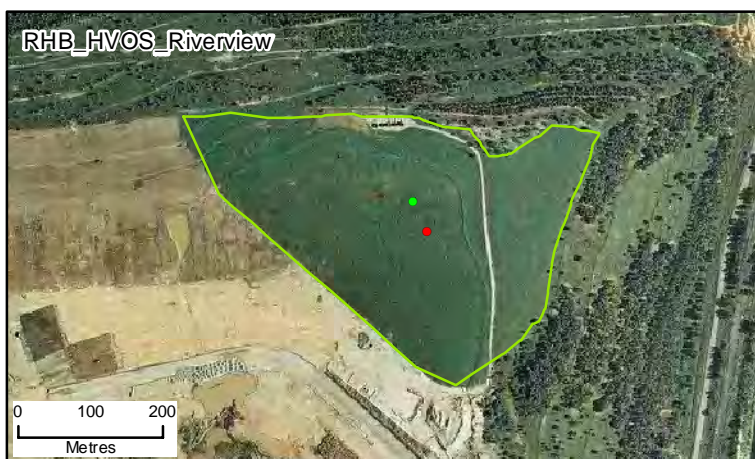
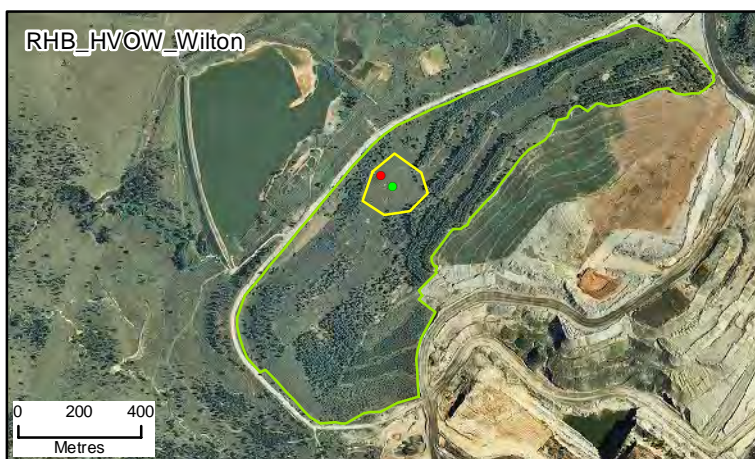
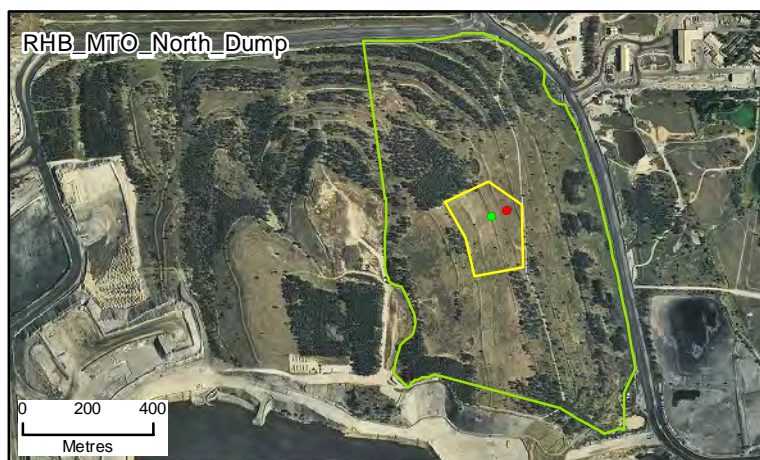
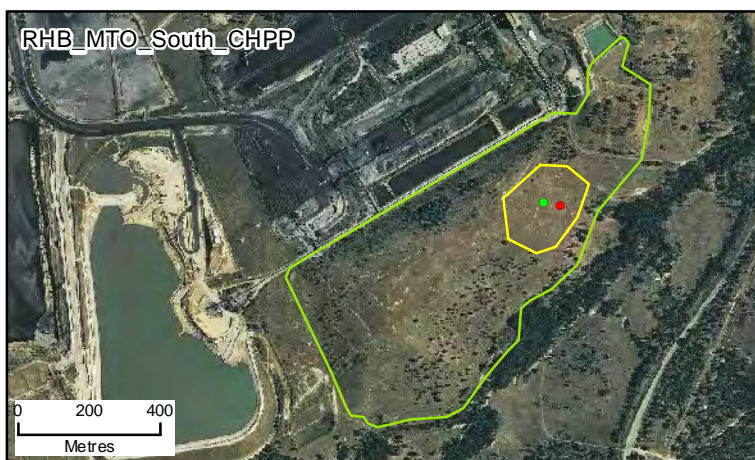
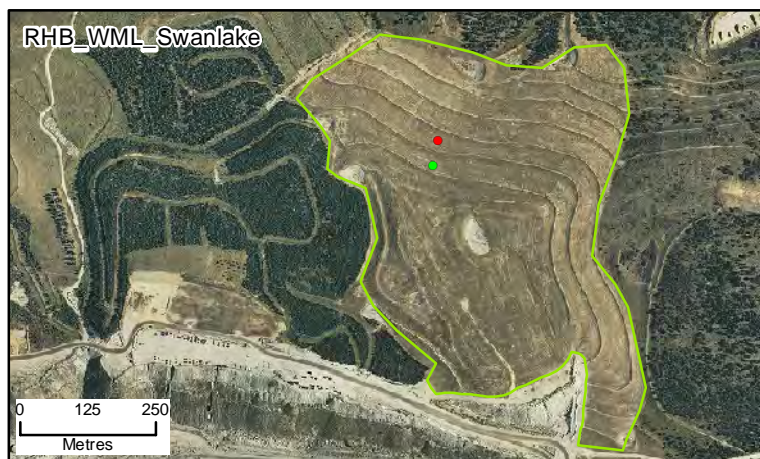
Fig. **1b**

Rehabilitation Polygon
Botanal Study Area

LFA Transect End
LFA Transect Start

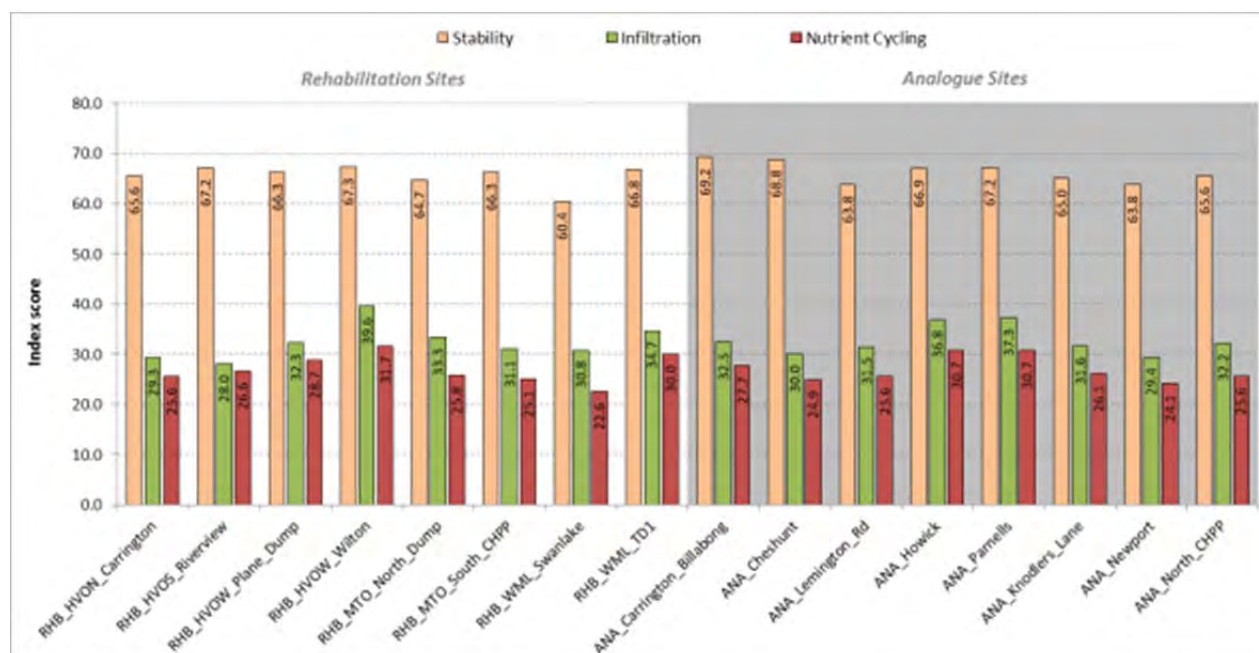
Figure 3 LFA monitoring results – Soil surface condition indices

Monitoring site		Landscape Organisation Index (LOI)	Soil surface condition indices		
			Stability	Infiltration	Nutrient cycling
Rehabilitation sites	RHB_HVON_Carrington	1.00	65.6	29.3	25.6
	RHB_HVOS_Riverview	1.00	67.2	28.0	26.6
	RHB_HVOW_Plane_Dump	1.00	66.3	32.3	28.7
	RHB_HVOW_Wilton	1.00	67.3	39.8	31.7
	RHB_MTO_North_Dump	0.98	64.7	33.3	25.8
	RHB_MTO_South_CHPP	1.0	66.3	31.1	25.1
	RHB_WML_Swanlake	0.93	60.4	30.8	22.6
	RHB_WML_TD1	0.97	66.8	34.7	30.0
Analogue sites	ANA_Carrington_Billabong	1.00	69.2	32.5	27.7
	ANA_Cheshunt	1.00	68.8	30.0	24.9
	ANA_Lemington_Rd	1.00	63.8	31.5	25.6
	ANA_Howick	1.00	66.9	36.8	30.7
	ANA_Parnells	1.00	67.2	37.3	30.7
	ANA_Knodlers_Lane	1.00	65.0	31.6	26.1
	ANA_Newport	1.00	63.8	29.4	24.1
	ANA_North_CHPP	1.00	65.6	32.2	25.6

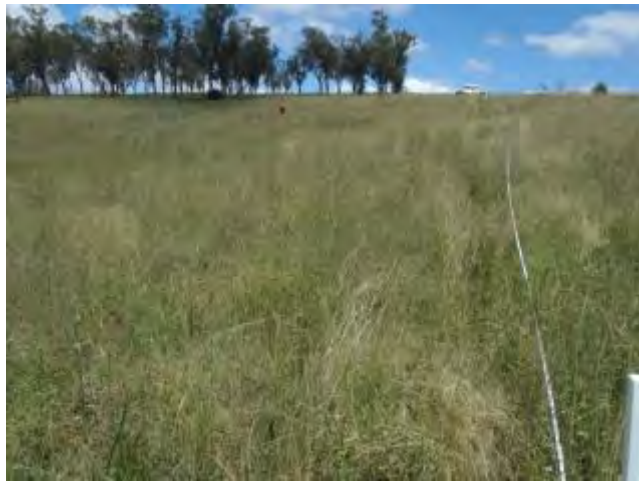
Monitoring site: ANA_Howick

View from start of transect

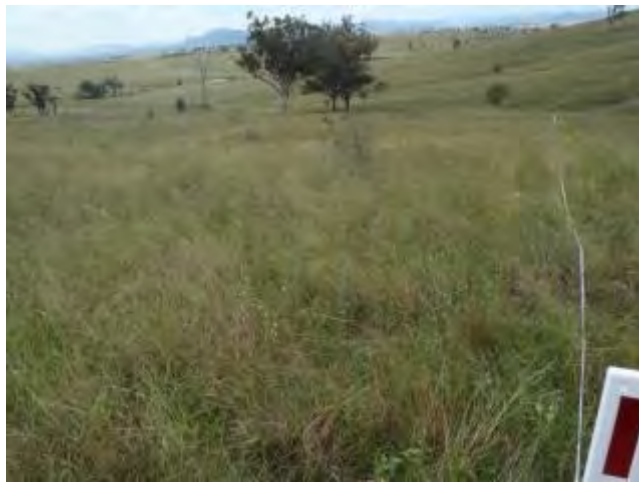
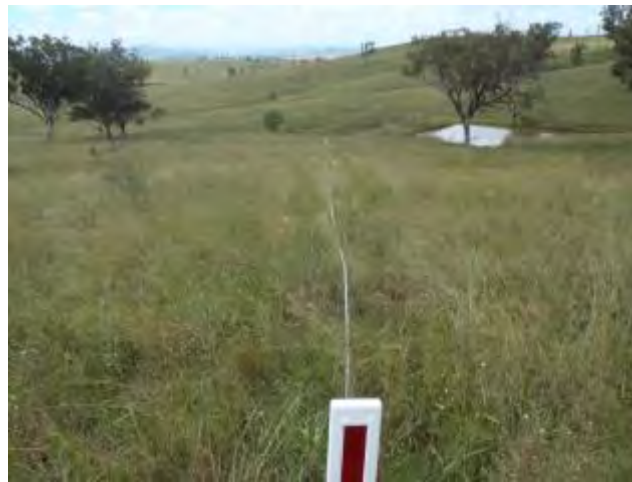
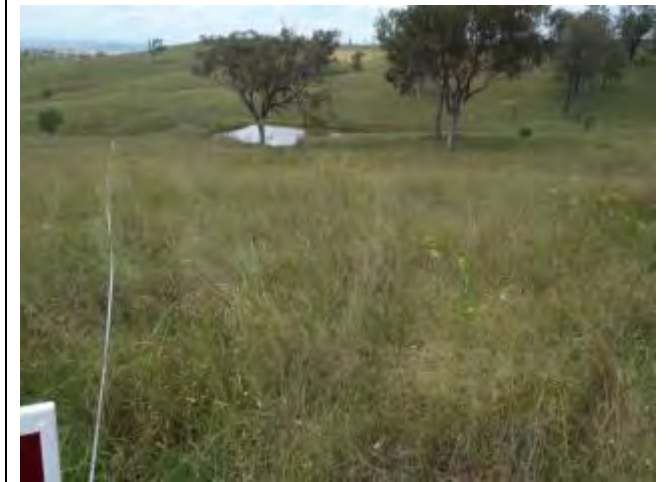
View from start of transect
