Mount Thorley Warkworth

2013 Annual Environmental Review

March 2014

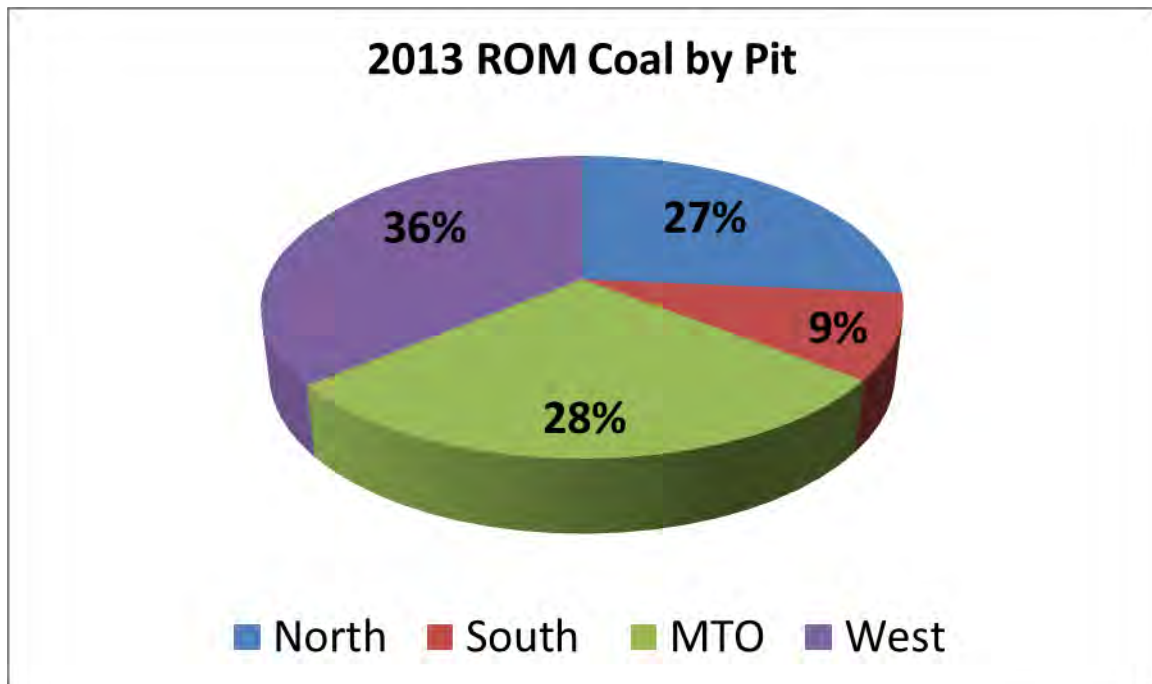
Figure 3: ROM Coal by Pit

west is dug entirely from top to bottom resulting in the absolute minimum amount of pre-strip material being moved in any given strip or year. During 2013 an extension to the southern endwall of South Pit was commenced. South Pit remains and will always remain a small “swing pit” at MTW, with only 9% of the 2013 ROM coal being mined from this area.

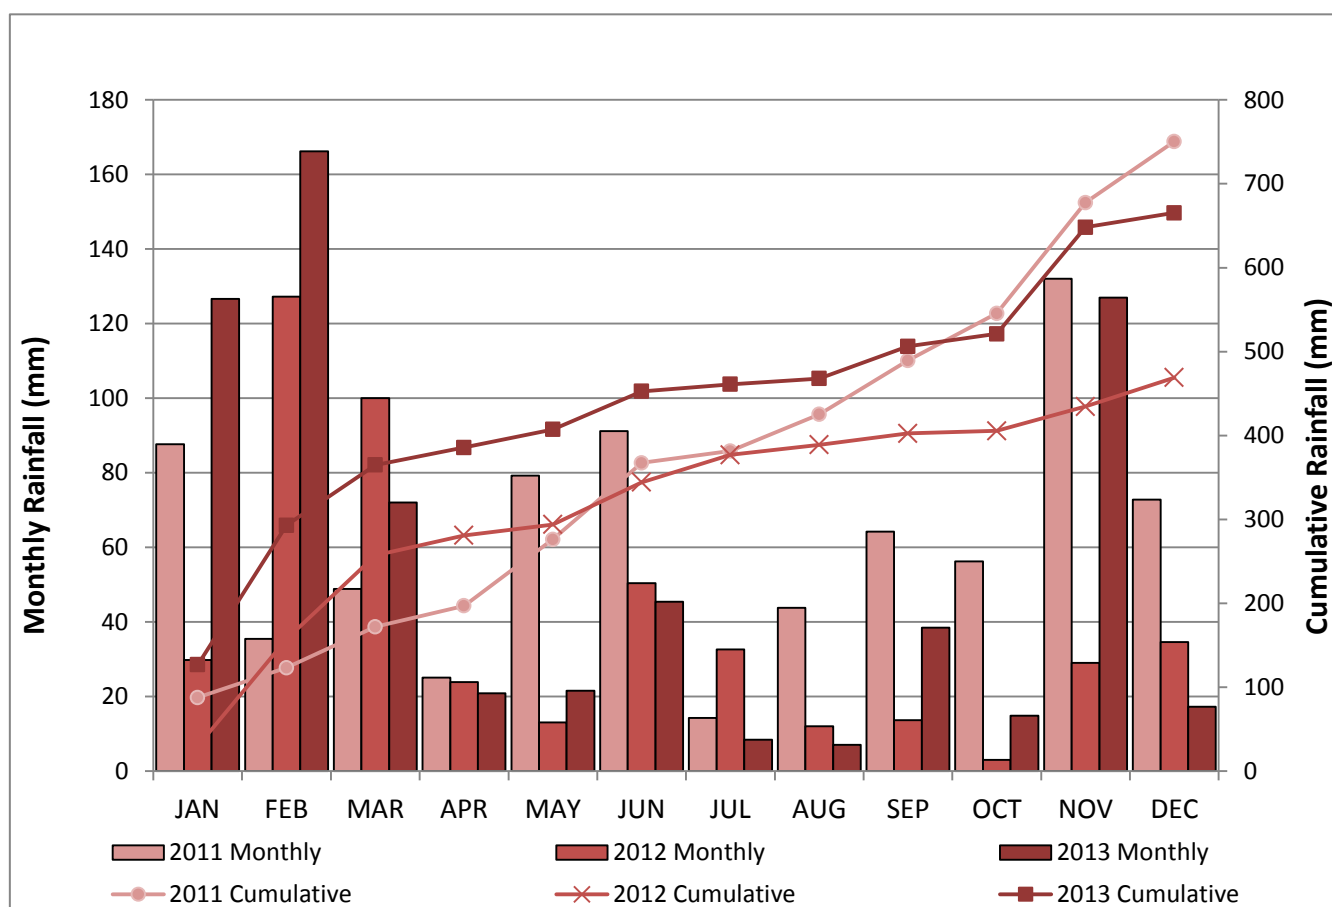
Figure 4: Monthly and Cumulative Rainfall, 2011 to 2013

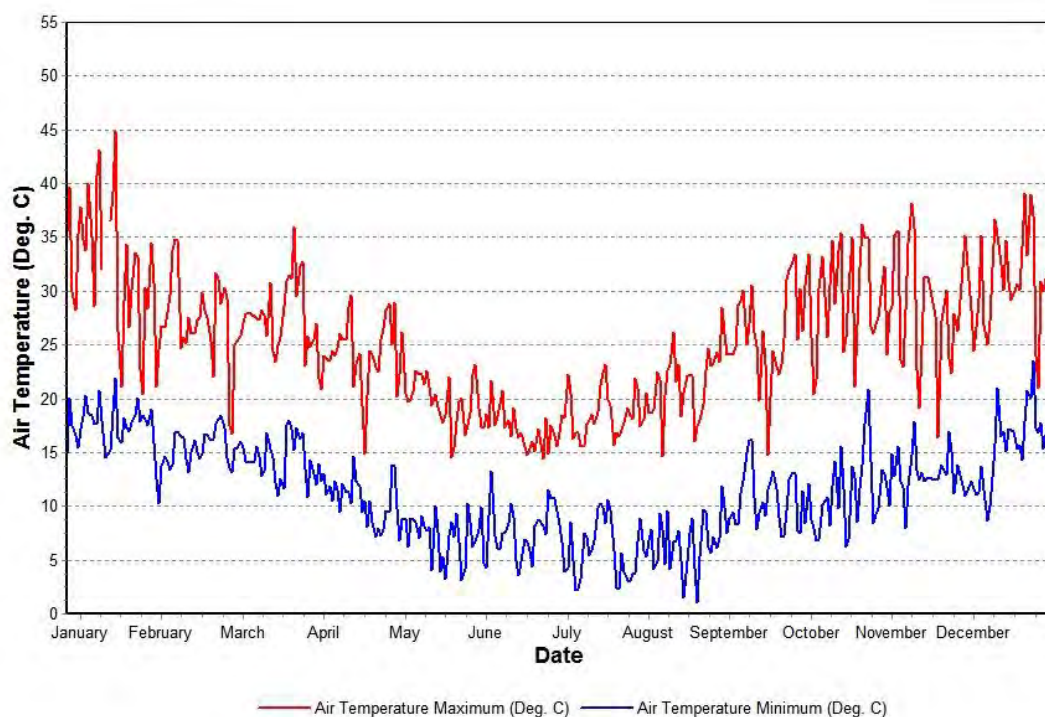
Figure 5: Maximum and Minimum Air Temperatures 2013

Maximum and Minimum temperatures recorded at the Charlton Ridge Meteorological station for 2013 are presented in Figure 5.

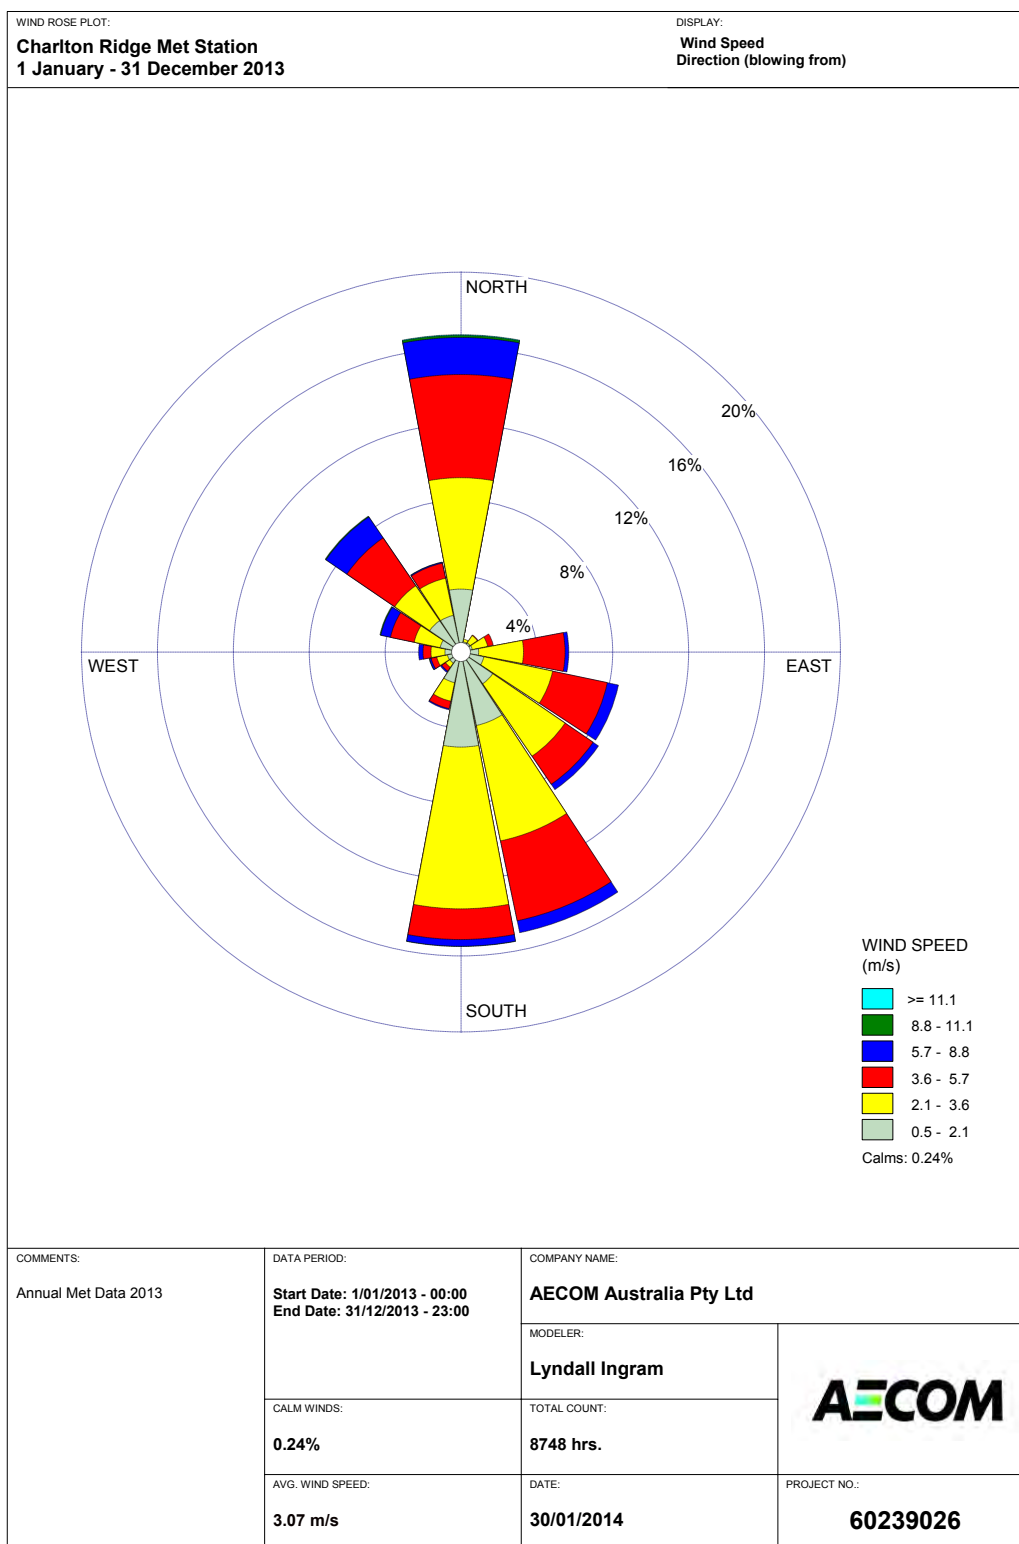
Figure 6: 2013 Annual Wind Rose

During 2013 the predominant wind direction at the Charlton Ridge Meteorological Station was from the North and North West (approximately 30% of the time) and from South and South East (approximately 30% of the time). Wind Speeds were strongest (>8.8m/s) from the North. The annual wind rose is shown in Figure 6 and quarterly wind roses for the 2013 reporting period can be seen in Figure 7 to Figure 10.

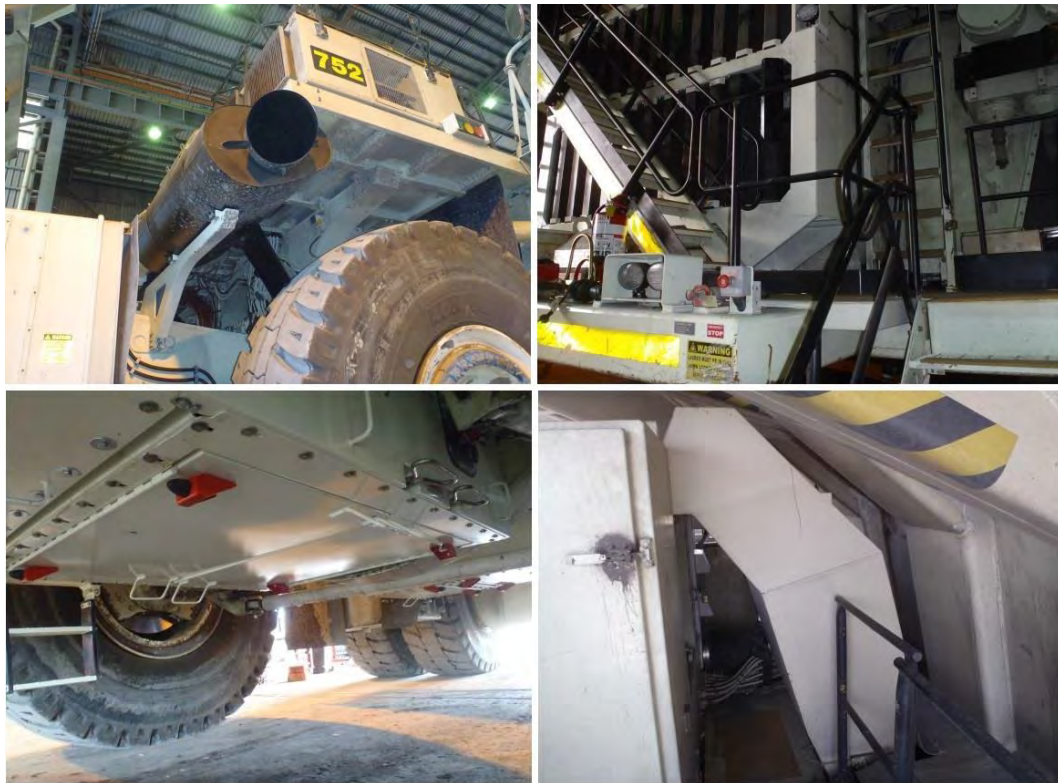
Figure 11: MTW engineered sound attenuation package. Clockwise from left: Exhaust system, Cooling fan silencer, body panels and; air duct silencer.

During 2013, MTW partnered with a number of selected businesses to investigate additional opportunities for retrofitting of sound attenuation packages to the existing haul truck fleet. This partnership has designed, manufactured, fitted and tested a robust sound attenuation package to two haul trucks in the MTW fleet. The MTW designed system targets sound reductions in a number of areas, incorporating an exhaust system, cooling fan silencer, engine bay enclosure, body pads, and an air duct silencer, see figure 11.

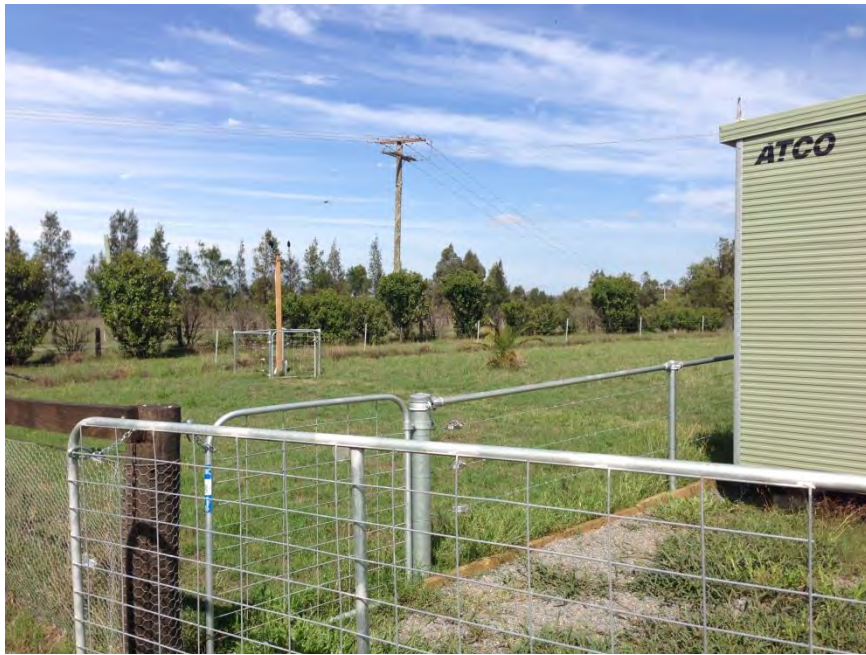
Figure 12: Long Point Directional Noise Monitor - established Q4 2013

Three additional directional, real-time noise monitors were installed during 2013 to augment MTW's existing sophisticated network of noise monitors in surrounding community areas. MTW now has four (4) directional monitors in place in the Bulga Village area and a new directional noise monitor in the Long Point area. The location of these monitors can be seen in Figure 12 and 13.

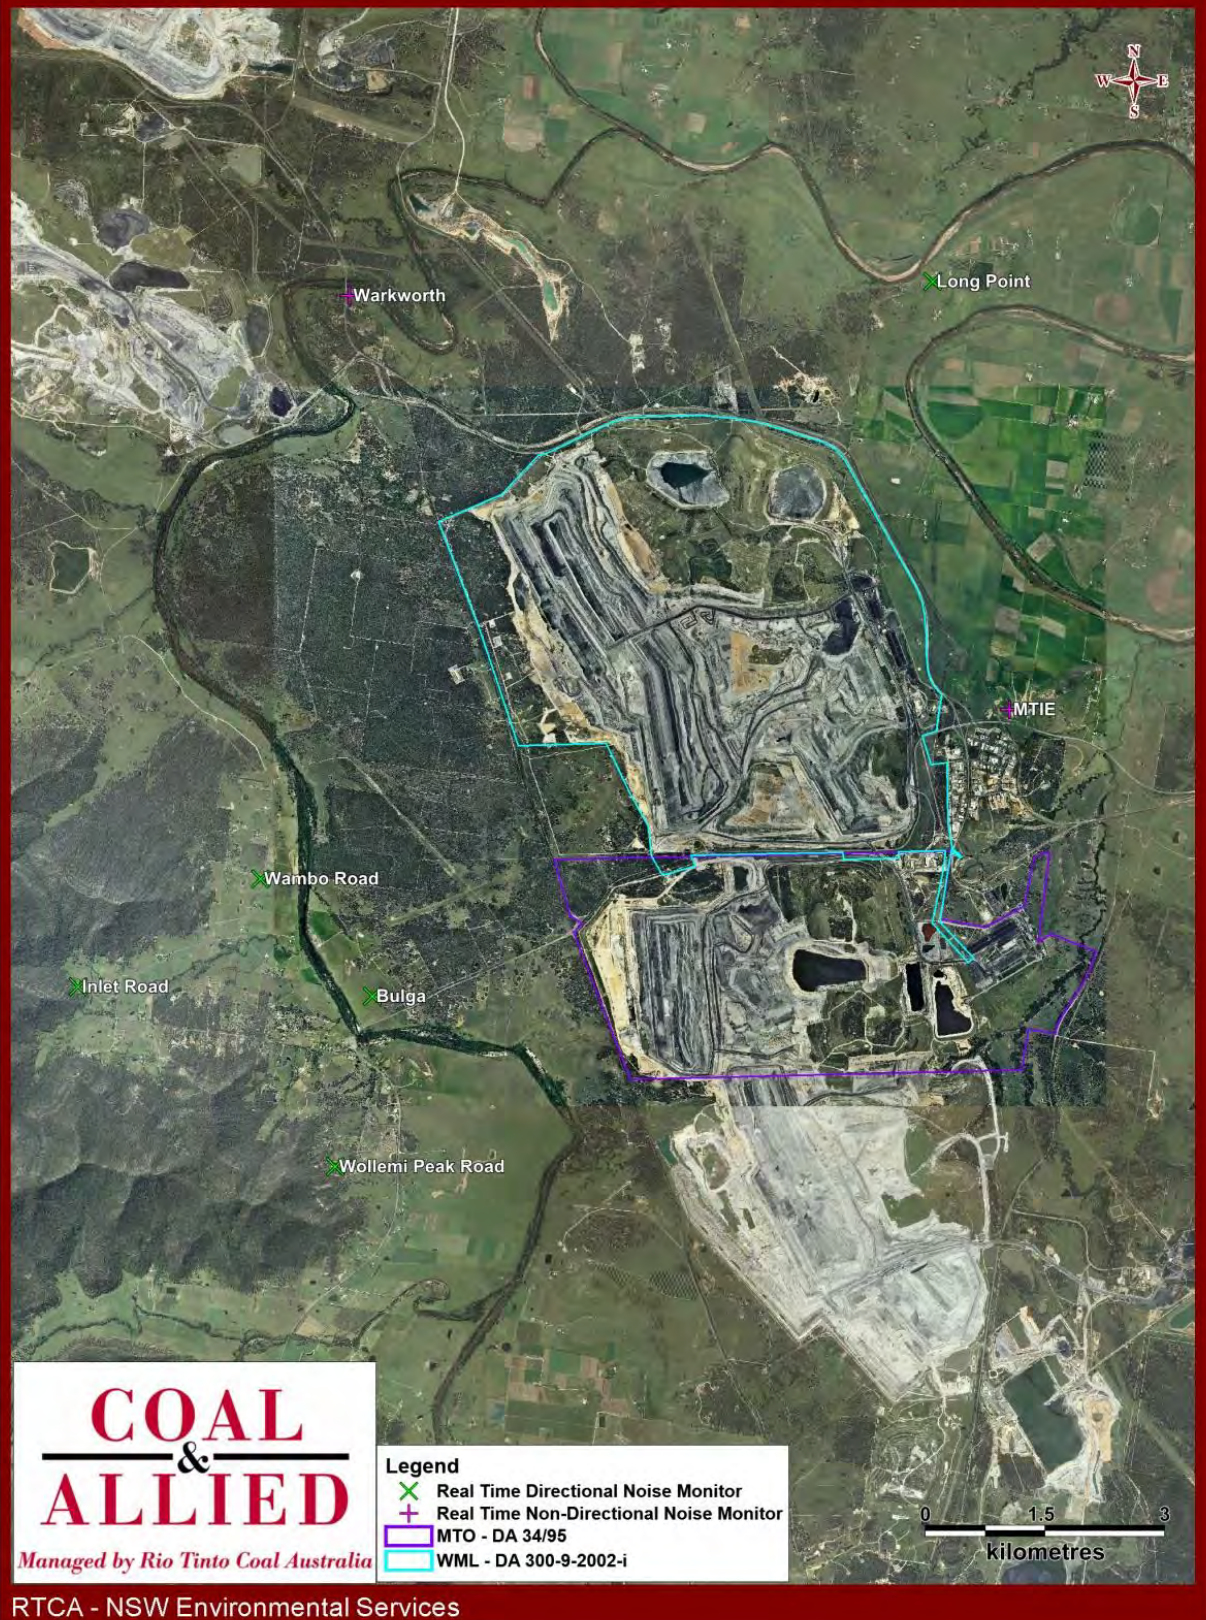
Figure 13: Real Time Directional Noise Monitoring Network

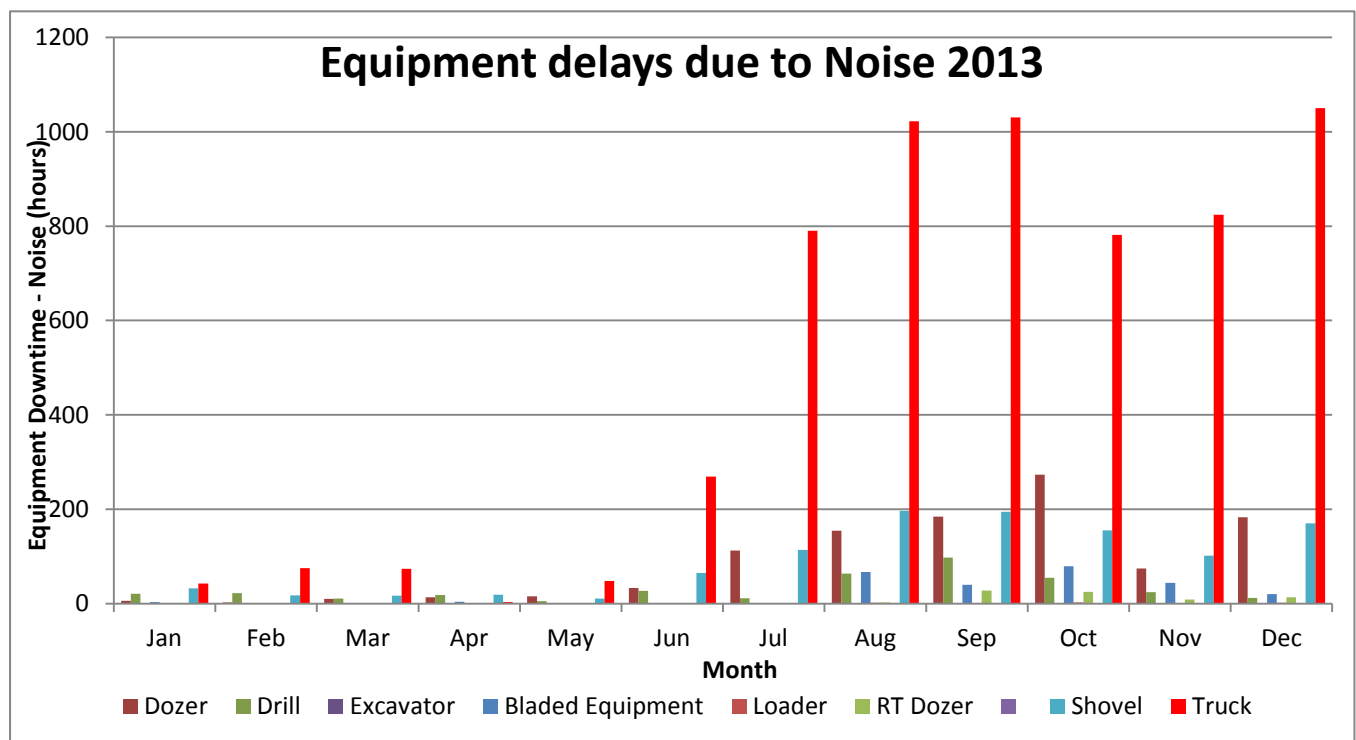
Figure 15: Equipment Delays due to Noise 2013

Figure 15 shows the breakdown of noise delays per month by equipment type.

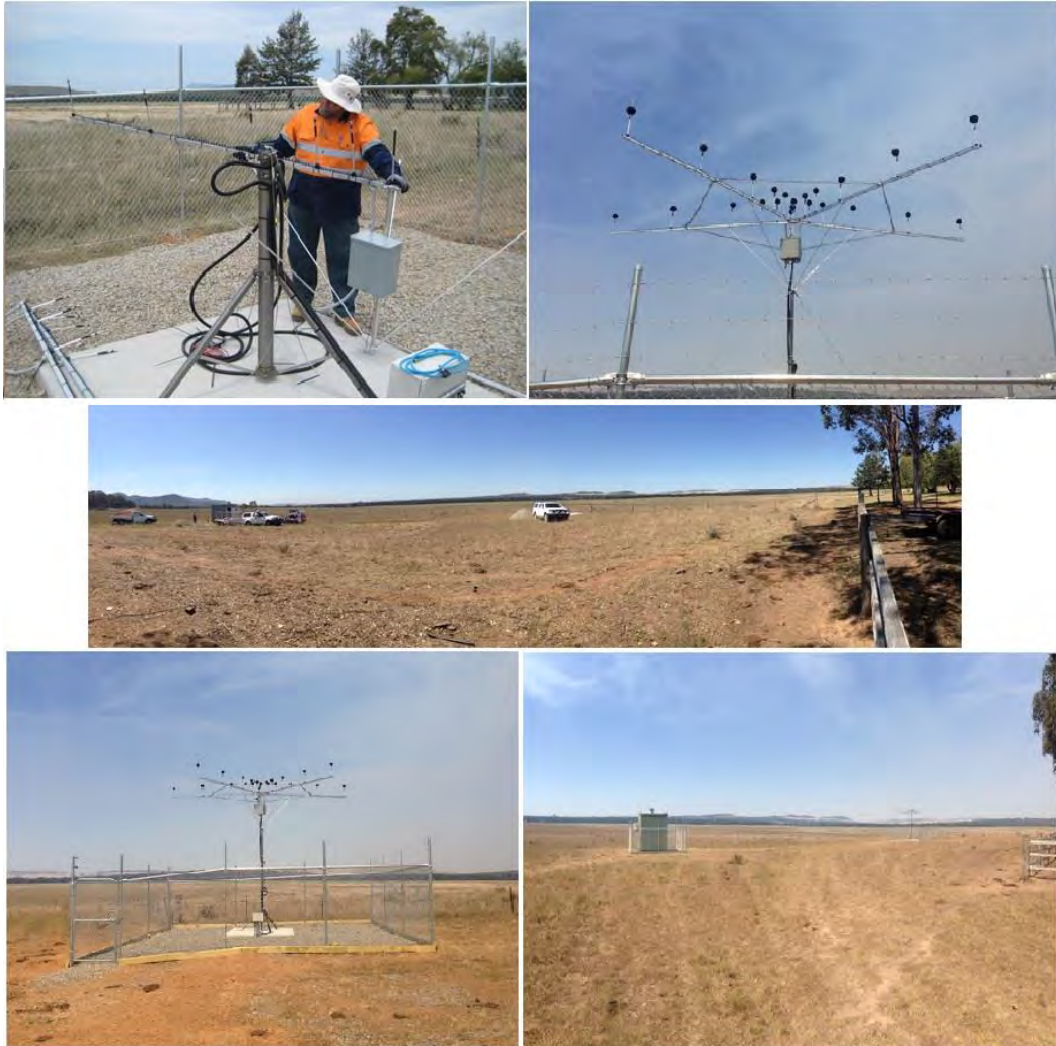
Figure 16: Environmental Noise Compass installation occurring during December 2013.

2013. Developed by ARL, the ENC utilises a 26 microphone array and conventional beamforming techniques (borrowed from military / submarine applications) to resolve the source direction of measured noise in real time. The system will undergo further commissioning and testing during 2014 ahead of integration into the existing real time noise management system at MTW.

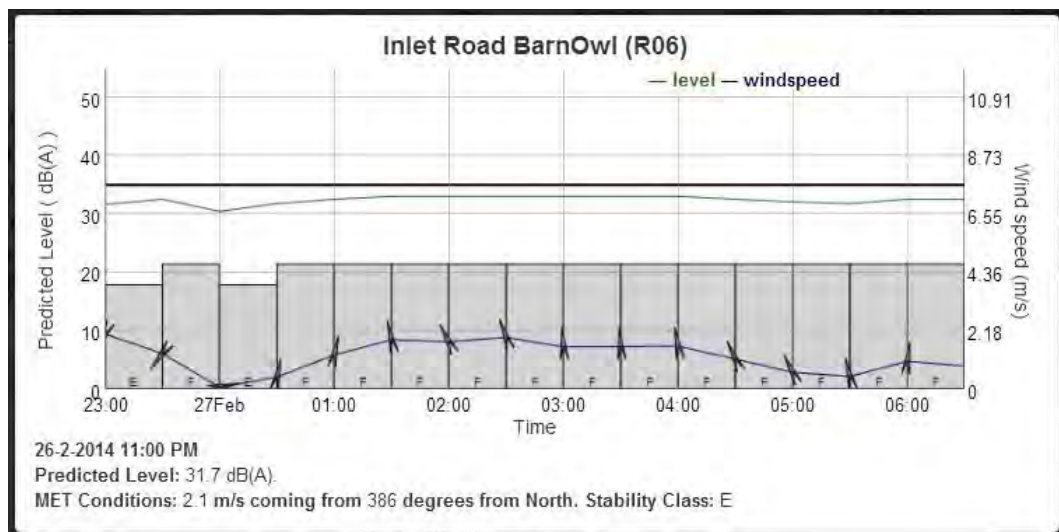
Figure 18: an example of noise predictions from the PMI

The initial testing of the tool has proved challenging. The level of agreement between predicted noise levels and measured levels to date has been poor. This is expected to improve as development and validation continues, however the tool will not be considered fit for full integration into the site noise management system until a greater level of confidence in the predicted outputs is achieved. MTW will continue to validate the tool, and report on development in future Annual Reviews.

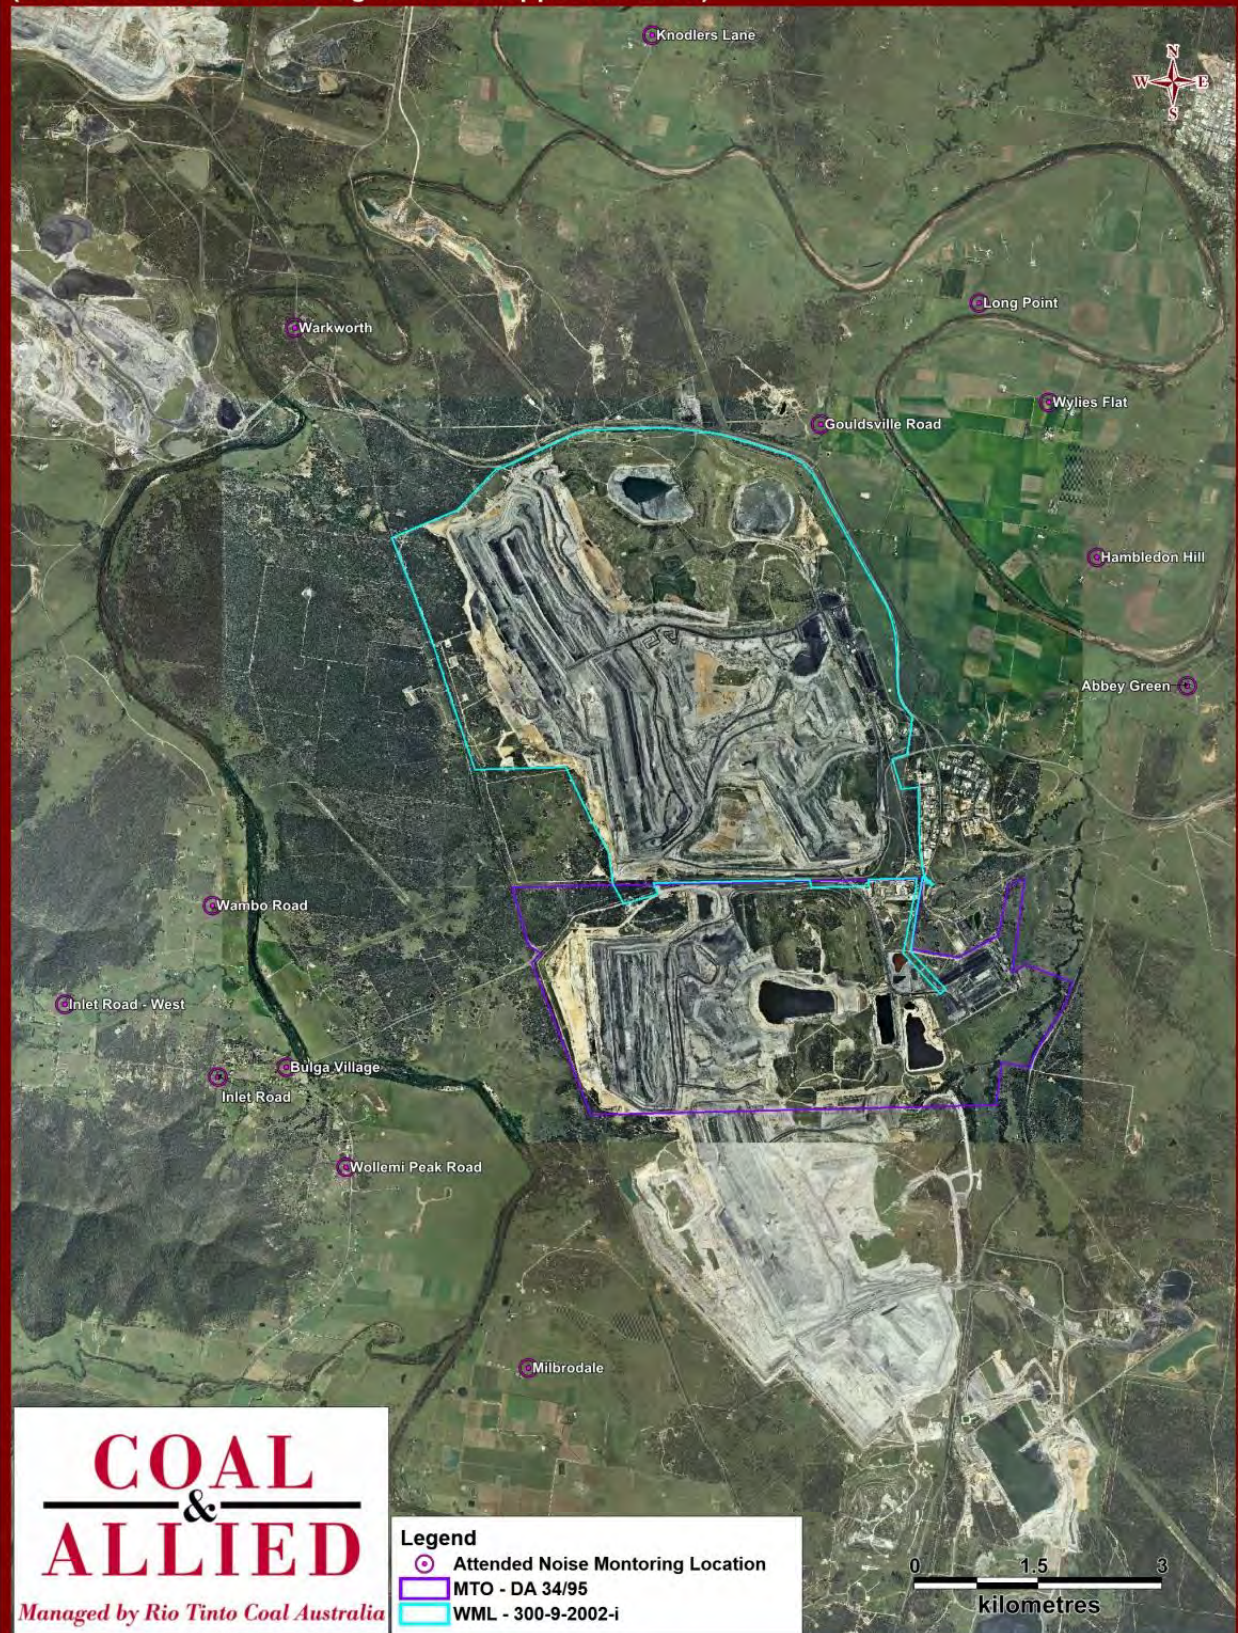
Figure 19: Attended Noise Monitoring Locations, Quarter 1

During Quarter 1 2013 attended monitoring was undertaken from a selection of thirteen locations (based on prevailing meteorological conditions) selected to represent groups of receivers surrounding MTW (shown in Figure 19). There were nine attended noise monitoring locations routinely surveyed at least once per month from July to December 2013, see figure 20.

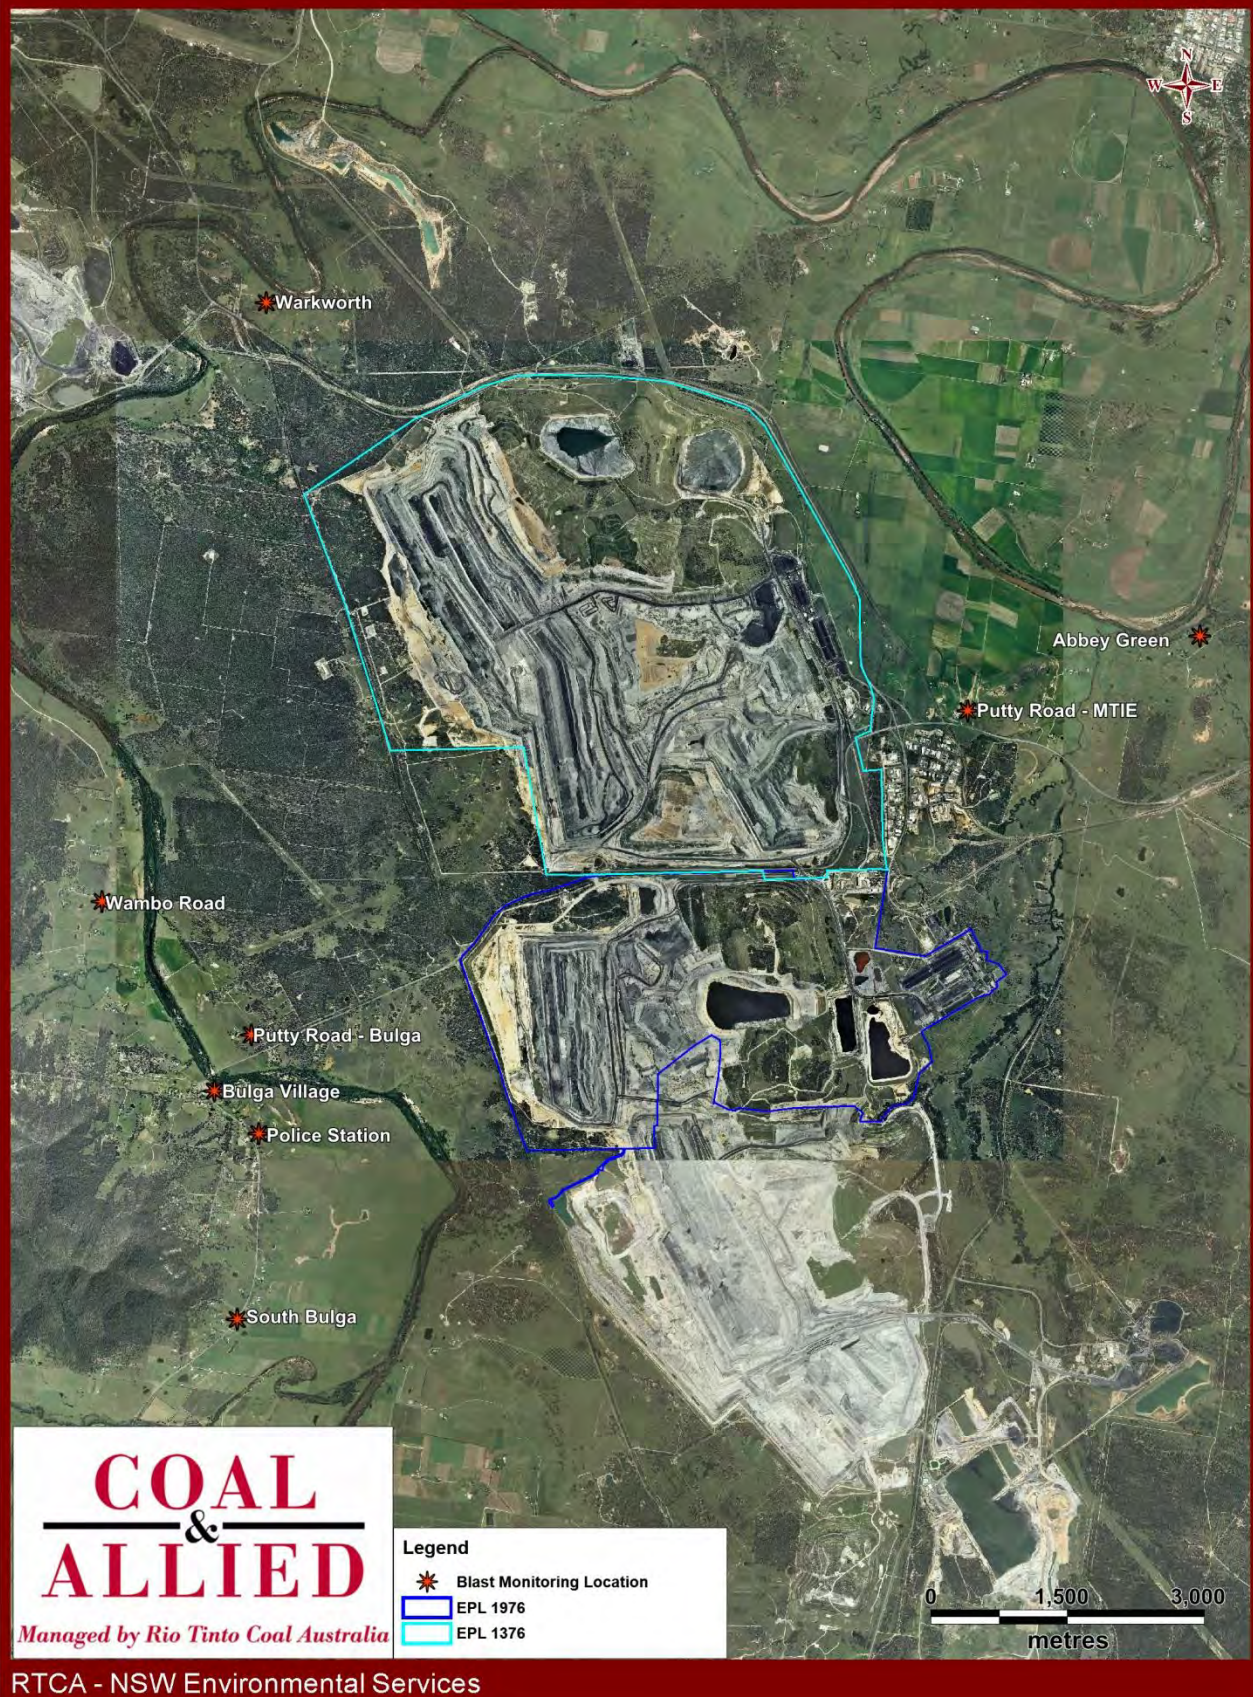
Figure 21: Blast Monitoring Locations

During 2013, MTW operated a network of eight Ecotech Dynamate DV6 R4 blast monitors. These monitors are generally located at nearby privately owned residences and function as regulatory compliance monitors. These monitors are located at the following locations (refer Figure 21):

- Abbey Green (Abbey Green Station, Putty Road, Glennridding);
- Bulga Village (Wambo Road, Bulga);
- Police Station (Putty Road, Bulga);
- Putty Road, Bulga (Putty Road, Bulga);
- Putty Road, Mount Thorley,
- South Bulga (Putty Road, Bulga);
- Wambo Road, Bulga (Wambo Road, Bulga); and
- Warkworth Village (former Warkworth Public School, Warkworth).

The Putty Road Bulga Monitor was relocated in October 2013 due to changes in property ownership. The monitor was relocated approximately 500m to the south-west, to the (now) nearest privately owned residence.

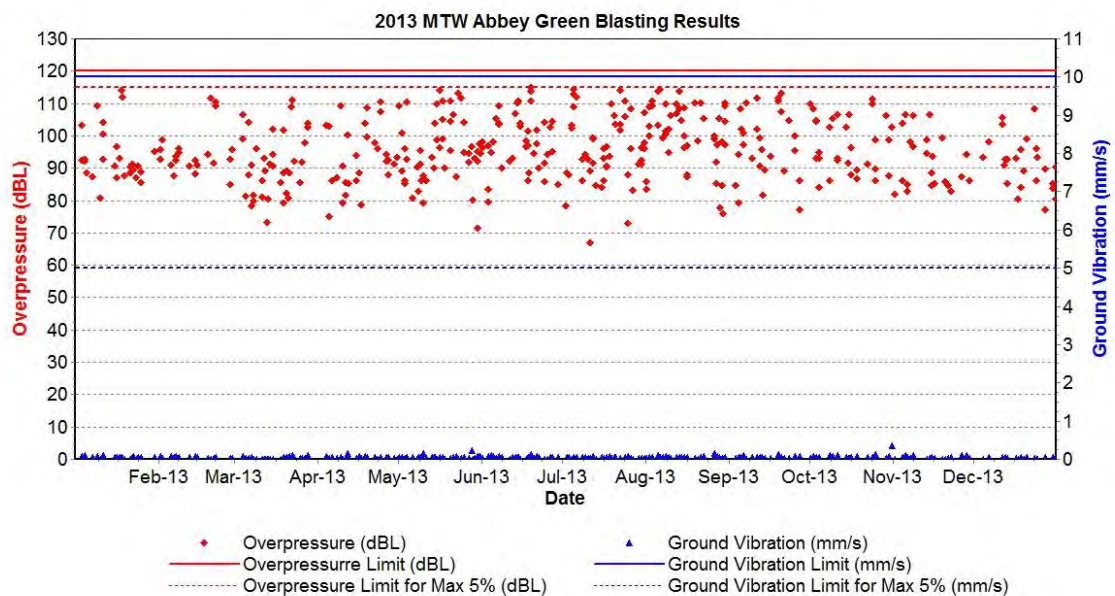
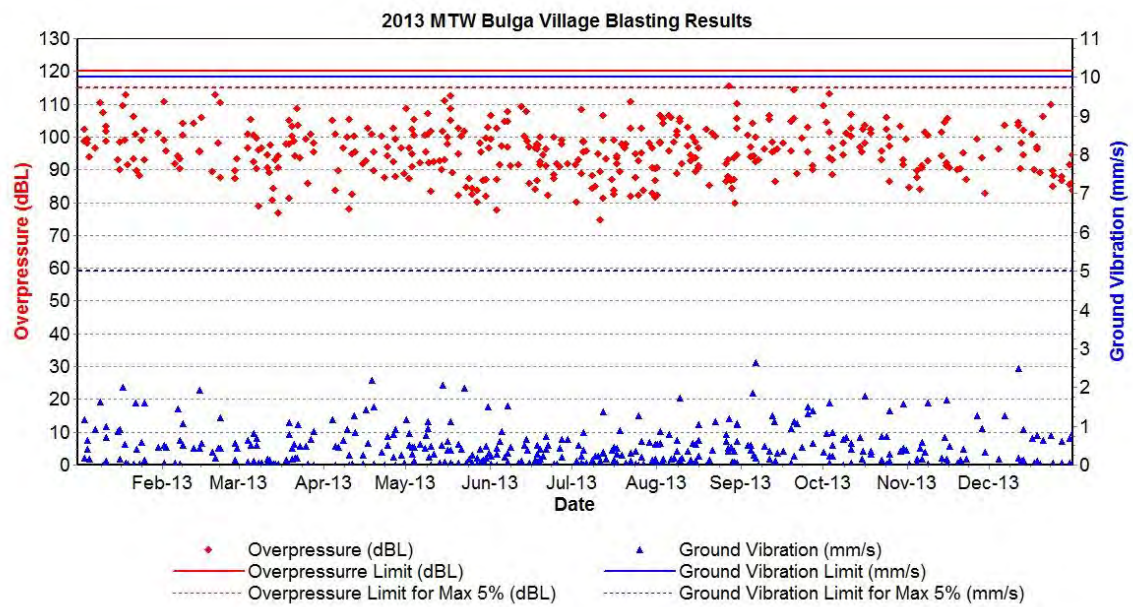
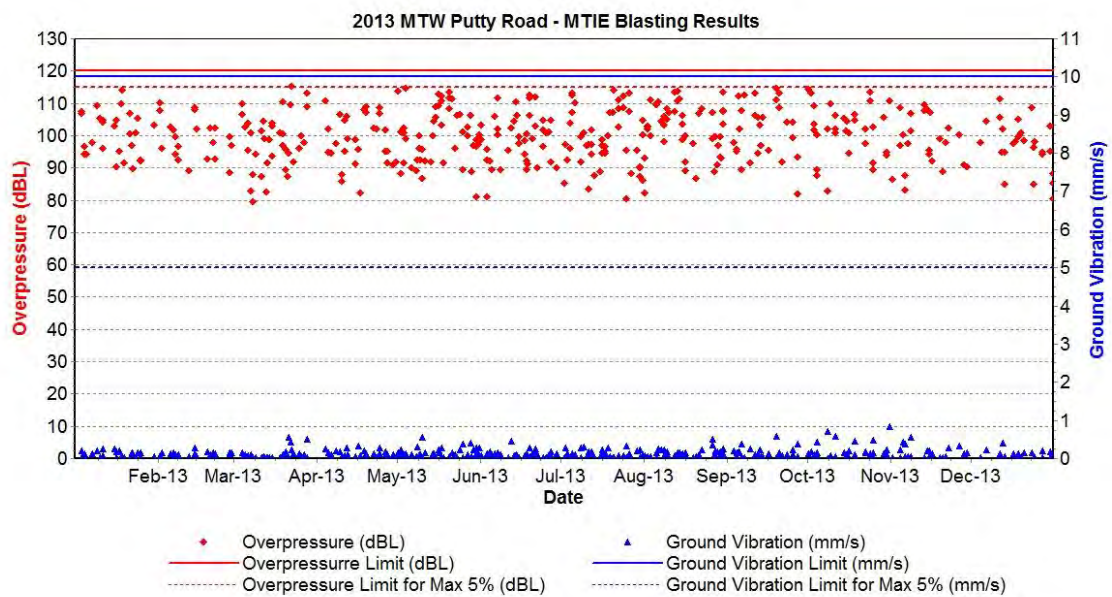
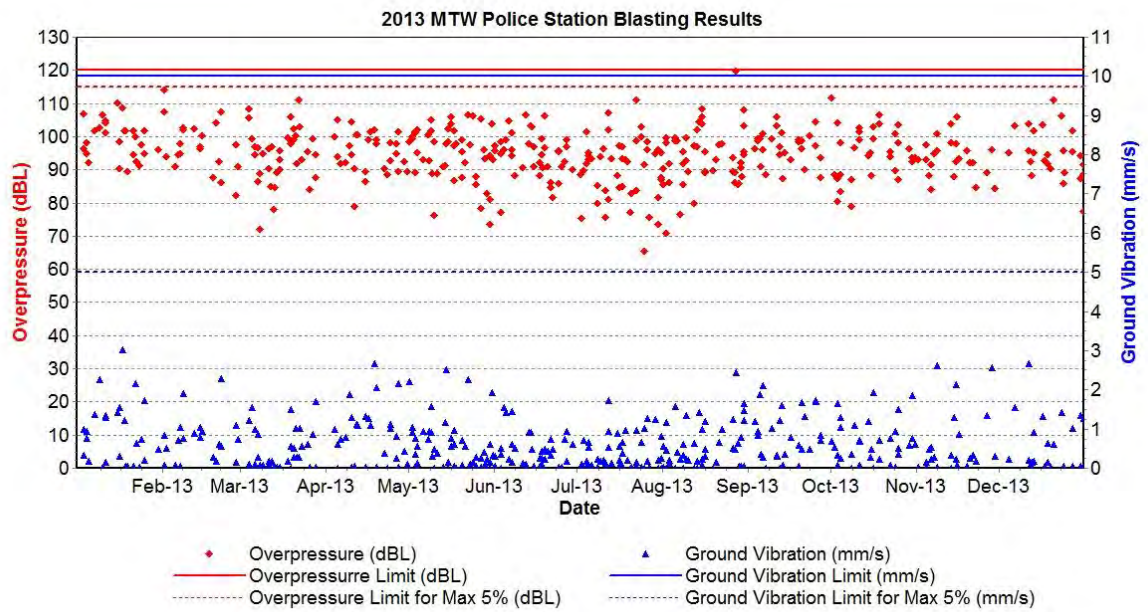
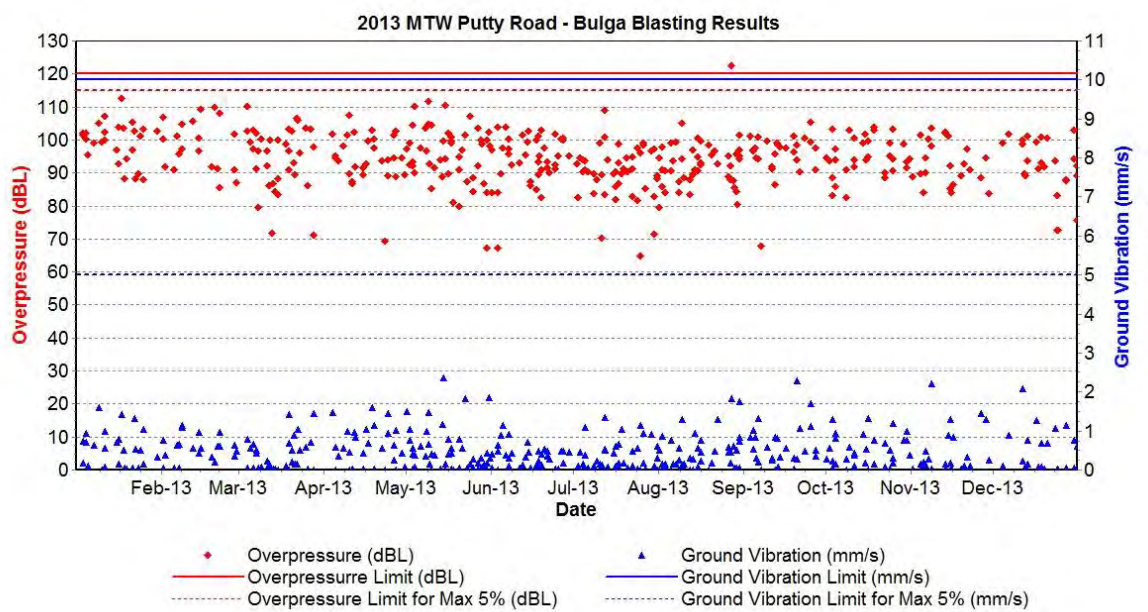
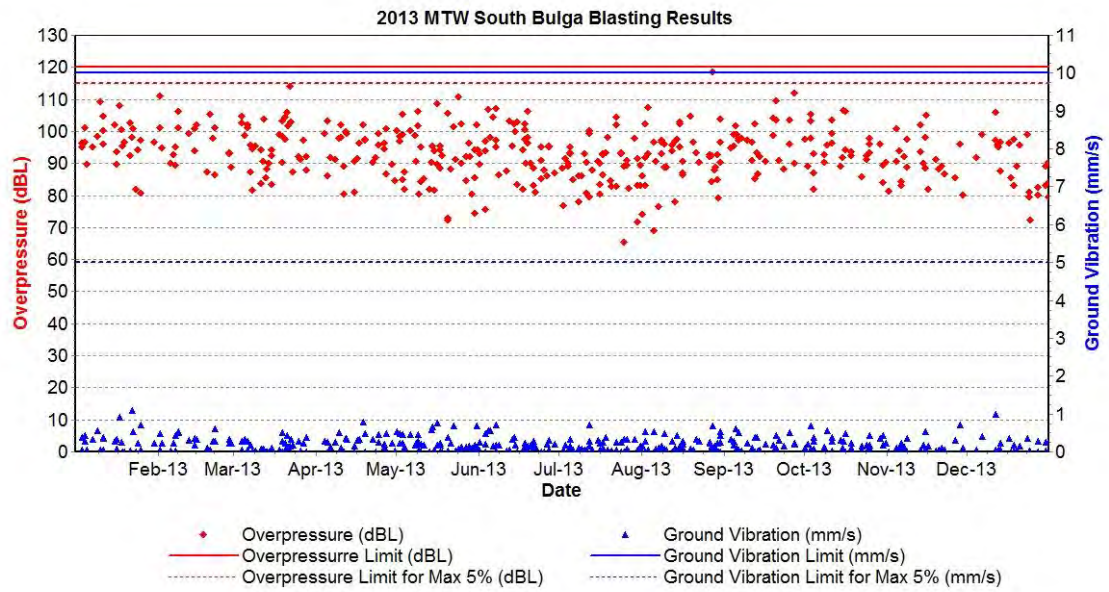
Figure 22: Blasting Results – Abbey Green

Figure 23: Blasting Results – Bulga Village

Figure 24: Blasting Results – Mount Thorley Industrial Estate

Figure 25: Blasting Results – Police Station

Figure 26: Blasting Results – Putty Road Bulga

Figure 27: Blasting Results – South Bulga

During the reporting period, 410 blasts were initiated at MTW. Results of ground vibration and air overpressure recorded during 2013 are presented in the following figures.

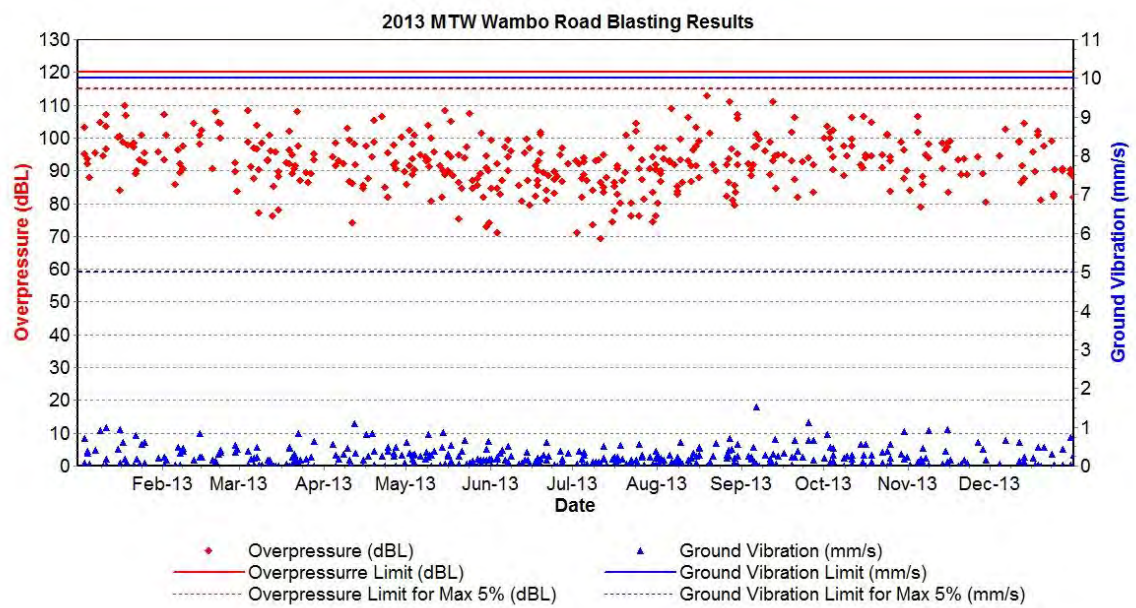
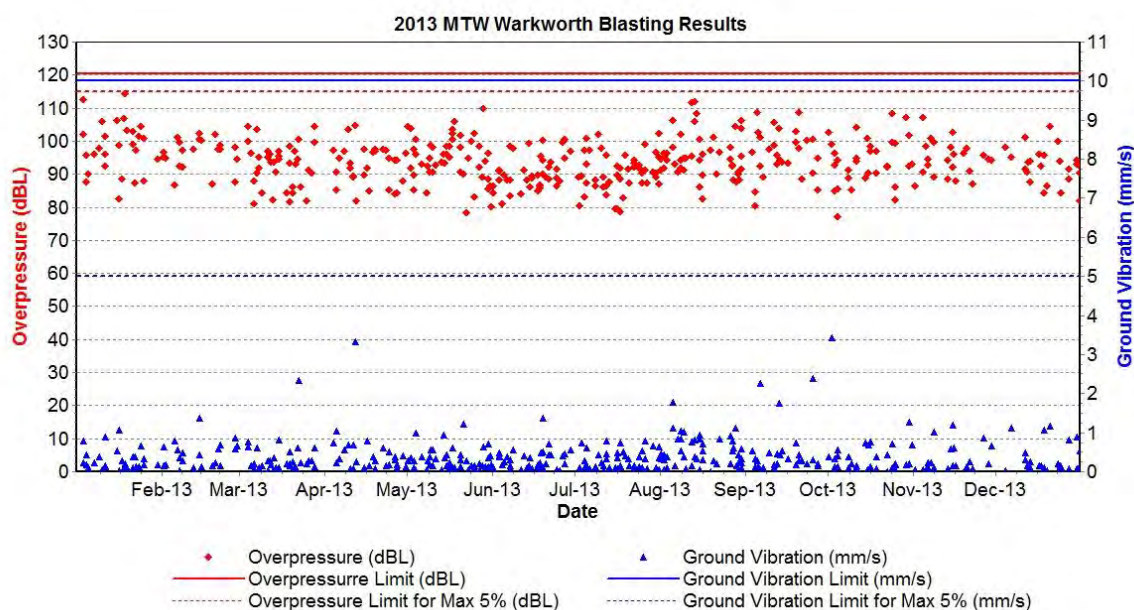
Figure 28: Blasting Results – Wambo Road

Figure 29: Blasting Results – Warkworth
