Mount Thorley Warkworth

2013 Annual Environmental Review

March 2014

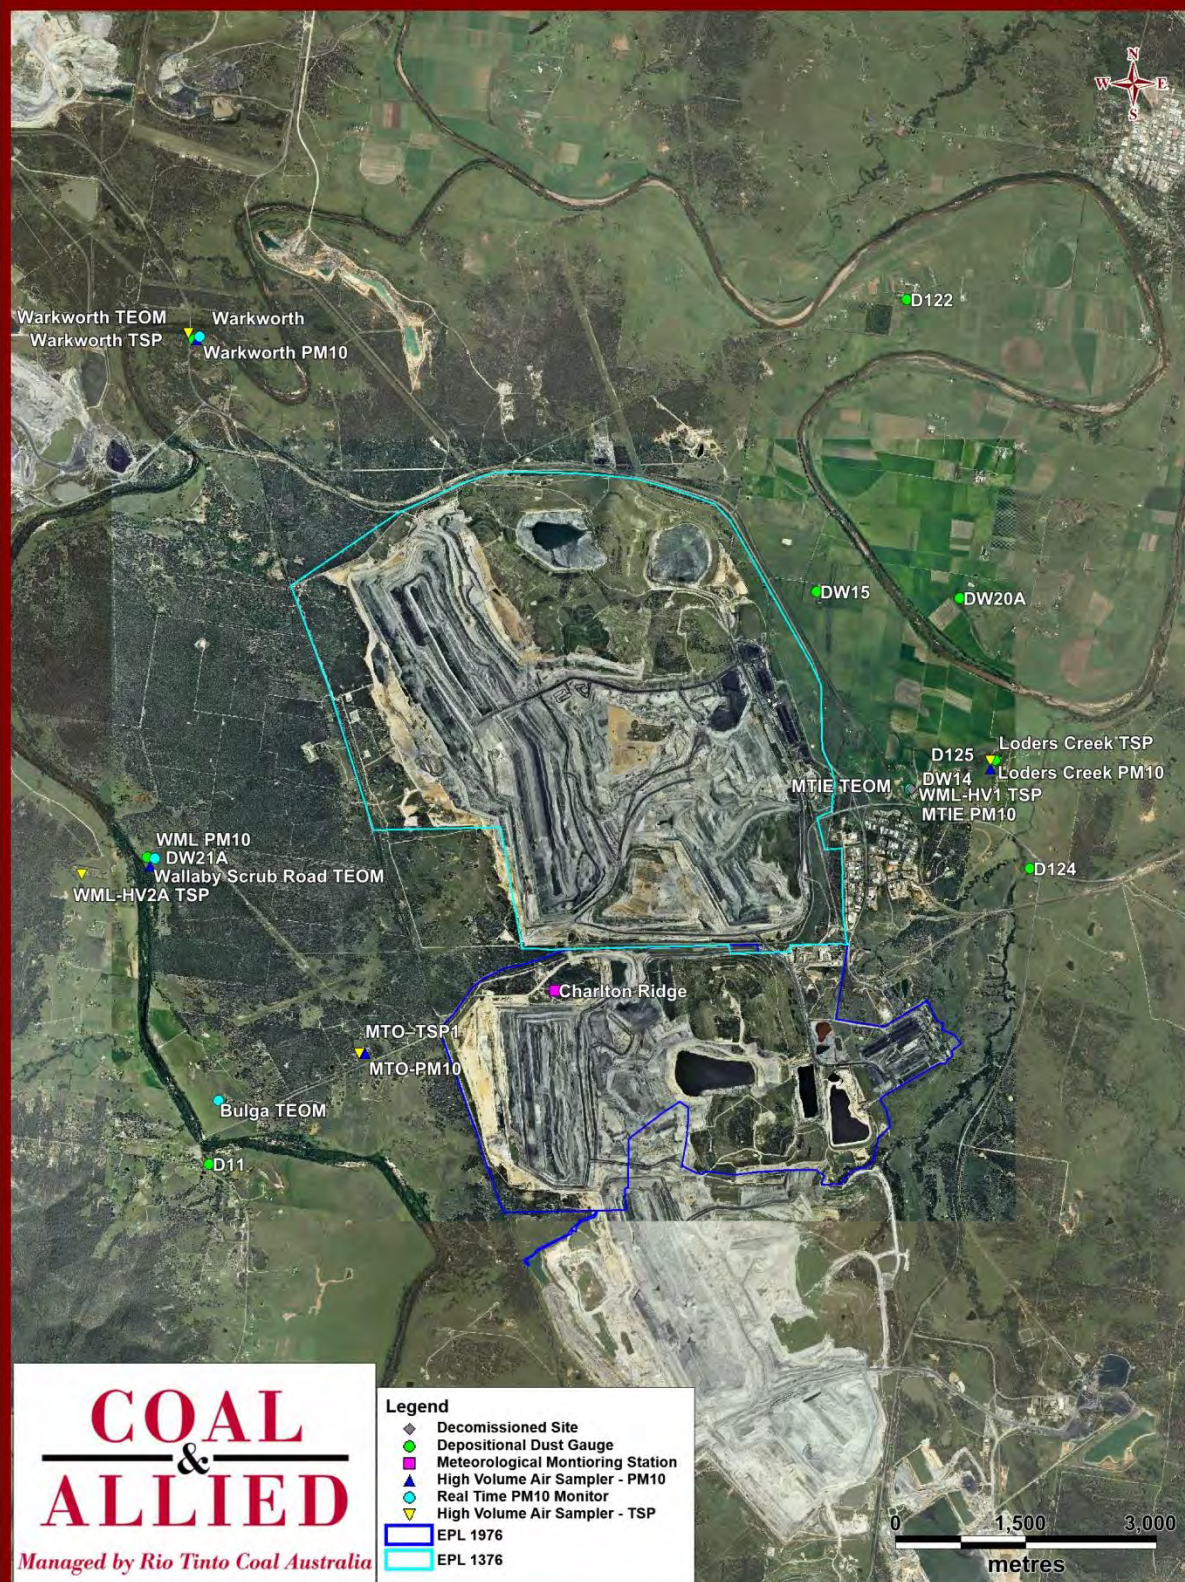
Figure 30: Air and Meteorological Monitoring Locations MTW 2013

Air quality monitoring at MTW is undertaken in accordance with the MTW Air Quality Monitoring Programme (http://www.riotintocoalaustralia.com.au/ouoperations/5090_management_plans.asp), and is comprised of an extensive **network of monitoring equipment** which is utilised to assess MTW's air quality performance against the relevant conditions of the approvals. Air quality monitoring locations are shown in Figure 30.

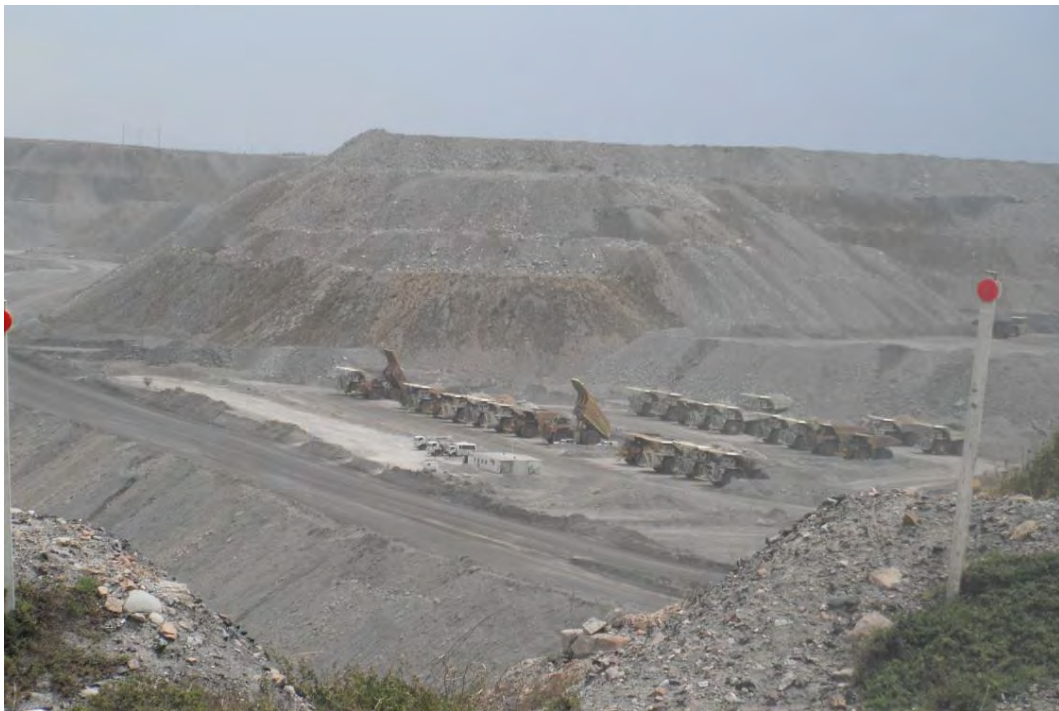
In response to alarms from the real time monitoring system and from in pit inspections by supervisors and operators, various equipment and tasks are often shut down to effectively manage particulate emissions. Delays and stoppages for dust are recorded in the mine monitoring system, allowing for accurate tracking **of the mines' response to adverse weather conditions**. Figure 31 shows trucks pulled up for dust in October 2013.

Figure 31: Trucks on stand-down during dust event of 29 October 2013

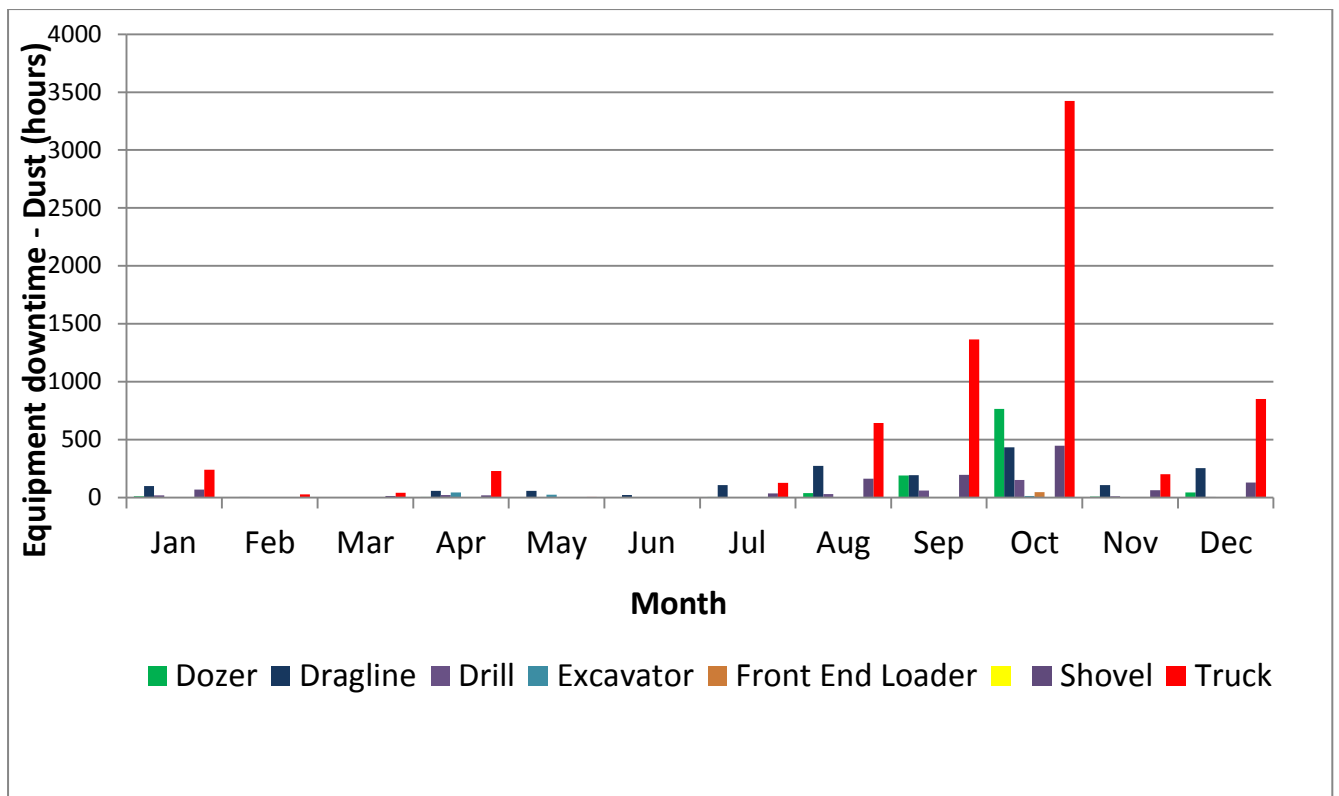
Figure 32: Equipment downtime for dust management by month, 2013

During 2013, a total of 11,744 equipment operating hours were recorded as lost due to dust management, see figure 32. 75% of the stoppages were recorded during the spring months, associated with elevated winds and warmer conditions. Haul truck stoppages accounted for approximately 60% of the downtime due to dust, followed by Dragline stoppages (13%). Excavators, Shovels and Front End Load units combined account for approximately 10% of stoppages due to dust or elevated wind conditions. The recorded delays attributed to dust in 2013 significantly increased from 2012 records (4,606 hours of equipment delays).

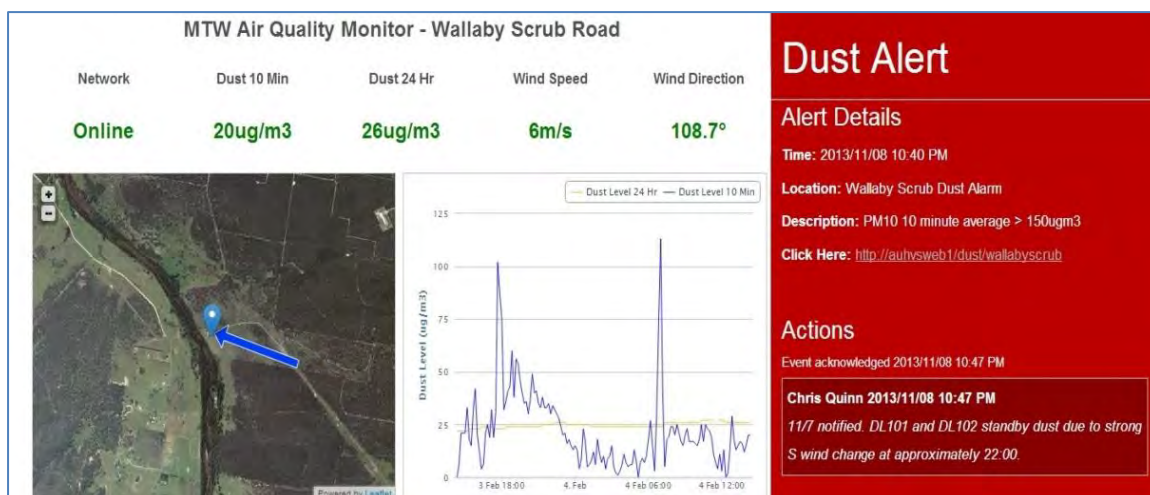
Figure 33: example of MTW's real time air quality monitoring tools

During 2013, MTW personnel responded to 812 alarms relating to air quality generated by the real time monitoring network.

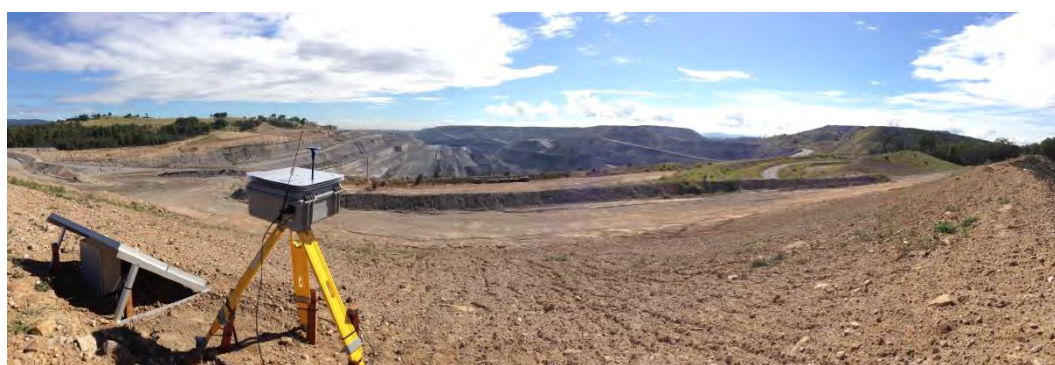
As committed in the Mount Thorley Warkworth Air Quality and Greenhouse Gas Management Plan, MTW purchased and installed a network of supplementary real time monitors to augment the existing network of real time instruments surrounding the mine. Designed to be operated as near-field monitors and an 'early warning' of periods when offsite dust generation is likely, the DustTrak II 8530 units have been deployed in key dust risk areas just outside the active mining area and adjacent to public roads (Putty Road and Golden Highway). Figure 34 shows the Putty Road DustTrak unit. During 2014 MTW will refine the triggers assigned to the units following assessment of the initial 12 months data and comparison against far-field TEOM and regional PM₁₀ monitors.

Figure 34: DustTrak II8530 unit deployed at WML, adjacent to the Putty Road

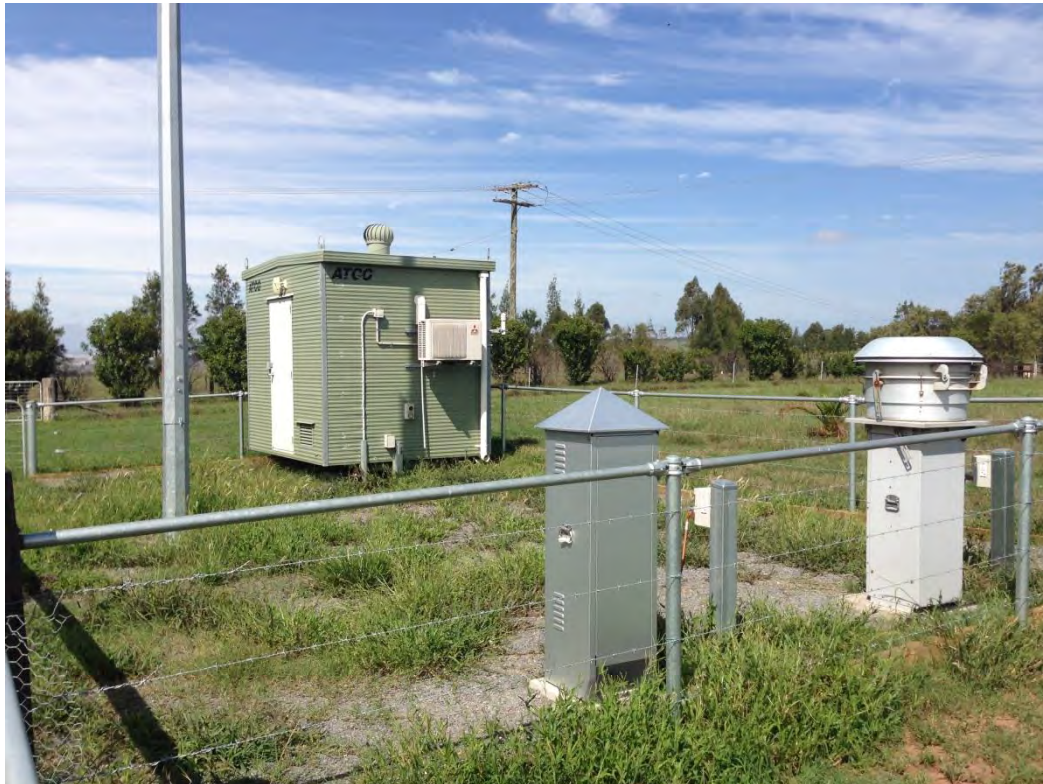
During 2013 a new monitoring location was established and commissioned in the Long Point area to collect air quality and noise monitoring data representative of privately owned receptors in Long Point. The Long Point monitoring compound is shown in Figure 35. Air Quality monitoring data from the newly installed Total Suspended Particulate (TSP) and PM₁₀ High Volume Air Samplers (HVAS) will continue to be collected through 2014 and will be reported in the 2014 Annual Review.

Figure 35: Long Point Environmental Monitoring compound

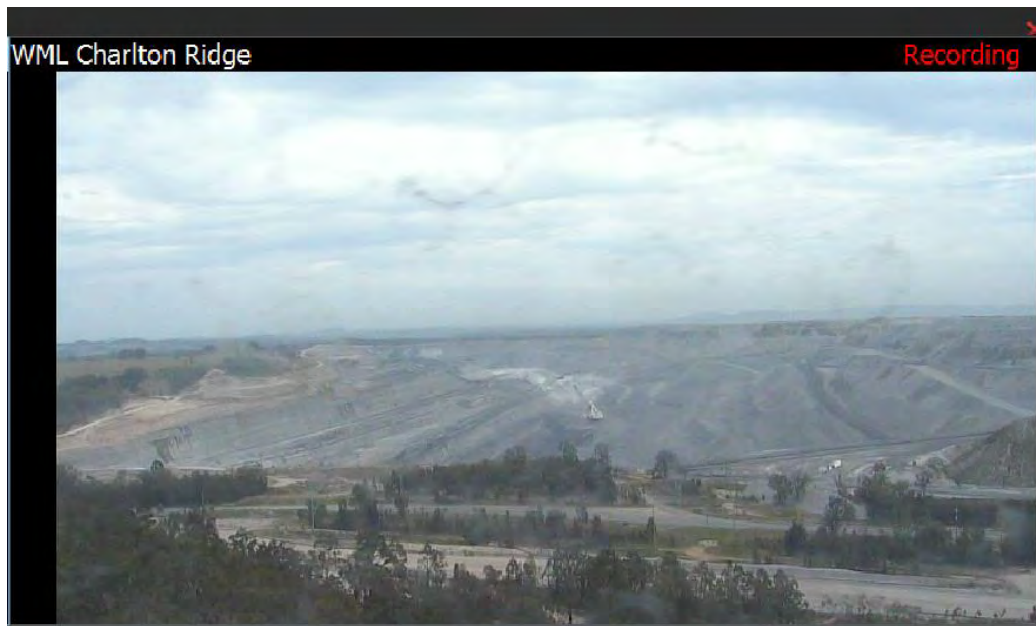
MTW commenced utilisation of two dust cameras during 2013, installed on Charlton Ridge, and atop the WML Maintenance Workshop, see figure 36.. Able to be rotated 360°, the cameras provide an additional vantage and operational inspection tool for Mining and Environmental personnel, assisting in decision making when additional controls such as ceasing or modifying tasks are required.

Figure 36: Vantage from MTW Dust camera (taken 10:46am, 23 December 2013)

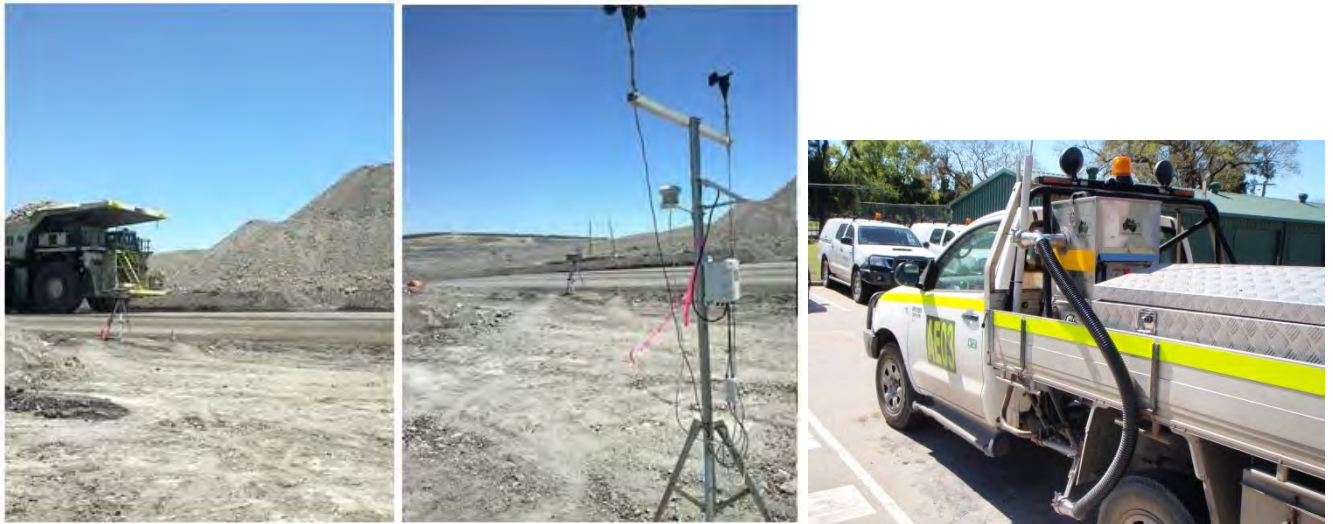
Figure 38: Wheel generated dust monitoring (fixed and mobile monitors)

During the reporting period, MTW commenced measurement and assessment against the requirements of the EPA Particulate Matter Control Best Practice Implementation programme (Dust Pollution Reduction Programme) for wheel generated dust. The program requires MTW to monitor and report on the effectiveness (%) of its' haul road dust control regime against a licenced target of 80%. This is done by way of comparing the dust control efficiency of two sections of road (one controlled and the other uncontrolled). Results of the monitoring programme will be reported to the EPA in August 2014. Figure 38 shows the two types of monitors (fixed and mobile) used in this programme.

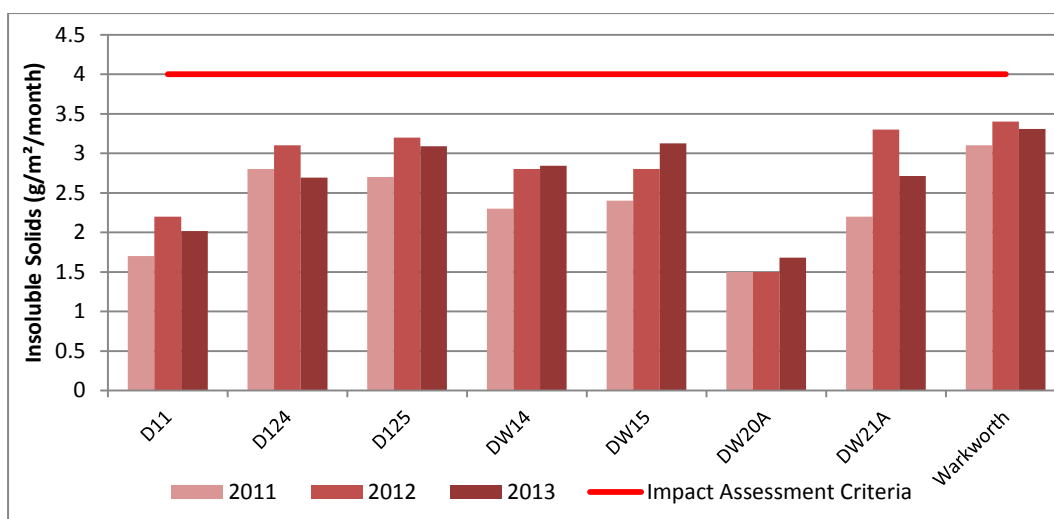
Figure 39:1 2013 Depositional Dust results compared against the impact assessment criteria and previous years' results

During 2013 monthly dust deposition rates equal to or greater than the long term impact assessment criteria of 4g/m².month were recorded at number of sites. Where field observations denote a sample as contaminated (typically with insects, bird droppings or vegetation), the results are excluded from Annual Average compliance assessment. Meteorological conditions and the results of nearby monitors for the sampling period are also considered when determining **MTW's level of contribution to any elevated result.**

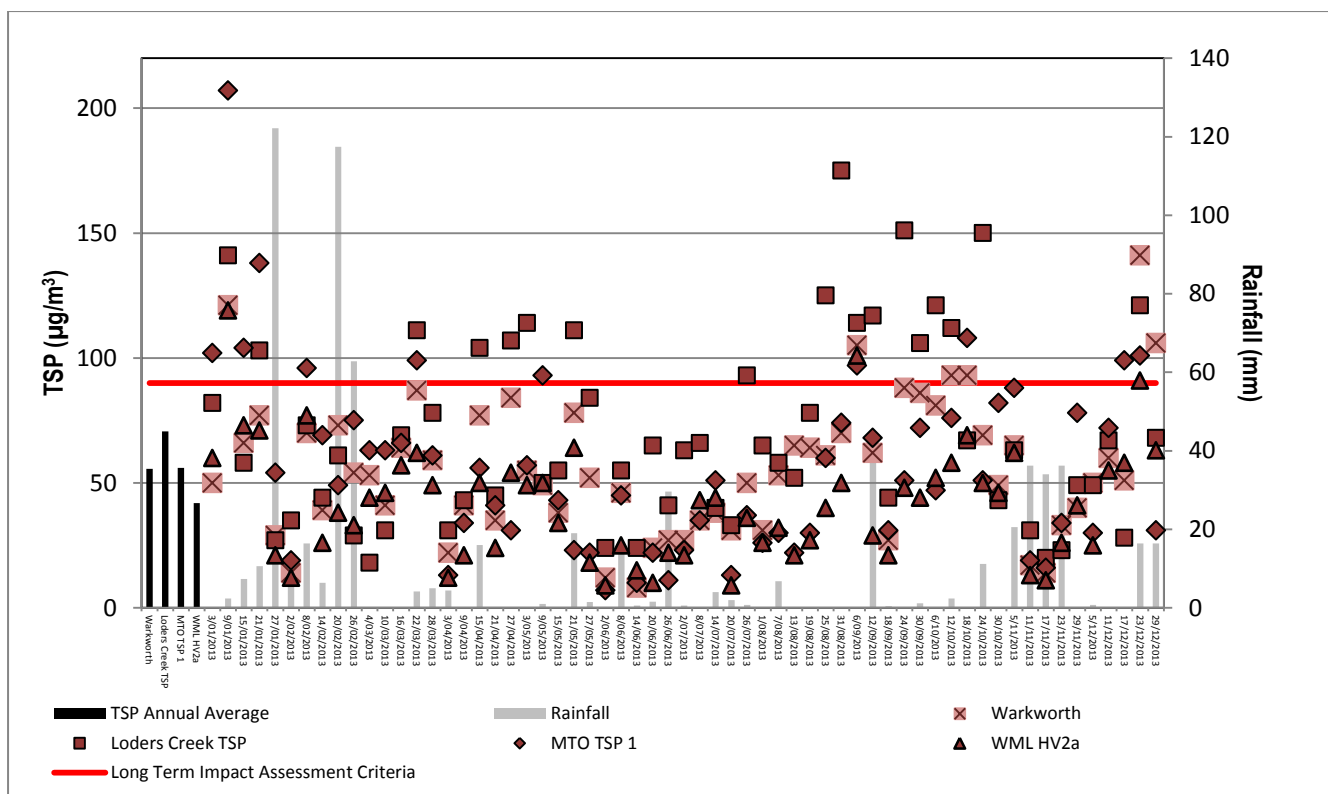
Figure 42: 2013 TSP monitoring results vs rainfall

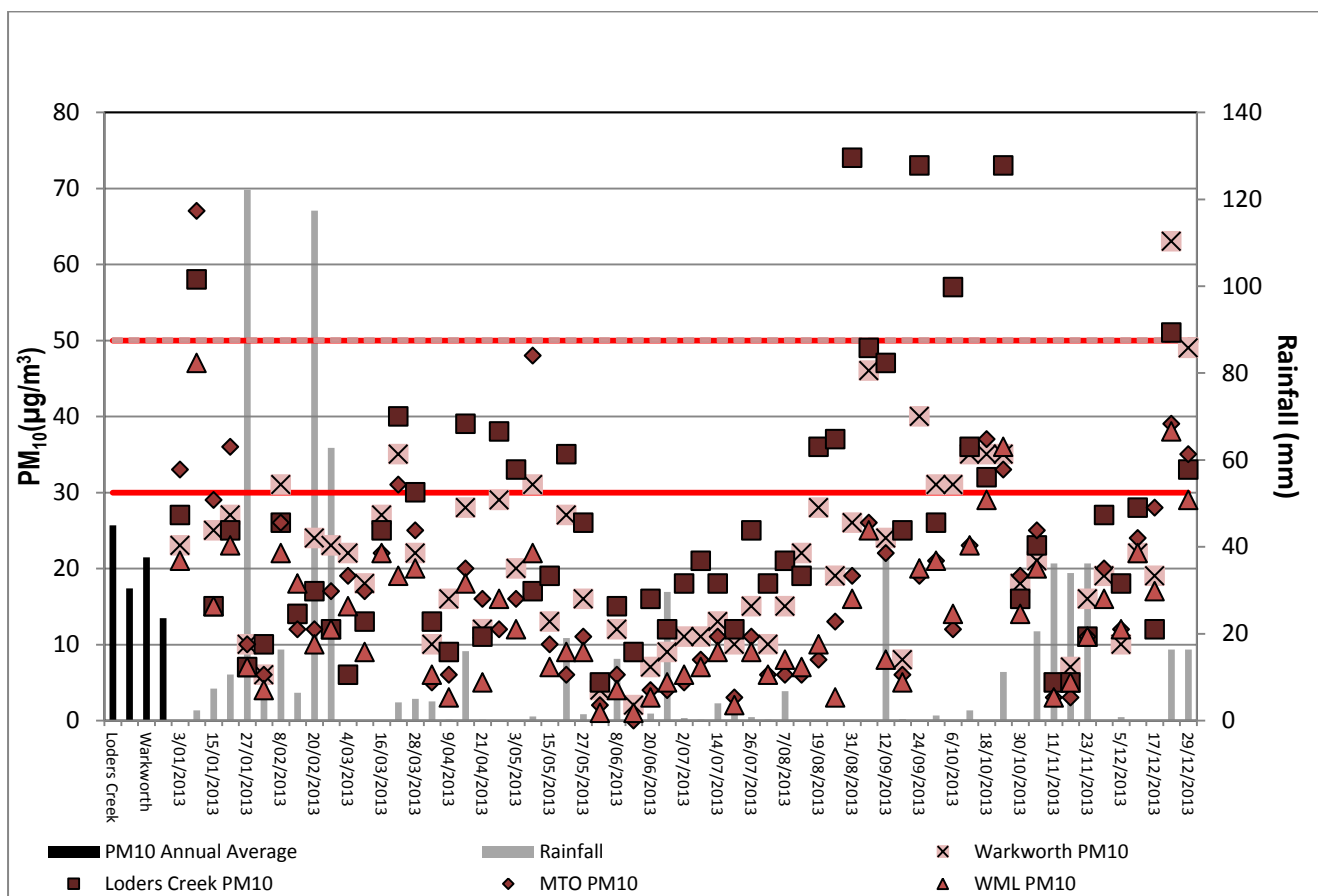
Figure 43: PM10 24hr monitoring results vs. rainfall

Monitoring results for 2013 PM_{10} (24 hour) compared against the short term impact assessment criteria and rainfall are shown in Figure 43.

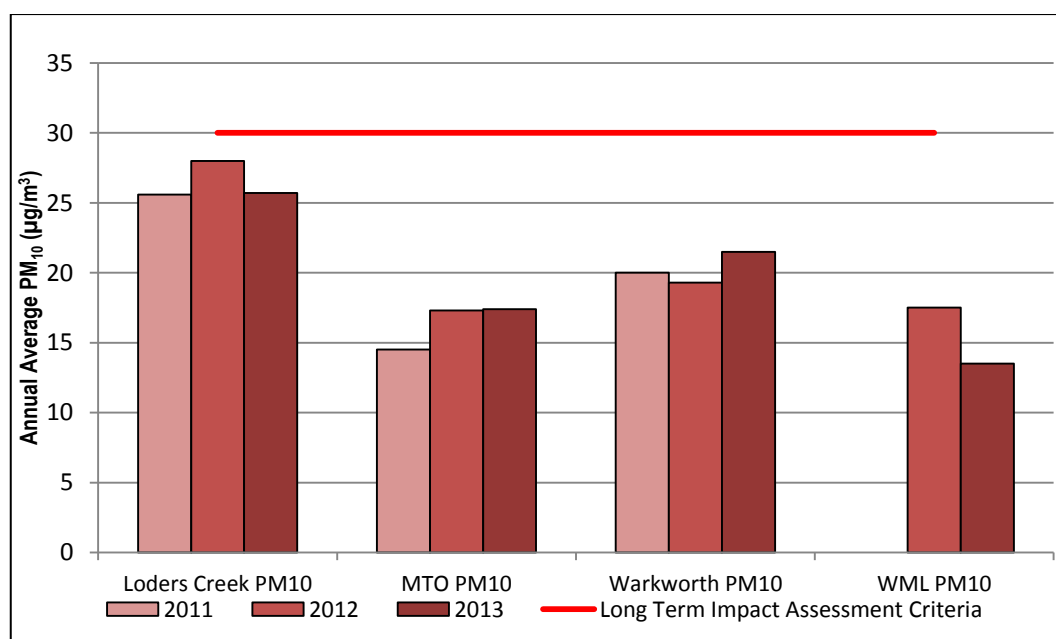
Figure 44: Annual average HVAS PM_{10} results 2011 to 2013

Annual average PM_{10} concentrations recorded at the four monitoring locations in 2013, compared with the long term PM_{10} impact assessment criterion and previous years' data, are shown on Figure 44. During 2013 all annual average PM_{10} concentrations recorded on privately owned land were compliant with the assessment criterion. The annual average PM_{10} concentrations recorded in 2013 are generally consistent with those recorded during previous years, though a slight increase ($2.2\mu\text{g}/\text{m}^3$) was recorded at the Warkworth monitoring location. As with TSP, the primary difference in monitoring results between 2012 and 2013 was seen during February, where the monthly average PM_{10} increased from $13.0\mu\text{g}/\text{m}^3$ in 2012 to $20.0\mu\text{g}/\text{m}^3$ in 2013. Analysis of rainfall data during this period identifies more rain during 2013 (173.2mm compared to 134.0mm in 2012), however the timing of the PM_{10} monitoring events compared to the timing of rainfall events explains the variation. During 2012, $>1.0\text{mm}$ of rain fell on the designated sampling day during 3 of the 5 monitoring events, while a fourth monitoring event occurred on the day following another significant fall. Analysis of the 2013 rainfall data however identifies that three of the five PM_{10} monitoring events in February occurred on days of zero rainfall, and followed prolonged periods (>3 days) without rain.

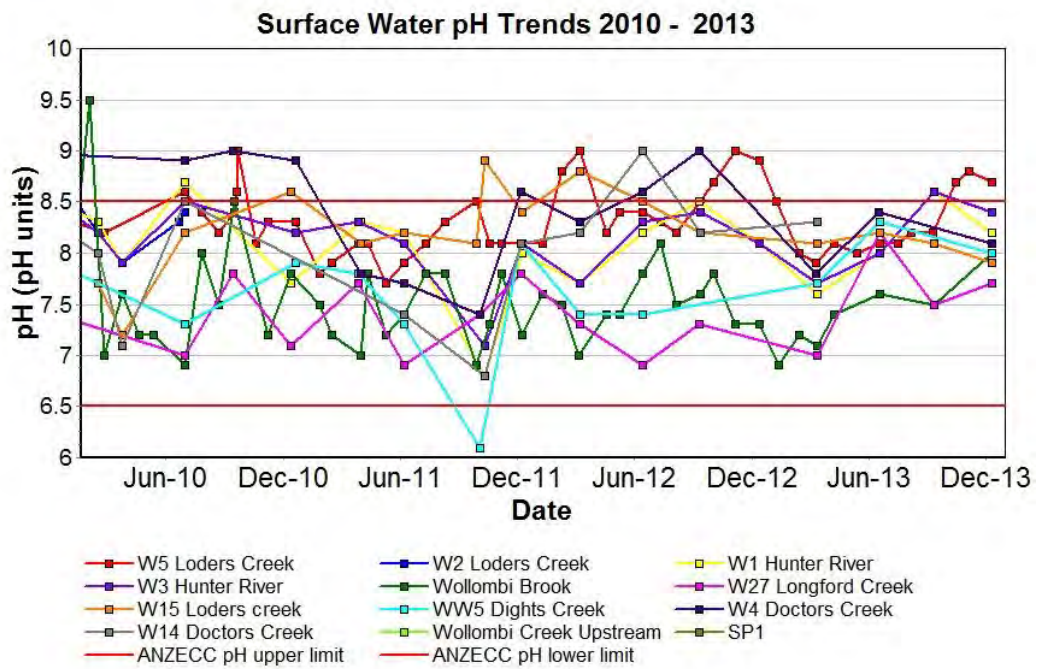
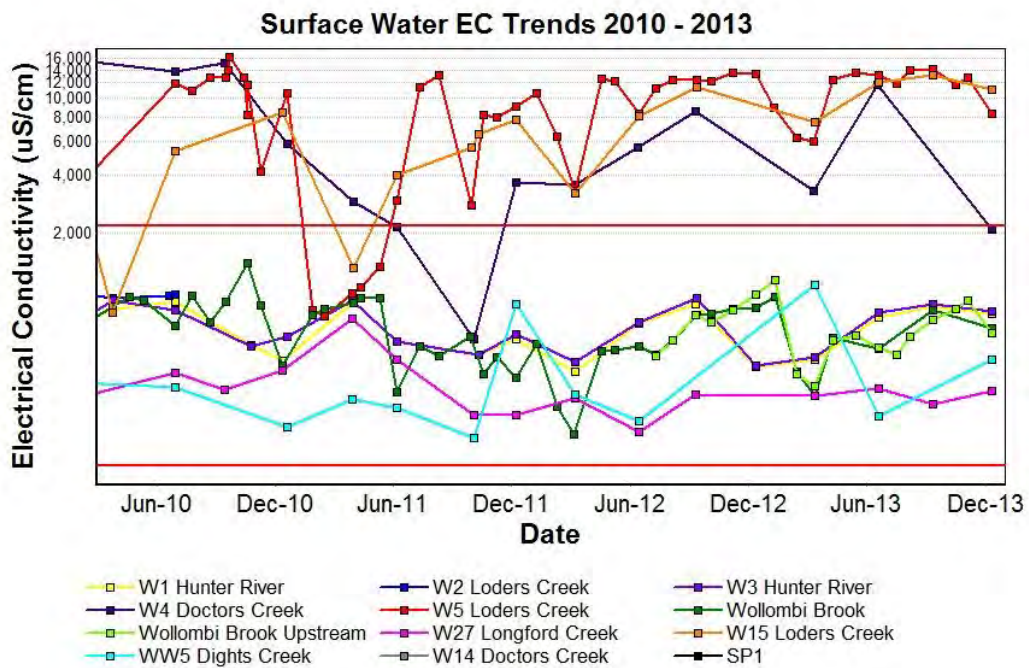
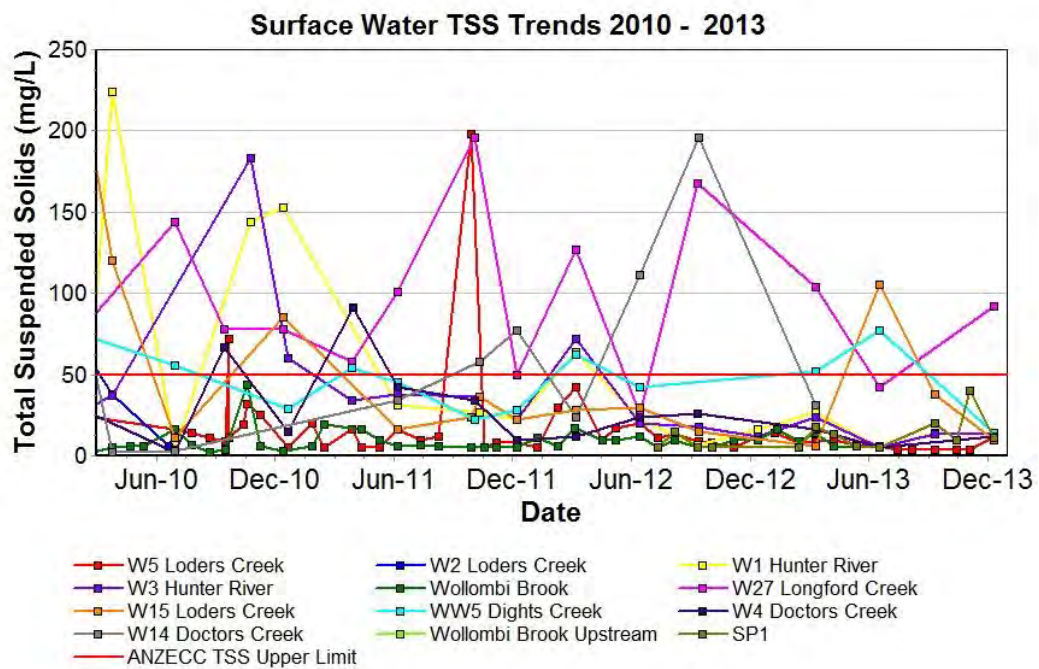
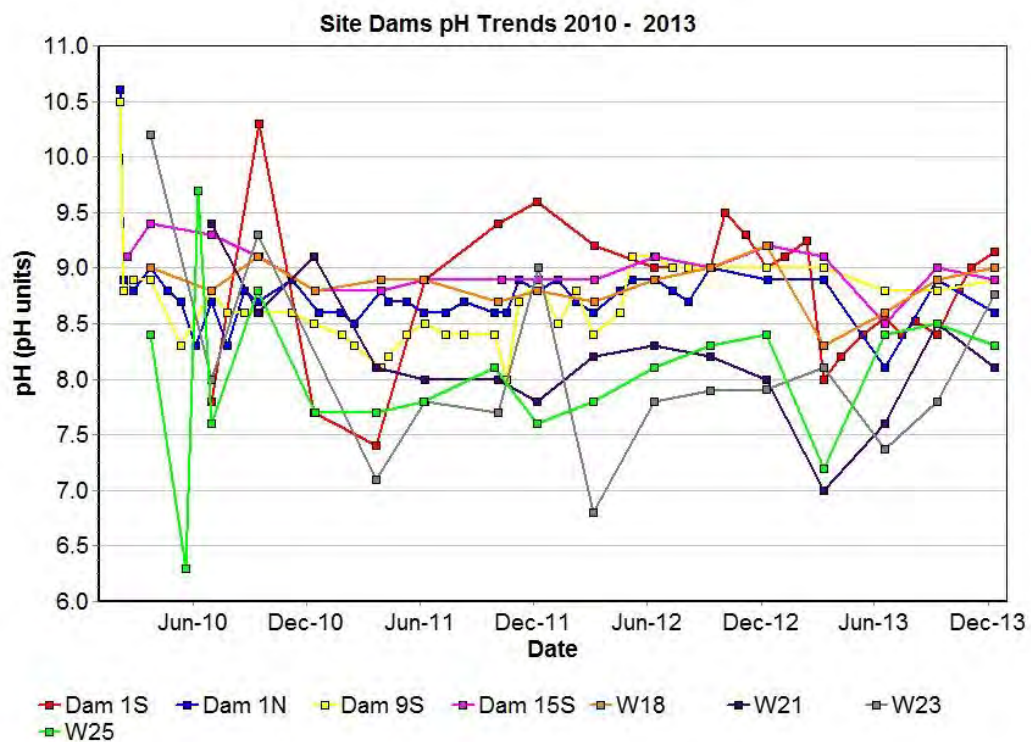
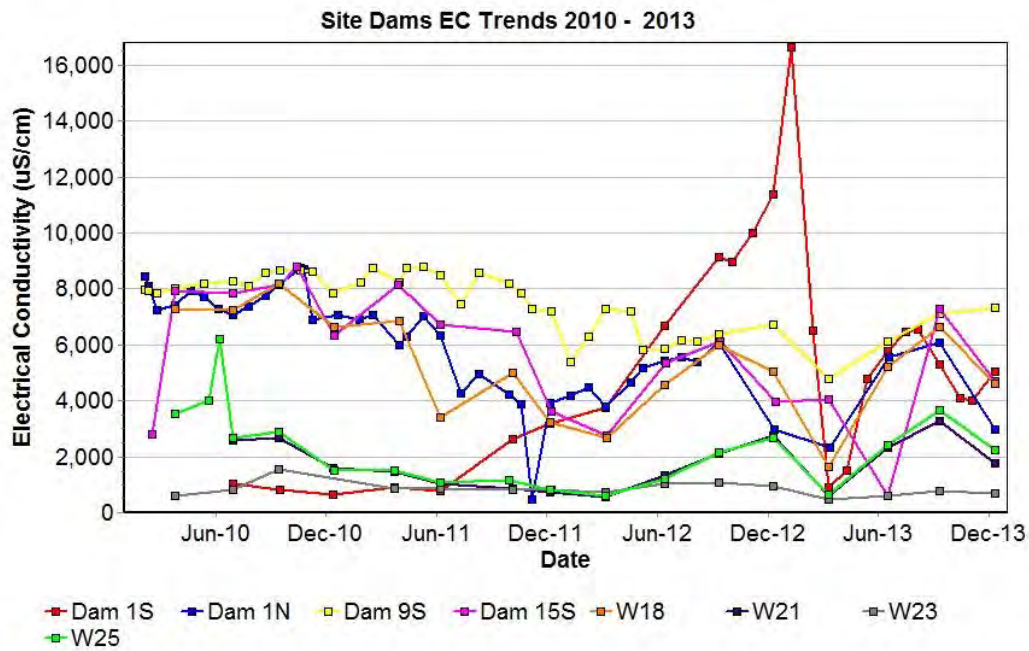
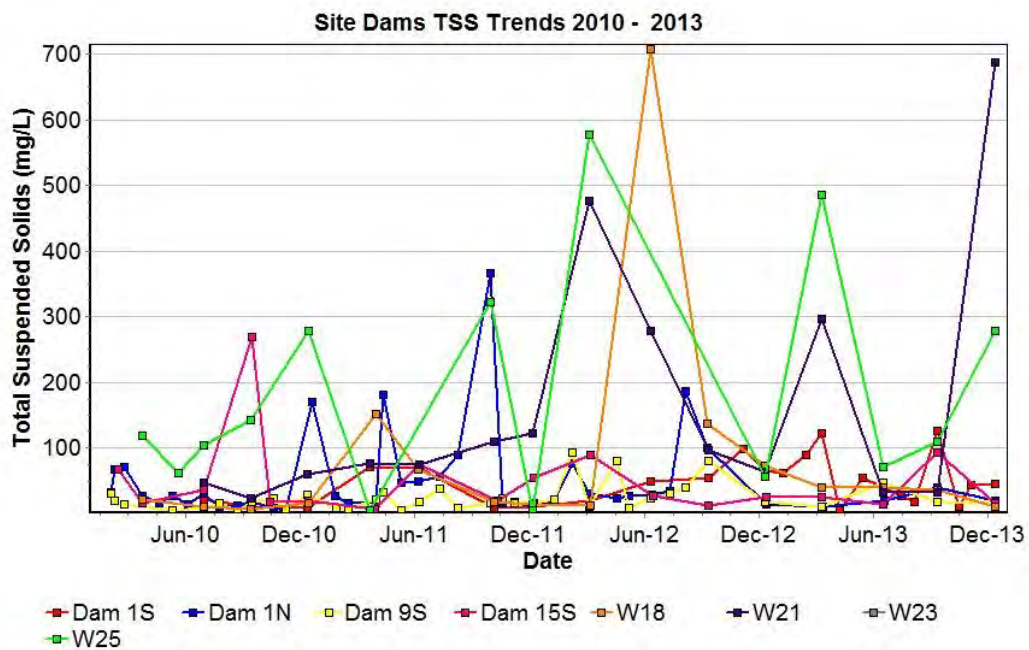
Figure 48: Watercourse pH Trends 2010 to 2013

Figure 49: Watercourse EC Trends 2010 to 2013

Figure 50: Watercourse TSS trends 2010 to 2013

Figure 51: Site Dams pH trends 2010 to 2013

Figure 52: Site Dams EC trends 2010 to 2013

Figure 53: Site Dams TSS trends 2010 to 2013

Figures 48 to 53, show long term water quality trends for the Hunter River, Wollombi Brook, other surrounding tributaries and site dams.

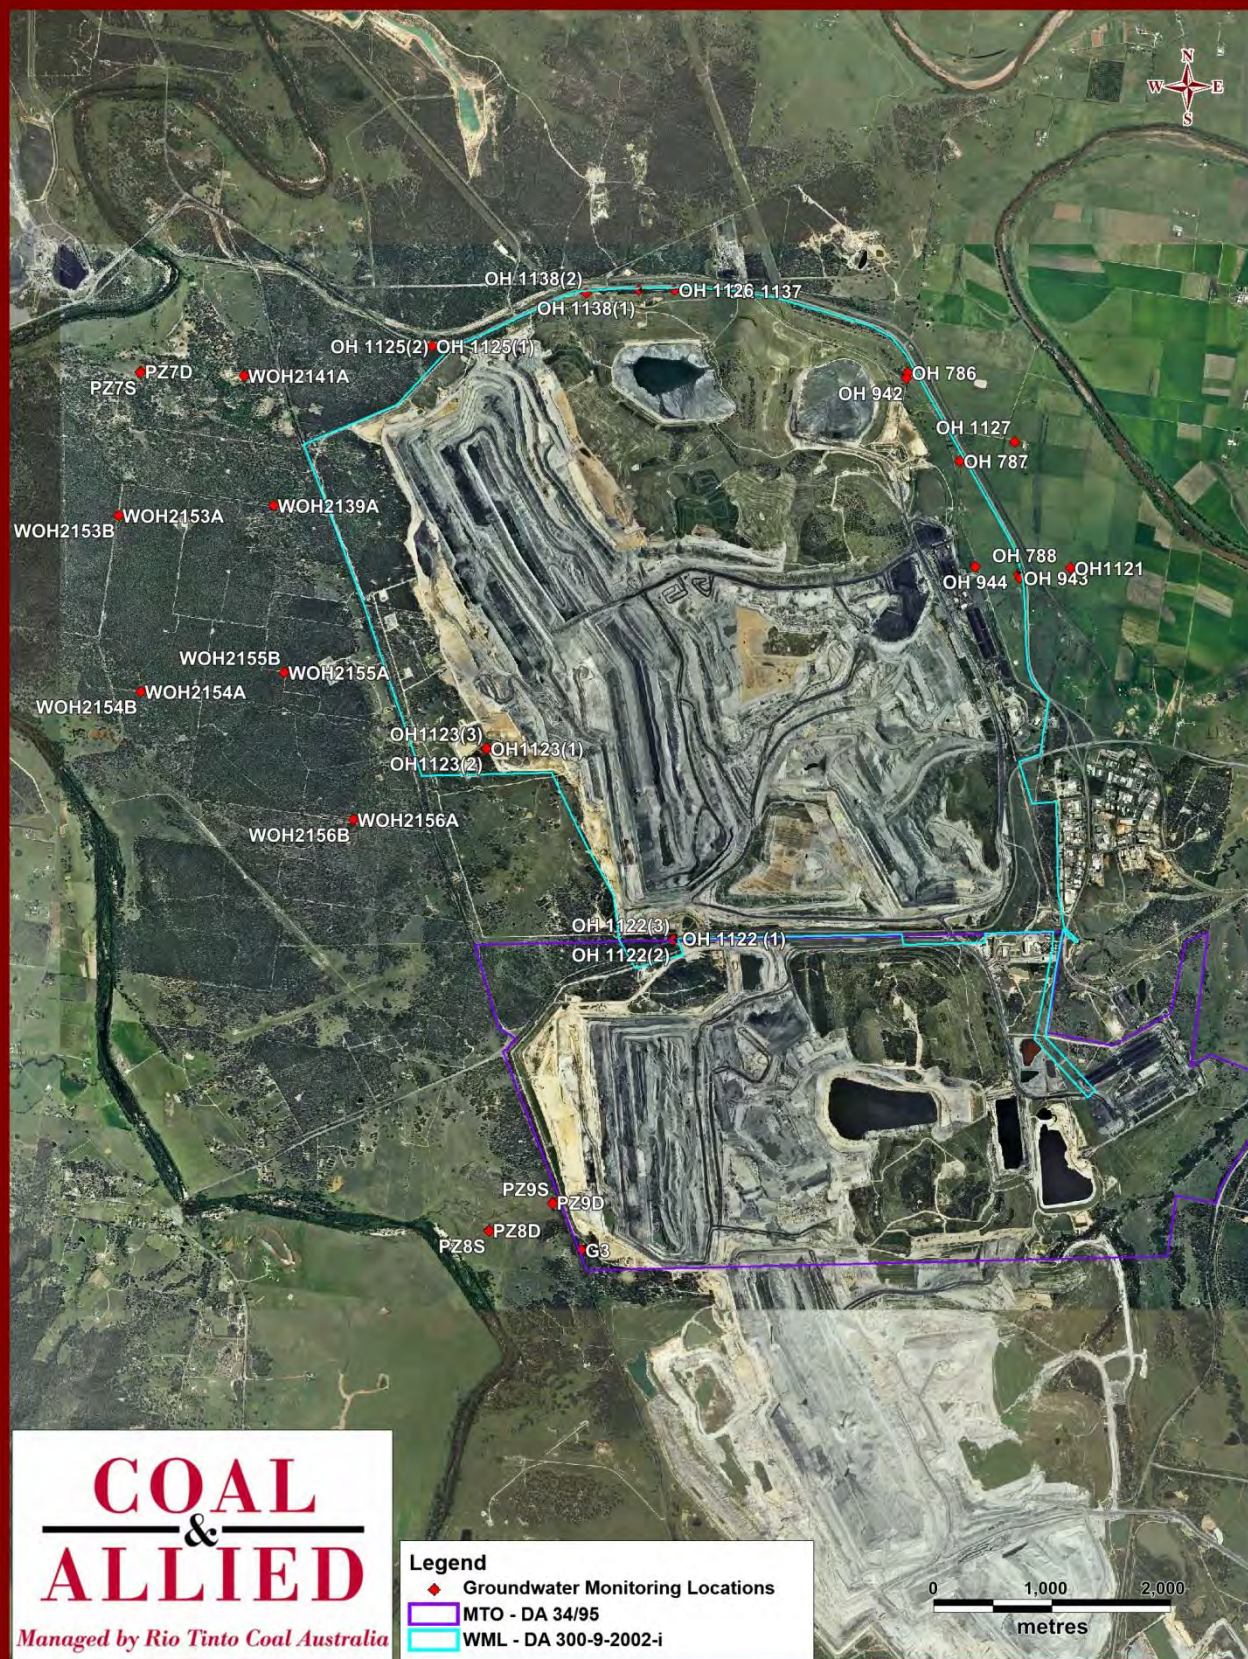
Figure 54: Groundwater Monitoring Network at MTW in 2013
