Mount Thorley Warkworth

2013 Annual Environmental Review

March 2014

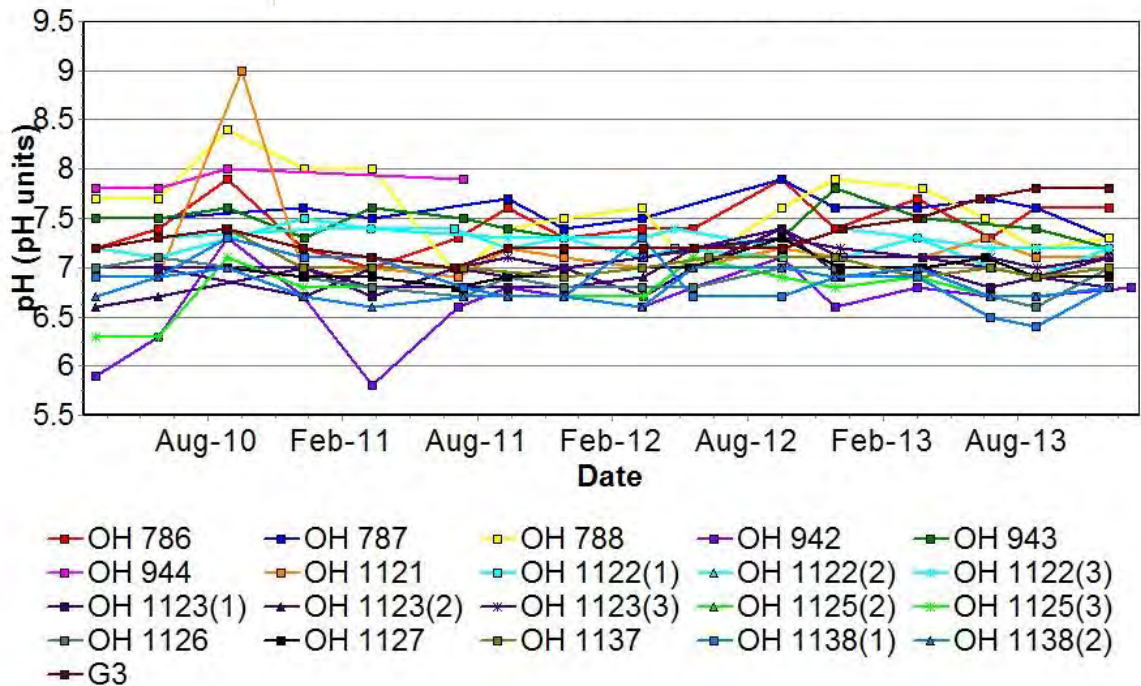
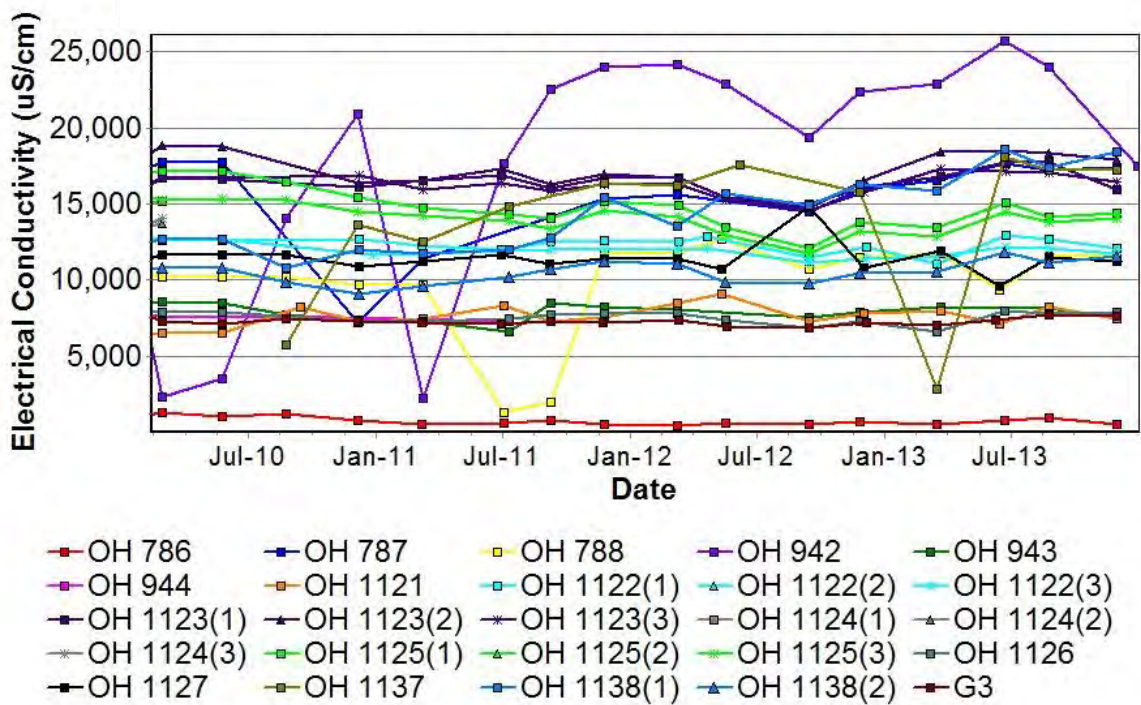
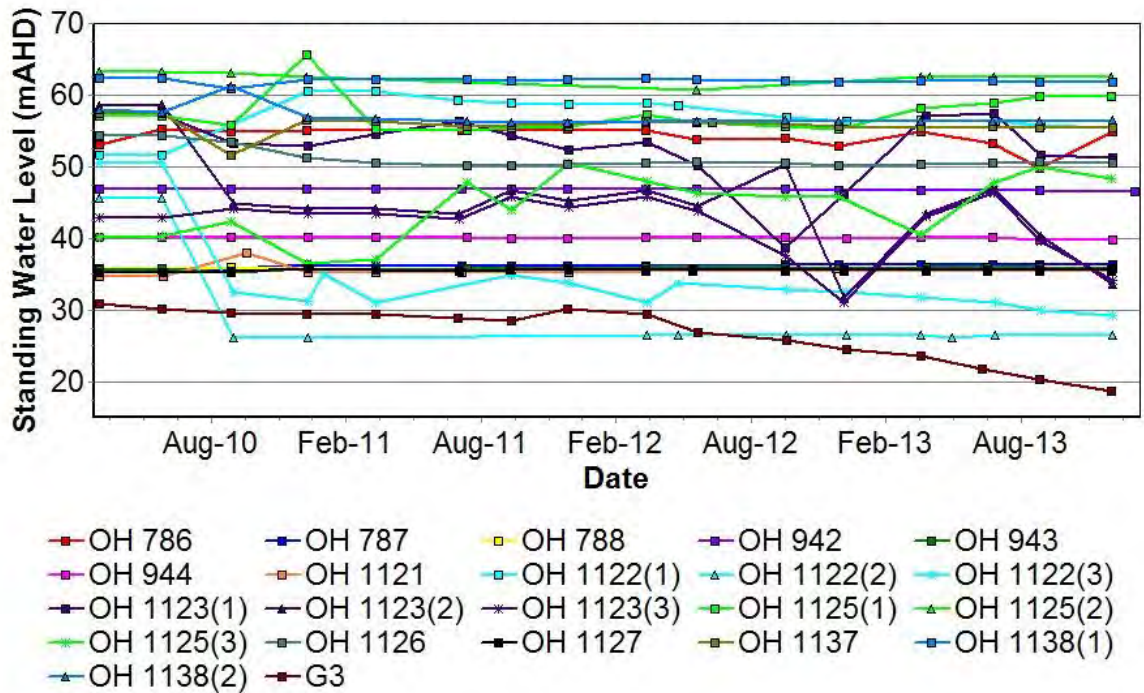
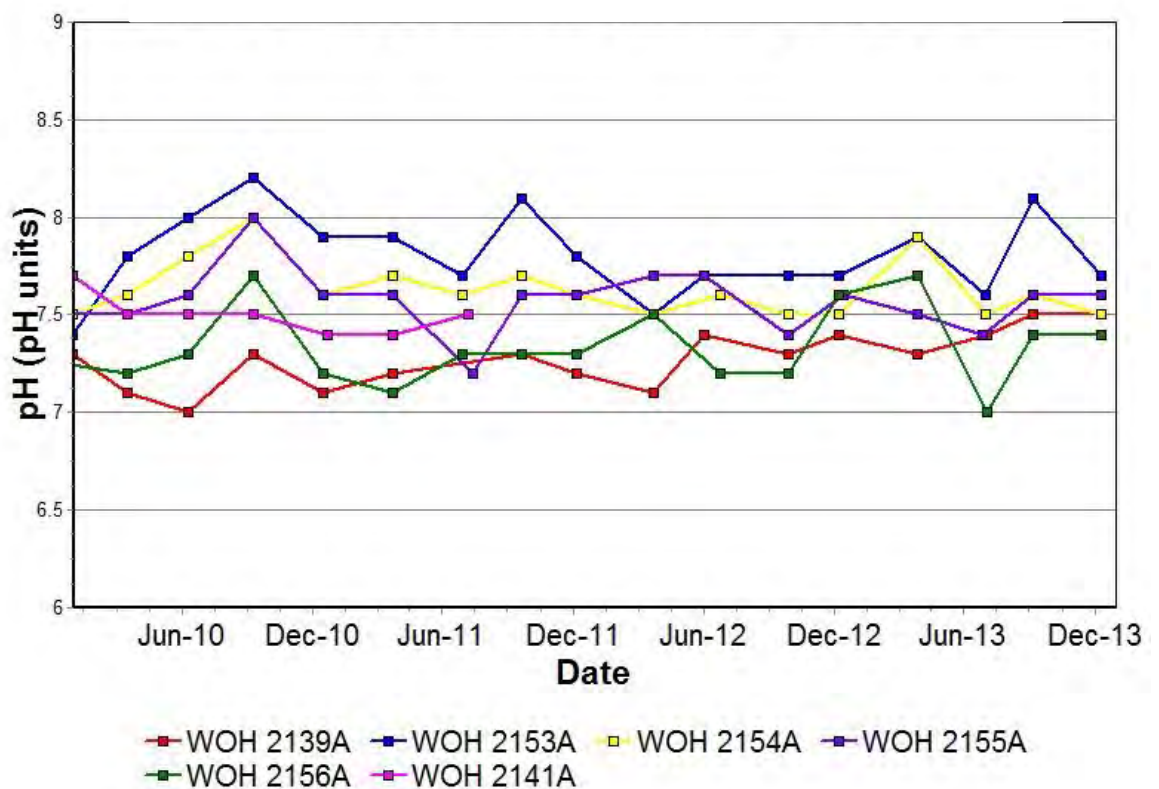
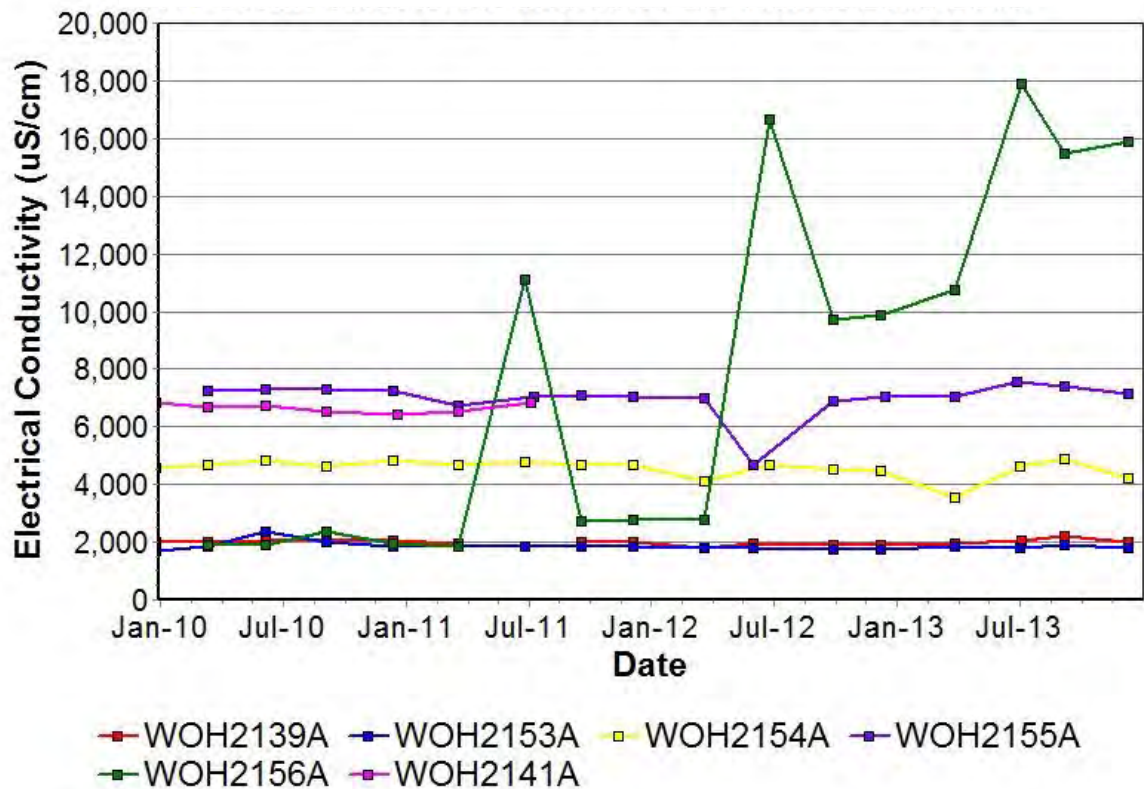
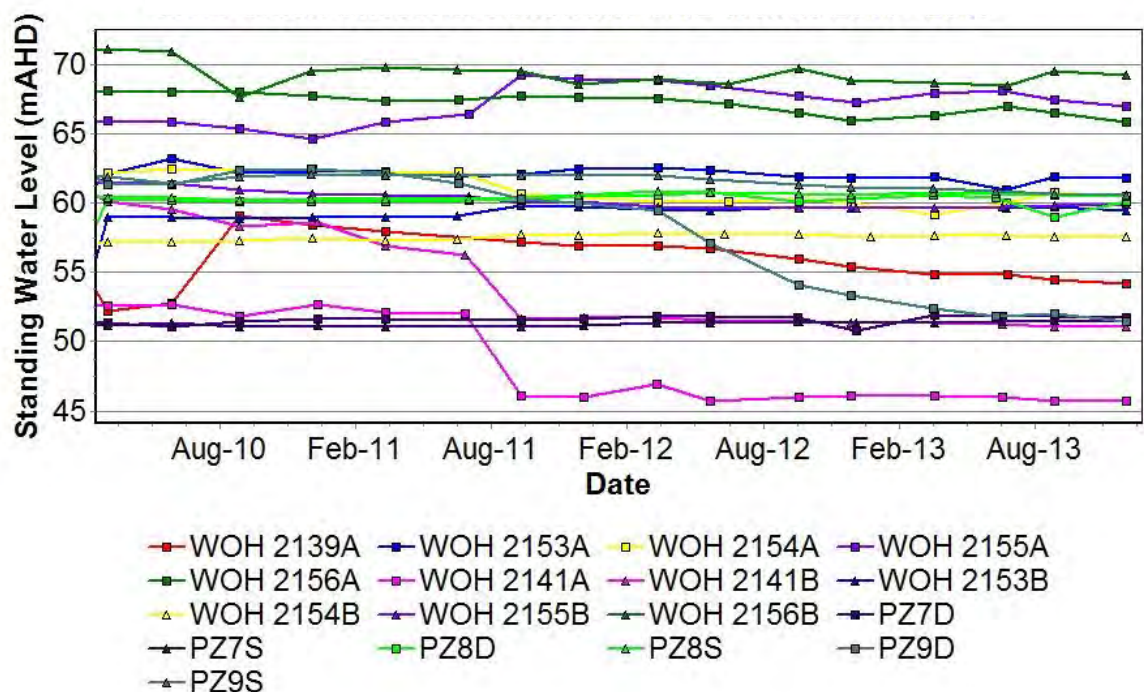
Figure 55: MTW groundwater pH trends 2010 to 2013

Figure 56: MTW groundwater EC trends 2010 to 2013

Figure 57: MTW groundwater SWL trends 2010 to 2013

Figure 58: Green Offsets Groundwater pH Trends 2010 to 2013

Figure 59: Green Offsets Groundwater EC Trends 2010 to 2013

Figure 60: Green Offsets Groundwater SWL Trends 2010 to 2013

Figure 55 to 60 summarise long term groundwater quality trends for pH, EC and standing water level adjacent to the mine and in the Green Offset areas respectively.

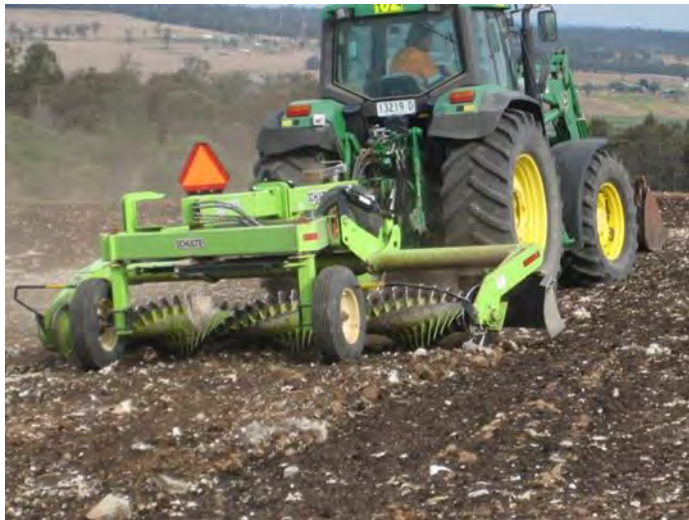
Figure 61: Rock windrower incorporating compost in rehabilitation, Cheshunt Pit

Two agricultural implements have been used to incorporate the compost through the top layer of growth medium. The first of these is a rock windrower (Figure 61) which is typically used to sweep rocks into a windrow for removal from cropping paddocks. A rock picker is then used to pick up the windrowed rocks. The benefit of using the rock windrower and rock picker is that the soil surface is then free of rocks that would cause difficulties for the direct-drill seeder.

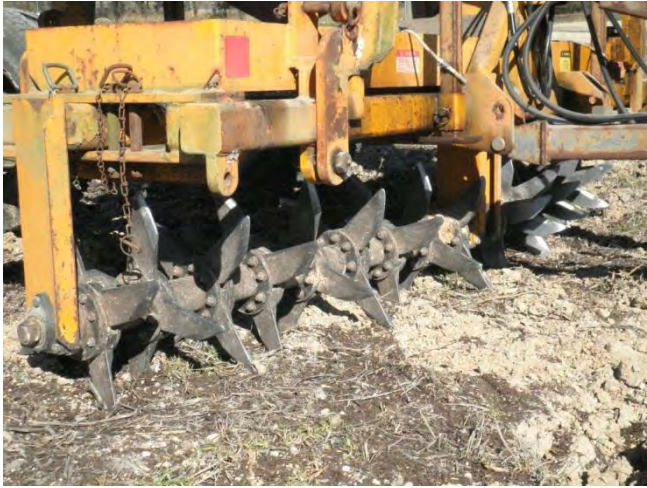
Figure 62: Aerator showing tyne arrangement

The second implement is an aerator (Figure 62) which is typically used in minimal tillage cropping operations to aerate soil that has been compacted due to equipment or grazing. Because the compost is typically being added to freshly spread topsoil the aerating function is not required but this implement was found to incorporate the compost while minimising the breakdown of soil structure that can be caused by traditional cultivation equipment. Where compost is being added to soil that has already formed a surface crust, the aerator is also useful for breaking up the surface crust and providing a suitable seed bed for sowing. The aerator is suited to mined land rehabilitation work as it does not pull rocks to the surface, which is typical of tyne-style equipment.

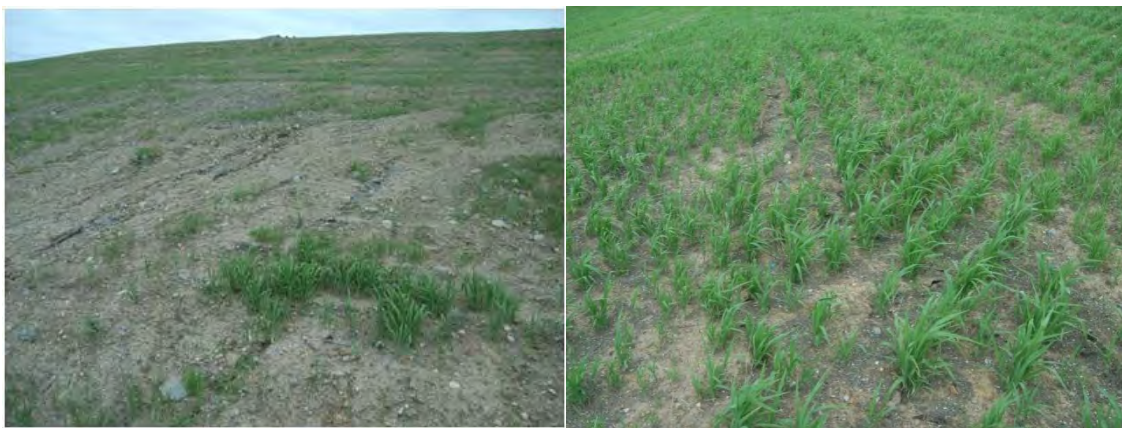
Figure 63 & 64: Photo (on left) comparing area harrowed, demonstrating poorer crop establishment and rill erosion, with the aerated surface (not harrowed), showing healthy cover crop establishment in the aerator pattern (photo on right).

Broadcast spreading of cover crop seed onto a freshly-prepared aerated surface has been found to be most effective in establishing initial cover on slopes. Seedlings that establish in the holes left by the aerator can survive dry conditions because of the improved water harvesting ability of the aerator pattern (see Figure 63). Harrows are not used to provide soil coverage after sowing because the seed that falls in the aerator holes is sufficiently buried by the movement of the fresh topsoil by rain and wind. Avoiding the use of harrows is important because they have been found to smooth out the aerator pattern and produce a slick surface less able to harvest water and more prone to erosion (see Figure 64).

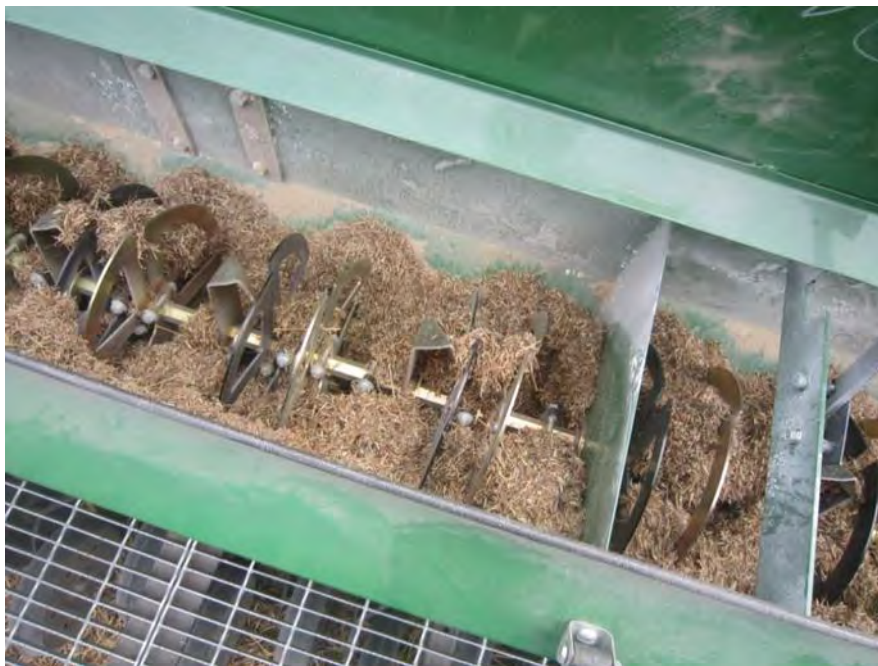
Figure 65: Native grass seed box on the direct-drill showing native grass seed (after processing through a garden mulcher) and agitator configuration.

The native grass seed box on the direct-drill is equipped with agitators (Figure 65) to keep the seed mix from bridging and pick-wheels to help pull seed down into metering points. Despite this the initial trials showed the native grass seed was still causing some blockages during seeding. Further processing of the native grass seed mix, by putting it through a garden style mulcher, was needed to reduce blockages. A commercial thresher will be used for processing seed in 2014. This machine will use stiff brushes and sieves to process the seed in order to improve the flowability of the seed mix through the direct-drill. The use of the thresher rather than the garden mulcher will reduce potential damage to seed caused by spinning mulcher blades.

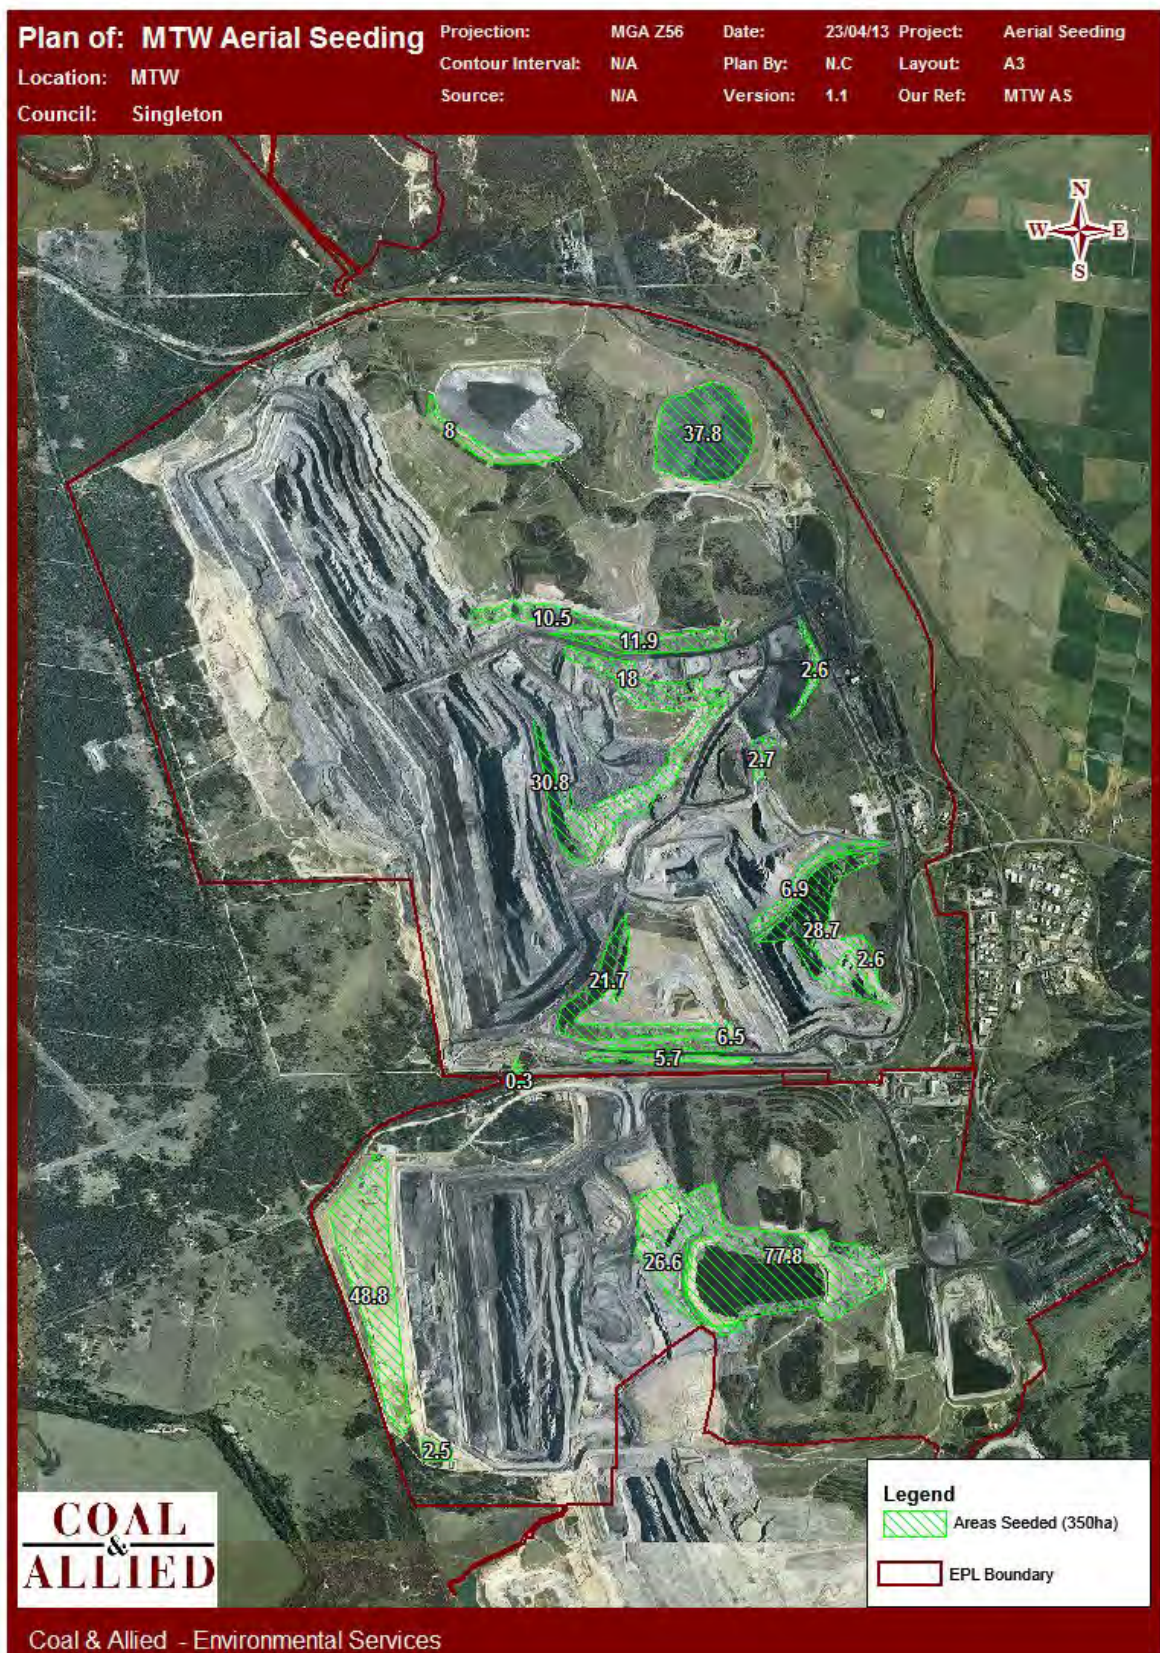
Figure 68: 2013 Aerial Seeding Areas

Aerial Seeding was undertaken in early May 2013 by a fixed wing aircraft to provide a temporary cover to areas exposed to wind generated dust and erosion at MTW. Waste dumps and exposed areas were selected for seeding if they were not planned to be disturbed within six months. The 350 hectares of area seeded included waste dumps and two tailings dams (Figure 68). All areas were seeded using an exotic pasture grass and legume mix suitable for an autumn sowing. The seed mix was revised slightly from previous years to reduce the number of species to those which were most successful from previous years. A starter fertiliser was mixed with the seed prior to loading to provide sufficient nutrients for plant growth.

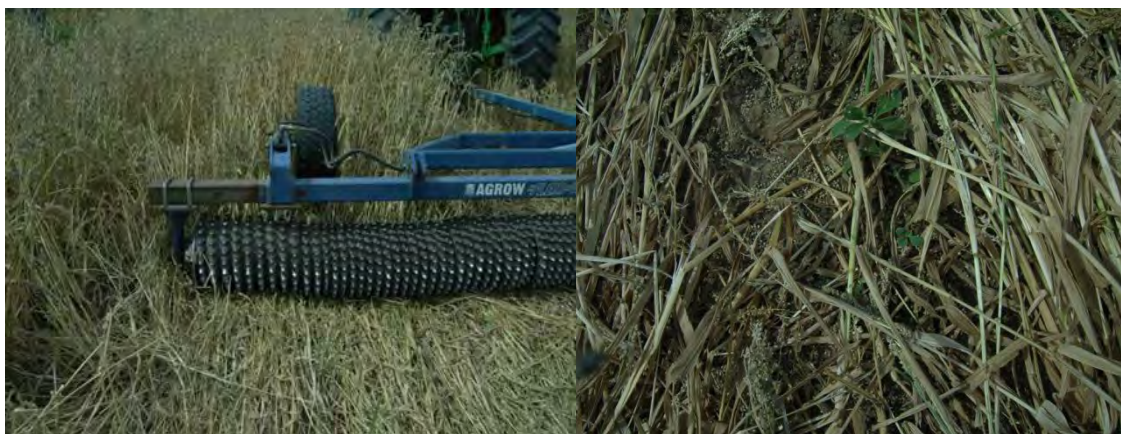
Figure 77 & 78: Crop rolling the millet cover crop on to the surface. Note the flexiroller is made up of individual rings which allow it to conform to the surface contours. Galenia plants exposed for effective herbicide spraying after crop rolling.

The configuration of the flexiroller lends itself to using in rehabilitation areas for this purpose because it is able to conform to the contours of the surface whereas a conventional rigid roller will bridge across any low points. The bridging action of a rigid roller will result in over compaction of the high points and ineffective rolling in low areas.

One of the aims of using sacrificial cover crops is to provide additional opportunities for weed control prior to sowing long term seed mixes. An issue that presented at HVO in 2013 was the difficulty of targeting small weed plants growing under a knee-high cover crop due to the high levels of herbicide spray interception on the standing cover crop. The solution that was adopted was the use of a flexiroller (Figure 77) to flatten the cover crop on the surface and allow the weeds to poke up through the flattened stubble. As can be seen in Figure 78, the weeds are then exposed for effective herbicide spraying with a boom spray. Crop rolling will be implemented at MTW during 2014.
