Mount Thorley Warkworth Community Consultative Committee (CCC)

BUSINESS PAPERS – May 2018

Monthly Environmental Monitoring Report

Yancoal Mt Thorley Warkworth

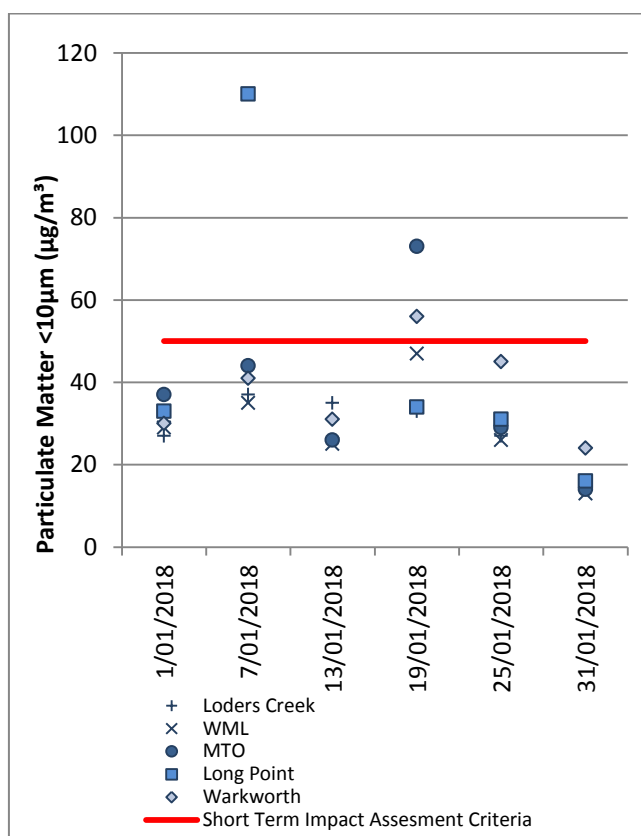
Figure 5 shows the individual PM₁₀ results at each monitoring station against the short term impact assessment criteria of 50µg/m³.

Data was not available on 13/01/2018 at the Long Point HVAS due to HVAS motor fault.

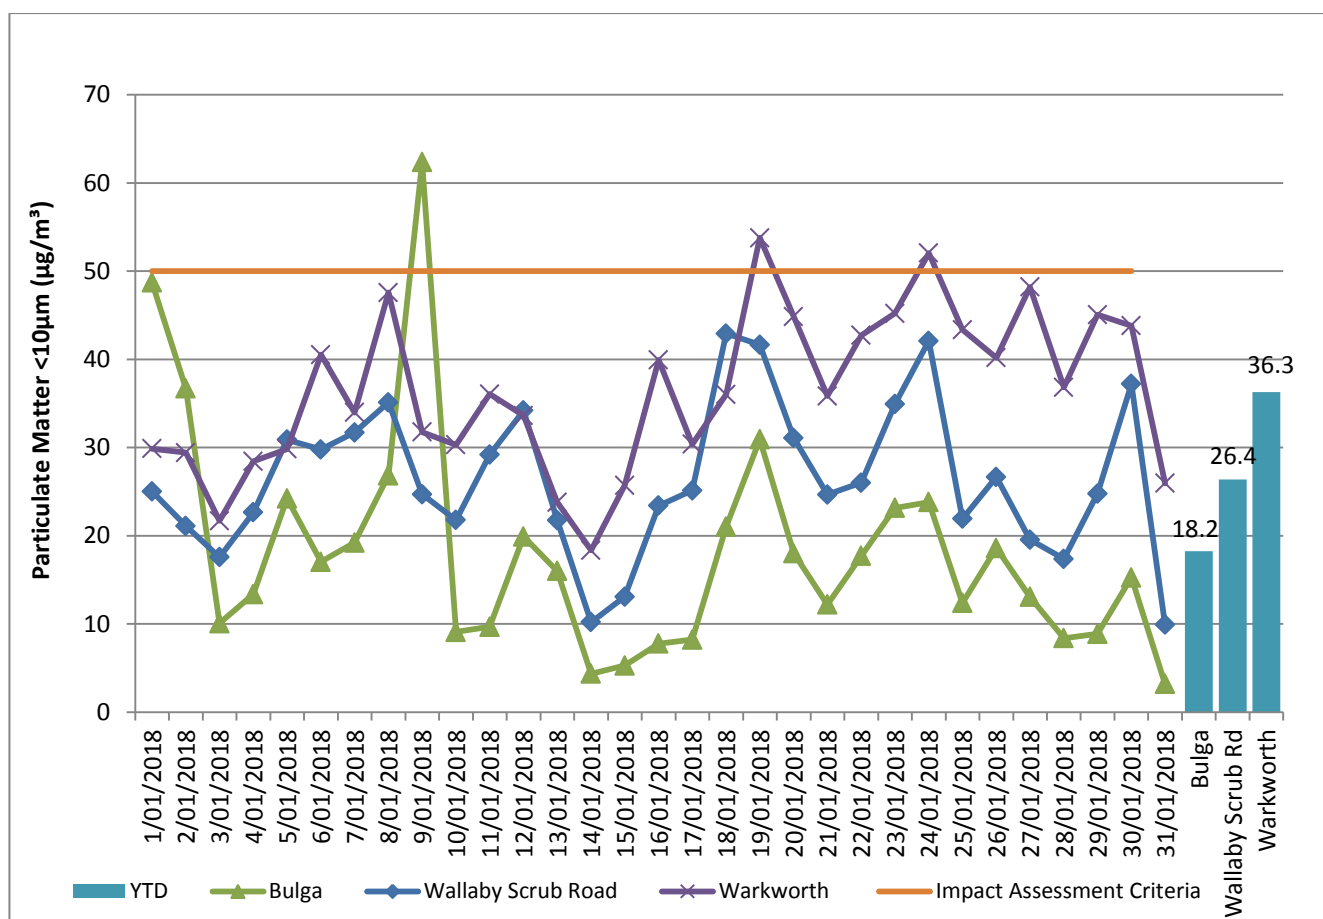
Figure 8: Real Time PM₁₀ daily 24hr average and annual average – January 2018

During January, the real time monitoring system generated 188 automated air quality related alerts, including 48 alert for adverse meteorological conditions and 140 alerts for elevated PM₁₀ levels.

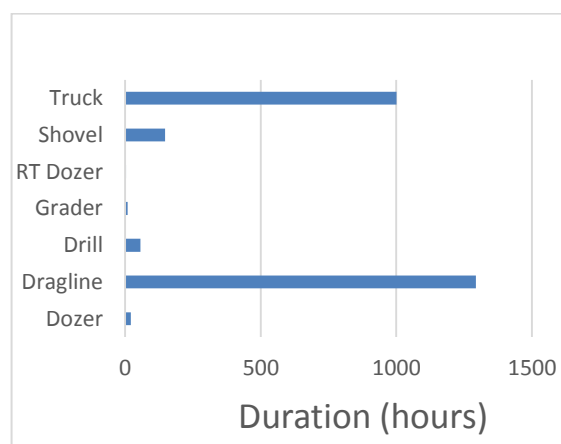
Figure 17: Operational Downtime by Equipment Type – January 2018

During January, a total of 2531 hours of equipment downtime was logged in response to environmental events such as dust, noise and adverse meteorological conditions. Operational downtime by equipment type is shown in Figure 17.

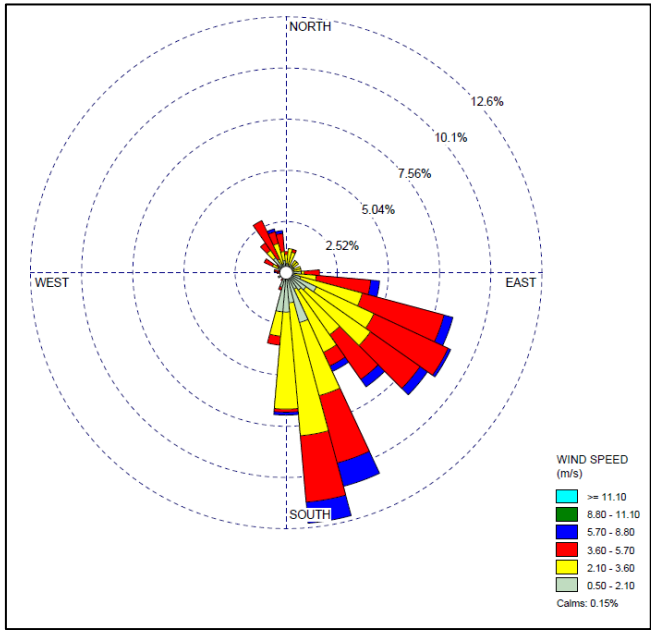
Figure 2: Charlton Ridge Wind Rose – February 2018

Winds from the South – East were dominant throughout the reporting period as shown in Error! Reference source not found..

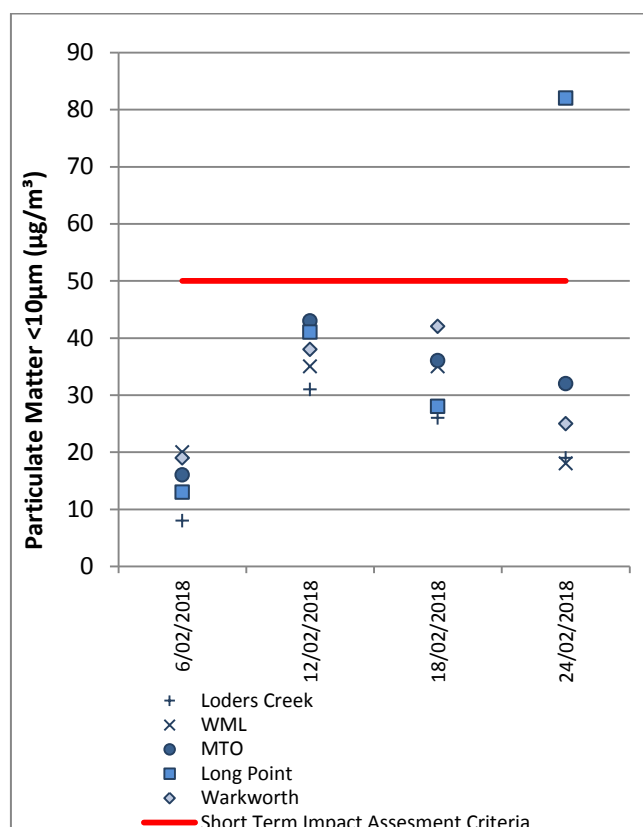
Figure 5 shows the individual PM₁₀ results at each monitoring station against the short term impact assessment criteria of 50µg/m³.

On 24/02/2018 the Long Point HVAS PM₁₀ unit recorded a result of 82µg/m³, which is greater than the short term (24hr) PM₁₀ impact assessment criteria.

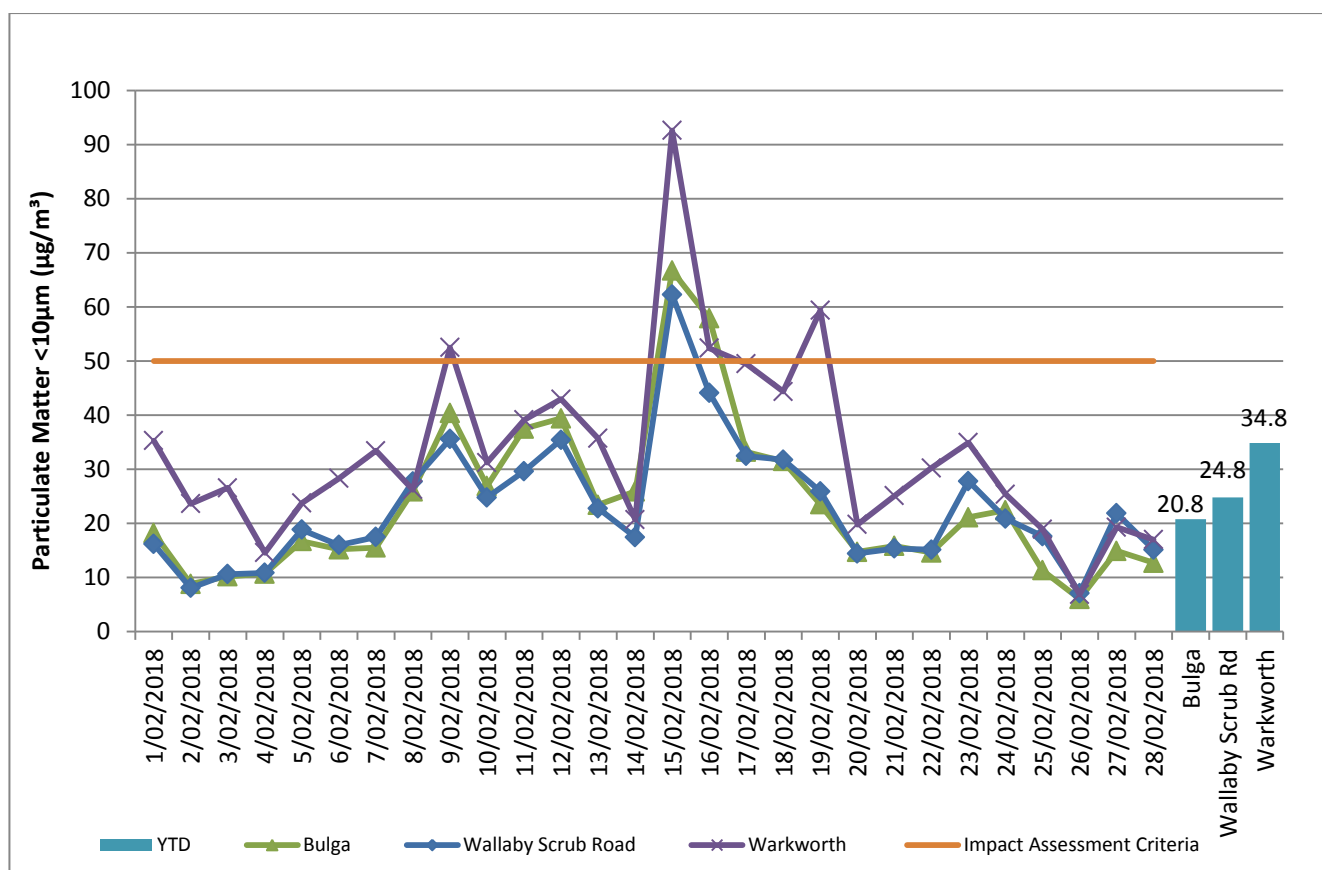
Figure 8: Real Time PM₁₀ daily 24hr average and annual average – February 2018

During February, the real time monitoring system generated 196 automated air quality related alerts, including 6 alerts for adverse meteorological conditions and 190 alerts for elevated PM₁₀ levels.

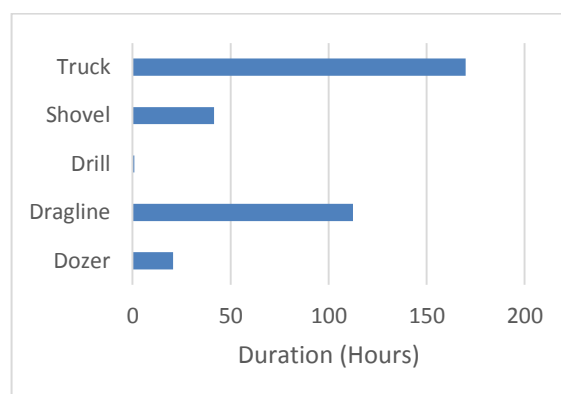
Figure 17: Operational Downtime by Equipment Type – February 2018

During February, a total of 346 hours of equipment downtime was logged in response to environmental events such as dust, noise and adverse meteorological conditions. Operational downtime by equipment type is shown in Figure 17.

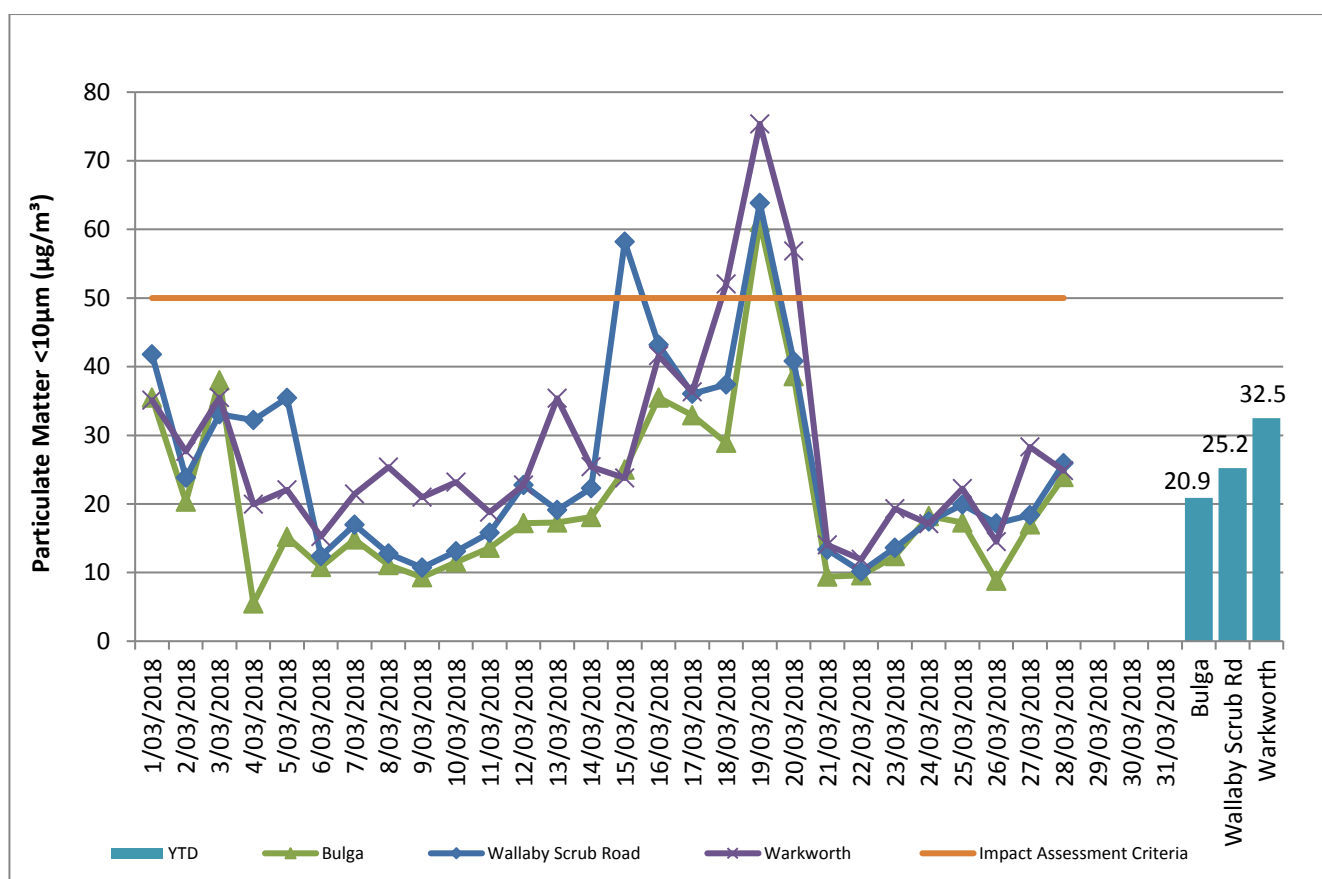
Figure 8: Real Time PM₁₀ 24hr average and Year-to-date average – March 2018

During March, the real time monitoring system generated 80 automated air quality related alerts, including 5 alerts for adverse meteorological conditions and 75 alerts for elevated PM₁₀ levels.

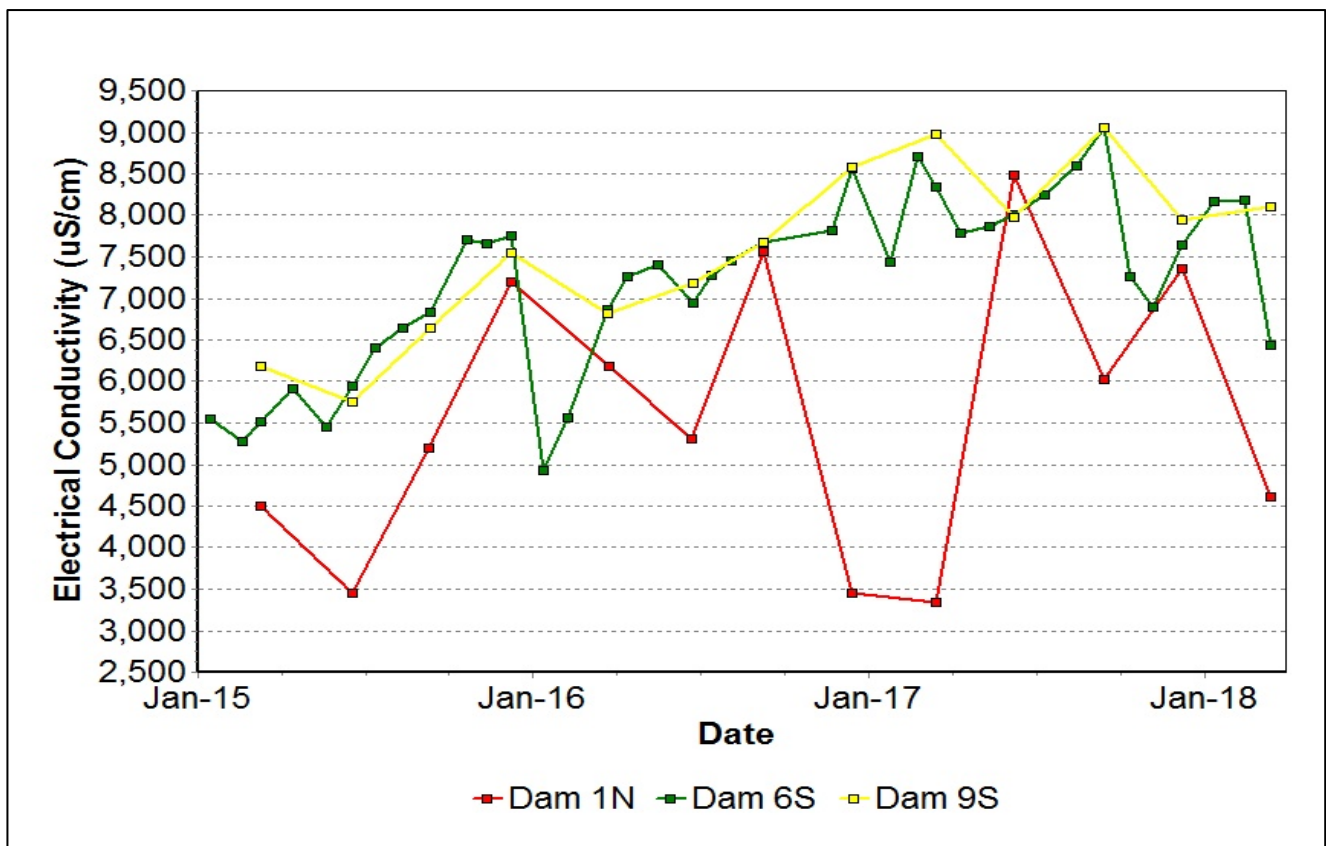
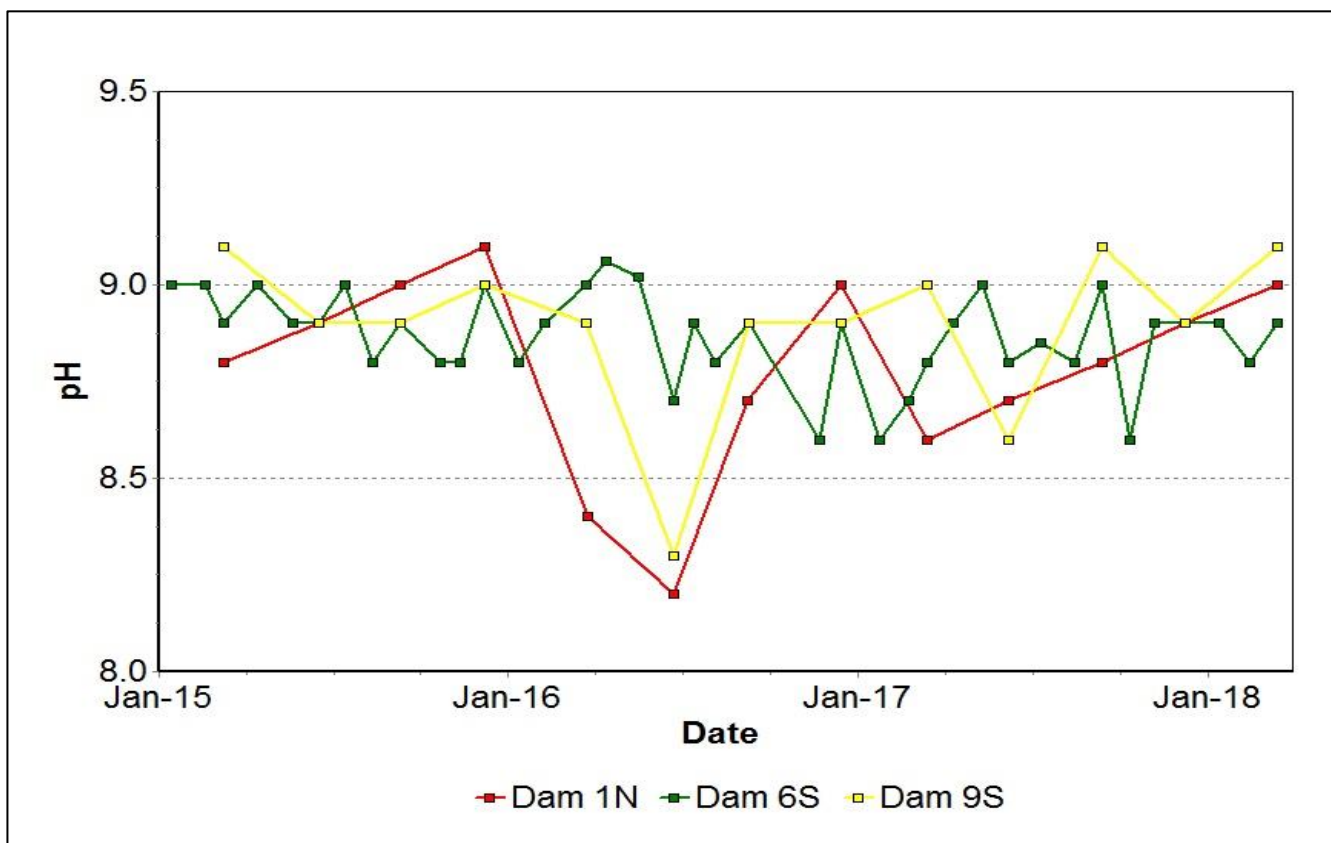
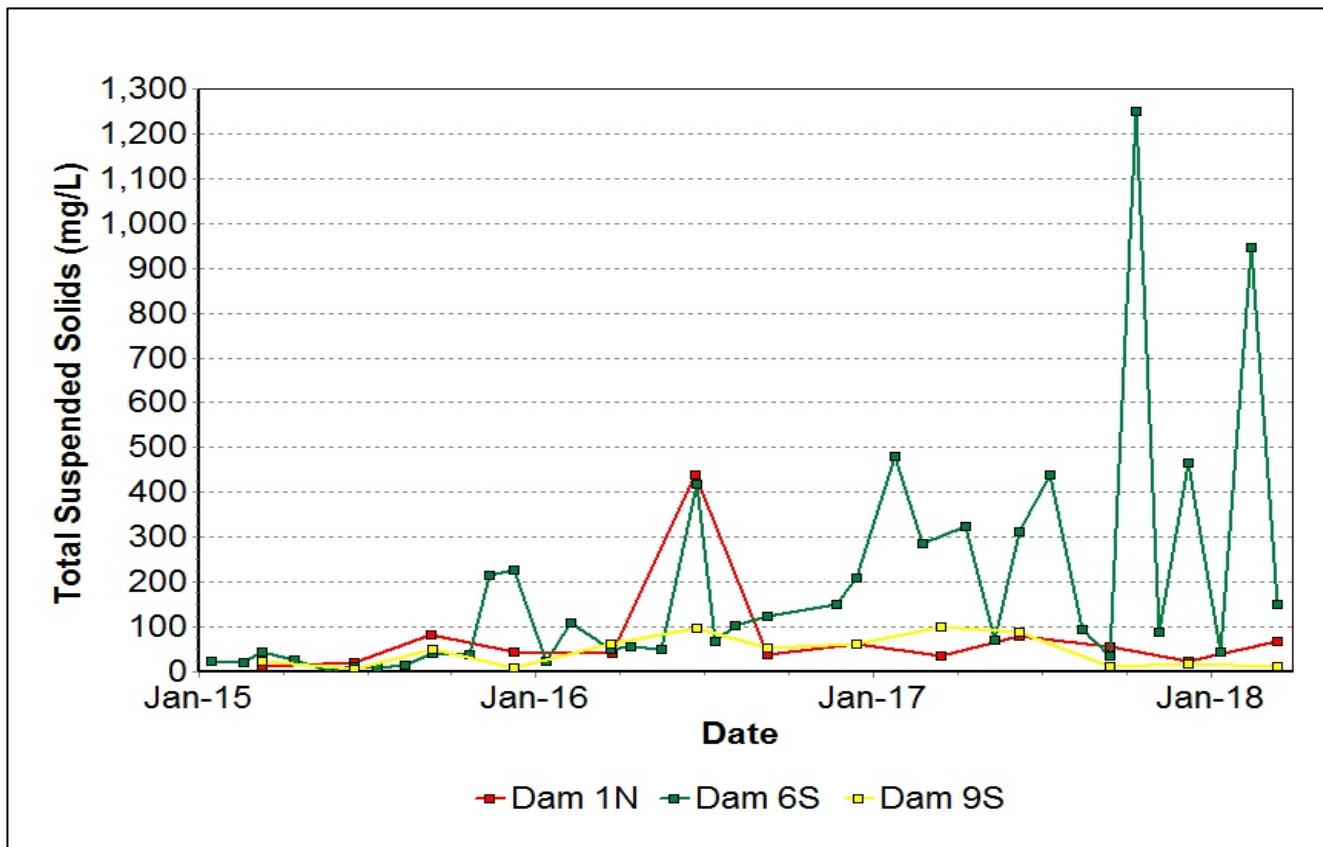
Figure 9 to Figure 11 show the long term surface water trend (2015 – current) within MTW mine dams. Figure 12 to Figure 14 show the long term surface water trend (2015 - current) in surrounding watercourses.

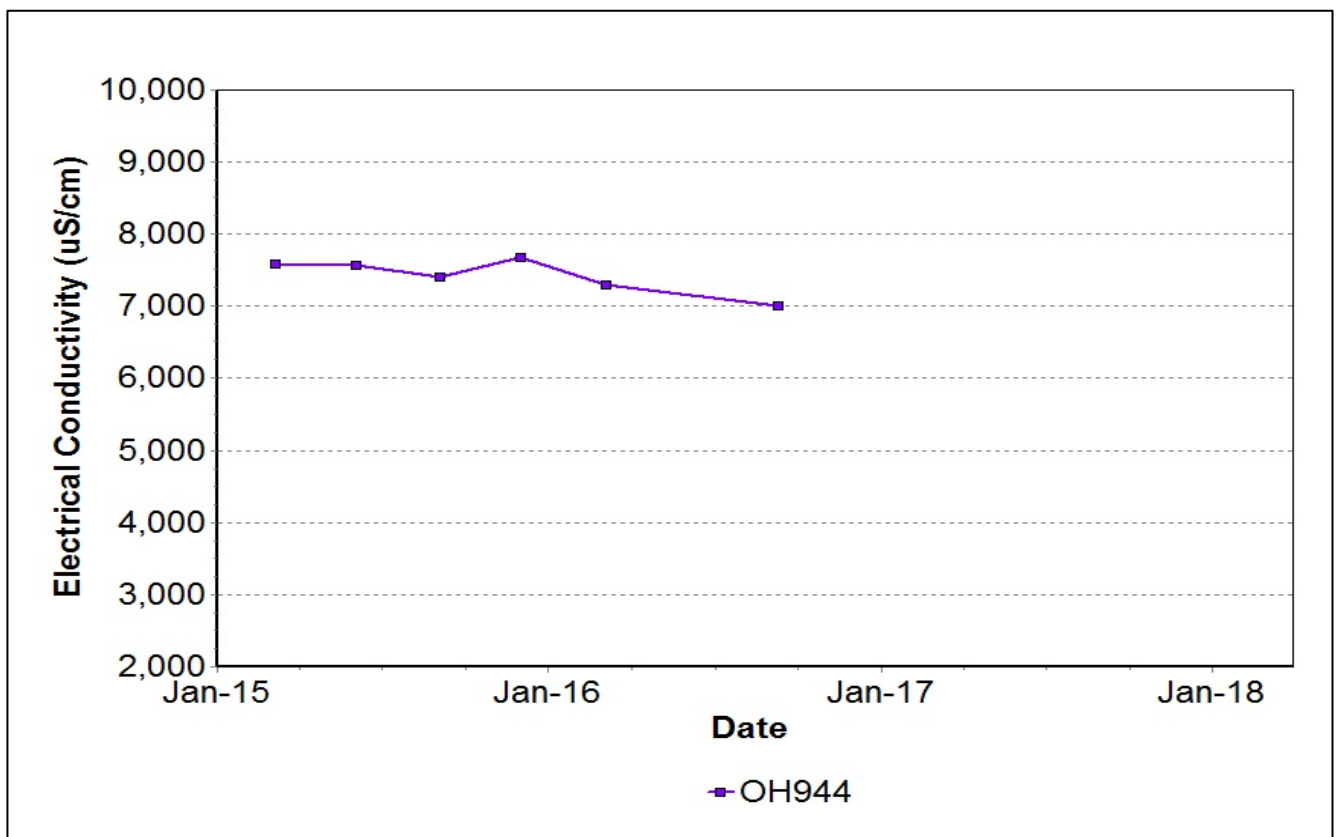
Figure 56: Hunter River Alluvium 5 Seam Electrical Conductivity Trend – March 2018

Note: There has been insufficient water to sample since September 2016.

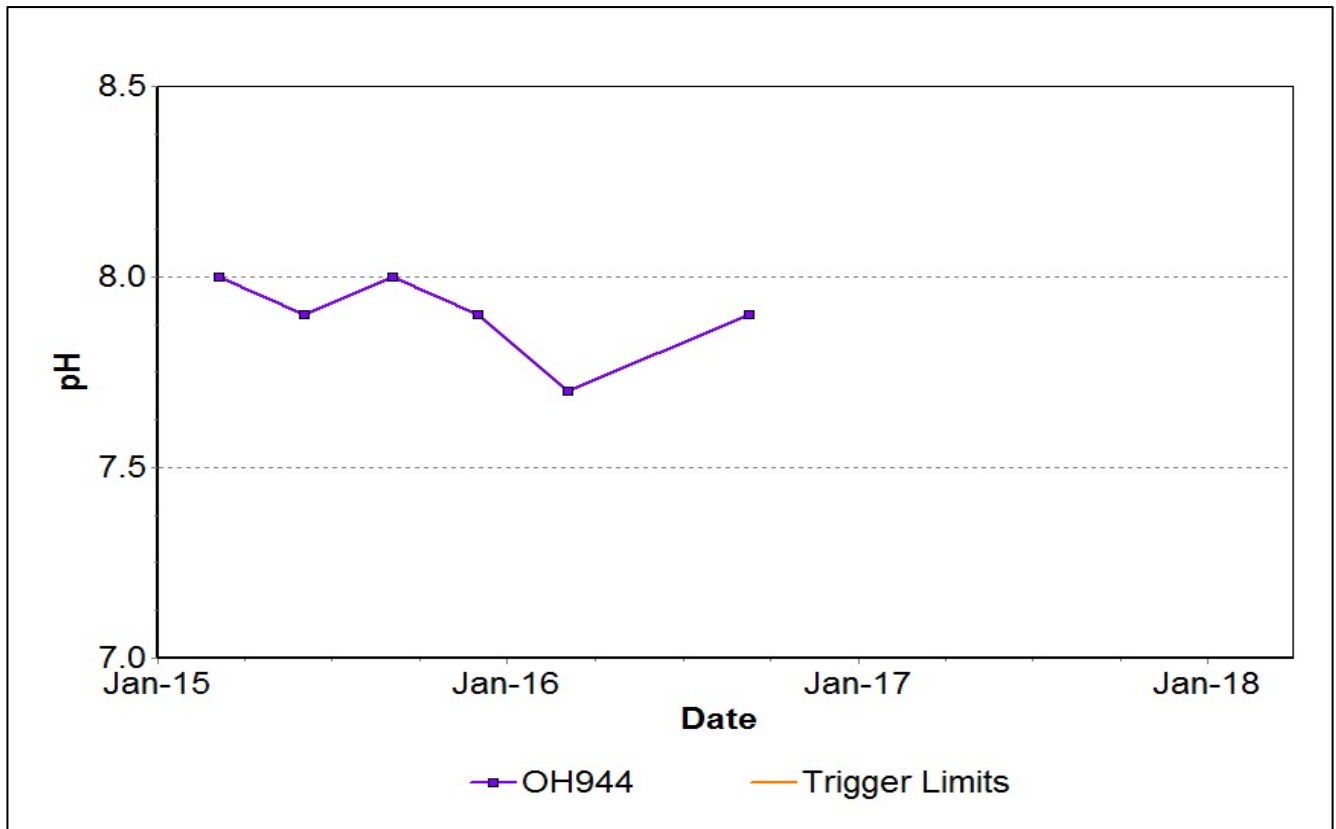
Figure 57: Hunter River Alluvium 5 Seam pH Trend – March 2018

Note: There has been insufficient water to sample since September 2016.
