# Mount Thorley Warkworth Community Consultative Committee (CCC)

BUSINESS PAPERS – August 2018

# Monthly Environmental Monitoring Report

Yancoal Mount Thorley Warkworth

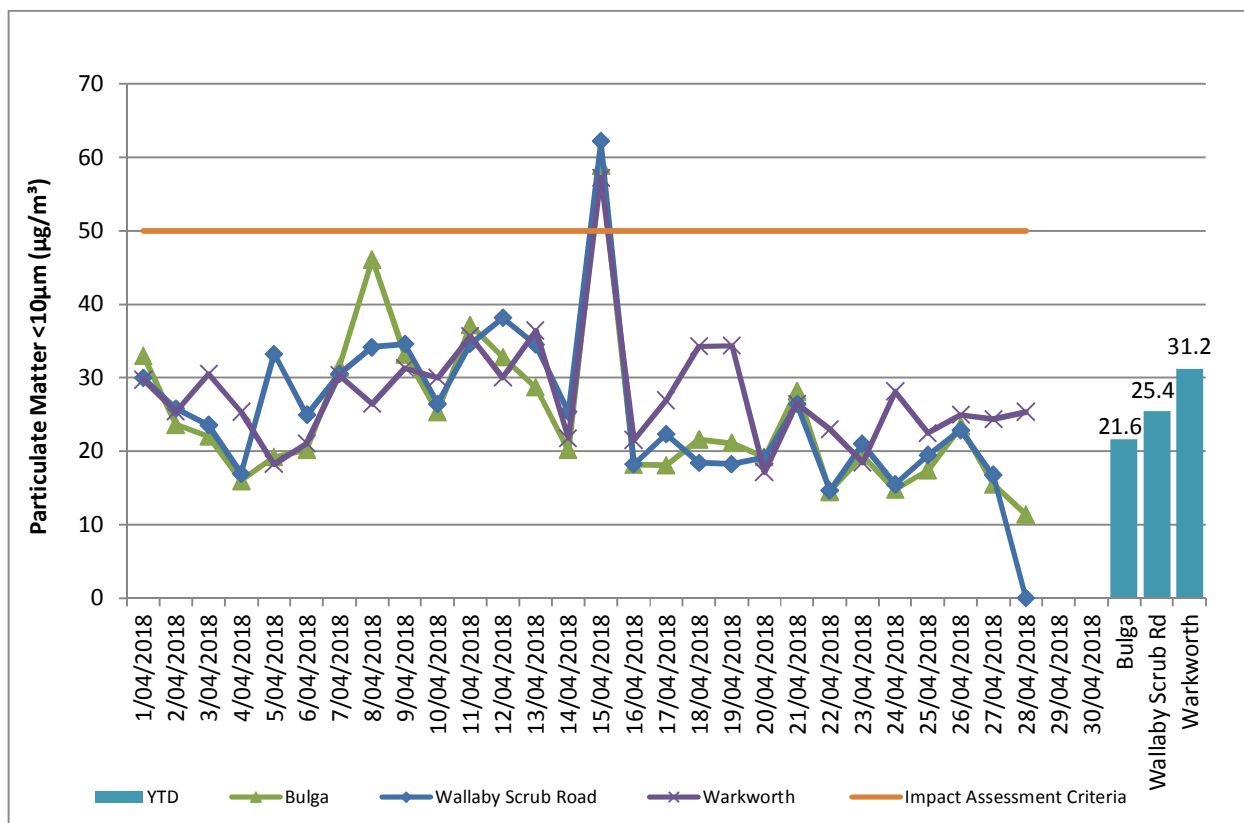
Figure 8: Real Time PM<sub>10</sub> daily 24hr average (line graphs) and YTD annual average (column graphs) – April 2018

During April, the real time monitoring system generated 113 automated air quality related alerts, including 14 alerts for adverse meteorological conditions and 99 alerts for elevated PM<sub>10</sub> levels.

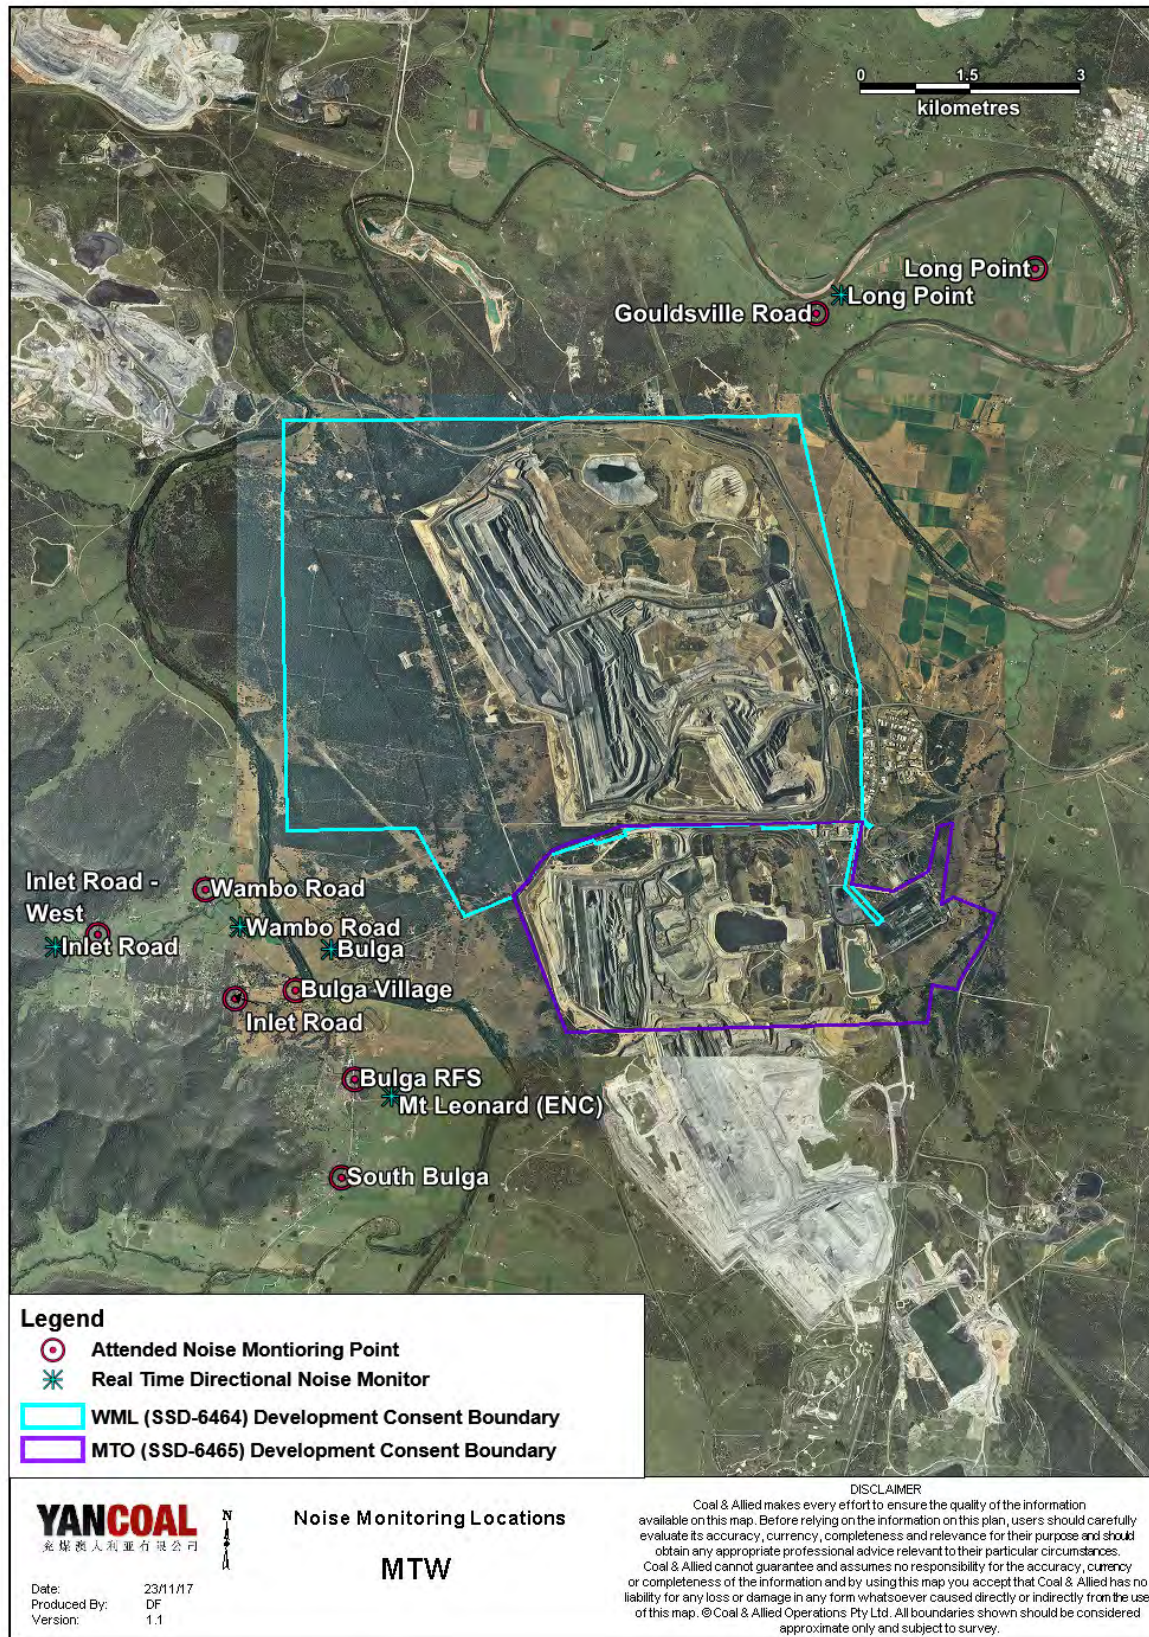
Figure 16: Noise Monitoring Location Plan

Routine attended noise monitoring is carried out in accordance with the MTW Noise Management Plan. A review against EIS predictions will be reported in the Annual Review Report. The purpose of the noise surveys is to quantify and describe the acoustic environment around the site and compare results with specified limits. Real time noise monitoring also occurs at five sites surrounding MTW. Noise monitoring locations are displayed in **Figure 16**.

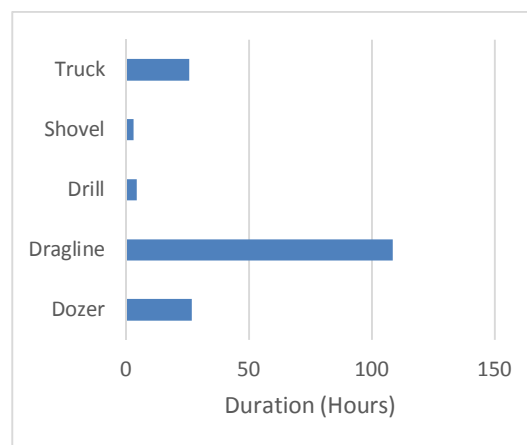
**Figure 17: Operational Downtime by Equipment Type – April 2018**

During April, a total of 168 hours of equipment downtime was logged in response to environmental events such as dust, noise and adverse meteorological conditions. Operational downtime by equipment type is shown in **Figure 17**.

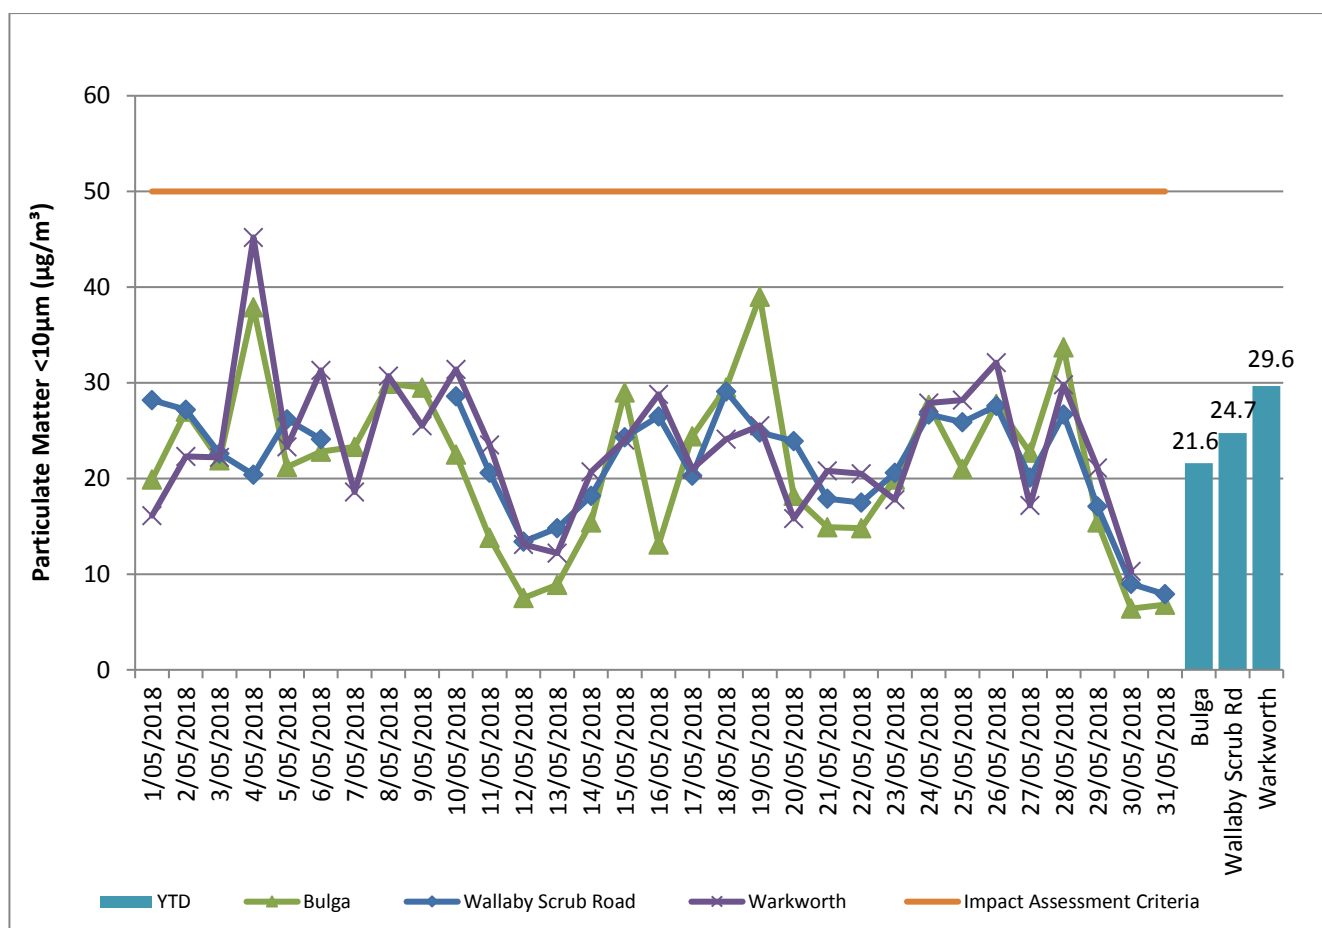
Figure 8: Real Time PM<sub>10</sub> daily 24hr average (line graphs) and YTD annual average (column graphs) – May 2018

During May, the real time monitoring system generated 74 automated air quality related alerts, including 11 alerts for adverse meteorological conditions and 63 alerts for elevated PM<sub>10</sub> levels.

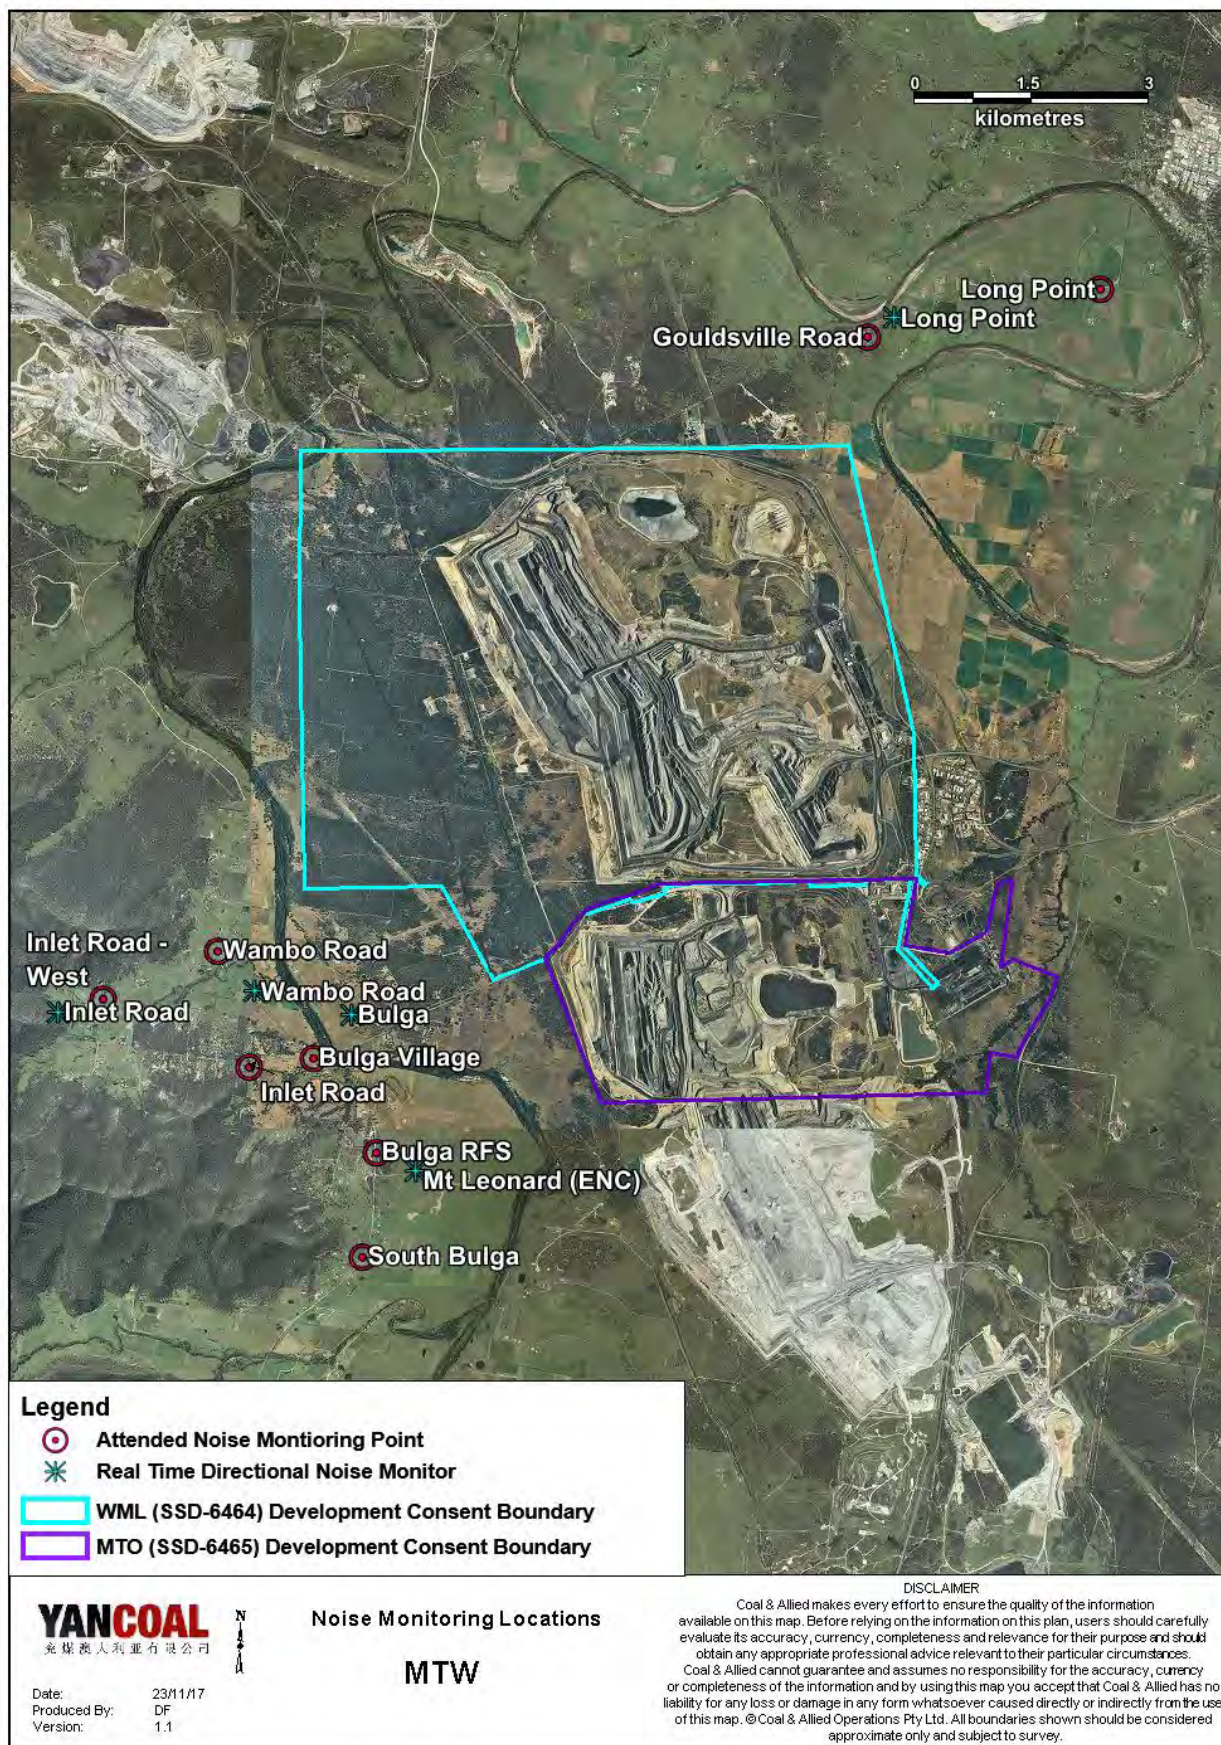
Figure 16: Noise Monitoring Location Plan

Routine attended noise monitoring is carried out in accordance with the MTW Noise Management Plan. A review against EIS predictions will be reported in the Annual Review Report. The purpose of the noise surveys is to quantify and describe the acoustic environment around the site and compare results with specified limits. Real time noise monitoring also occurs at five sites surrounding MTW. Noise monitoring locations are displayed in **Figure 16**.

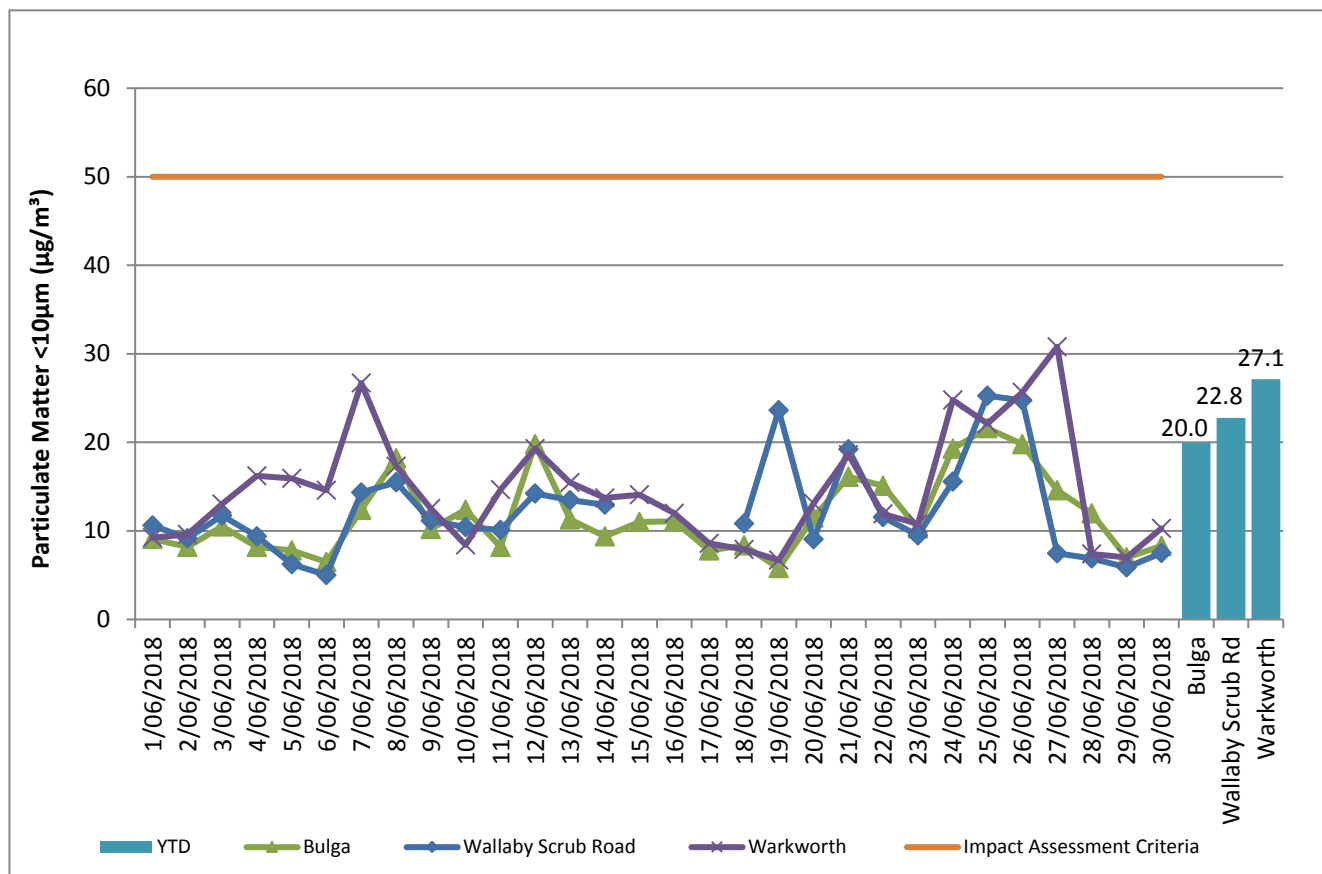
Figure 8: Real Time PM<sub>10</sub> 24hr average and Year-to-date average – June 2018

During July, the real time monitoring system generated 52 automated air quality related alerts, including 12 alerts for adverse meteorological conditions and 40 alerts for elevated PM<sub>10</sub> levels.

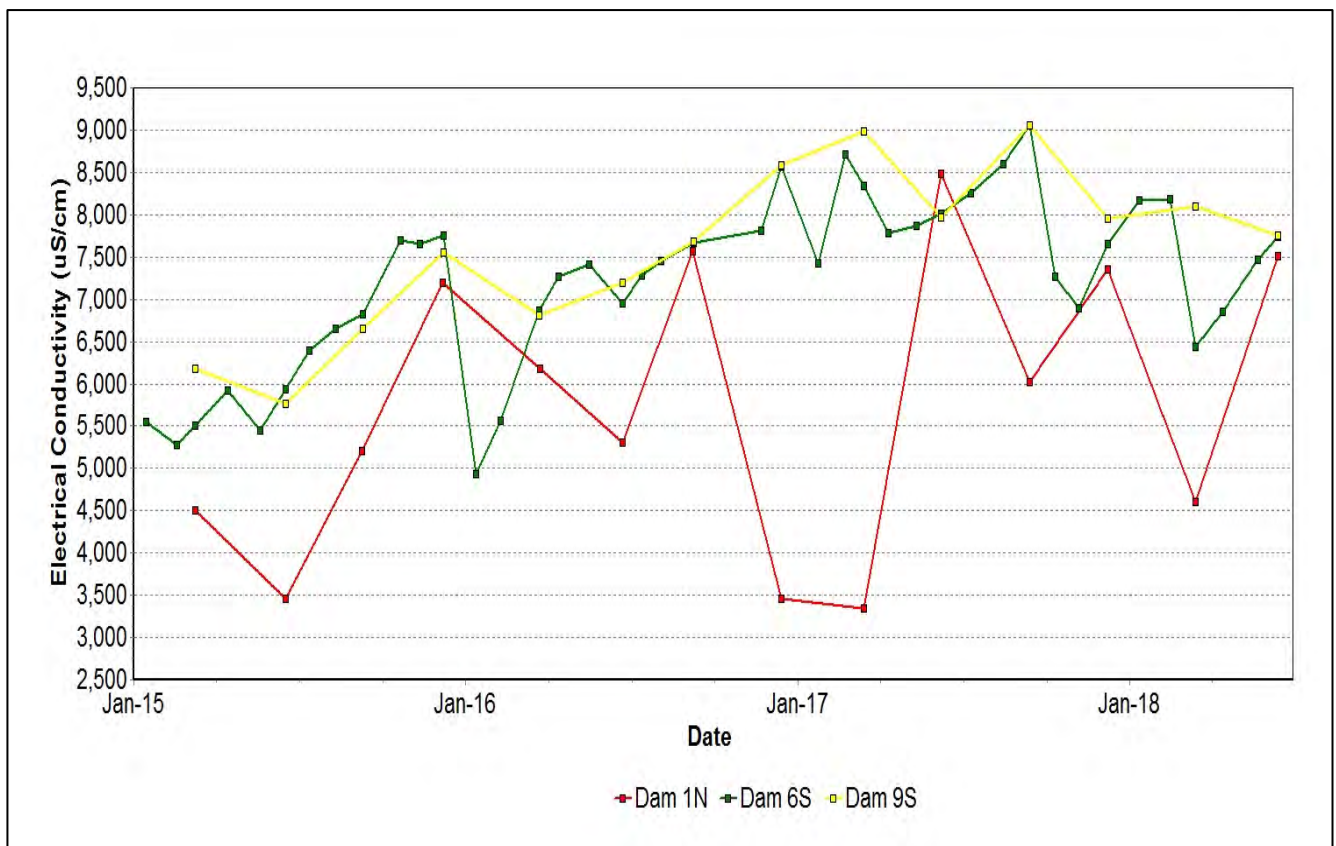
Figure 9: Site Dams Electrical Conductivity Trend – June 2018

Figure 9 to Figure 11 show the long term surface water trend (2015 – current) within MTW mine dams. Figure 12 to Figure 14 show the long term surface water trend (2015 - current) in surrounding watercourses.
