Mount Thorley Warkworth

2017 Annual Review

MT THORLEY WARKWORTH

Mount Thorley Warkworth (MTW) is an integrated operation of two open cut coal mines, Warkworth Mining Limited (WML) and Mount Thorley Operations (MTO). This Annual Review reports on the environmental performance of Mount Thorley Warkworth (MTW) for the period 1 January 2017 to 31 December 2017.

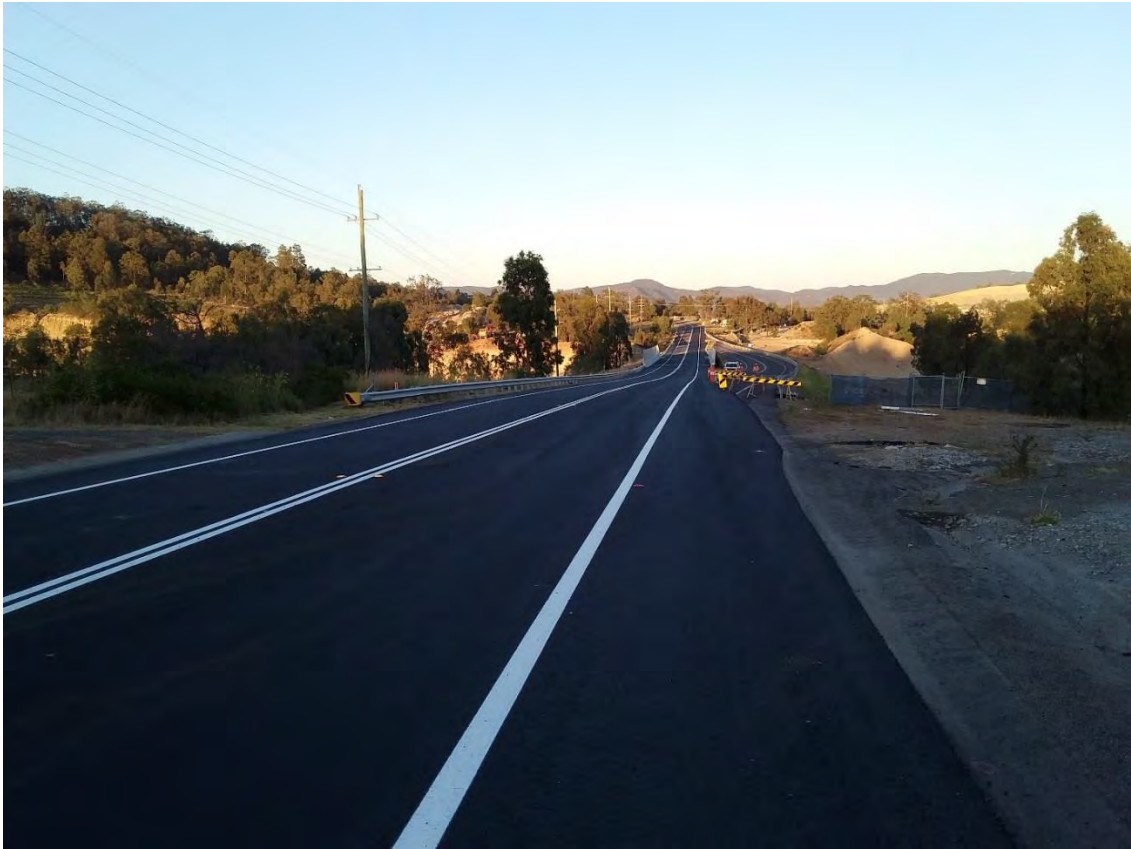
FIGURE 3: PUTTY ROAD COMPLETED ROAD SURFACE OVERPASSING THIRD CROSSING – LOOKING WEST BOUND TOWARDS BULGA

- Some additional and replacement heavy equipment was purchased in 2017, including 5 new 320t haul trucks, one 360t replacement Excavator and a new 500t Excavator.
- Mining activity during the reporting period with regard to volumes, location and equipment was consistent with 2016
- South Pit accelerated rehabilitation plan has progressed in line with the consent condition
- Construction Putty Road underpass commenced in 2017 with planned project completion in May 2018. The underpass will service as the main linkage of the Mount Thorley and

Warkworth operations reducing hauling length of Prime Waste (overburden) as the Warkworth Pit progresses west. Update of project progress in figures

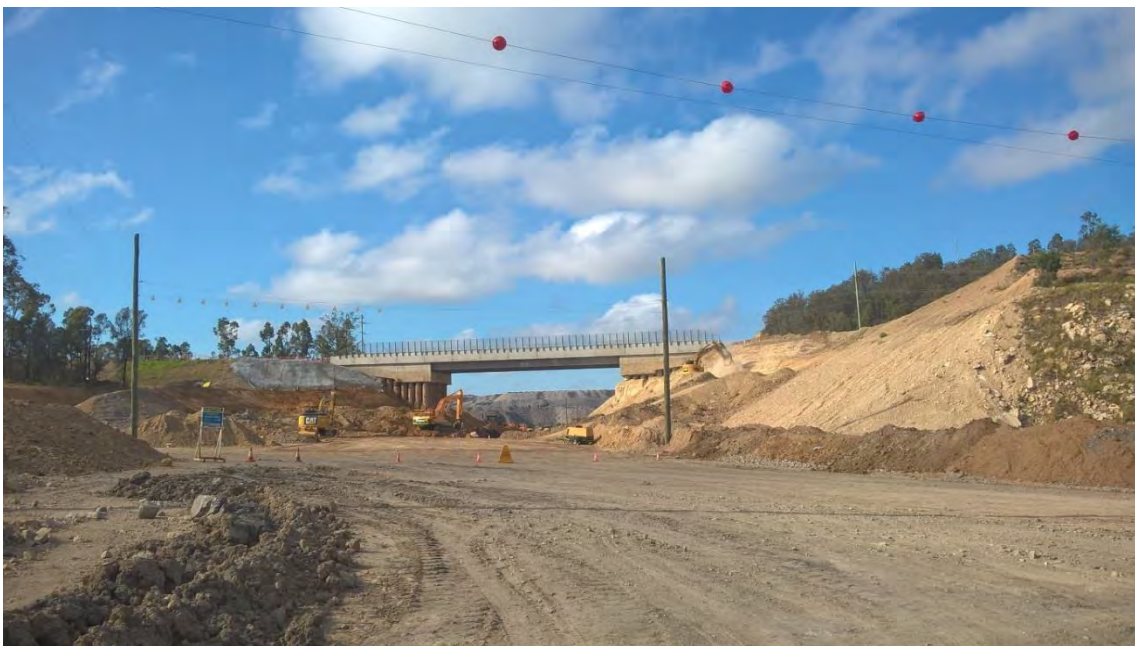
FIGURE 4: PUTTY ROAD THIRD CROSSING - MINE VIEW LOOKING SOUTH

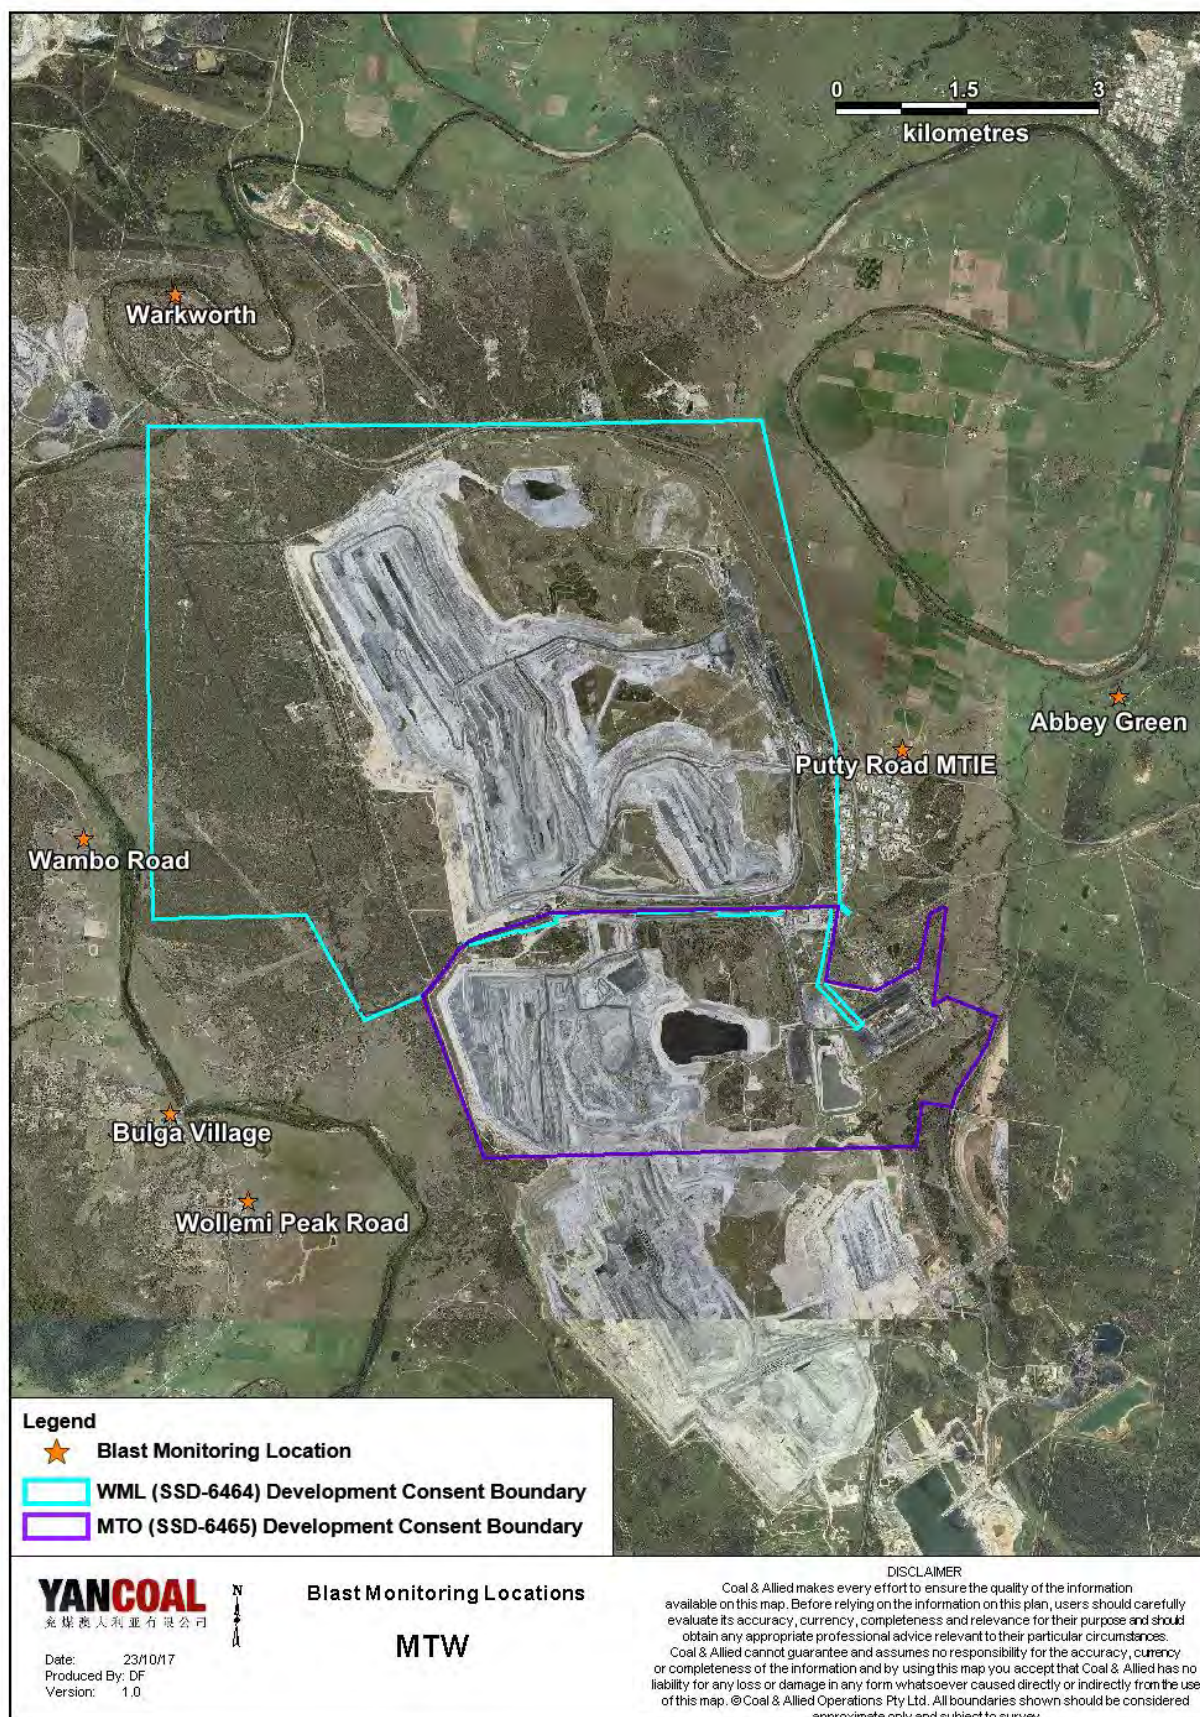
FIGURE 5: BLAST MONITORING LOCATIONS

- Abbey Green (Abbey Green Station, Putty Road, Glenridding);
- Bulga Village (Wambo Road, Bulga);
- Putty Road, Mount Thorley (known as MTIE -)
- Wambo Road (Wambo Road, Bulga);
- Warkworth Village (former Warkworth Public School, Warkworth); and
- Wollemi Peak Road (intersection of Putty & Wollemi Peak Roads, Bulga).

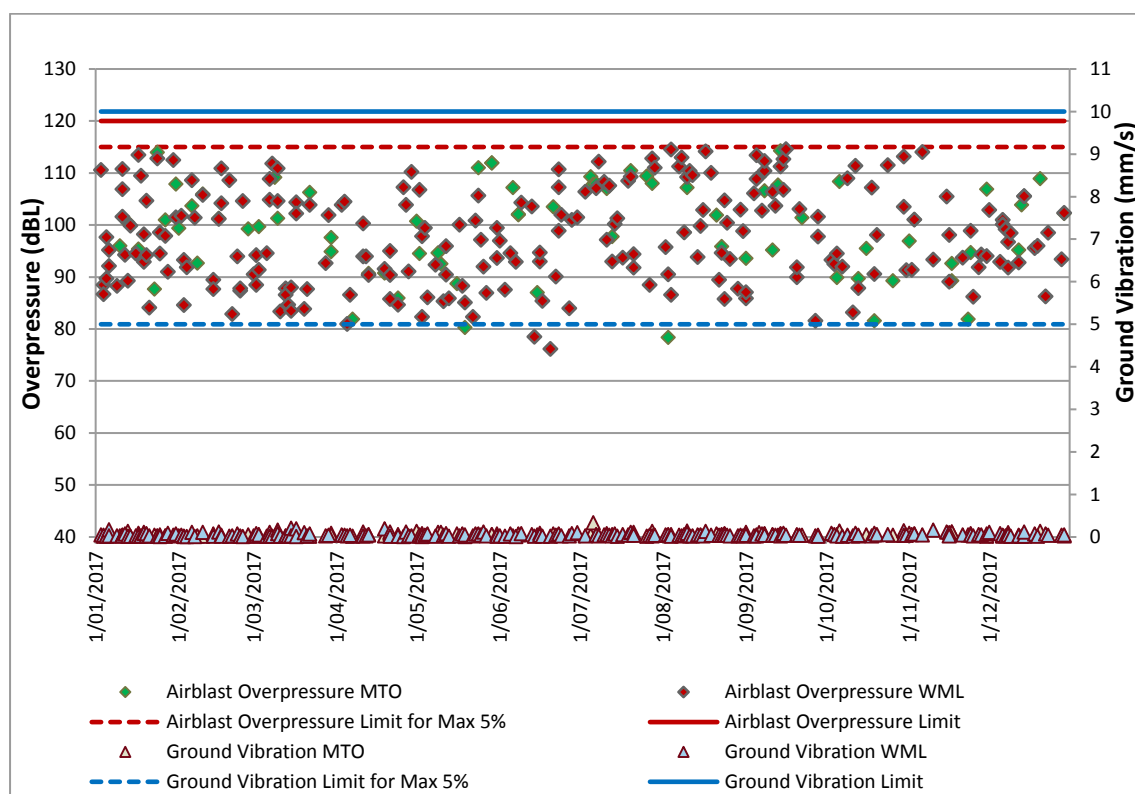
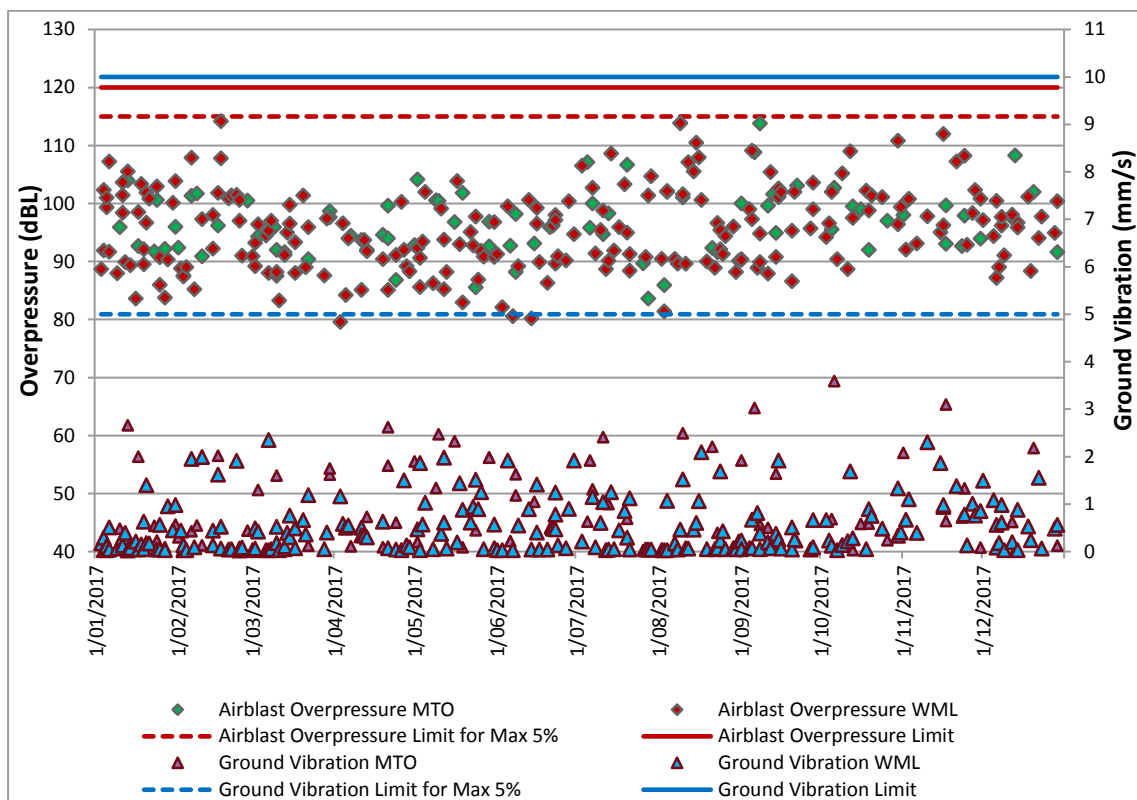
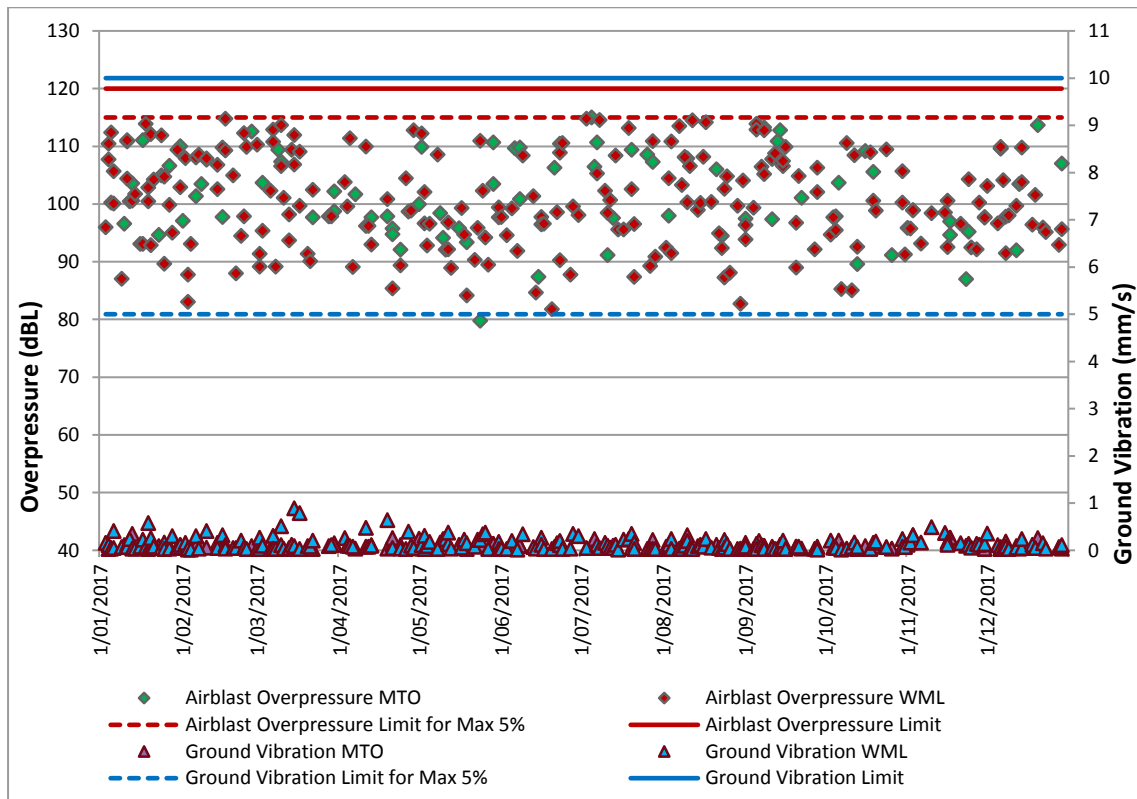
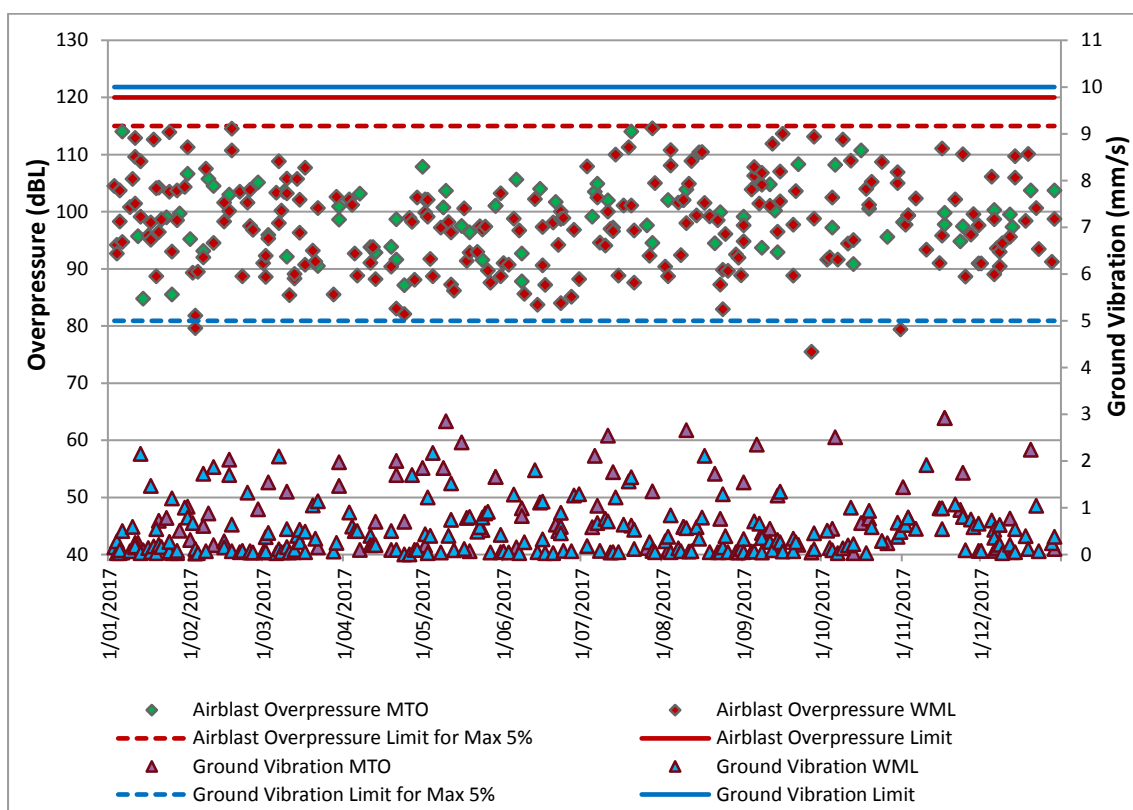
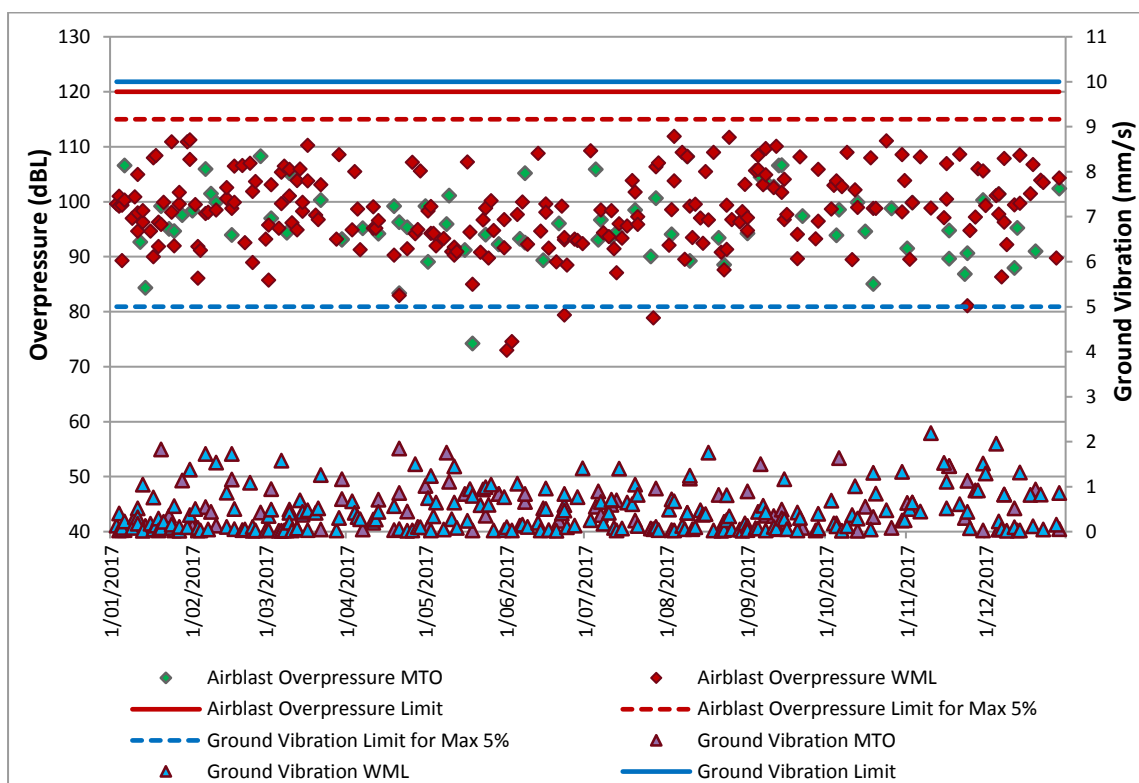
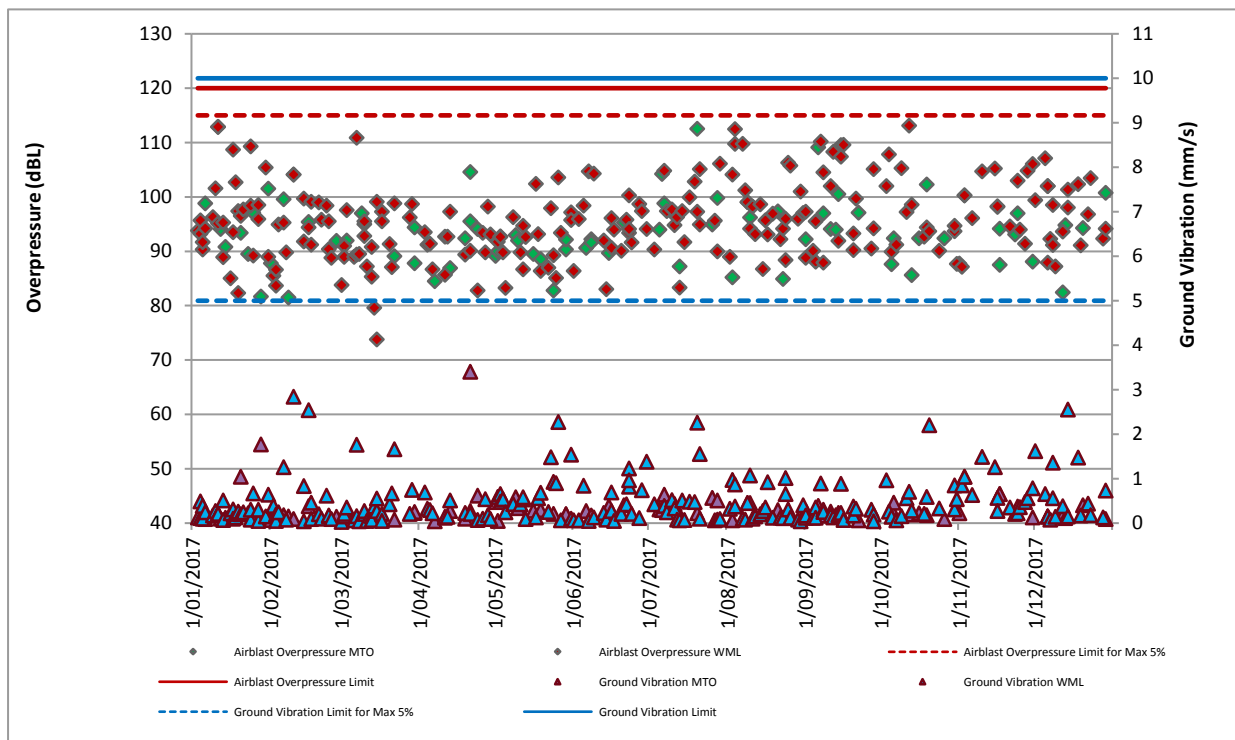
FIGURE 6: ABBEY GREEN BLASTING RESULTS

FIGURE 7: BULGA VILLAGE BLAST RESULTS

FIGURE 8: MTIE BLAST RESULTS

FIGURE 9: WOLLEMI PEAK ROAD BULGA BLAST RESULTS

FIGURE 10: WAMBO ROAD BLAST RESULTS

FIGURE 11: WARKWORTH BLAST RESULTS

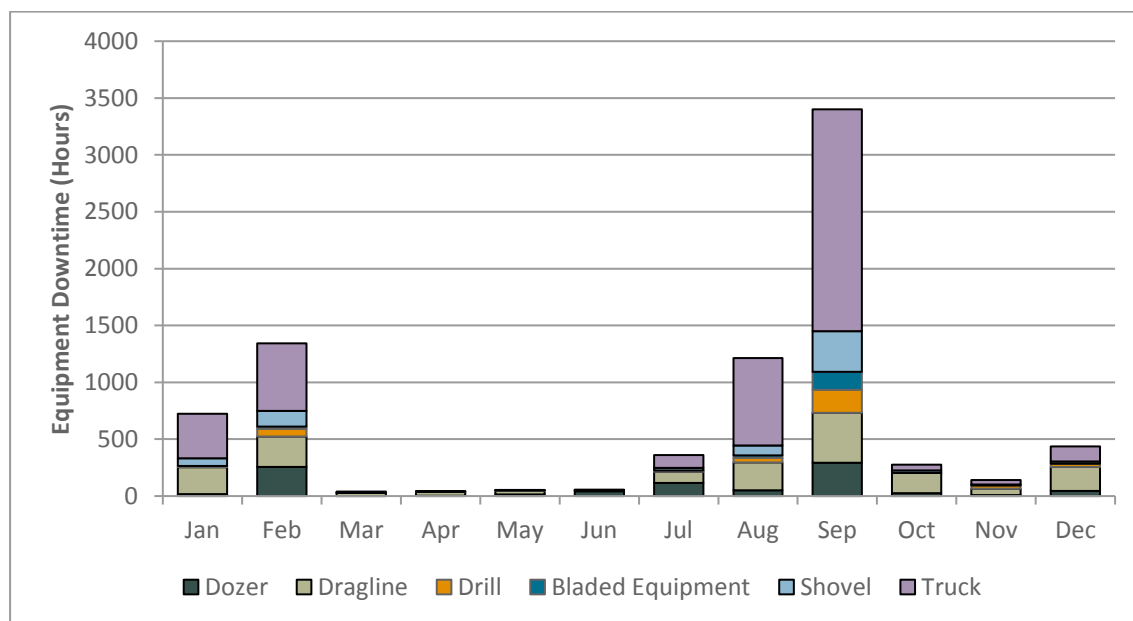
FIGURE 12: EQUIPMENT DOWNTIME FOR DUST MANAGEMENT BY MONTH

1,603 real-time alarms for air quality and wind conditions were received and acknowledged during 2017. In response, 8,030 hours of equipment downtime was recorded due to air quality management. A detailed breakdown of air quality related equipment stoppages (per month, per equipment type) is presented in Figure 12.

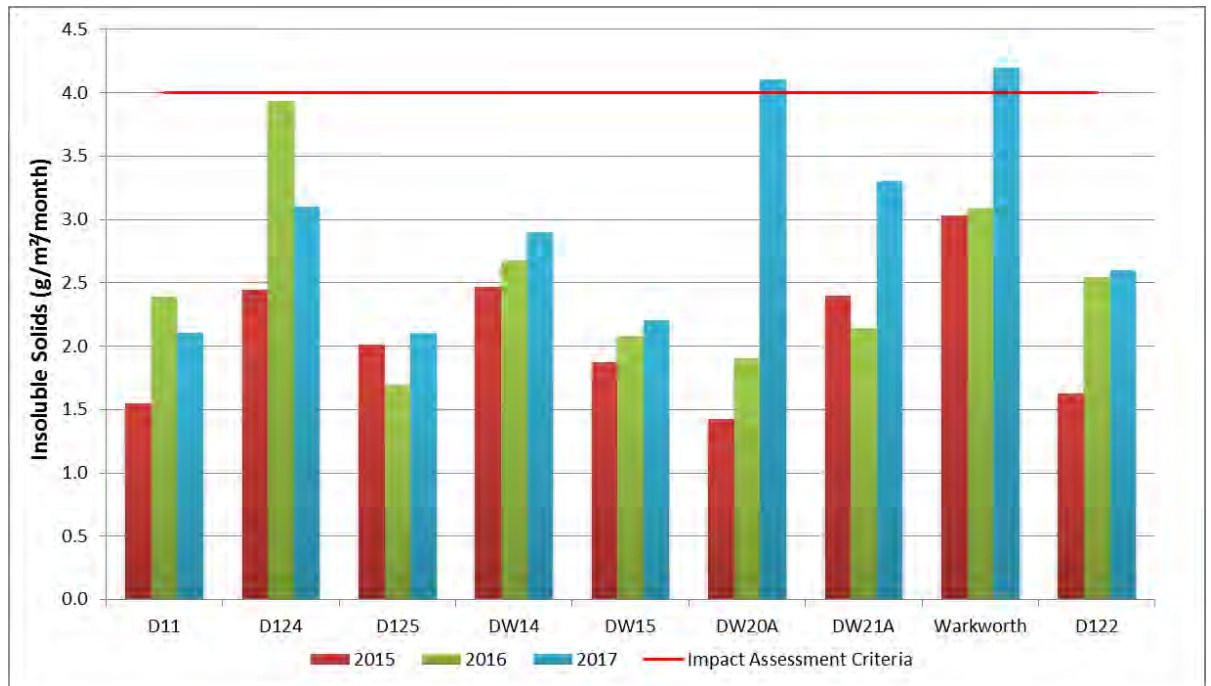
FIGURE 15: 2017 DEPOSITIONAL DUST RESULTS COMPARED AGAINST THE IMPACT ASSESSMENT CRITERIA AND PREVIOUS YEARS' RESULTS

presented in the relevant MTW Monthly Environmental Monitoring Report. The graphs below illustrate a general trend in increased Depositional Dust across the board compared to previous year's. This is consistent with adverse meteorological conditions of low rain fall and consistent wind days.

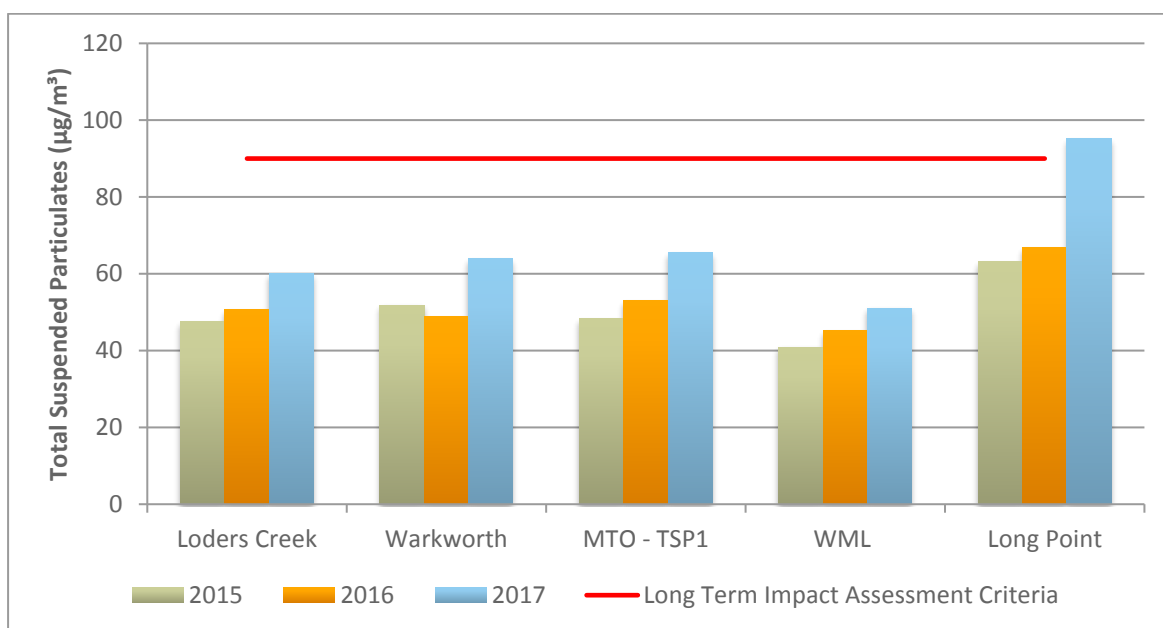
FIGURE 17: 2017 TSP ANNUAL AVERAGE COMPARED AGAINST THE IMPACT ASSESSMENT CRITERIA AND PREVIOUS YEARS' RESULTS

The annual average TSP concentrations recorded in 2017 are higher than those recorded in previous years, which is likely related to well below average rainfall for the year (Figure 17).

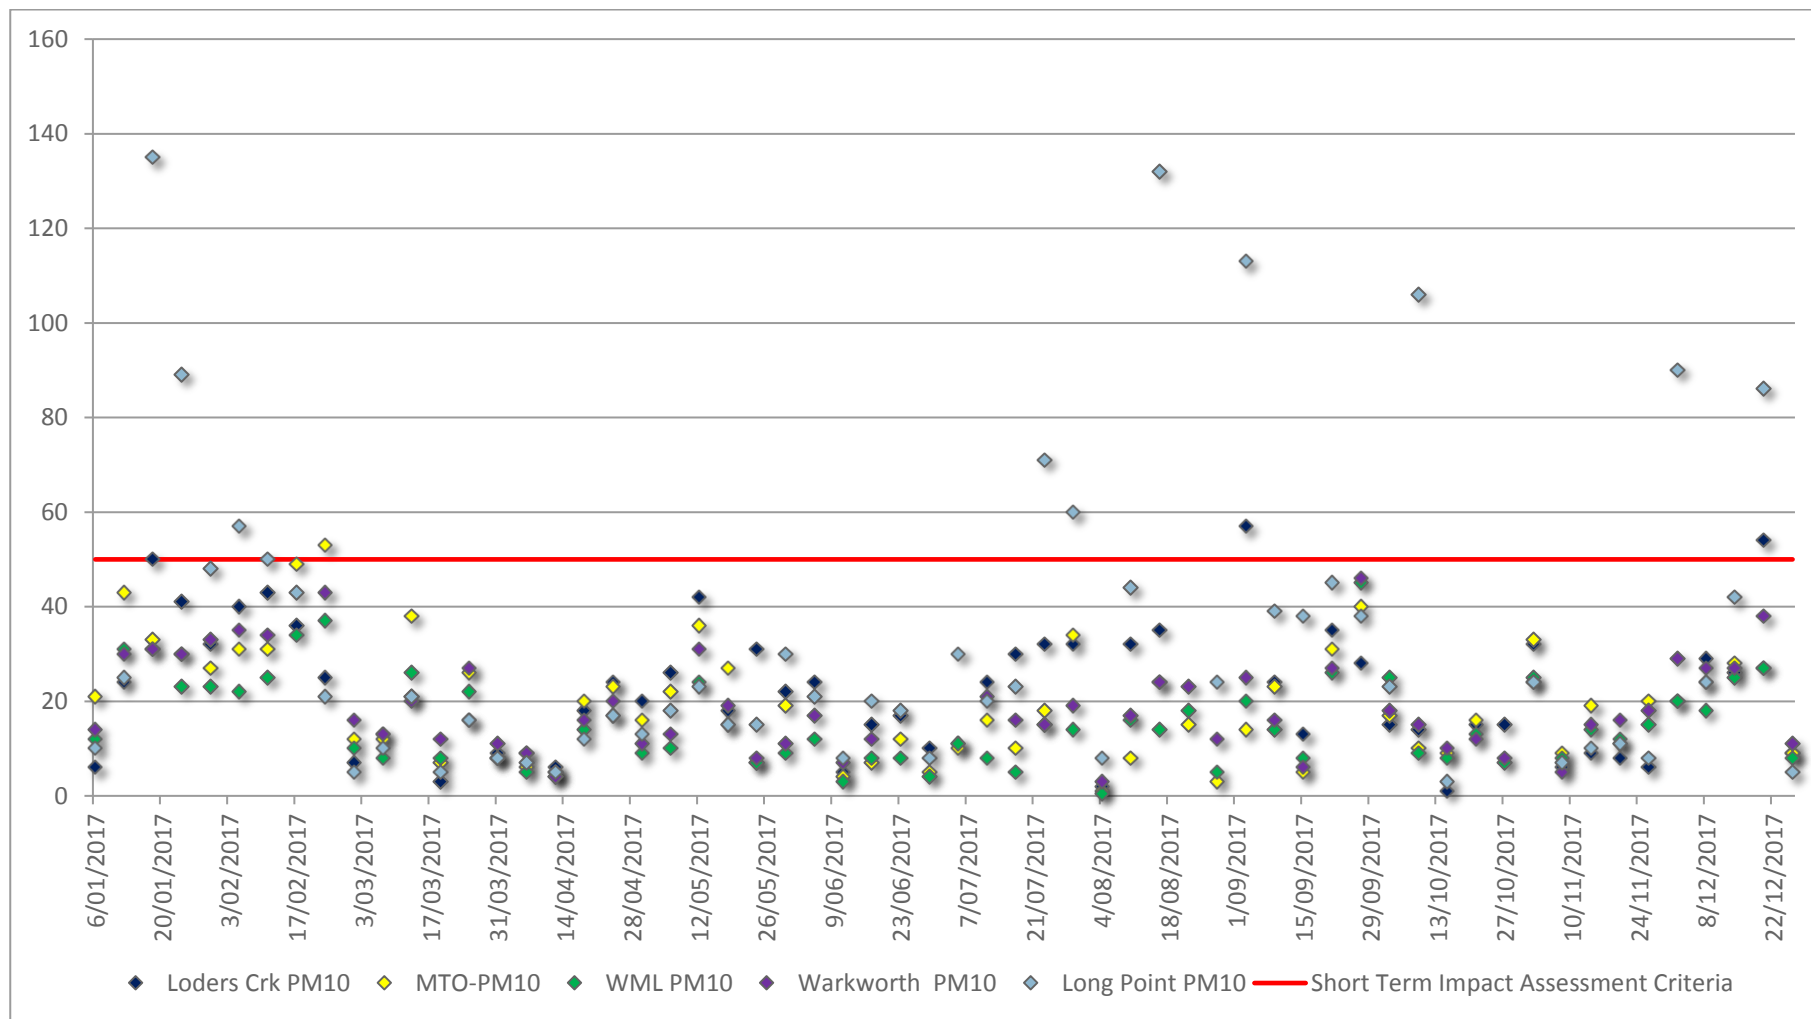
FIGURE 18: PM₁₀ 24HR MONITORING RESULTS (MEASURED BY MTW PM₁₀ HVAS NETWORK)

Monitoring results for PM₁₀ (24 hour) collected through the High-Volume Air Sampler monitoring network are compared against the short-term impact assessment criteria (Figure 18). All 24hr average results recorded by MTW's surrounding network of TEOM monitors are presented on a quarterly basis in Figure 19 to Figure 22.

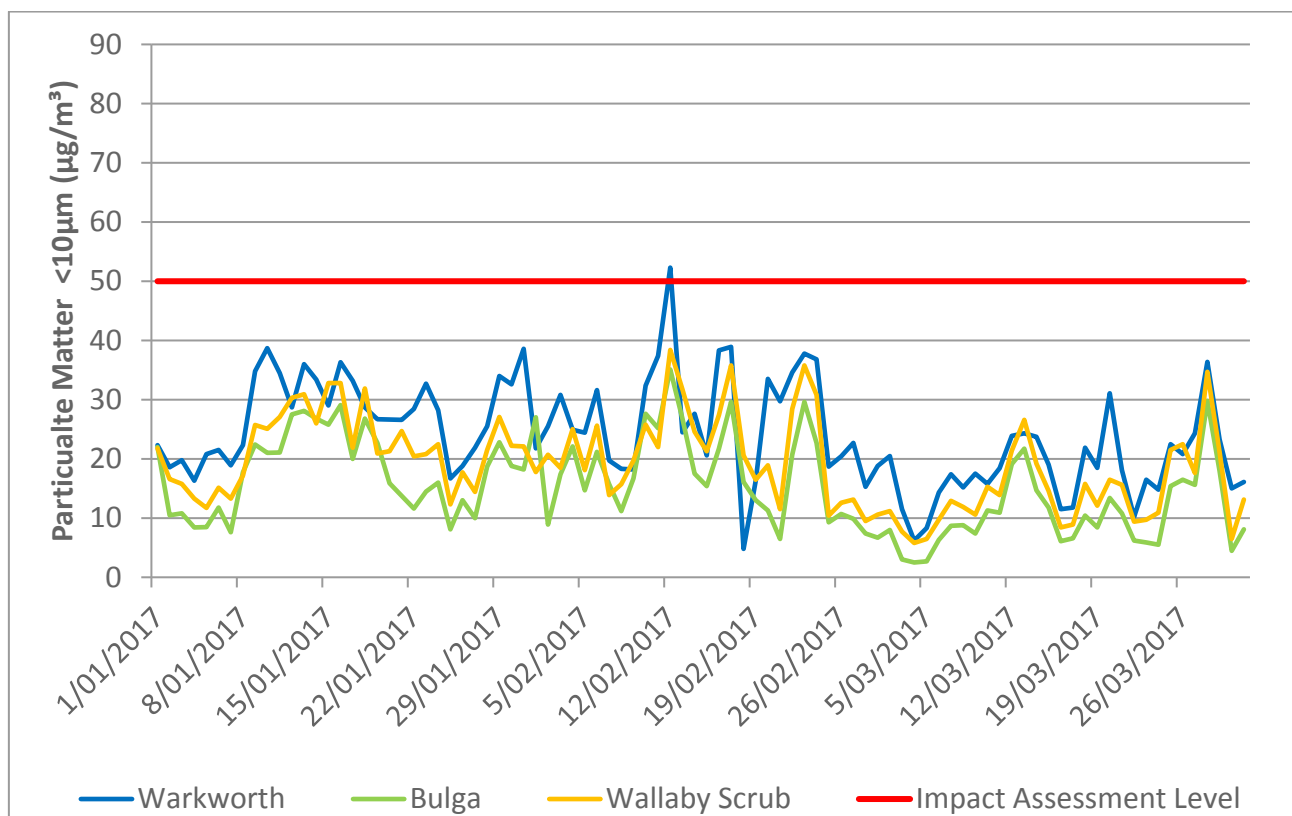
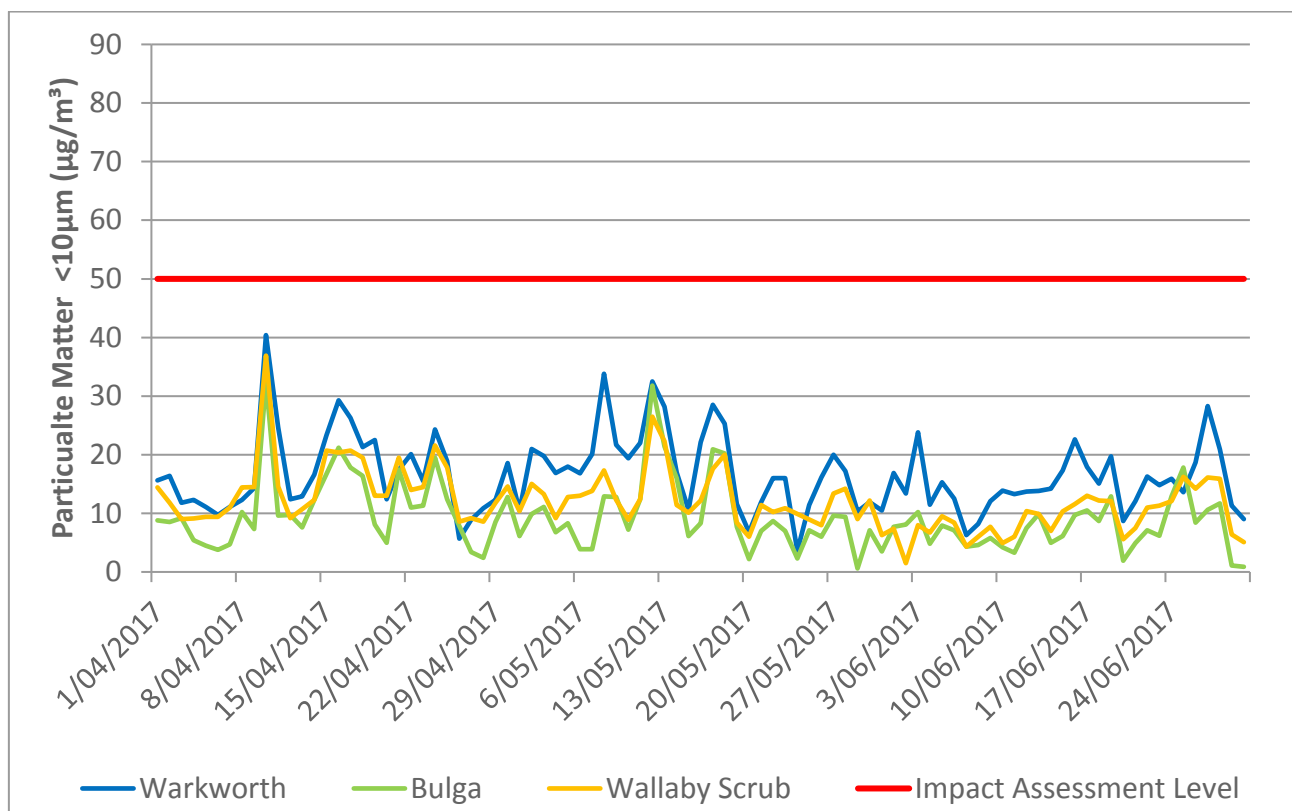
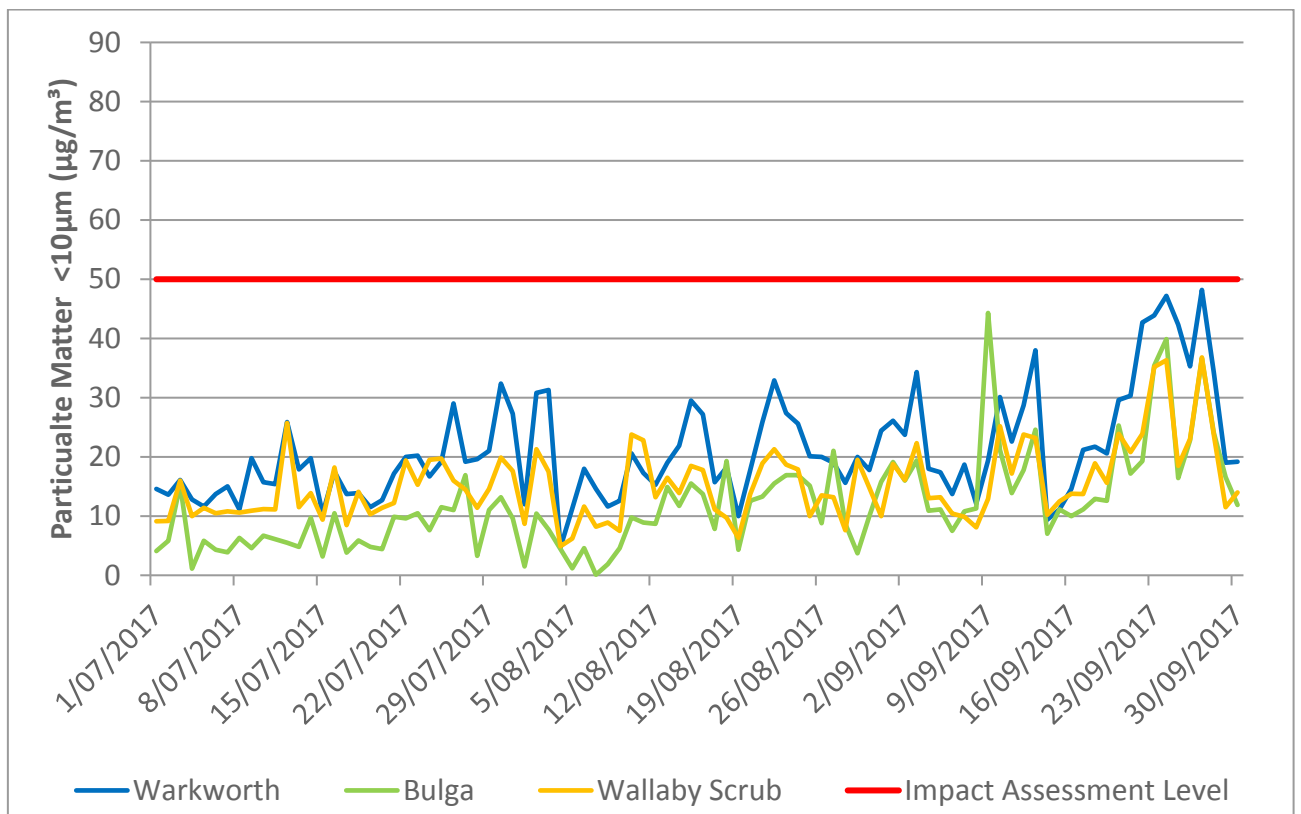
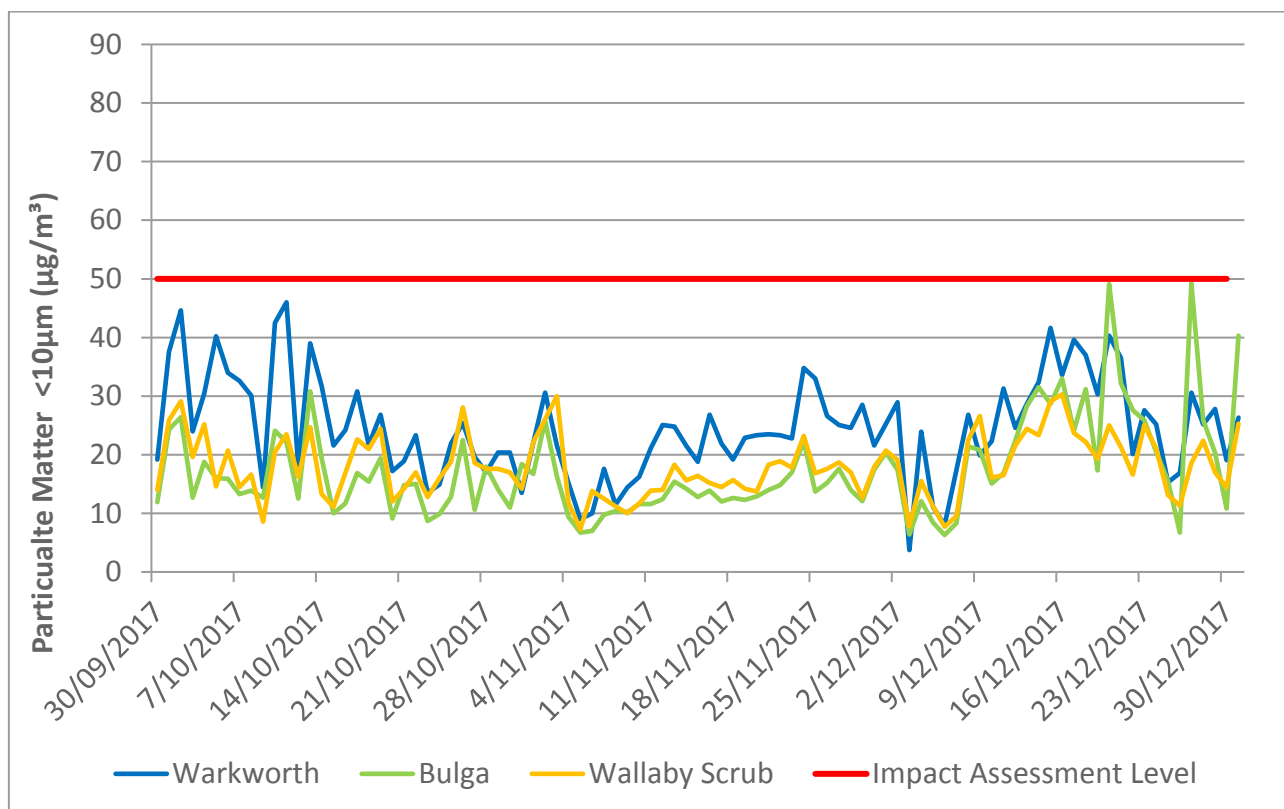
FIGURE 19: 24HR AVERAGE PM₁₀ MEASURED AT TEOM MONITORS SURROUNDING MTW - QUARTER ONE 2017

FIGURE 20: 24HR AVERAGE PM₁₀ MEASURED AT TEOM MONITORS SURROUNDING MTW - QUARTER TWO 2017

FIGURE 21: 24HR AVERAGE PM₁₀ MEASURED AT TEOM MONITORS SURROUNDING MTW - QUARTER THREE 2017

FIGURE 22: 24HR AVERAGE PM₁₀ MEASURED AT TEOM MONITORS SURROUNDING MTW - QUARTER FOUR 2017

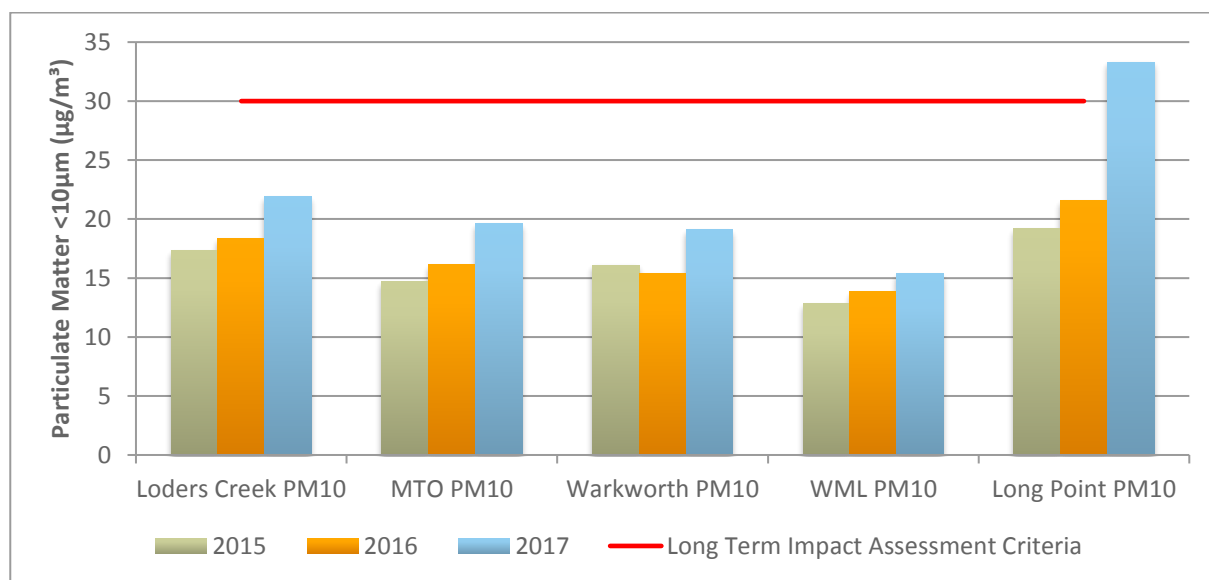
FIGURE 23: ANNUAL AVERAGE HVAS PM₁₀ RESULTS 2015 TO 2017

All monitoring locations recorded increases in PM₁₀ compared to 2016. This is likely related to below average rainfall for the year, substantially lower than the 2016 total.

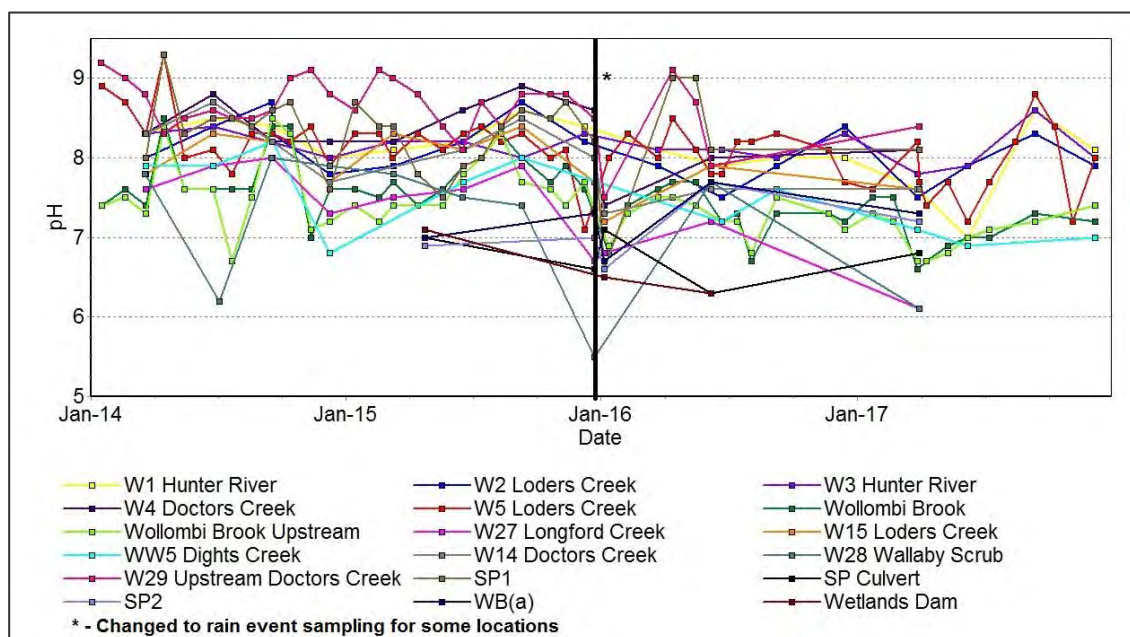
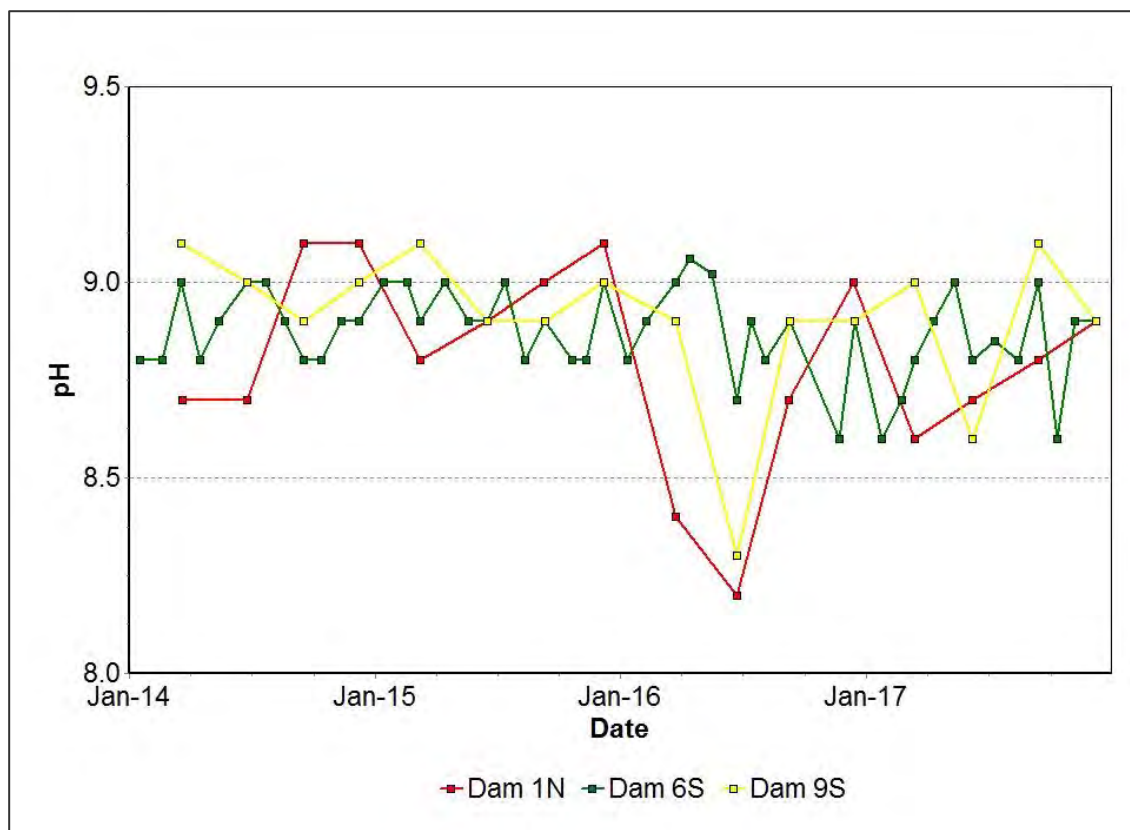
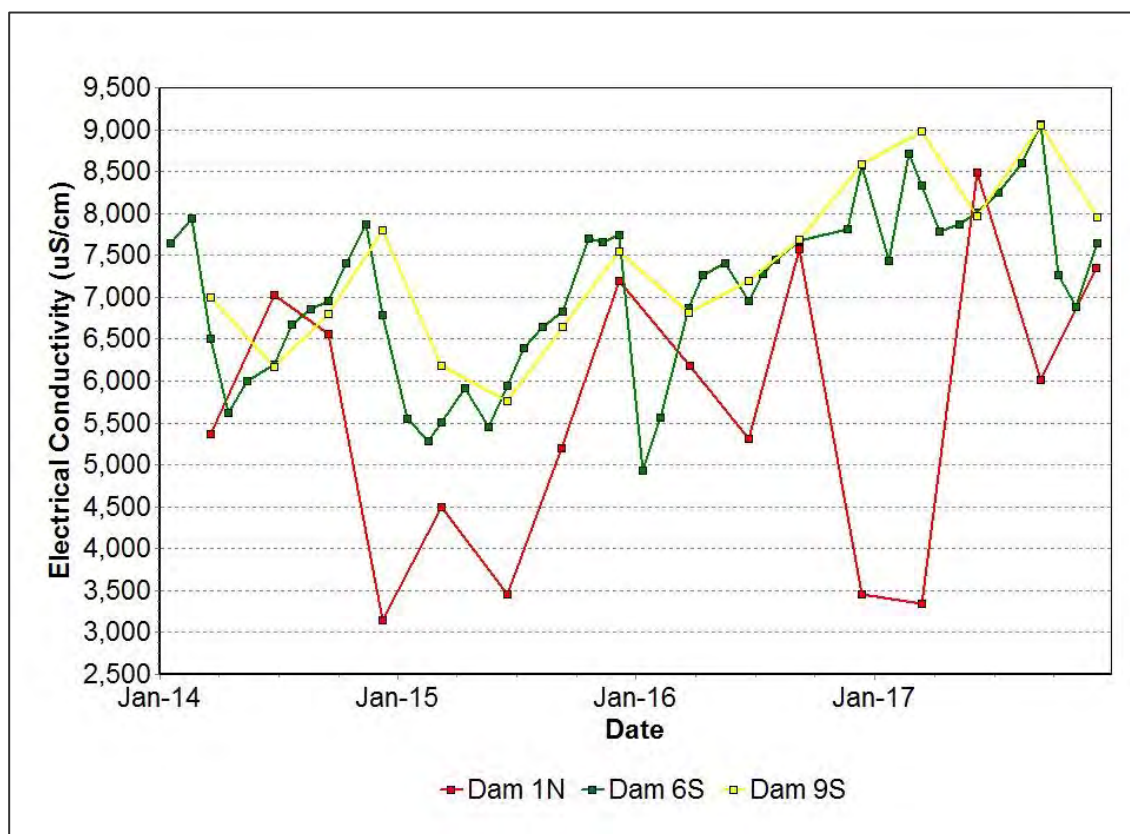
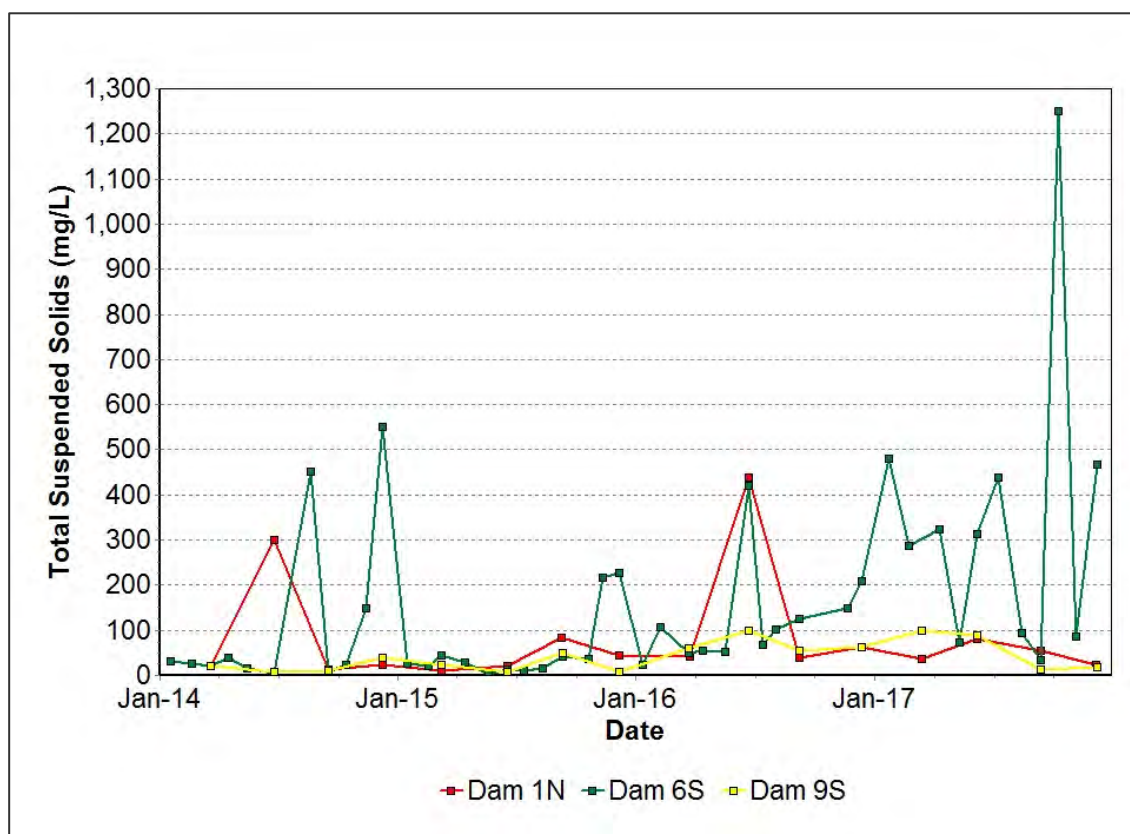
FIGURE 28: WATERCOURSE PH TRENDS 2014 TO 2017

FIGURE 31: SITE DAMS PH TRENDS 2014 TO 2017

FIGURE 32: SITE DAMS EC TRENDS 2014 TO 2017

FIGURE 33: SITE DAMS TSS TRENDS 2014 TO 2017

Figure 28 to Figure 33 show long term water quality trends for the Hunter River, Wollombi Brook, other surrounding tributaries and site dams. Measurements of EC and pH were generally stable during the reporting period and consistent with historical seasonal trends. Electrical conductivity shows an increasing trend during 2017 in site Dams 6S and 9S; drier weather conditions resulted in evapo-concentration of salts in mine water, combined with reduced fresh-water inputs from rainfall runoff.
