Mount Thorley Warkworth

2017 Annual Review

MT THORLEY WARKWORTH

Mount Thorley Warkworth (MTW) is an integrated operation of two open cut coal mines, Warkworth Mining Limited (WML) and Mount Thorley Operations (MTO). This Annual Review reports on the environmental performance of Mount Thorley Warkworth (MTW) for the period 1 January 2017 to 31 December 2017.

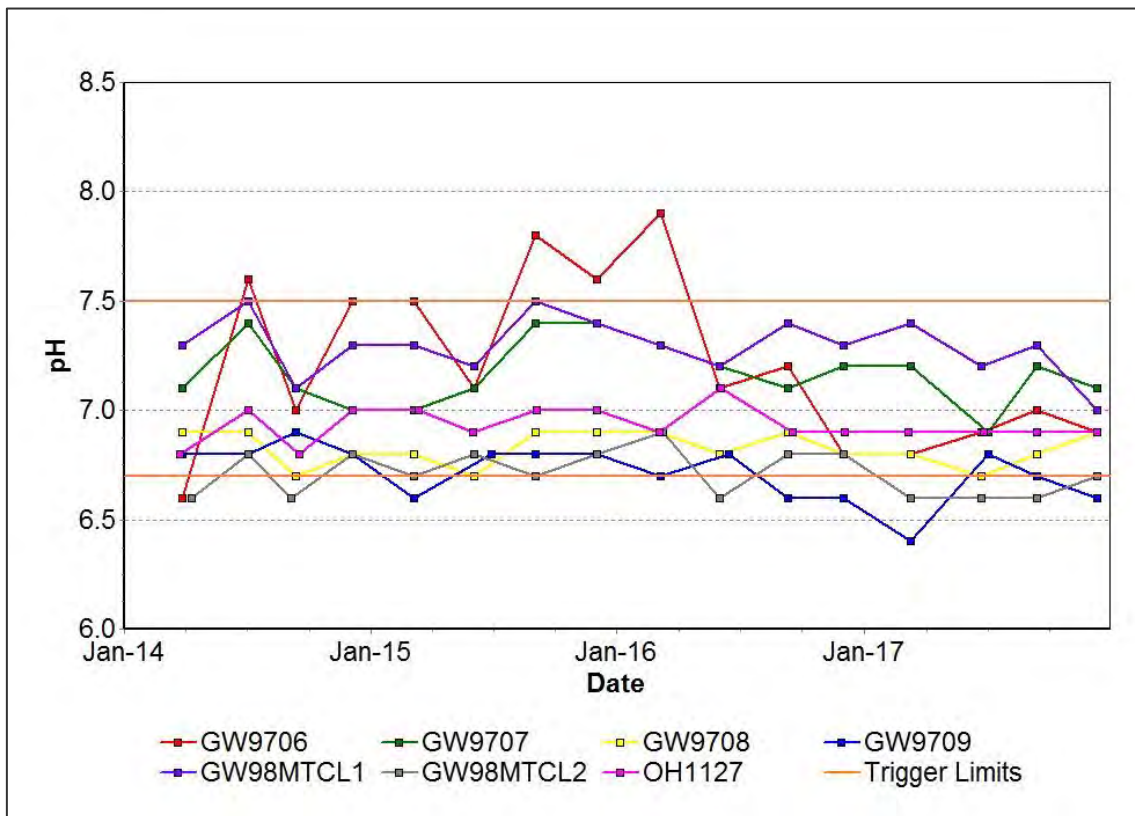
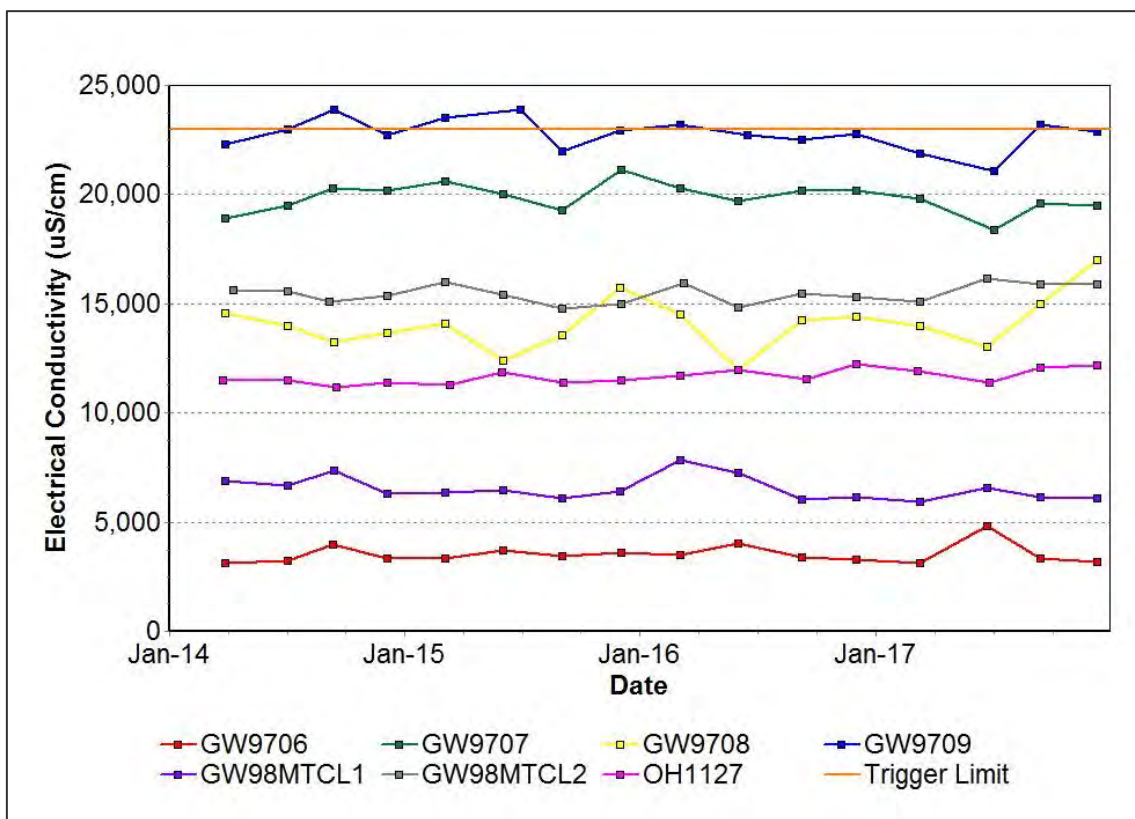
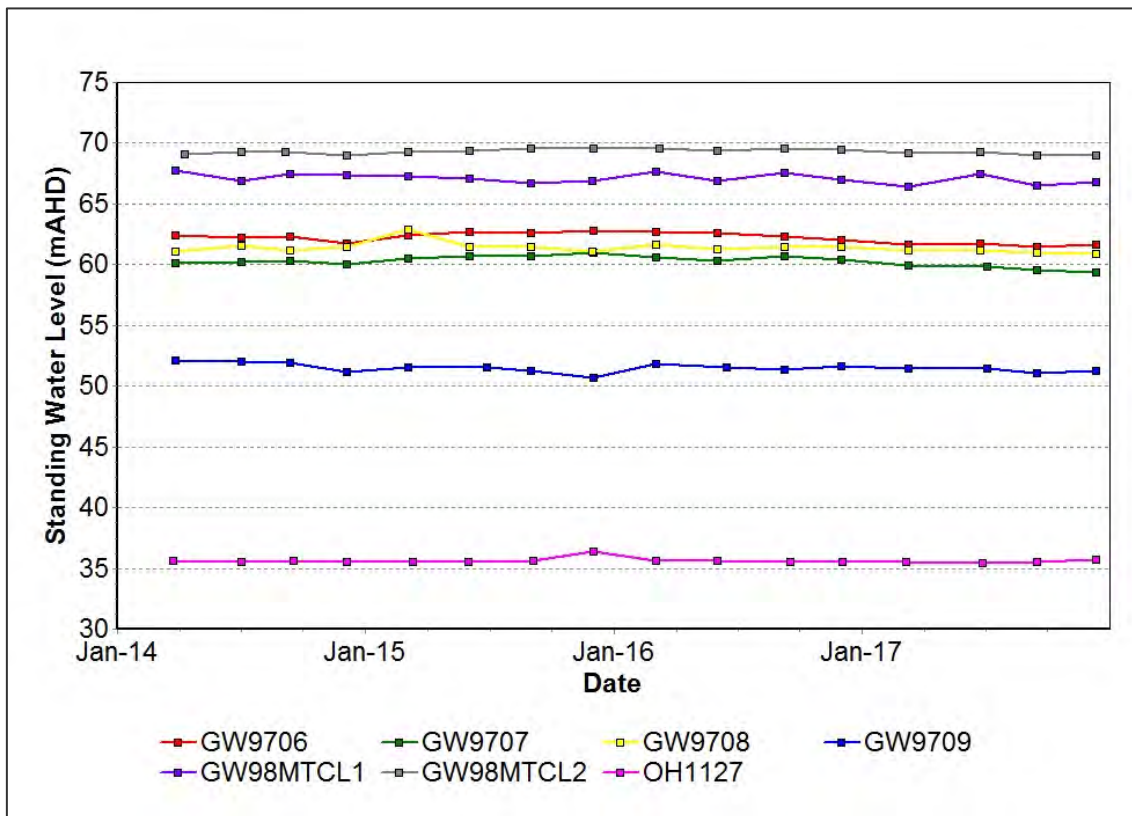
FIGURE 35: BAYSWATER SEAM PH TRENDS 2014TO 2017

FIGURE 36: BAYSWATER SEAM EC TRENDS 2014 TO 2017

FIGURE 37: BAYSWATER SWL TRENDS 2014 TO 2017

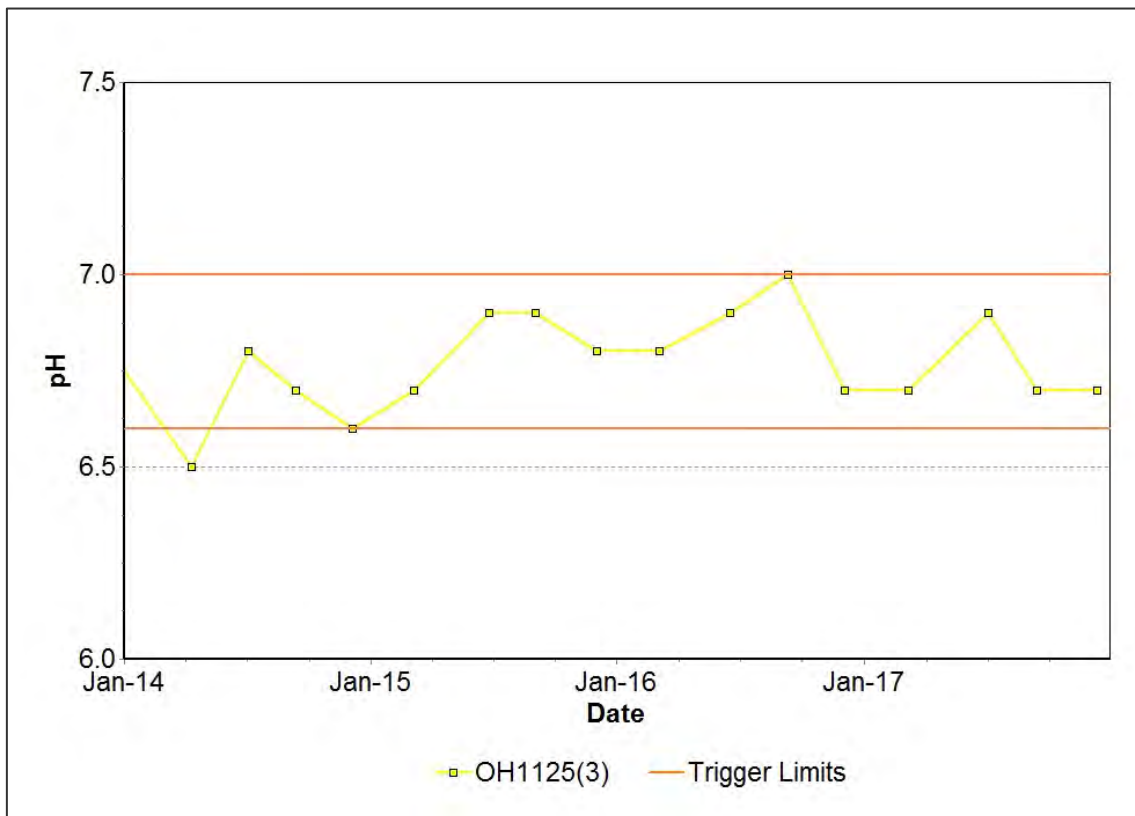
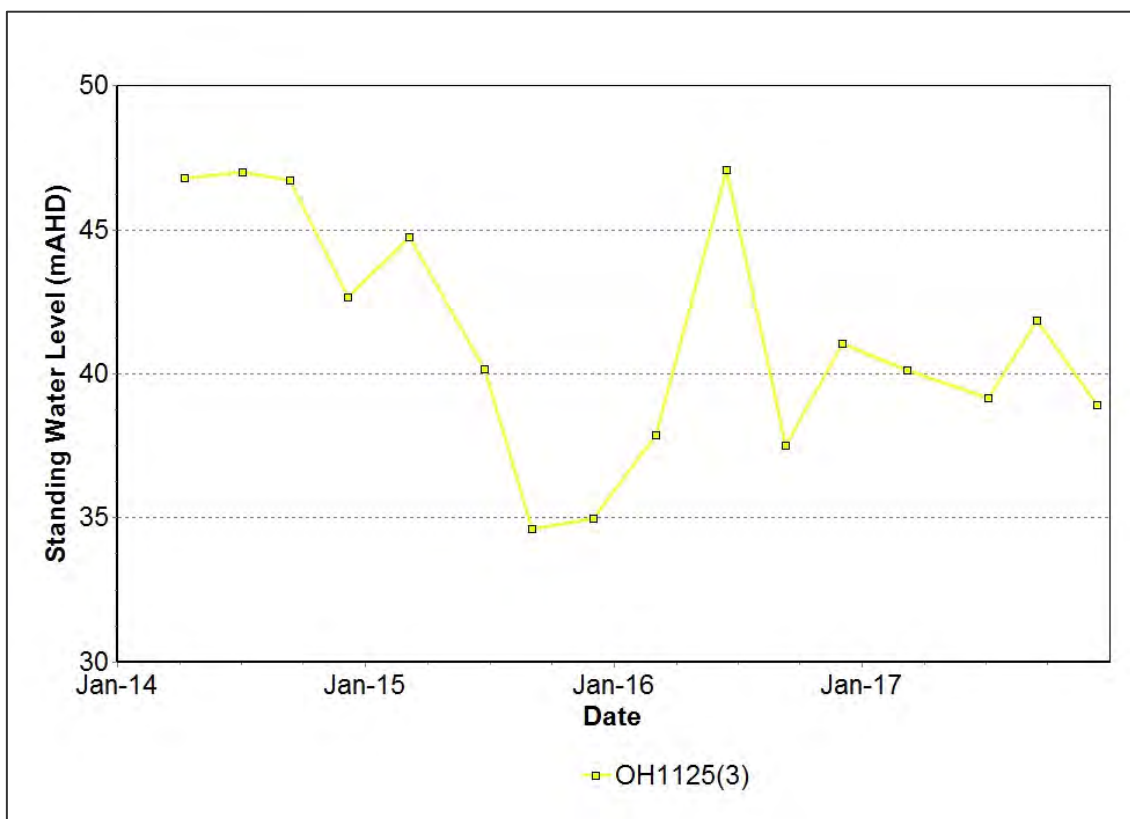
FIGURE 38 : BOWFIELD SEAM PH TREND 2014 TO 2017

FIGURE 40: BOWFIELD SEAM SWL TREND 2014 TO 2017

Groundwater monitoring in the Bowfield seam was undertaken at one site during 2017. A total of 4 samples were collected during the reporting period. The pH, EC and SWL trends for 2014 to 2017 are shown in Figure 38, Figure 39 and Figure 40 respectively. Water quality results were similar to historical data.

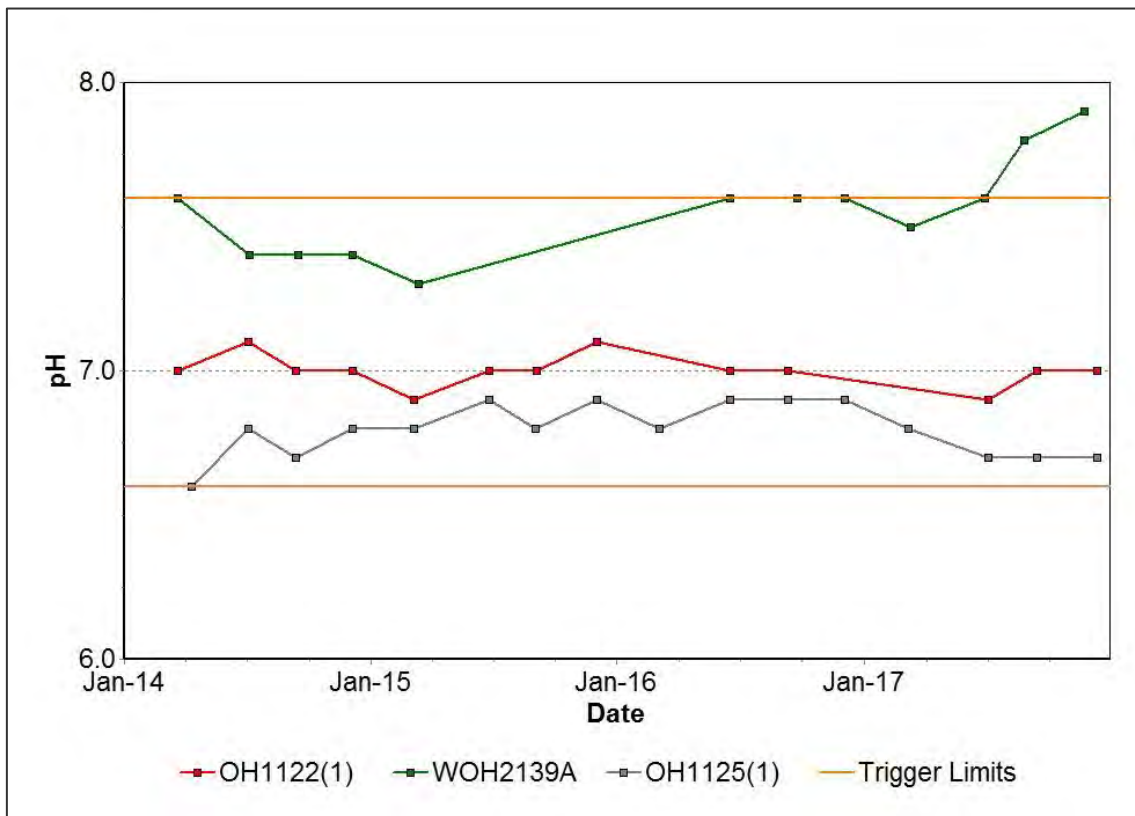
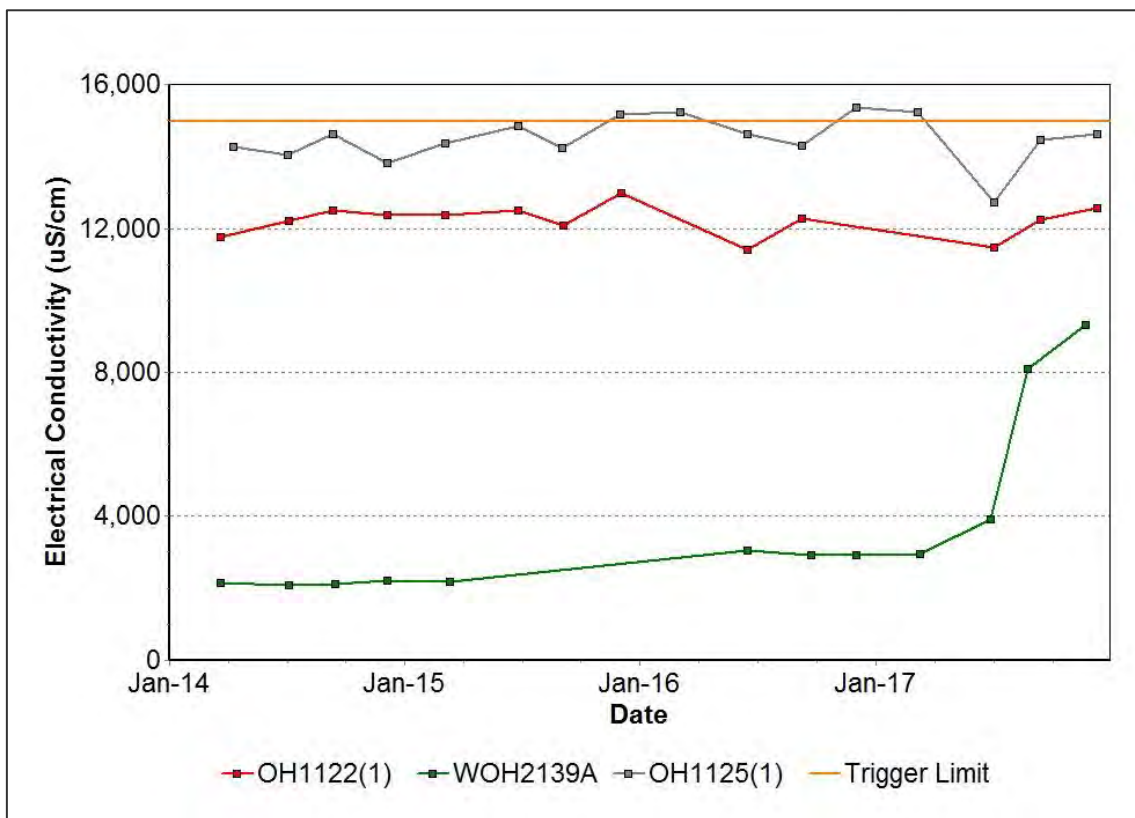
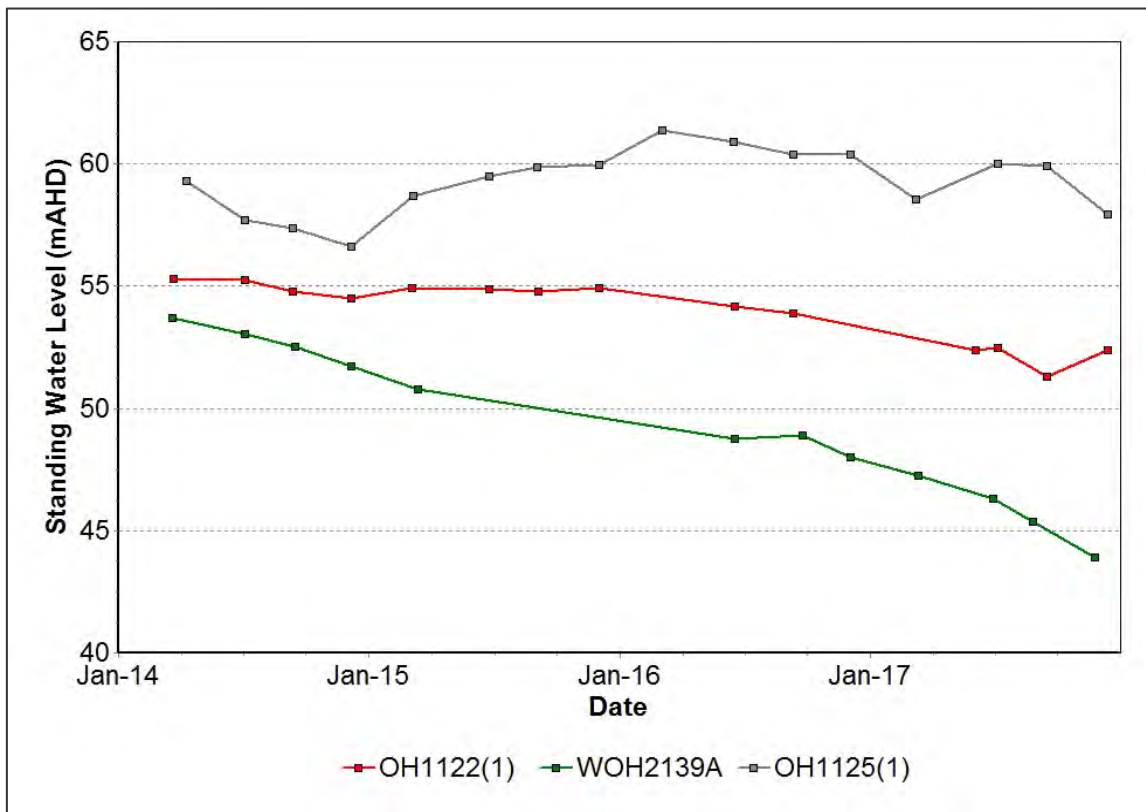
FIGURE 41: BLAKEFIELD SEAM GROUNDWATER PH TRENDS 2014 TO 2017

FIGURE 42: BLAKEFIELD SEAM GROUNDWATER EC TRENDS 2014 TO 2017

FIGURE 43: BLAKEFIELD SEAM GROUNDWATER SWL TRENDS 2014 TO 2017

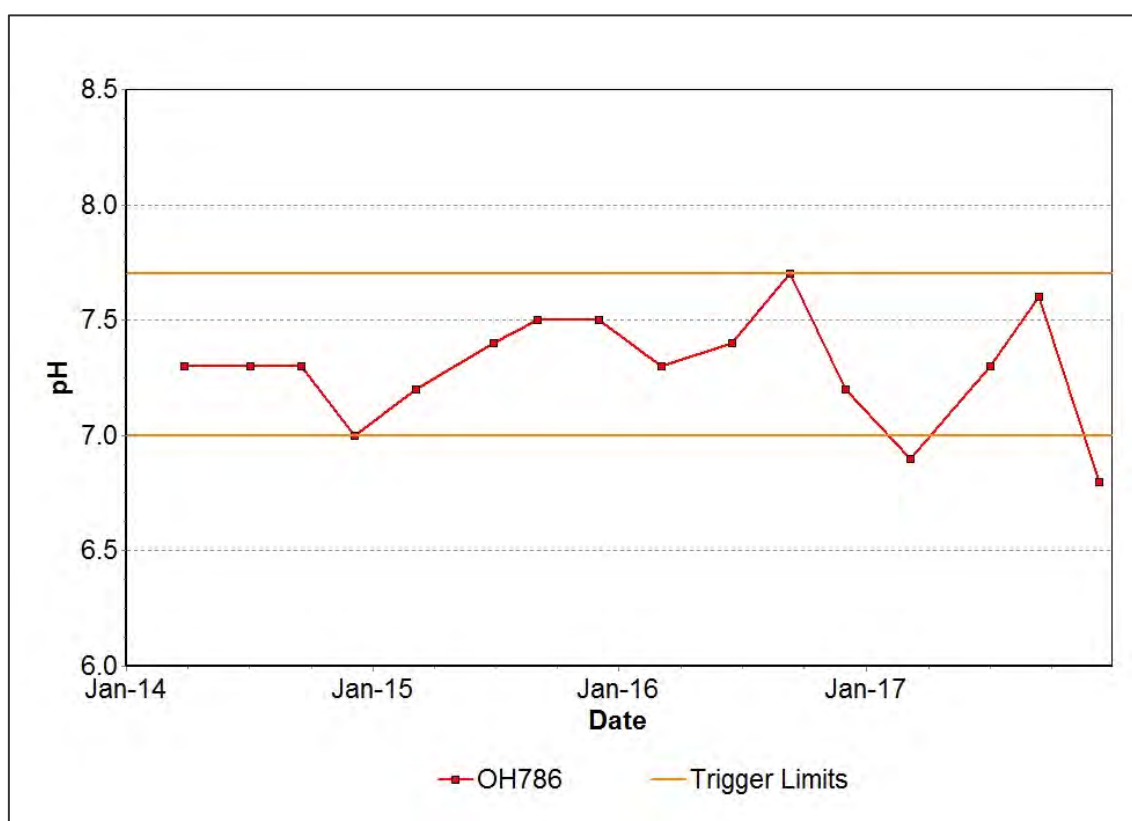
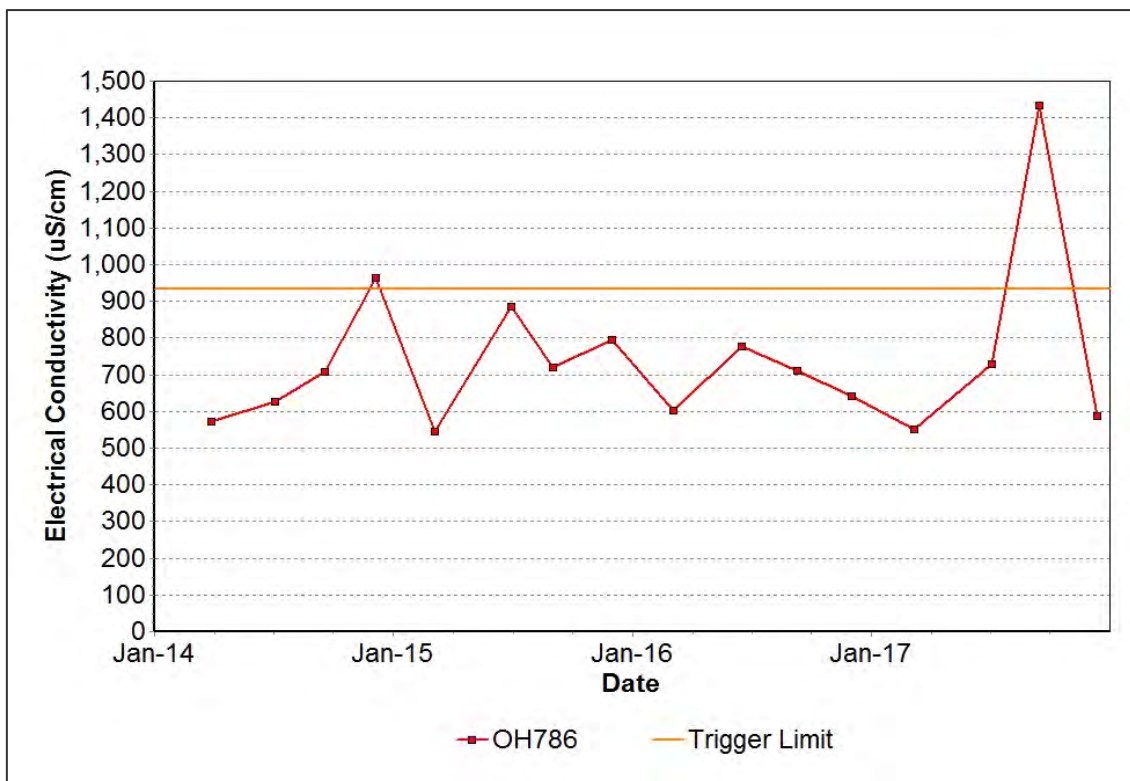
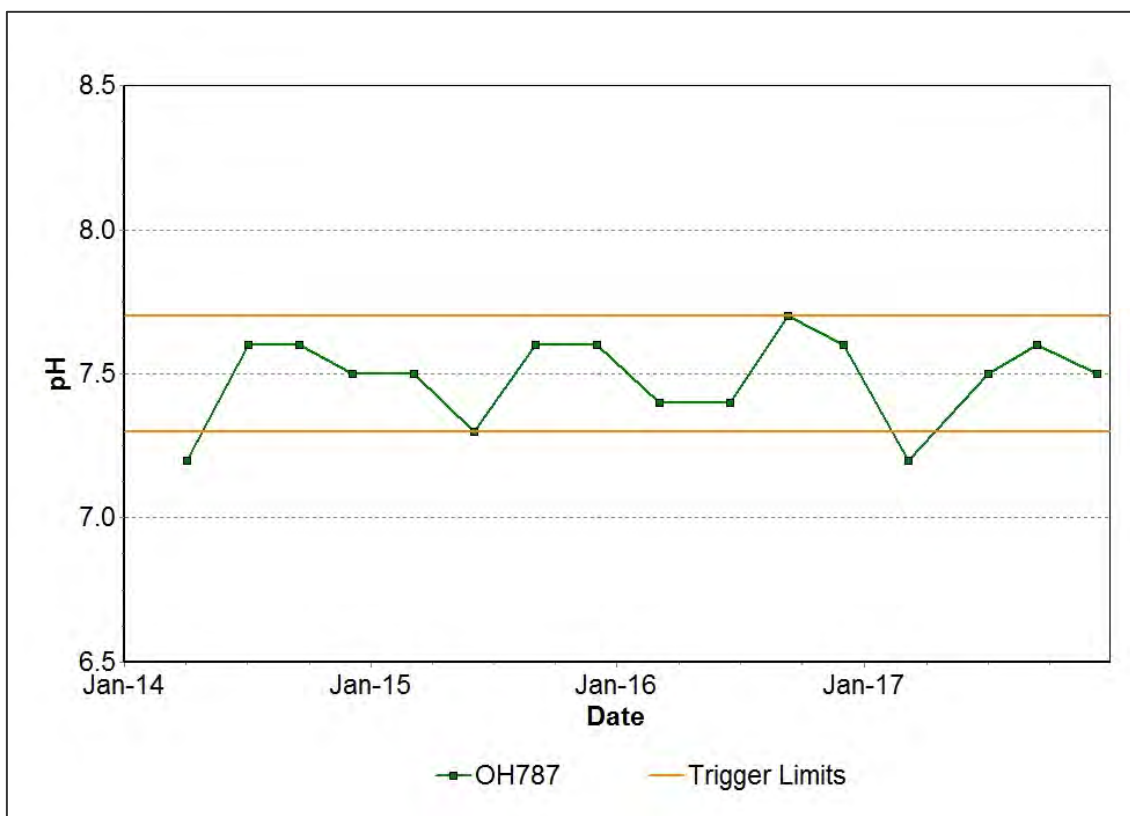
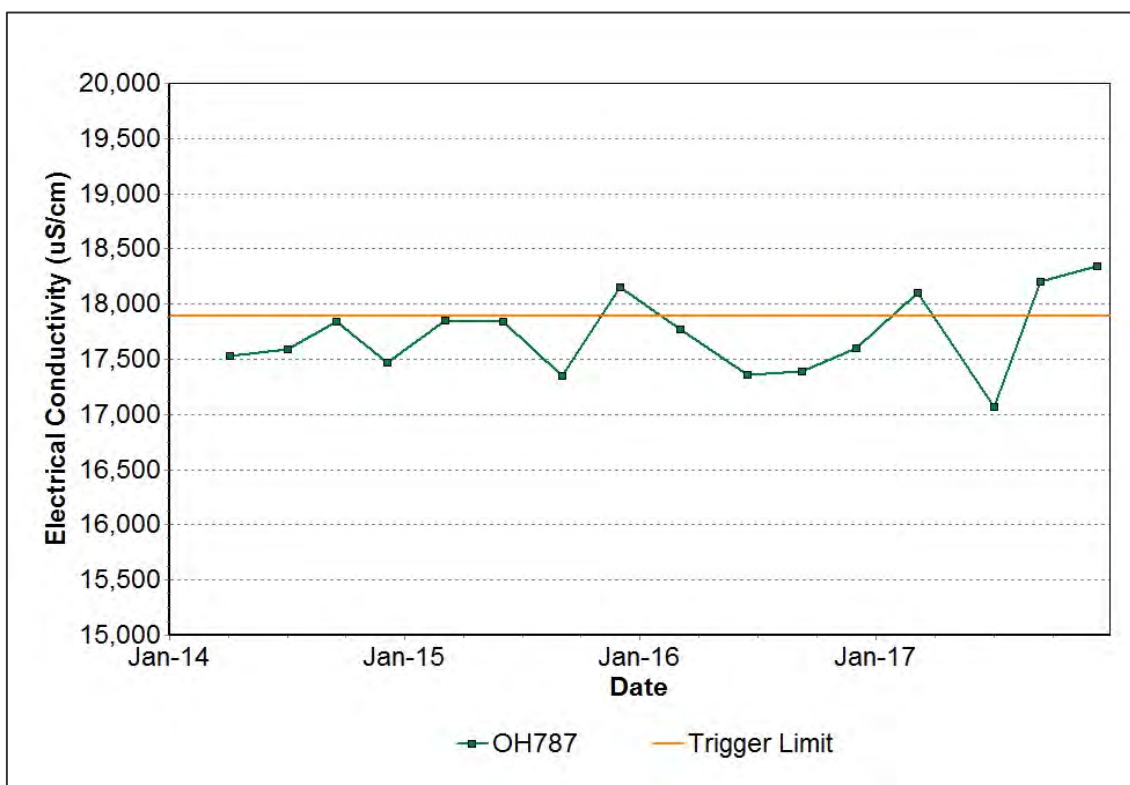
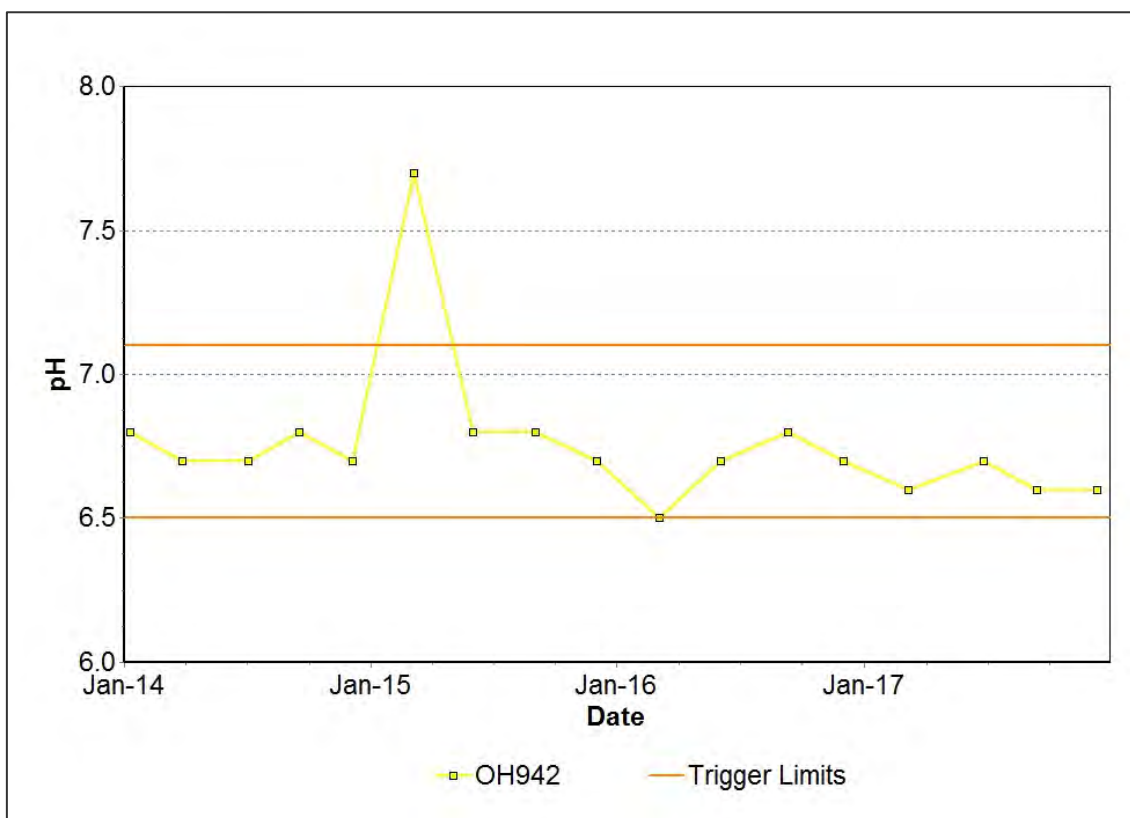
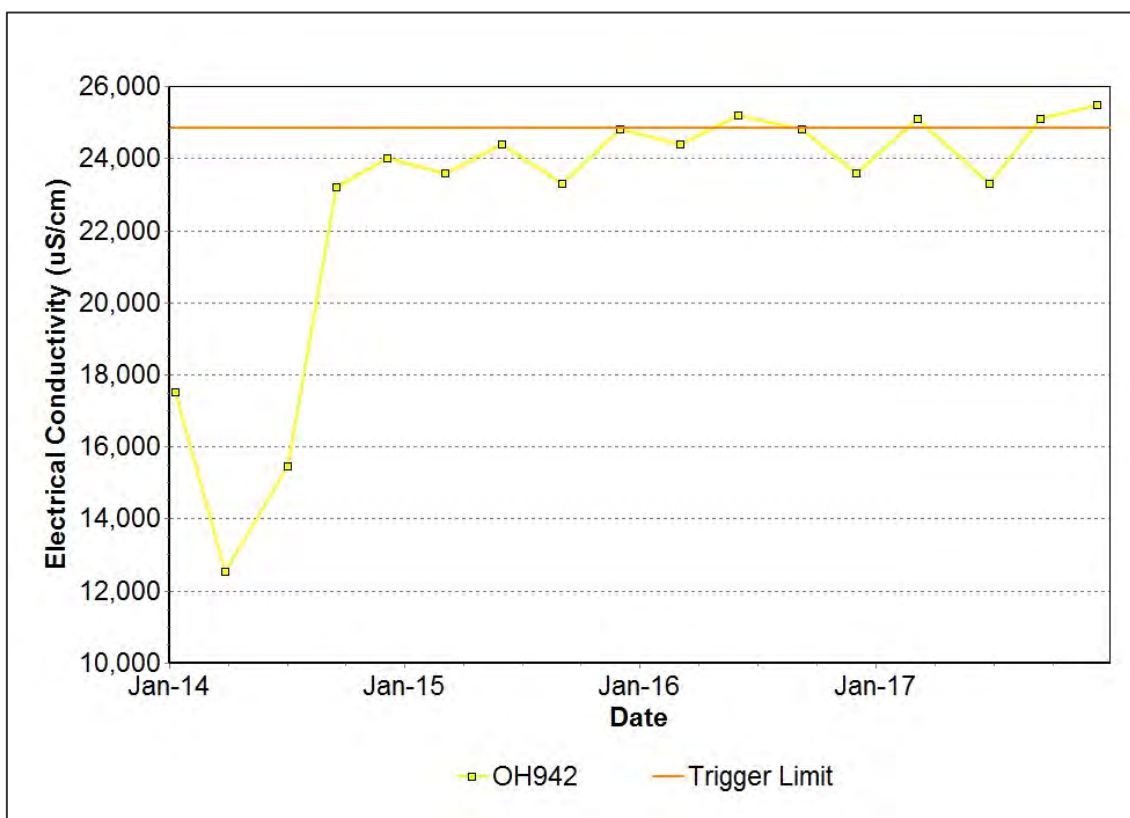
FIGURE 44: HUNTER RIVER ALLUVIUM BORE OH786 PH TREND 2014 TO 2017

FIGURE 45: HUNTER RIVER ALLUVIUM BORE OH786 EC TREND 2014 TO 2017

FIGURE 46: HUNTER RIVER ALLUVIUM BORE OH787 PH TREND 2014 TO 2017

FIGURE 47: HUNTER RIVER ALLUVIUM BORE OH787 EC TREND 2014 TO 2017

FIGURE 48: HUNTER RIVER ALLUVIUM BORE OH942 PH TREND 2014 TO 2017

FIGURE 49: HUNTER RIVER ALLUVIUM BORE OH942 EC TREND 2014 TO 2017

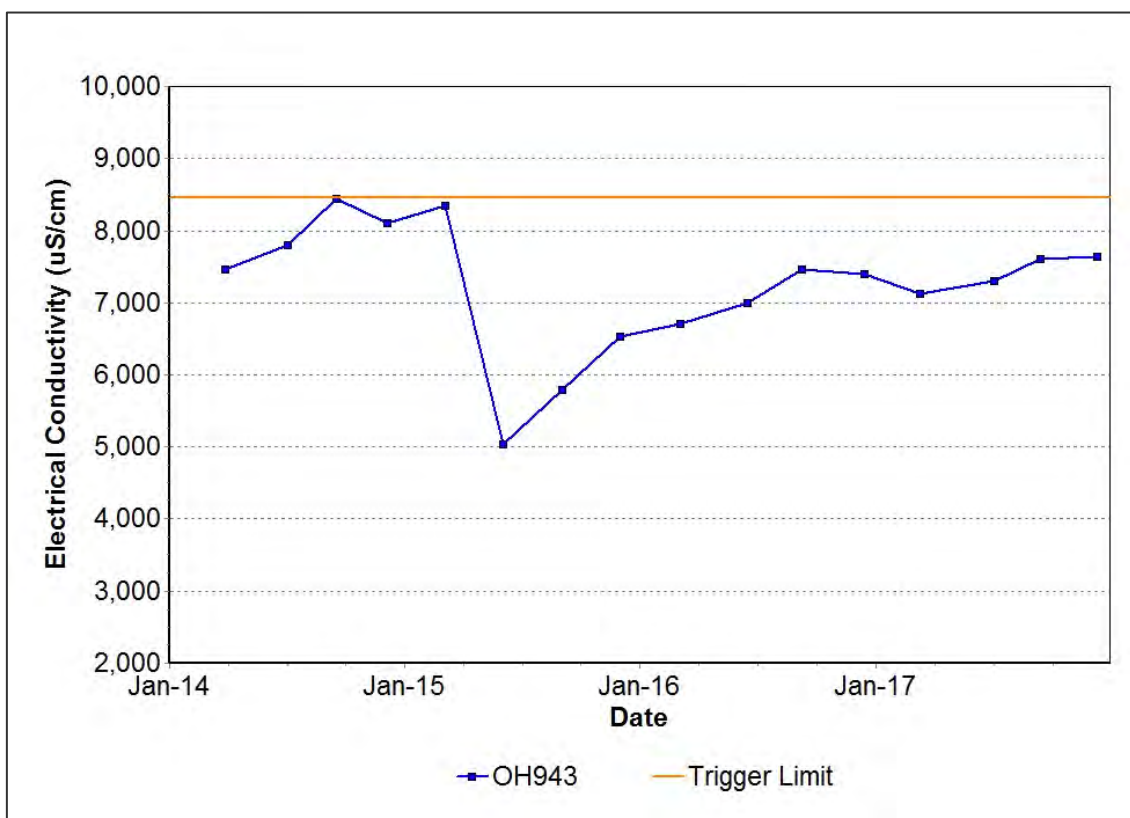
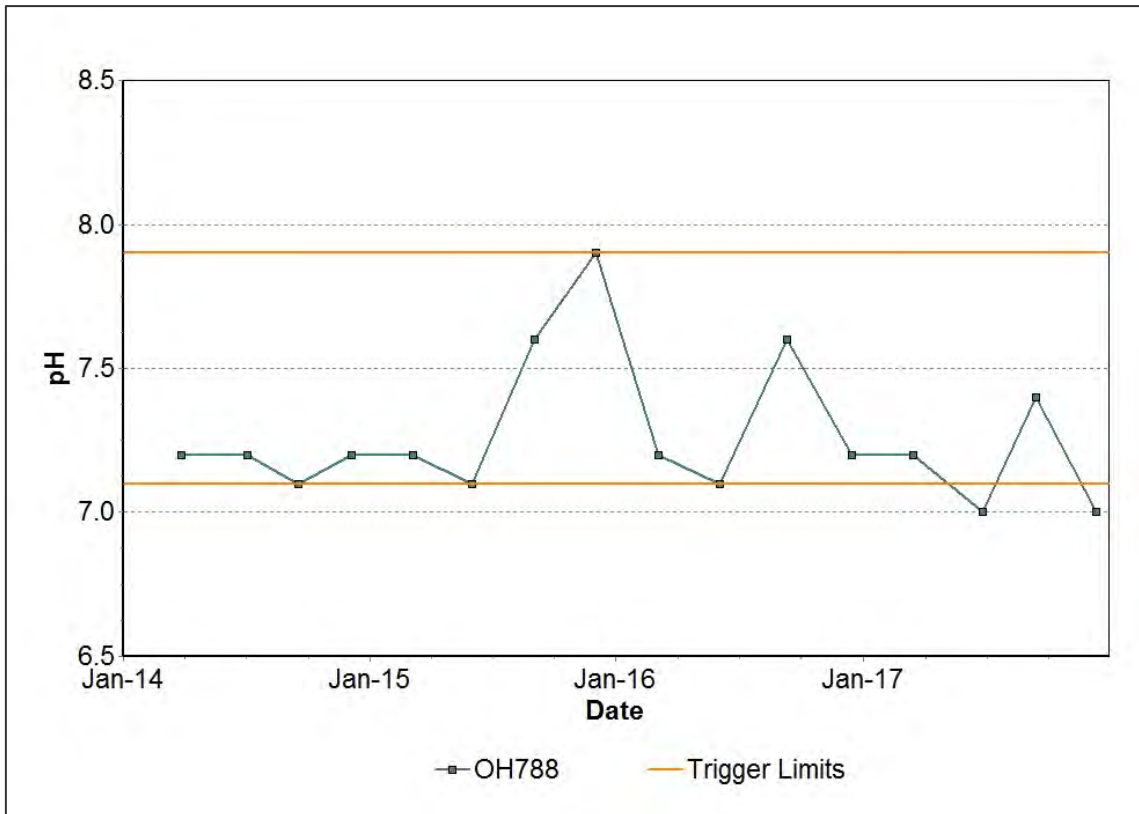
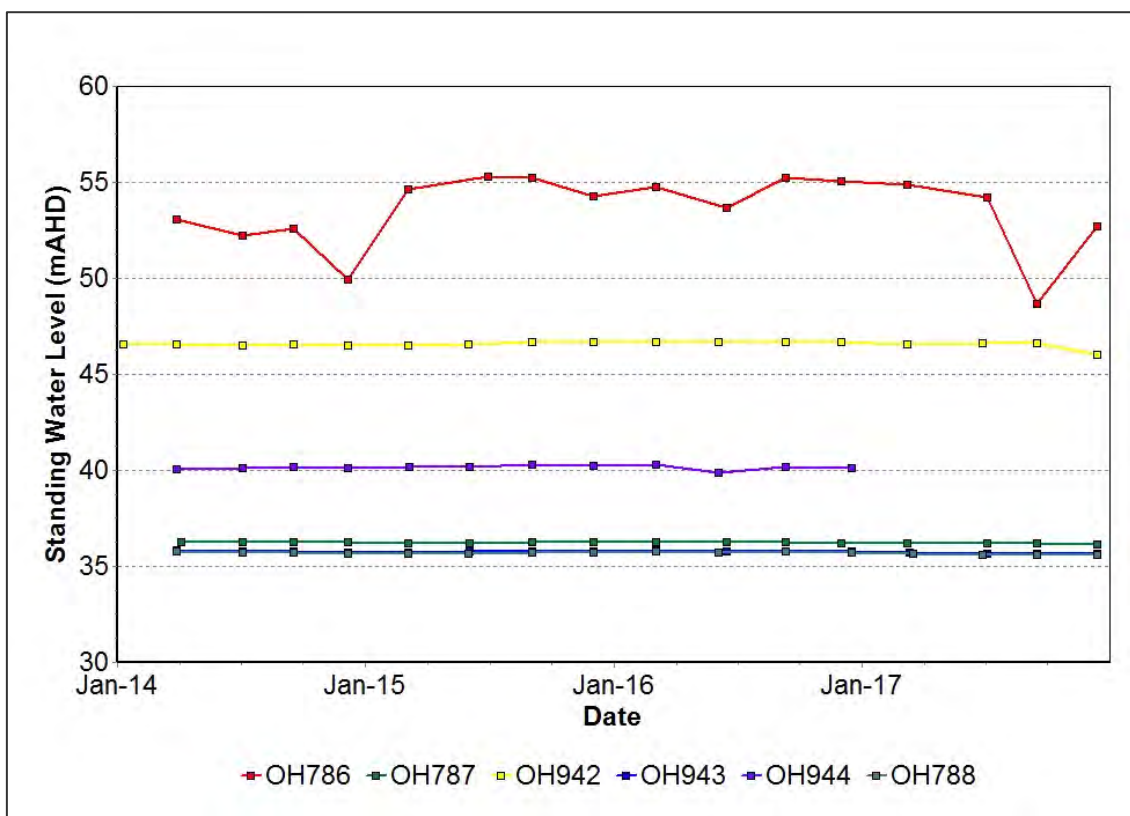
FIGURE 51: HUNTER RIVER ALLUVIUM BORE OH943 EC TREND 2014 TO 2017

FIGURE 54: HUNTER RIVER ALLUVIUM BORE OH788 PH TREND 2014 TO 2017

FIGURE 56: HUNTER RIVER ALLUVIUM GROUNDWATER SWL TRENDS 2014 TO 2017

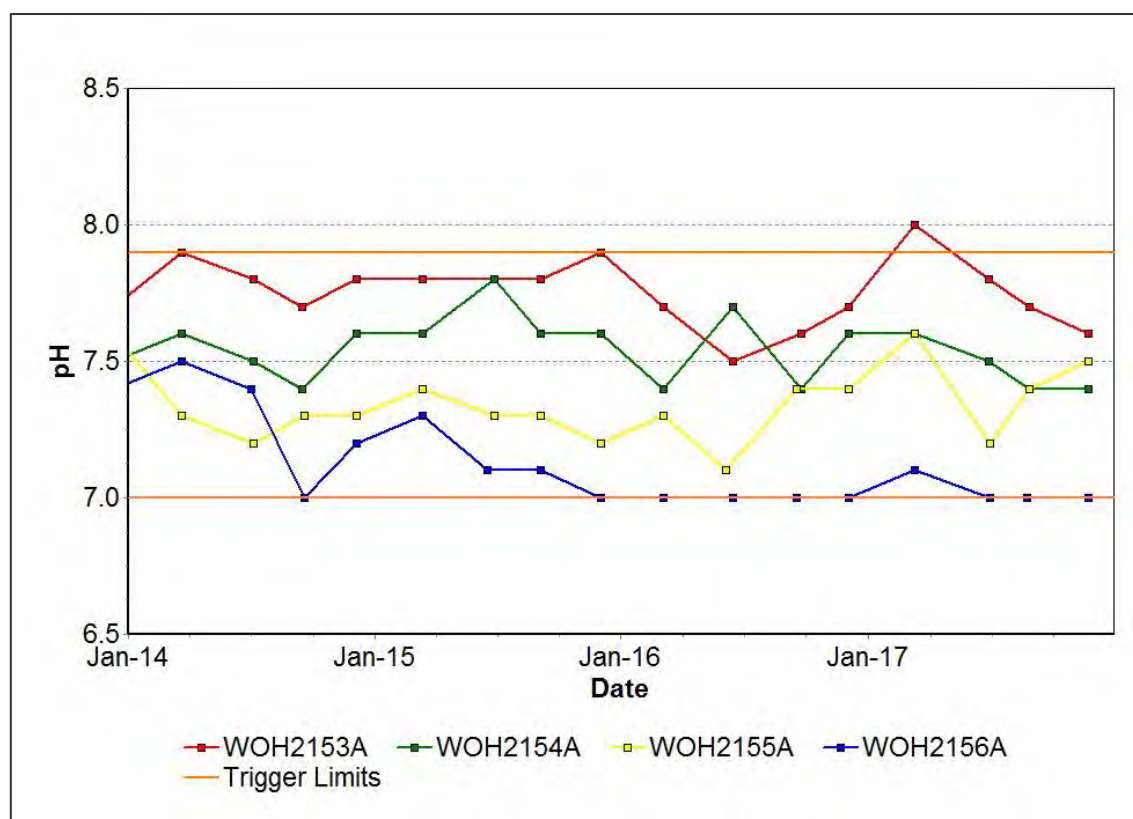
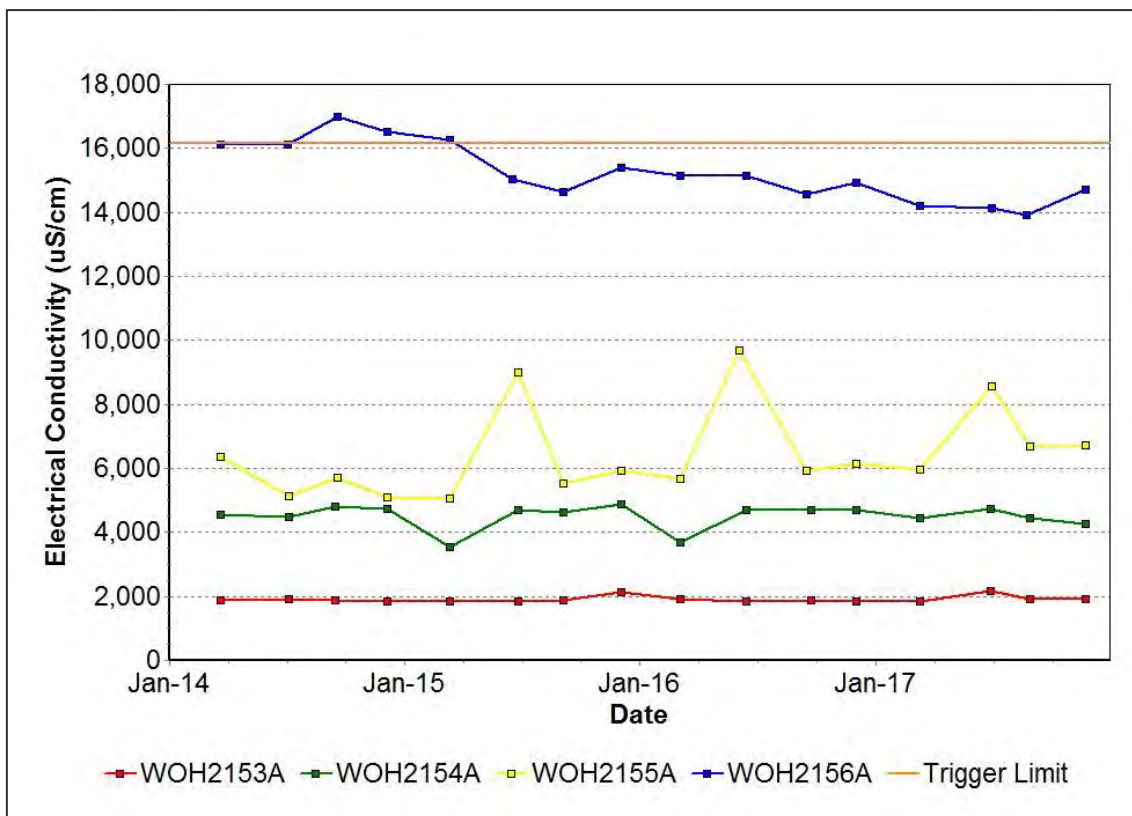
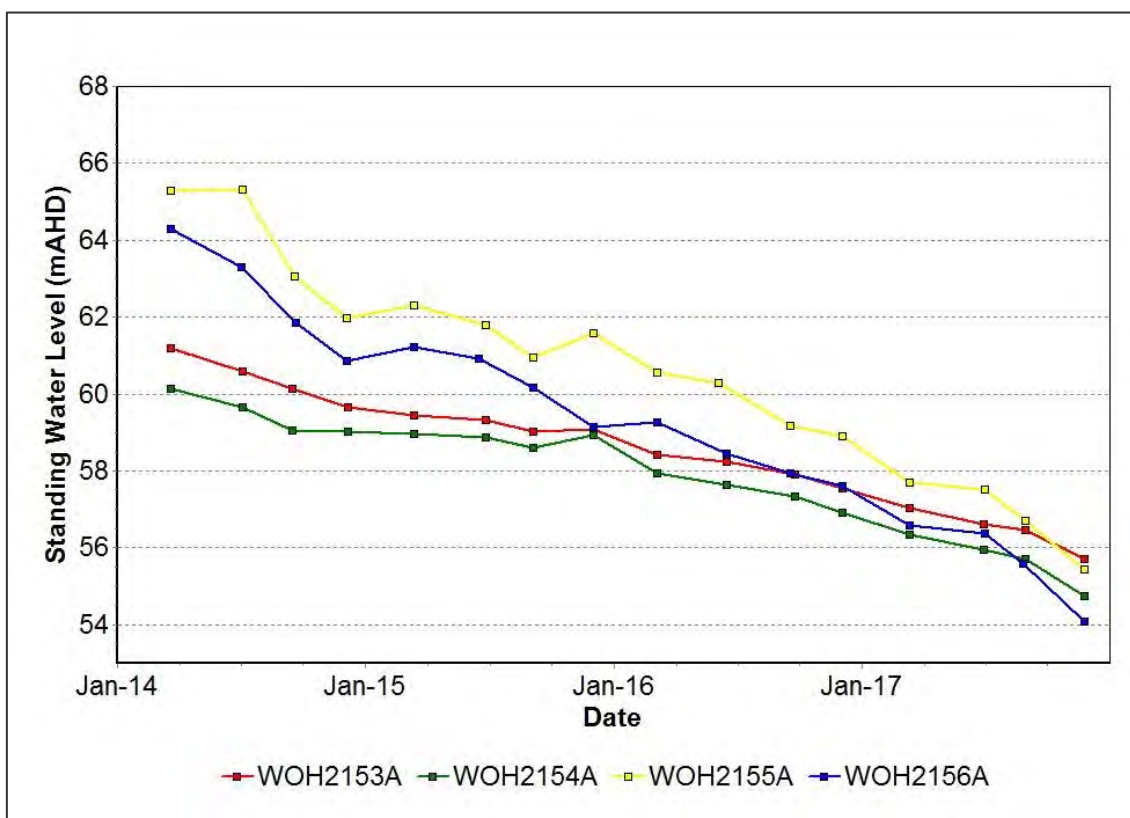
FIGURE 57: REDBANK SEAM GROUNDWATER PH TRENDS 2014 TO 2017

FIGURE 58: REDBANK SEAM GROUNDWATER EC TRENDS 2014 TO 2017

FIGURE 59: REDBANK SEAM GROUNDWATER SWL TRENDS 2014 TO 2017

Location	Date	Trigger limit	Action taken in response
WOH2153A	10/03/2017	pH – 95 th percentile	Watching brief *

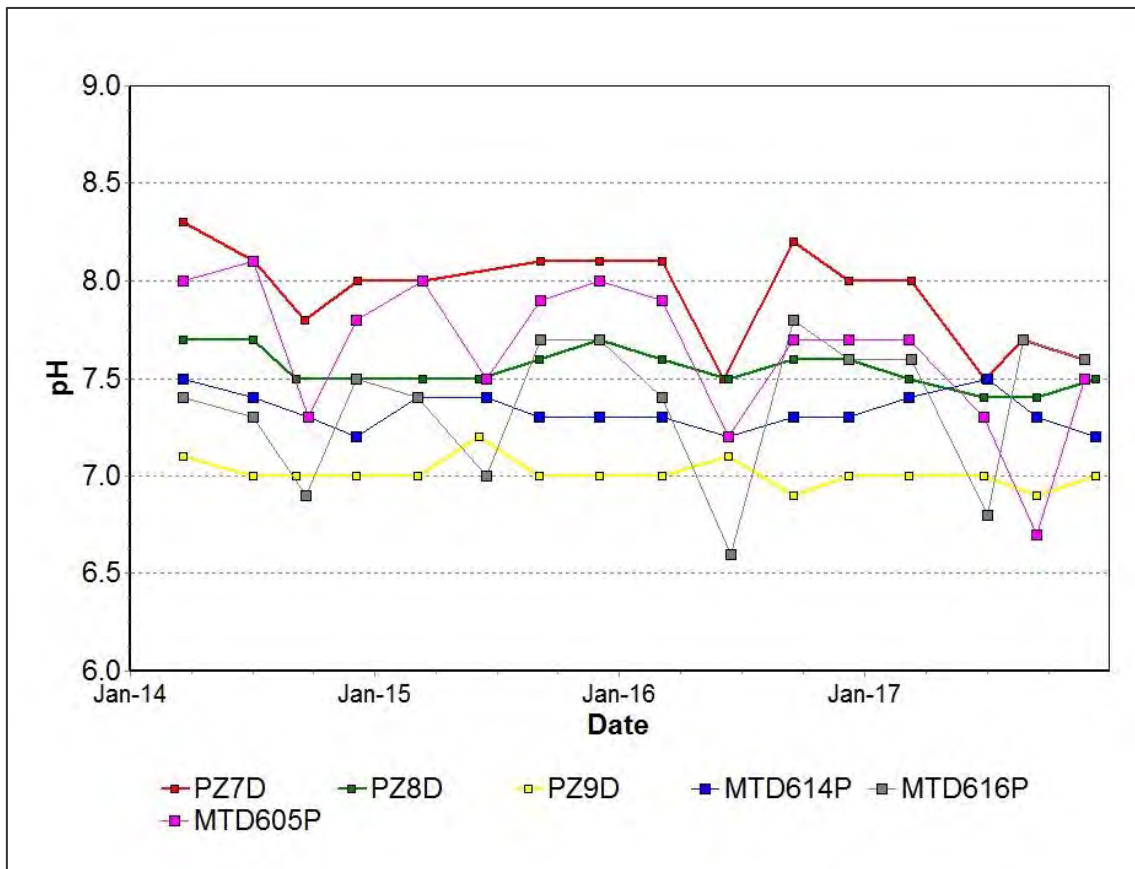
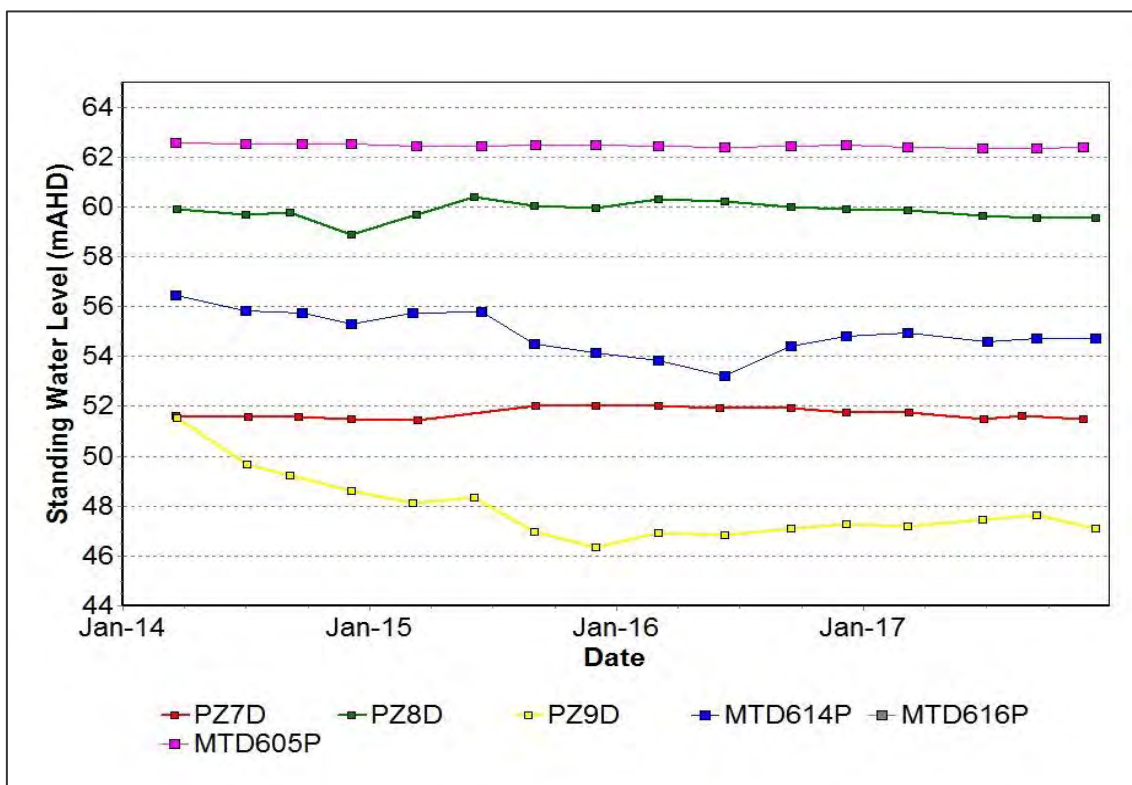
FIGURE 60 : SHALLOW OVERBURDEN SEAM GROUNDWATER PH TRENDS 2014 TO 2017

FIGURE 62: SHALLOW OVERBURDEN SEAM GROUNDWATER SWL TRENDS 2014 TO 2017

Groundwater monitoring in the Shallow Overburden was undertaken from three sites during 2017. A total of 12 samples were collected during the reporting period. The pH, EC and SWL trends for 2014 to 2017 for Shallow Overburden groundwater bores are shown in Figure 60, Figure 61 and Figure 62 respectively. Water levels and water quality were steady in all bores during the reporting period.
