Mount Thorley Warkworth

2017 Annual Review

MT THORLEY WARKWORTH

Mount Thorley Warkworth (MTW) is an integrated operation of two open cut coal mines, Warkworth Mining Limited (WML) and Mount Thorley Operations (MTO). This Annual Review reports on the environmental performance of Mount Thorley Warkworth (MTW) for the period 1 January 2017 to 31 December 2017.

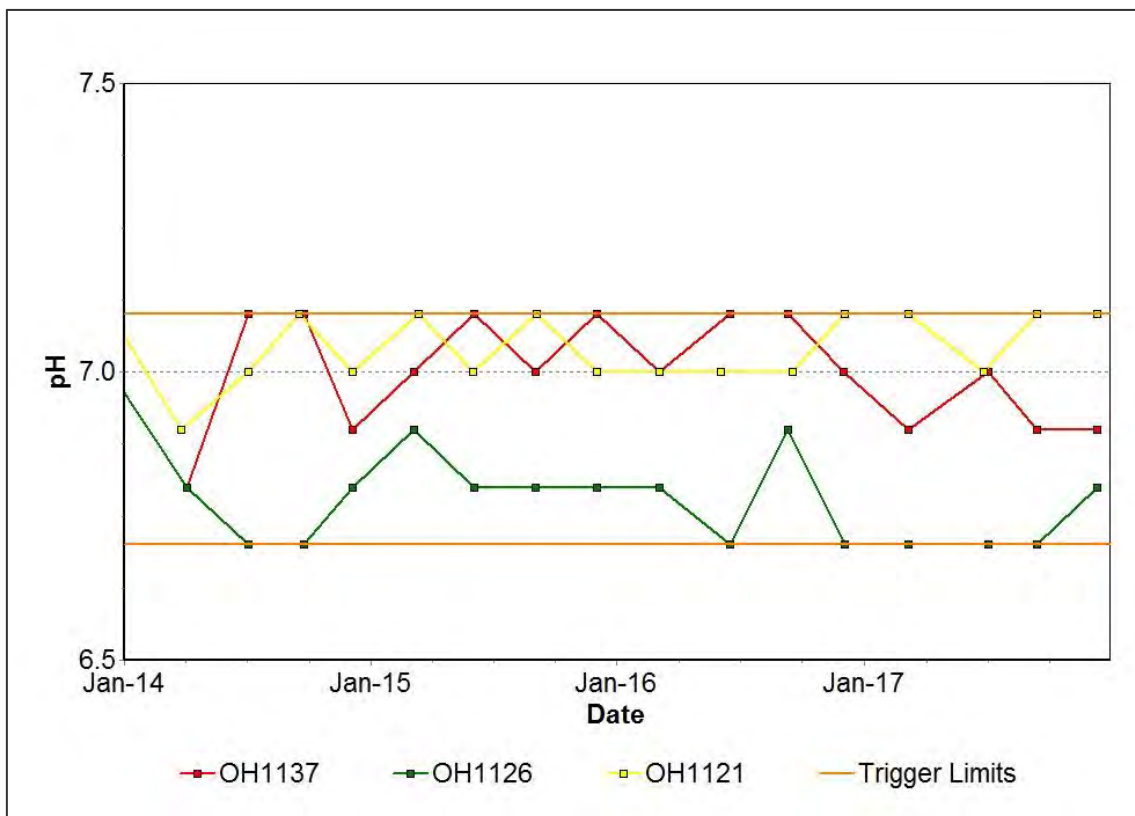
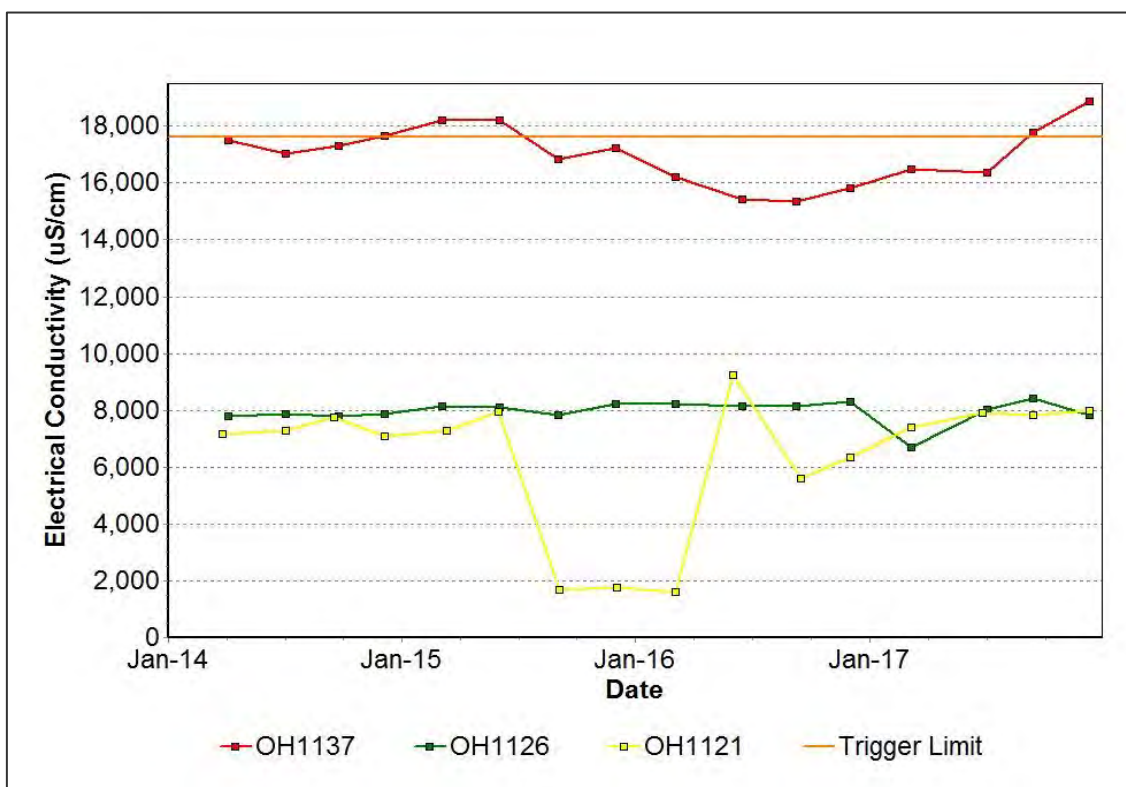
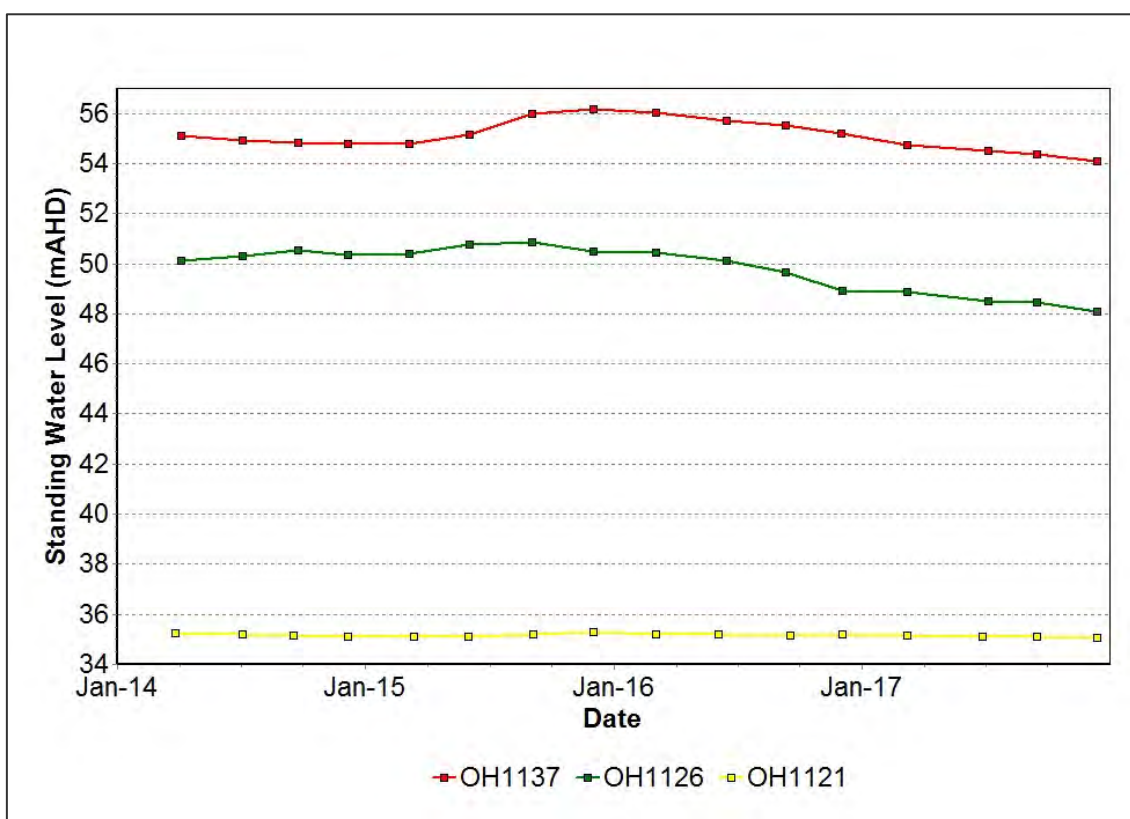
FIGURE 63: VAUX SEAM GROUNDWATER PH TRENDS 2014 TO 2017

FIGURE 64: VAUX SEAM GROUNDWATER EC TRENDS 2014 TO 2017

FIGURE 65: VAUX SEAM GROUNDWATER SWL TRENDS 2014 TO 2017

Location	Date	Trigger limit	Action taken in response
OH1137	14/09/2017	EC – 95th percentile	Watching brief *
	11/12/2017		Watching brief *

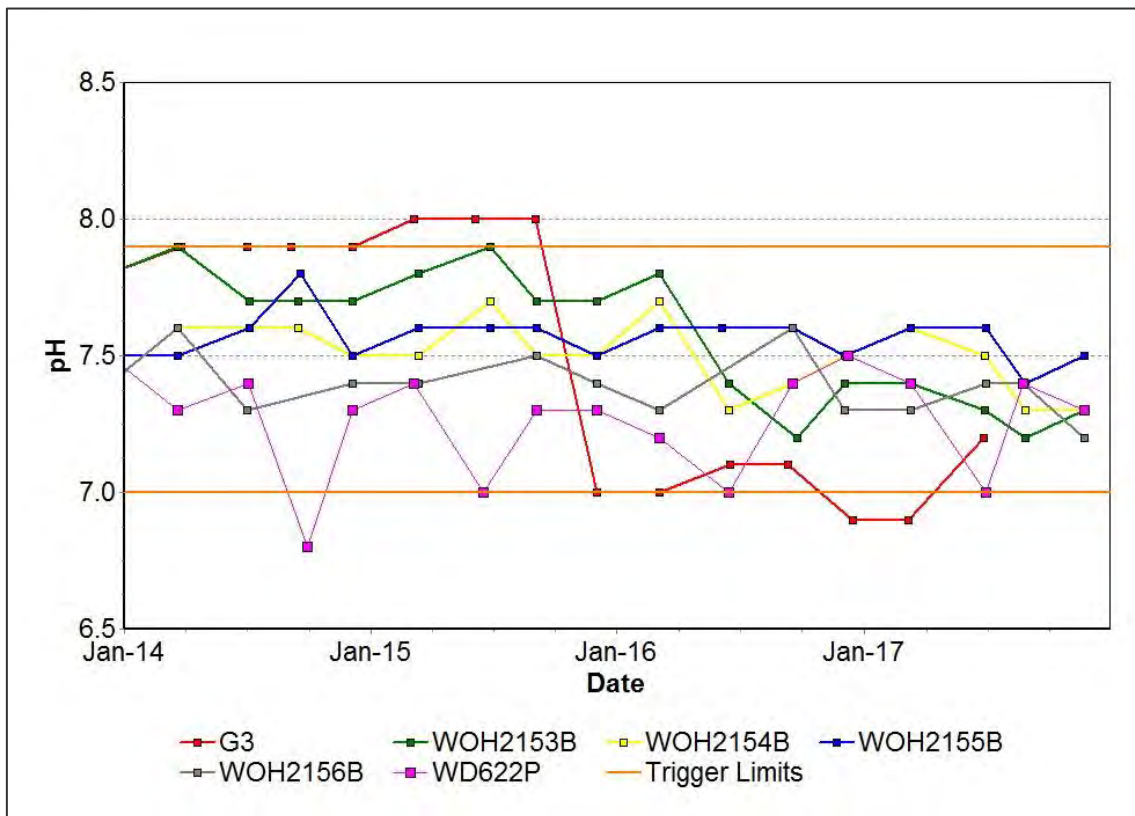
FIGURE 66: WAMBO SEAM GROUNDWATER PH TRENDS 2014 TO 2017

Location	Date	Trigger limit	Action taken in response
G3	15/12/2016	pH – 5th percentile	Bore partially collapsed in early 2016 so data may not be representative of aquifer. Removal from monitoring programme has been recommended following review of data from nearby bores.
	07/03/2017		Watching brief *
WOH2156B	10/03/2017	EC – 95th percentile	Elevated EC is likely the result of coal seam depressurisation, as evidenced by falling water level. This trend is consistent with effects of nearby mining. No further action required.
	30/06/2017		
	24/08/2017		
	23/11/2017		
WD622P	30/06/2017	EC – 95th percentile	Watching brief *

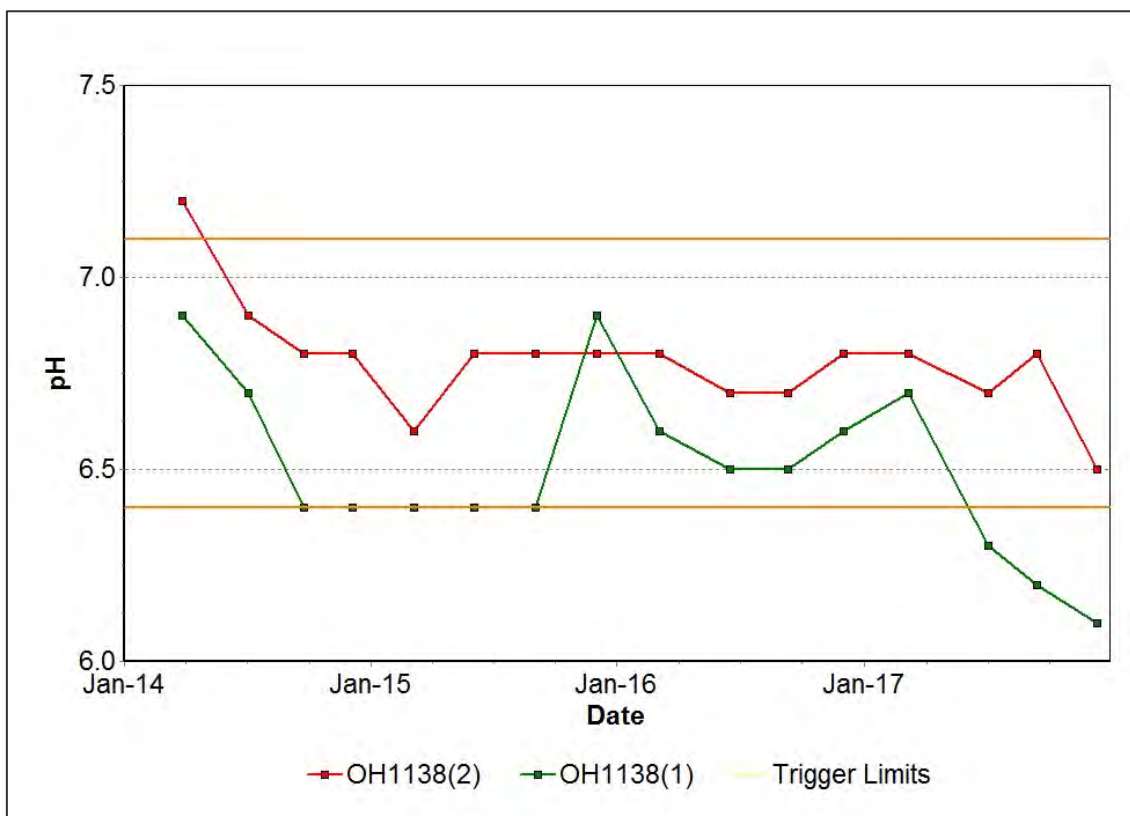
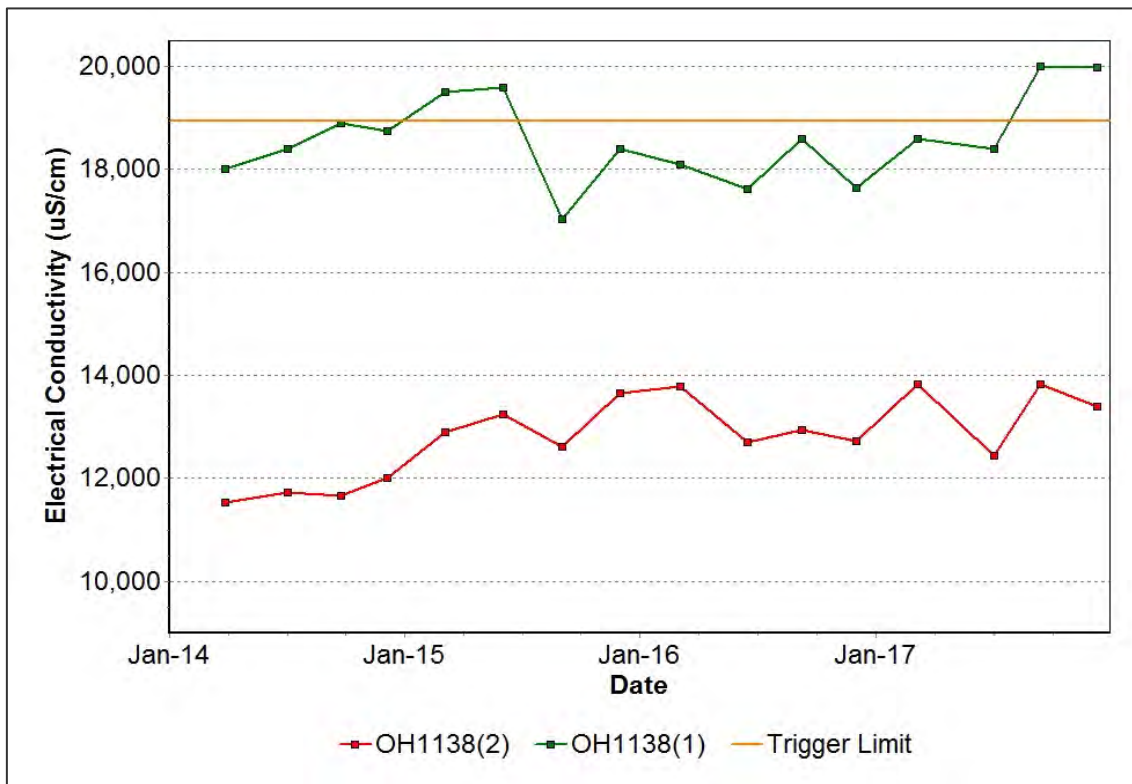
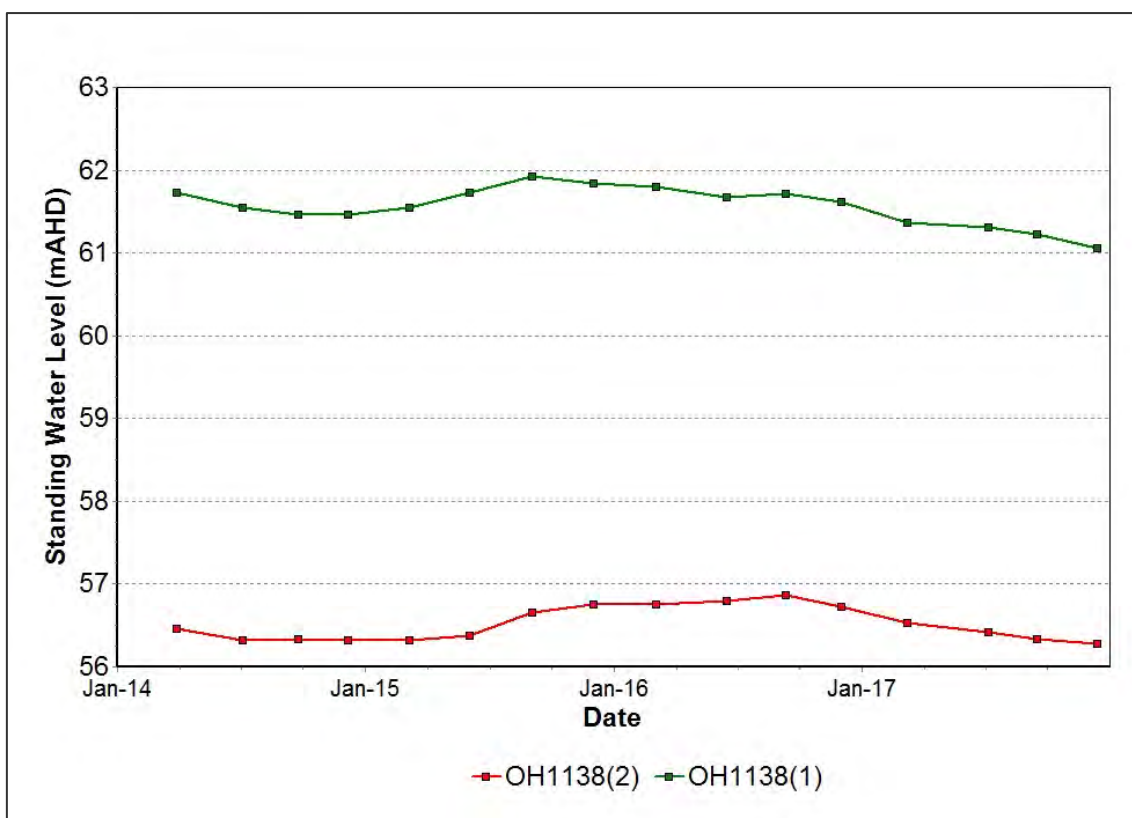
FIGURE 69: WARKWORTH SEAM GROUNDWATER PH TRENDS 2014 TO 2017

FIGURE 70: WARKWORTH SEAM GROUNDWATER EC TRENDS 2014 TO 2017

FIGURE 71: WARKWORTH SEAM GROUNDWATER SWL TRENDS 2014 TO 2017

Location	Date	Trigger limit	Action taken in response
OH1138(1)	04/07/2017	pH – 5 th percentile	Watching brief *
	14/09/2017		Watching brief *
	11/12/2017		Under investigation.
OH1138(1)	14/09/2017	EC – 95 th percentile	Watching brief *
	11/12/2017		Watching brief *

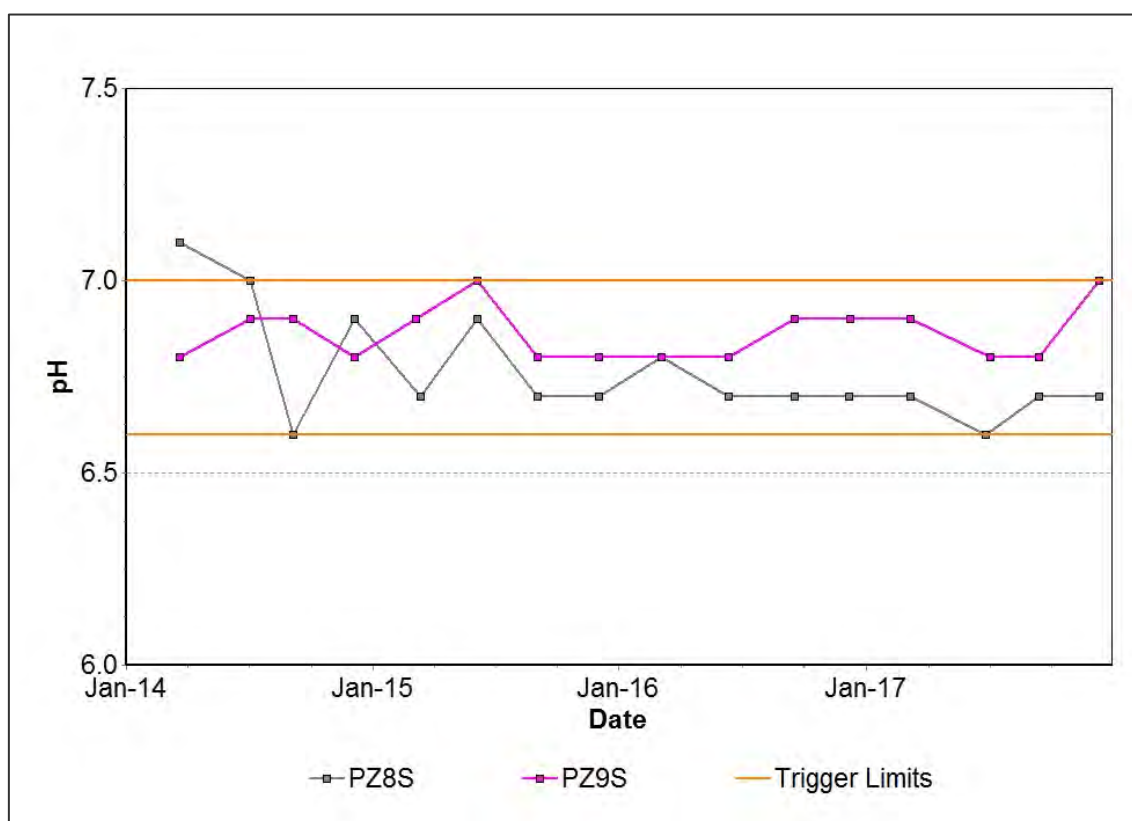
FIGURE 72: WOLLOMBI BROOK ALLUVIUM SEAM GROUNDWATER PH TRENDS 2014 TO 2017

Location	Date	Trigger limit	Action taken in response
PZ9S	07/03/2017	EC – 95 th percentile	Watching brief *

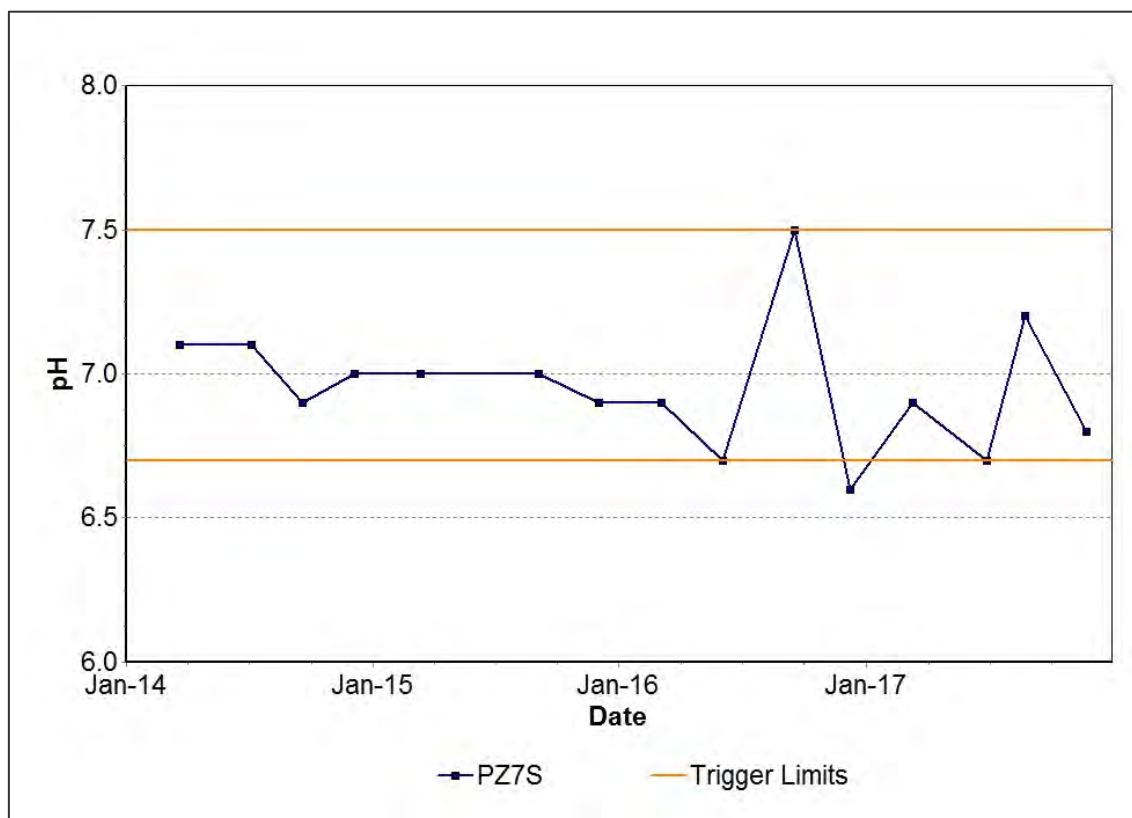
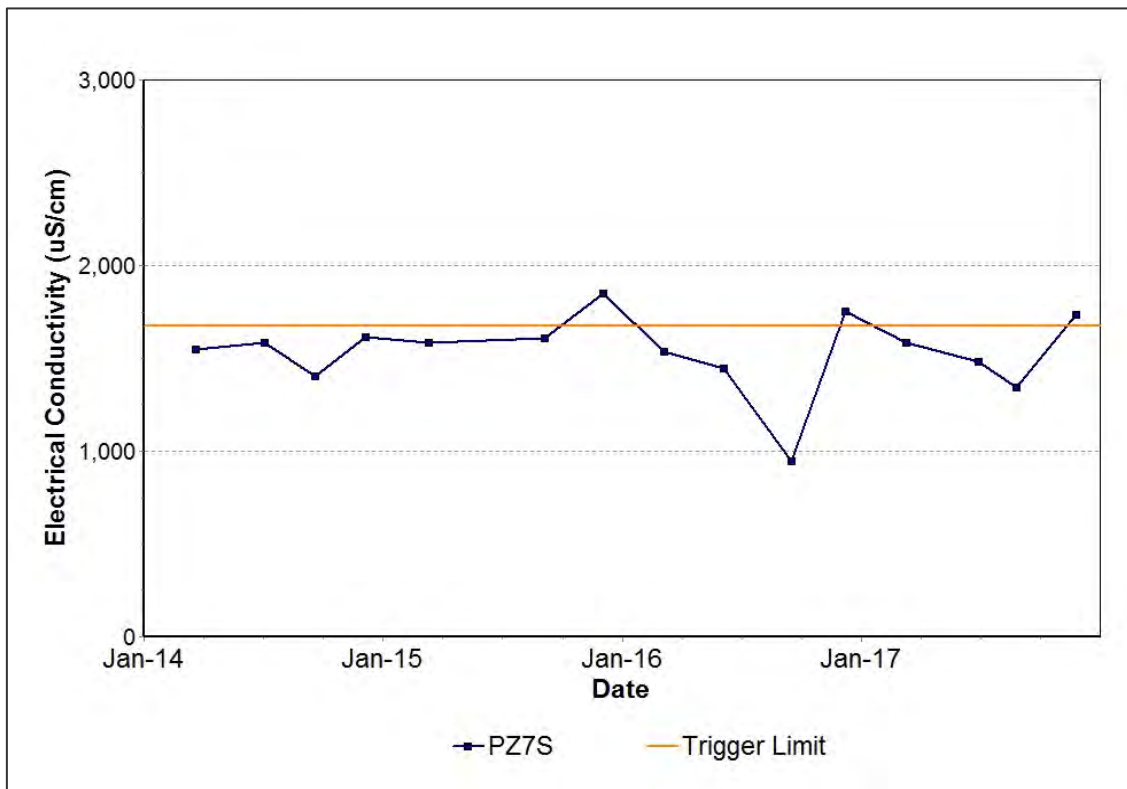
FIGURE 75 : AEOLIAN WARKWORTH SANDS GROUNDWATER PH TRENDS 2014 TO 2017

FIGURE 76: AEOLIAN WARKWORTH SANDS GROUNDWATER EC TRENDS 2014 TO 2017

Location	Date	Trigger limit	Action taken in response
PZ7S	23/11/2017	EC – 95 th percentile	Watching brief *

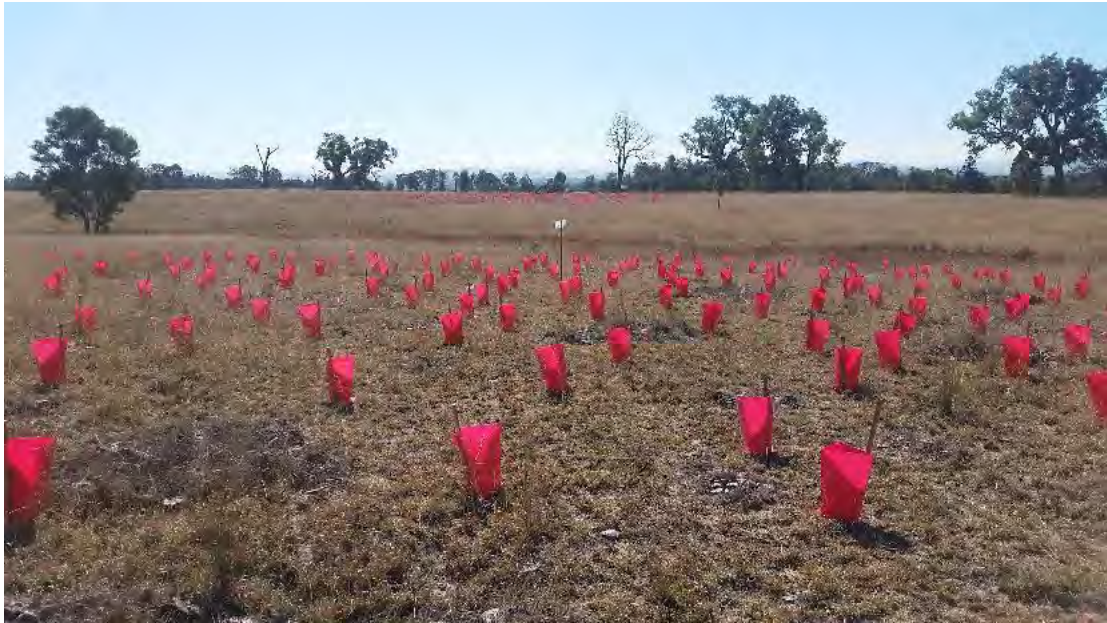
FIGURE 84: TUBE STOCK PLANTED INTO ONE OF THE PLOTS IN THE NORTHERN BIODIVERSITY AREA

Restoration activities also included planting Central Hunter Grey Box – Ironbark Woodland in a small area of the Northern BA and 89 ha of the Southern BA with over 13,000 seedlings planted into rip lines. The site preparation for these sites included ripping by dozer and weed control. The team planted the seedlings into rip lines. To mimic nature the tree species were planted at a spacing of 5 -10m and shrubs species planted in clumps as commonly found with understory species within this vegetation type. All plants were watered, fertilised and protected with a tree guard.

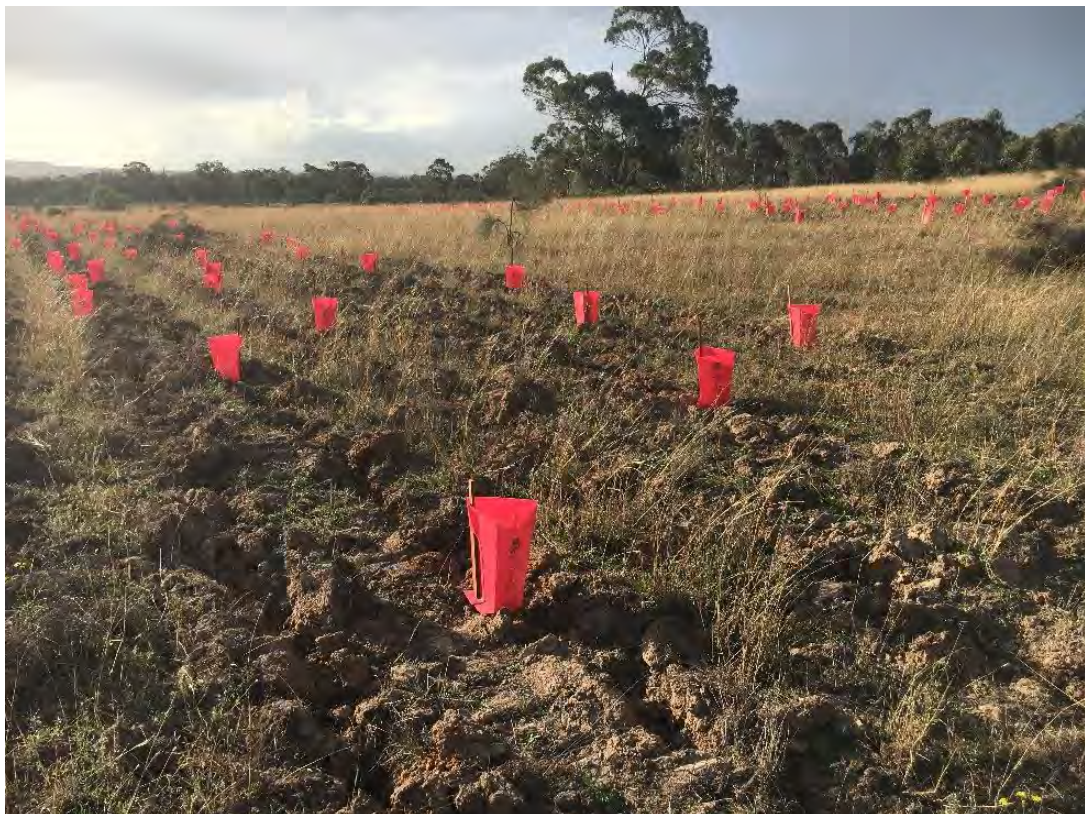
FIGURE 85: TUBE STOCK PLANTED INTO RIP LINES AT THE SOUTHERN BIODIVERSITY AREA
