Mount Thorley Warkworth

Monthly Environmental Report

April 2017

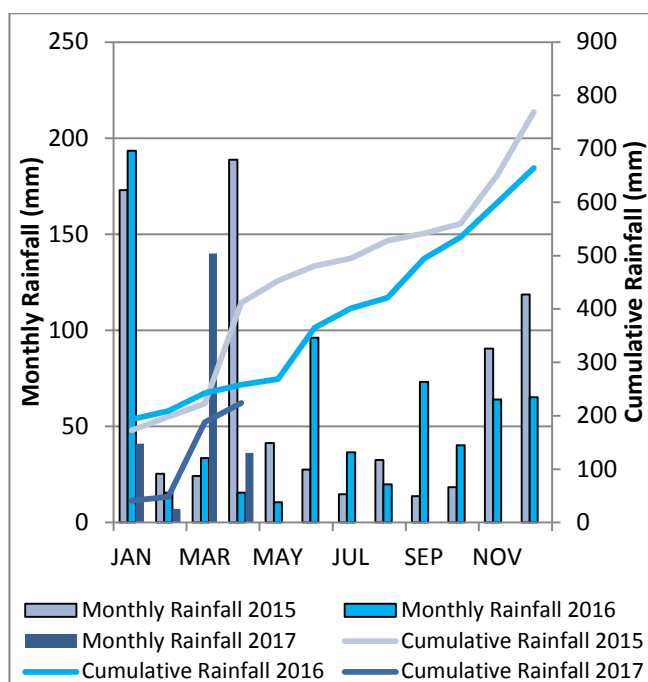
Figure 1: Rainfall Trend YTD

Rainfall for the period is summarised in Table 1, the year-to-date trend and historical trend are shown in Figure 1.

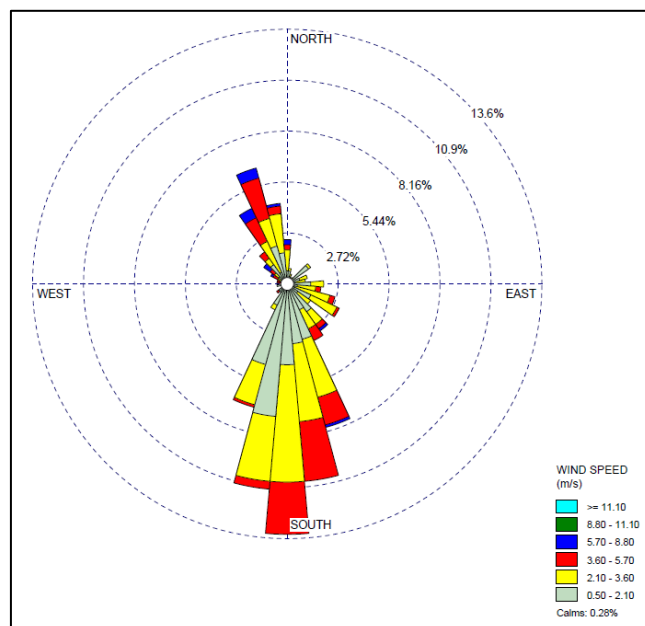
Figure 2: Charlton Ridge Wind Rose – April 2017

Winds from the South were dominant throughout the reporting period as shown in Figure 2.

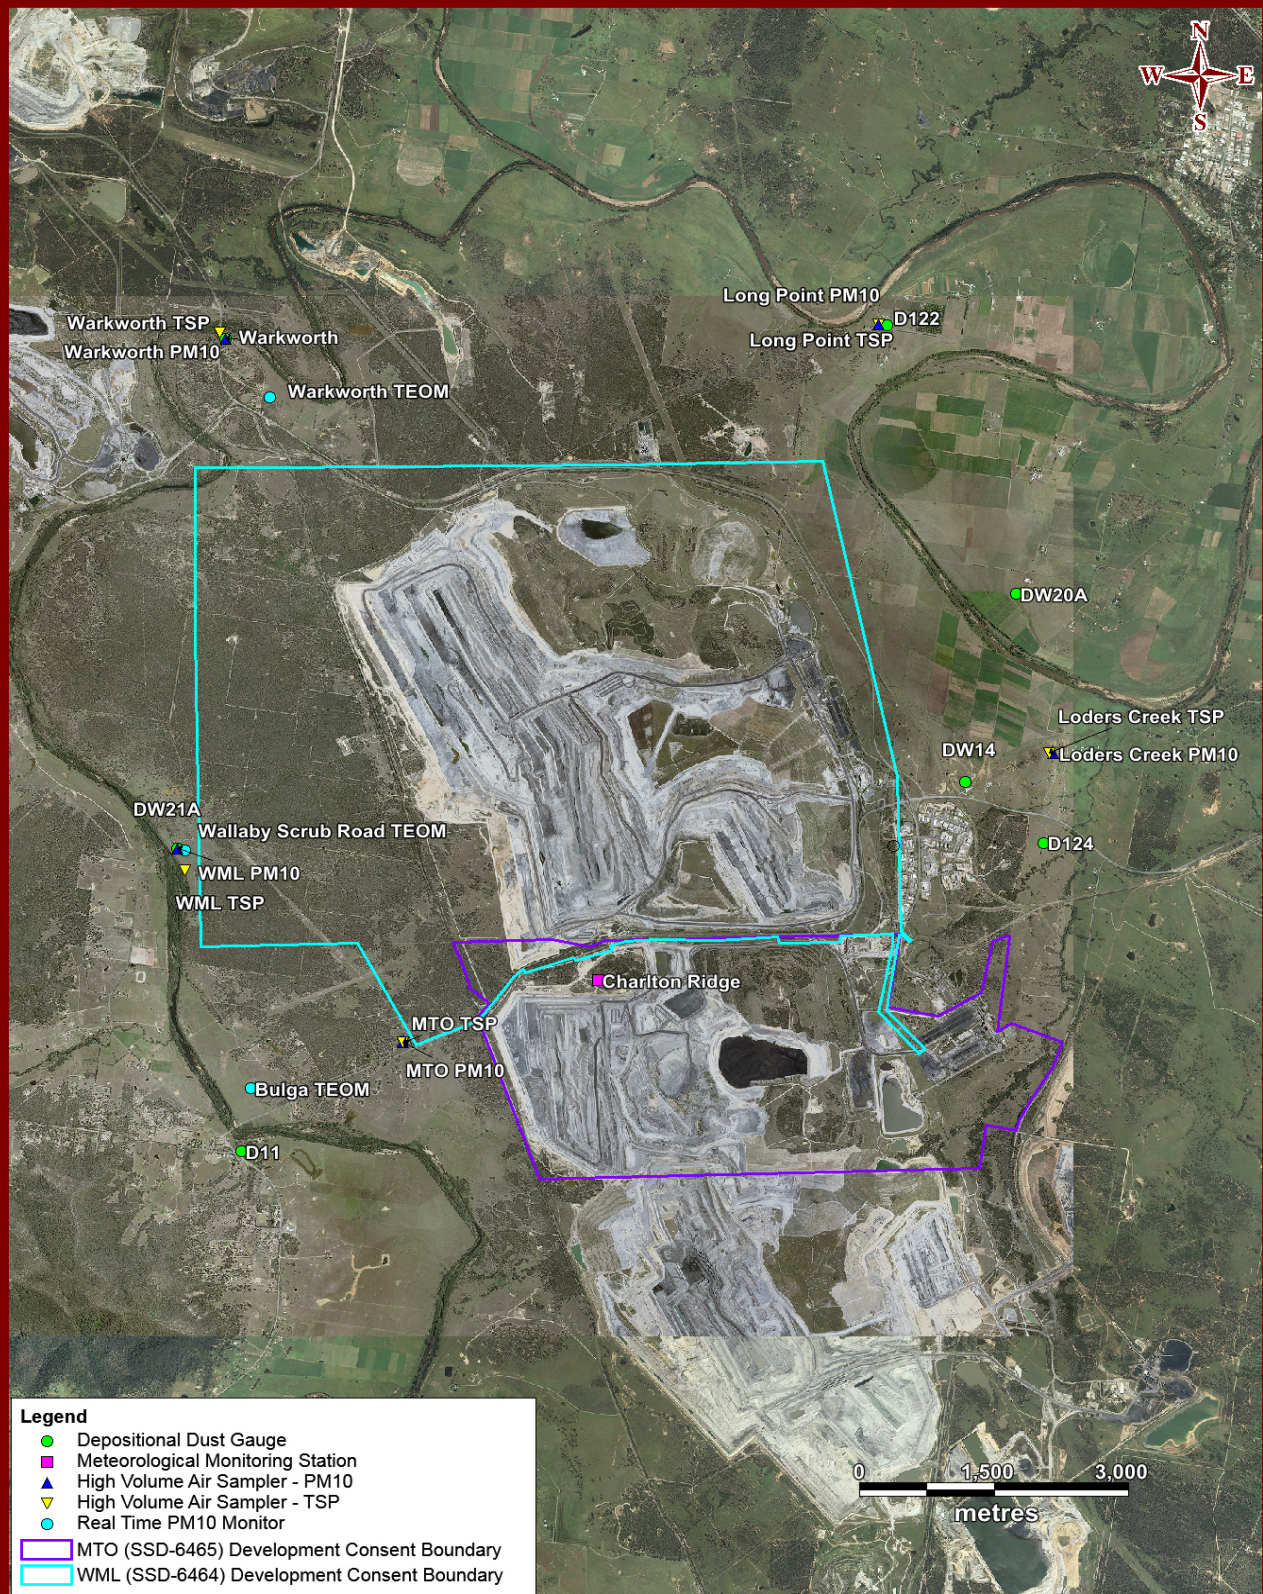
Figure 3: Air Quality Monitoring Locations

Meteorological data is collected at MTW's 'Charlton Ridge' meteorological station (refer to Figure 3: Air Quality Monitoring Locations).

Suspended particulates are measured by a network of High Volume Air Samplers (HVAS) measuring Total Suspended Particulates (TSP) and Particulate Matter <10µm (PM₁₀). The location of these monitors can be found in Figure 3. Each HVAS was run for 24 hours on a six-day cycle in accordance with EPA requirements.

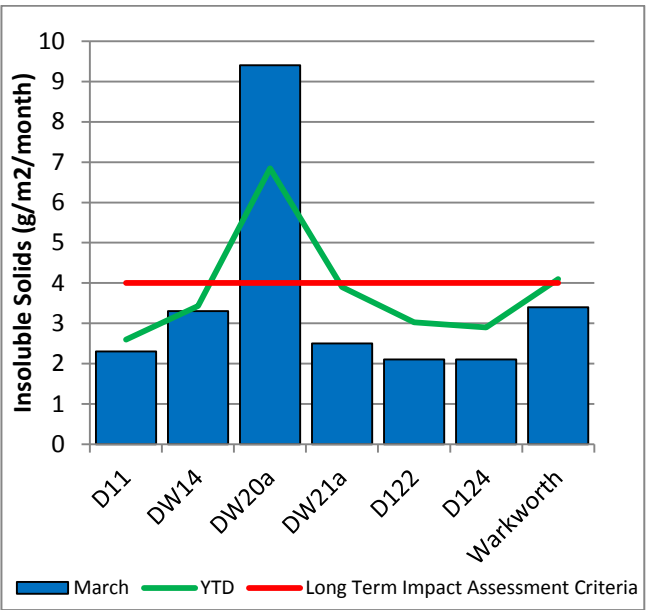
Figure 4: Depositional Dust – April 2017

Figure 4 displays insoluble solids results from depositional dust gauges during the reporting period compared against the year-to-date average and the annual impact assessment criteria.

During the reporting period the DW20a monitor recorded a monthly result above the long term impact assessment criteria of 4.0 g/m² per month. There is no evidence to suggest that the DW20a result was contaminated. Accordingly, this result will be included in the annual average calculation.

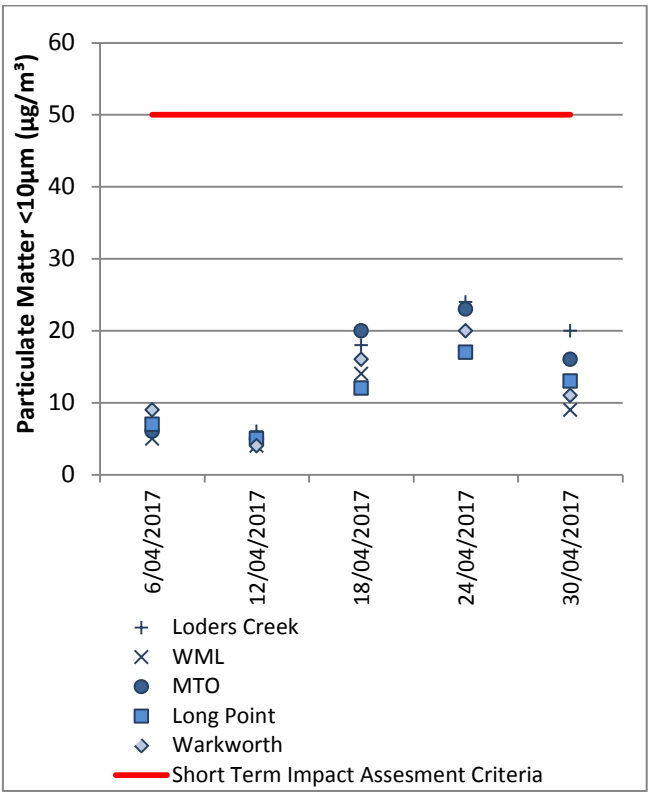
Figure 5: Individual PM₁₀ Results – April 2017

Figure 5 shows the individual PM₁₀ results at each monitoring station against the short term impact assessment criteria of 50µg/m³.

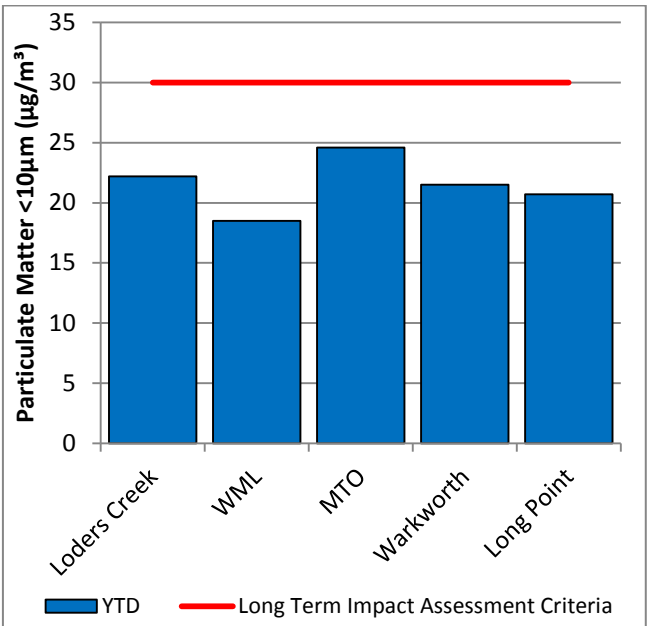
Figure 6: Annual Average PM₁₀ – April 2017

Figure 6 shows the annual average PM₁₀ results against the long term impact assessment criteria.

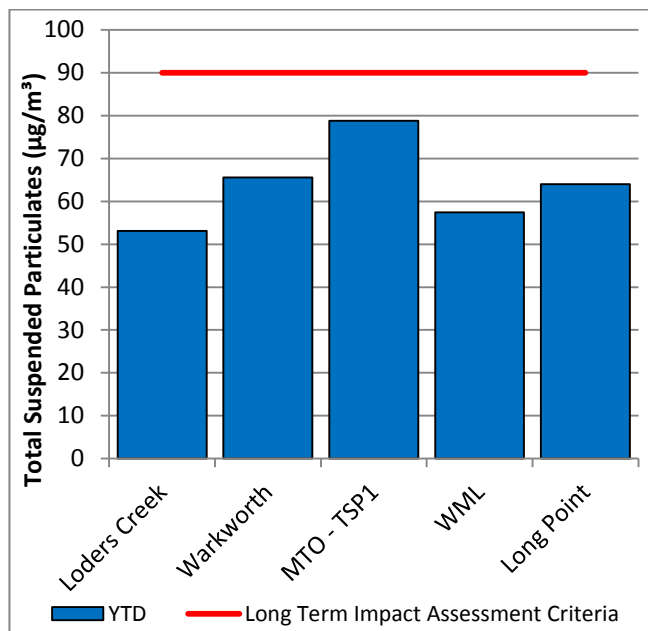
Figure 7: Annual Average Total Suspended Particulates – April 2017

Figure 7 shows the annual average TSP results compared against the long term impact assessment criteria of $90\mu\text{g}/\text{m}^3$.

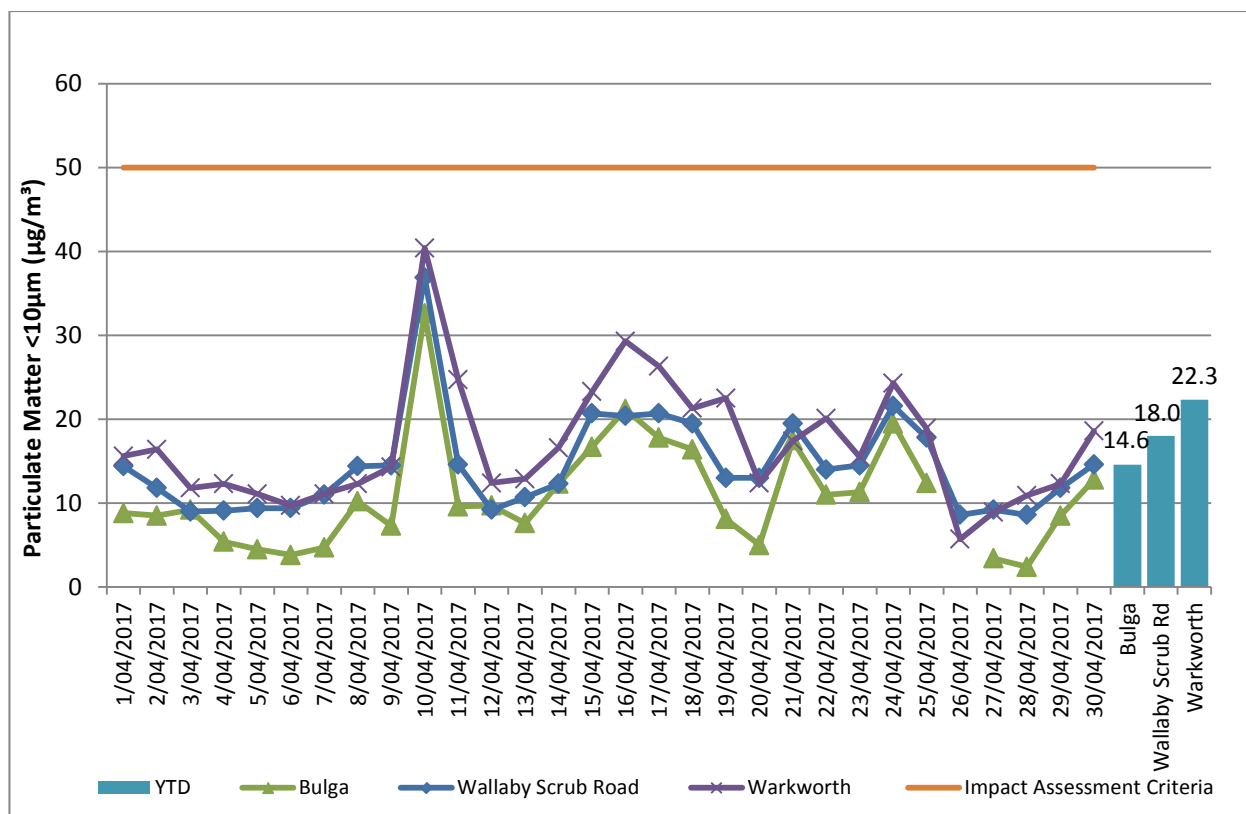
Figure 8: Real Time PM₁₀ daily 24hr average and annual average – April 2017

Results for real time dust sampling are shown in Figure 8, including the daily 24 hour average PM₁₀ result and the annual PM₁₀ average.

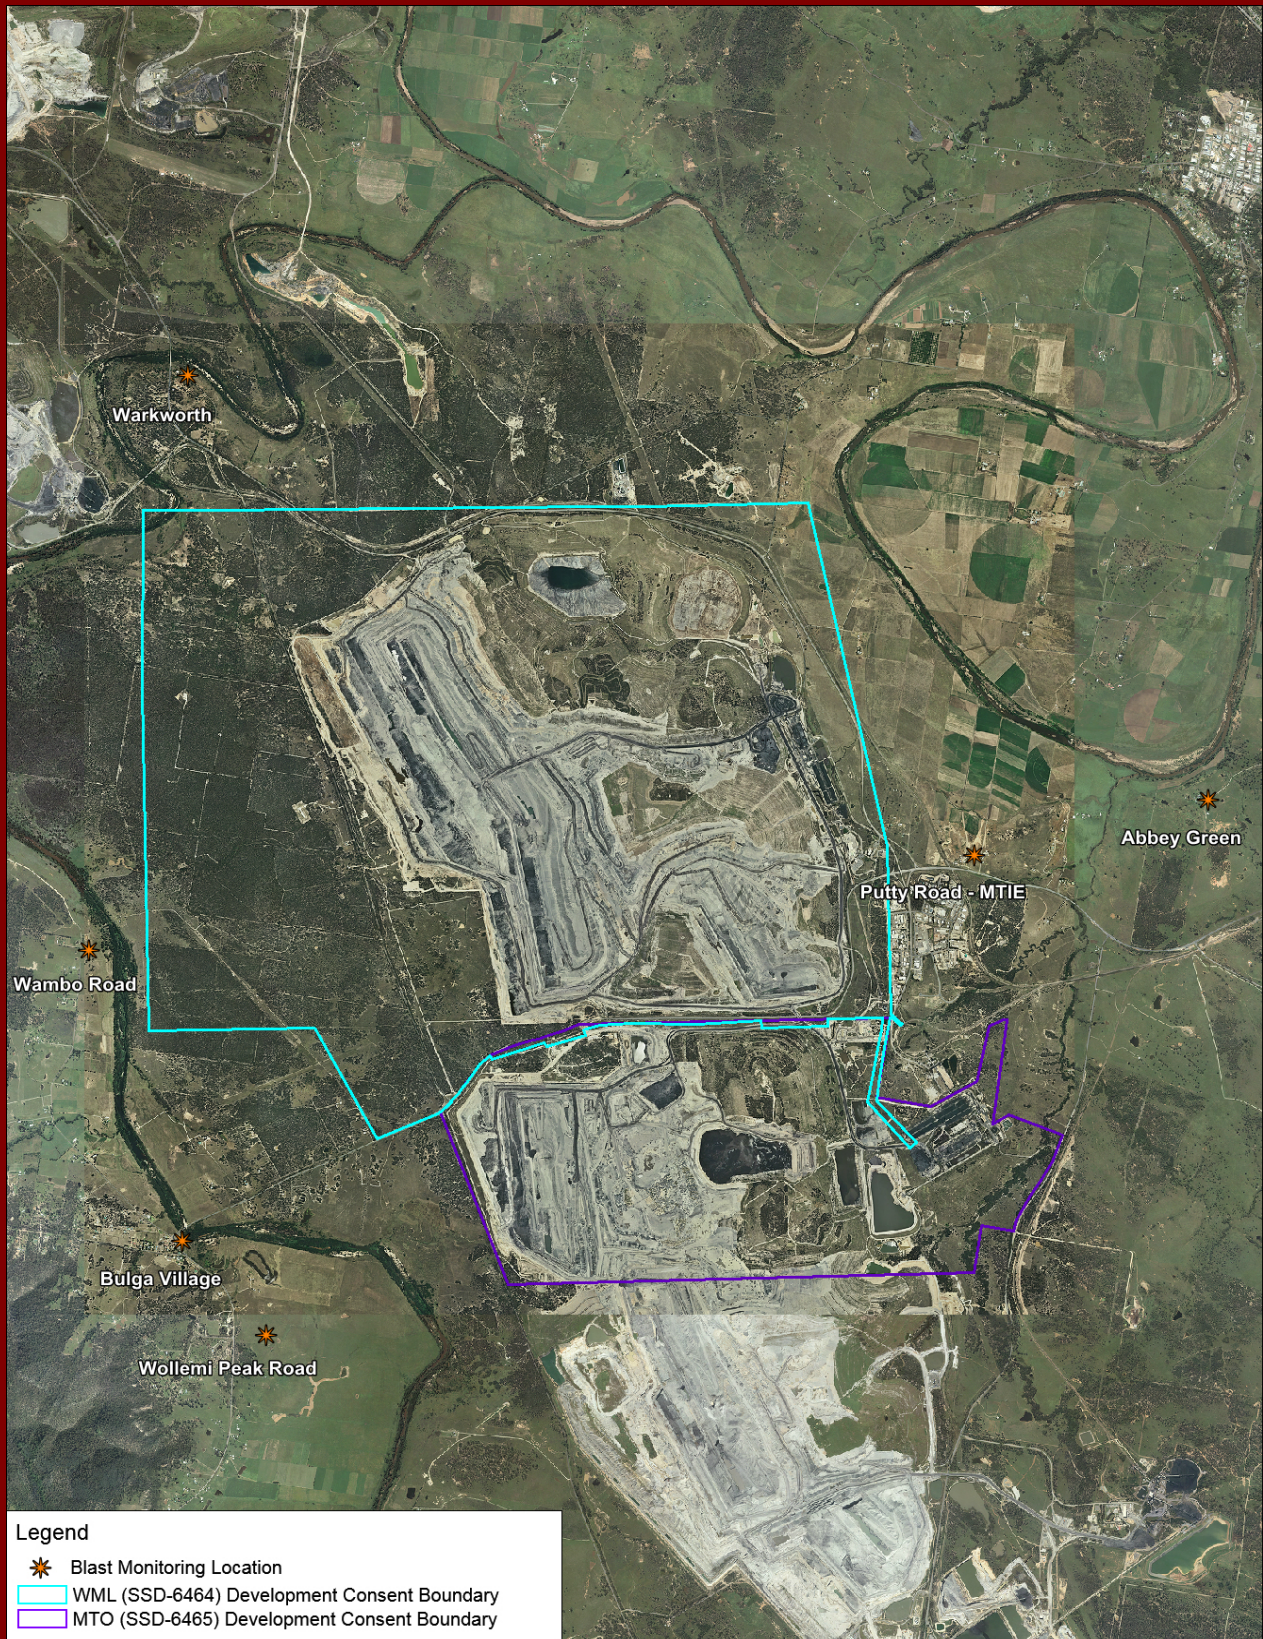
Figure 15: MTW Blast Monitoring Location Plan

MTW have a network of six blast monitoring units. These are located at nearby privately owned residences and function as regulatory compliance monitors.

The location of these monitors can be found in Figure 15.

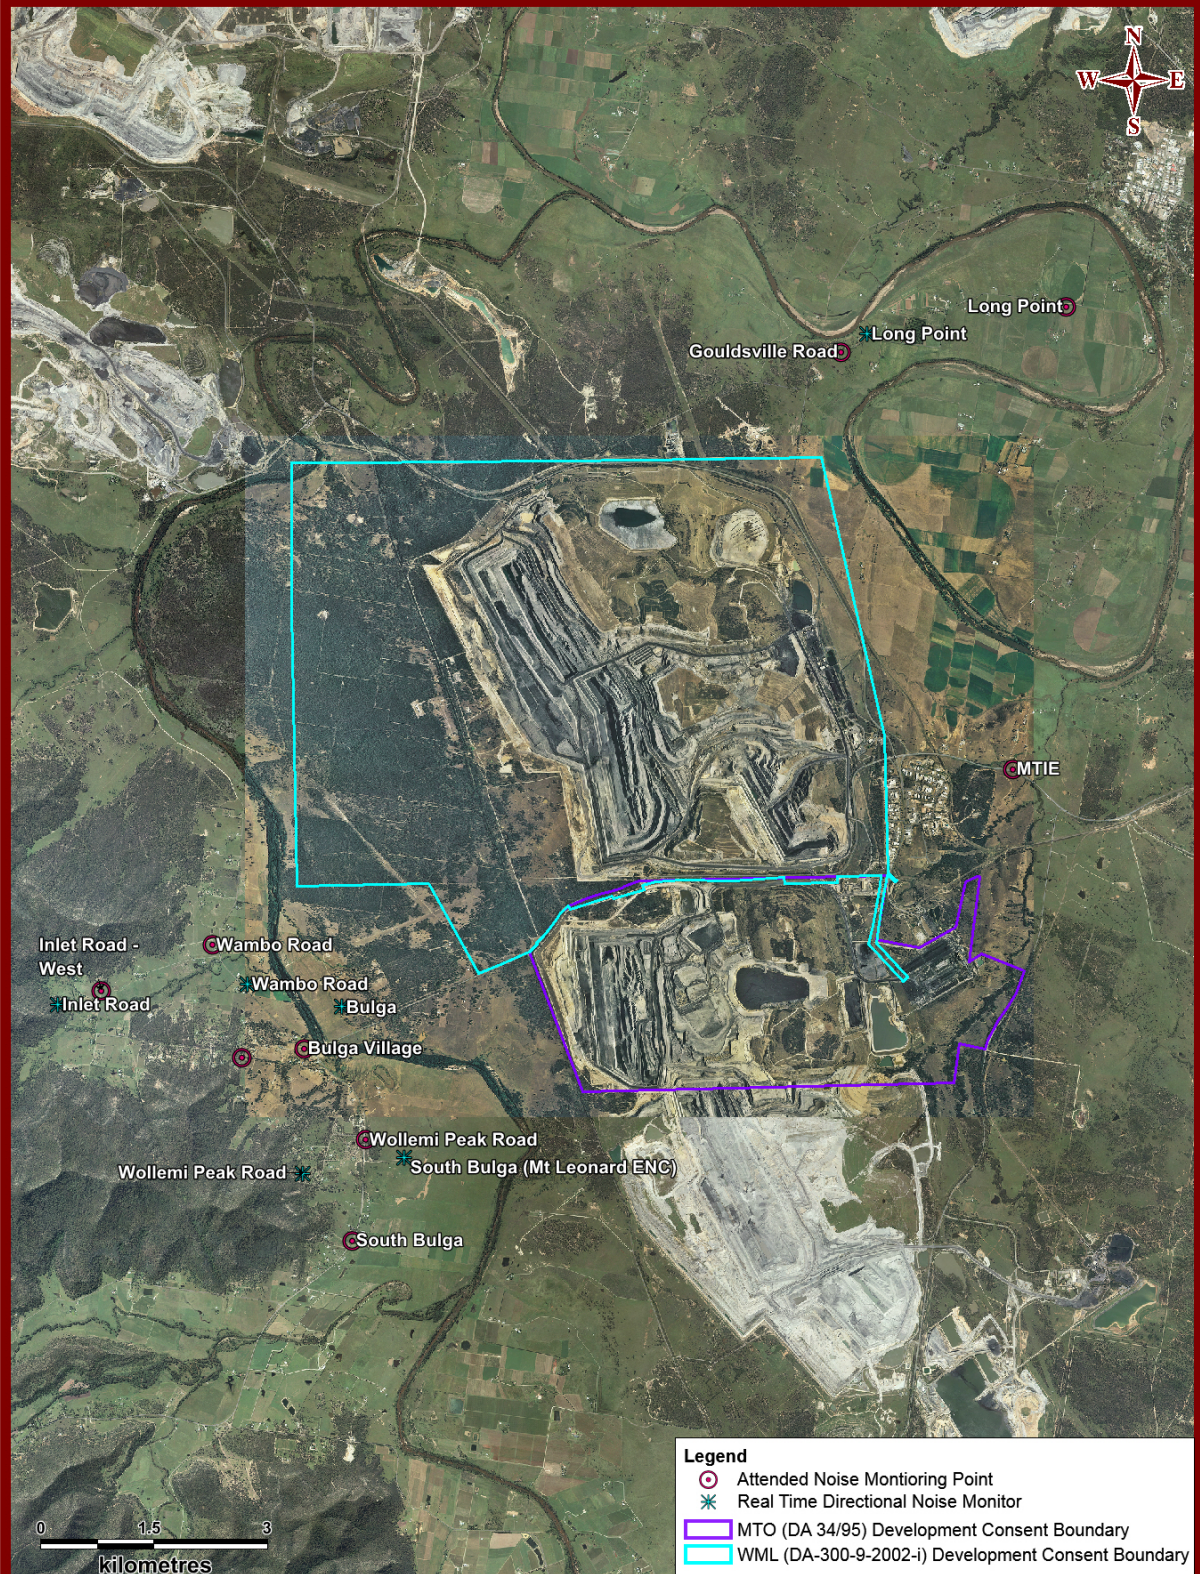
Figure 16: Noise Monitoring Location Plan

Routine attended noise monitoring is carried out in accordance with the MTW Noise Management Plan. A review against EIS predictions will be reported in the Annual Review. The purpose of the noise surveys is to quantify and describe the acoustic environment around the site and compare results with specified limits. Real time noise monitoring also occurs at nine sites surrounding MTW. Noise monitoring locations are displayed in Figure 16.

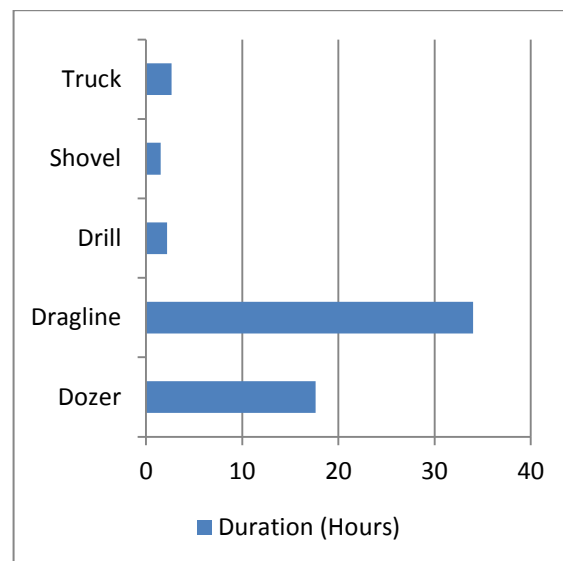
Figure 17: Operational Downtime by Equipment Type – April 2017

During April, a total of 58.0 hours of equipment downtime was logged in response to environmental events such as dust, noise and adverse meteorological conditions. Operational downtime by equipment type is shown in Figure 17.

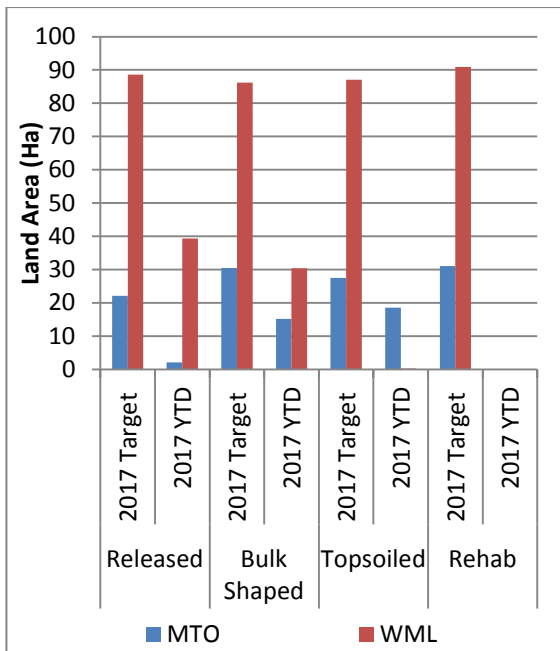
Figure 18: Rehabilitation YTD - April 2017

During April, 5.97 Ha of land was released, 5.42 Ha of land was bulk shaped and 7.35 Ha of land was topsoiled.
