# Monthly Environmental Monitoring Report

Yancoal Mount Thorley Warkworth

October 2019

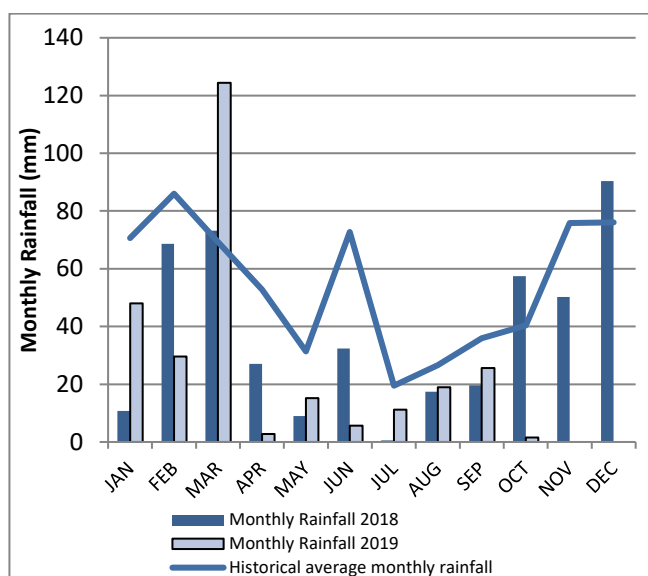
**Figure 1: Rainfall Trend YTD**

Rainfall for the reporting period is summarised in **Table 1**, the year-to-date monthly rainfall totals, 2019 monthly rainfall totals and historical average monthly rainfall trend are shown in **Figure 1**.

*Note: The historical average monthly rainfall is calculated from 2007 to 2018 monthly totals*

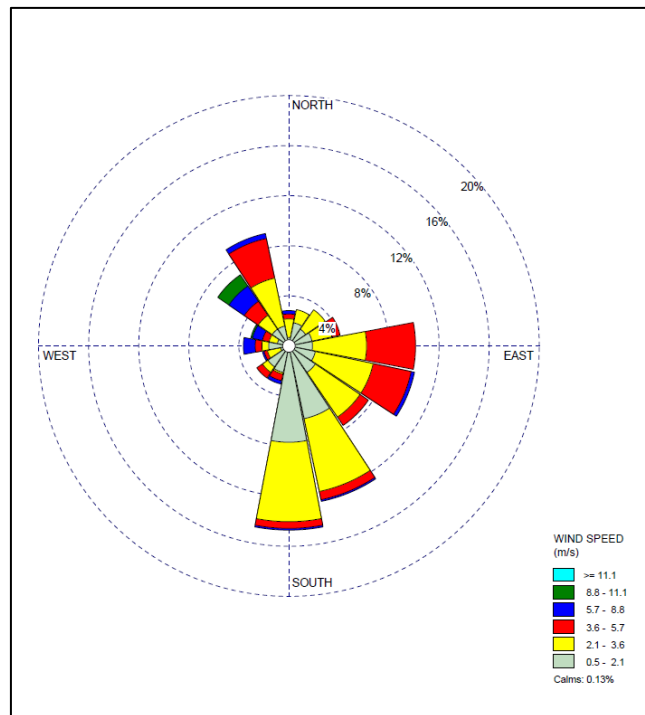
**Figure 2: Charlton Ridge Wind Rose – October 2019**

Winds from the south were dominant throughout the reporting period as shown in **Figure 2**.

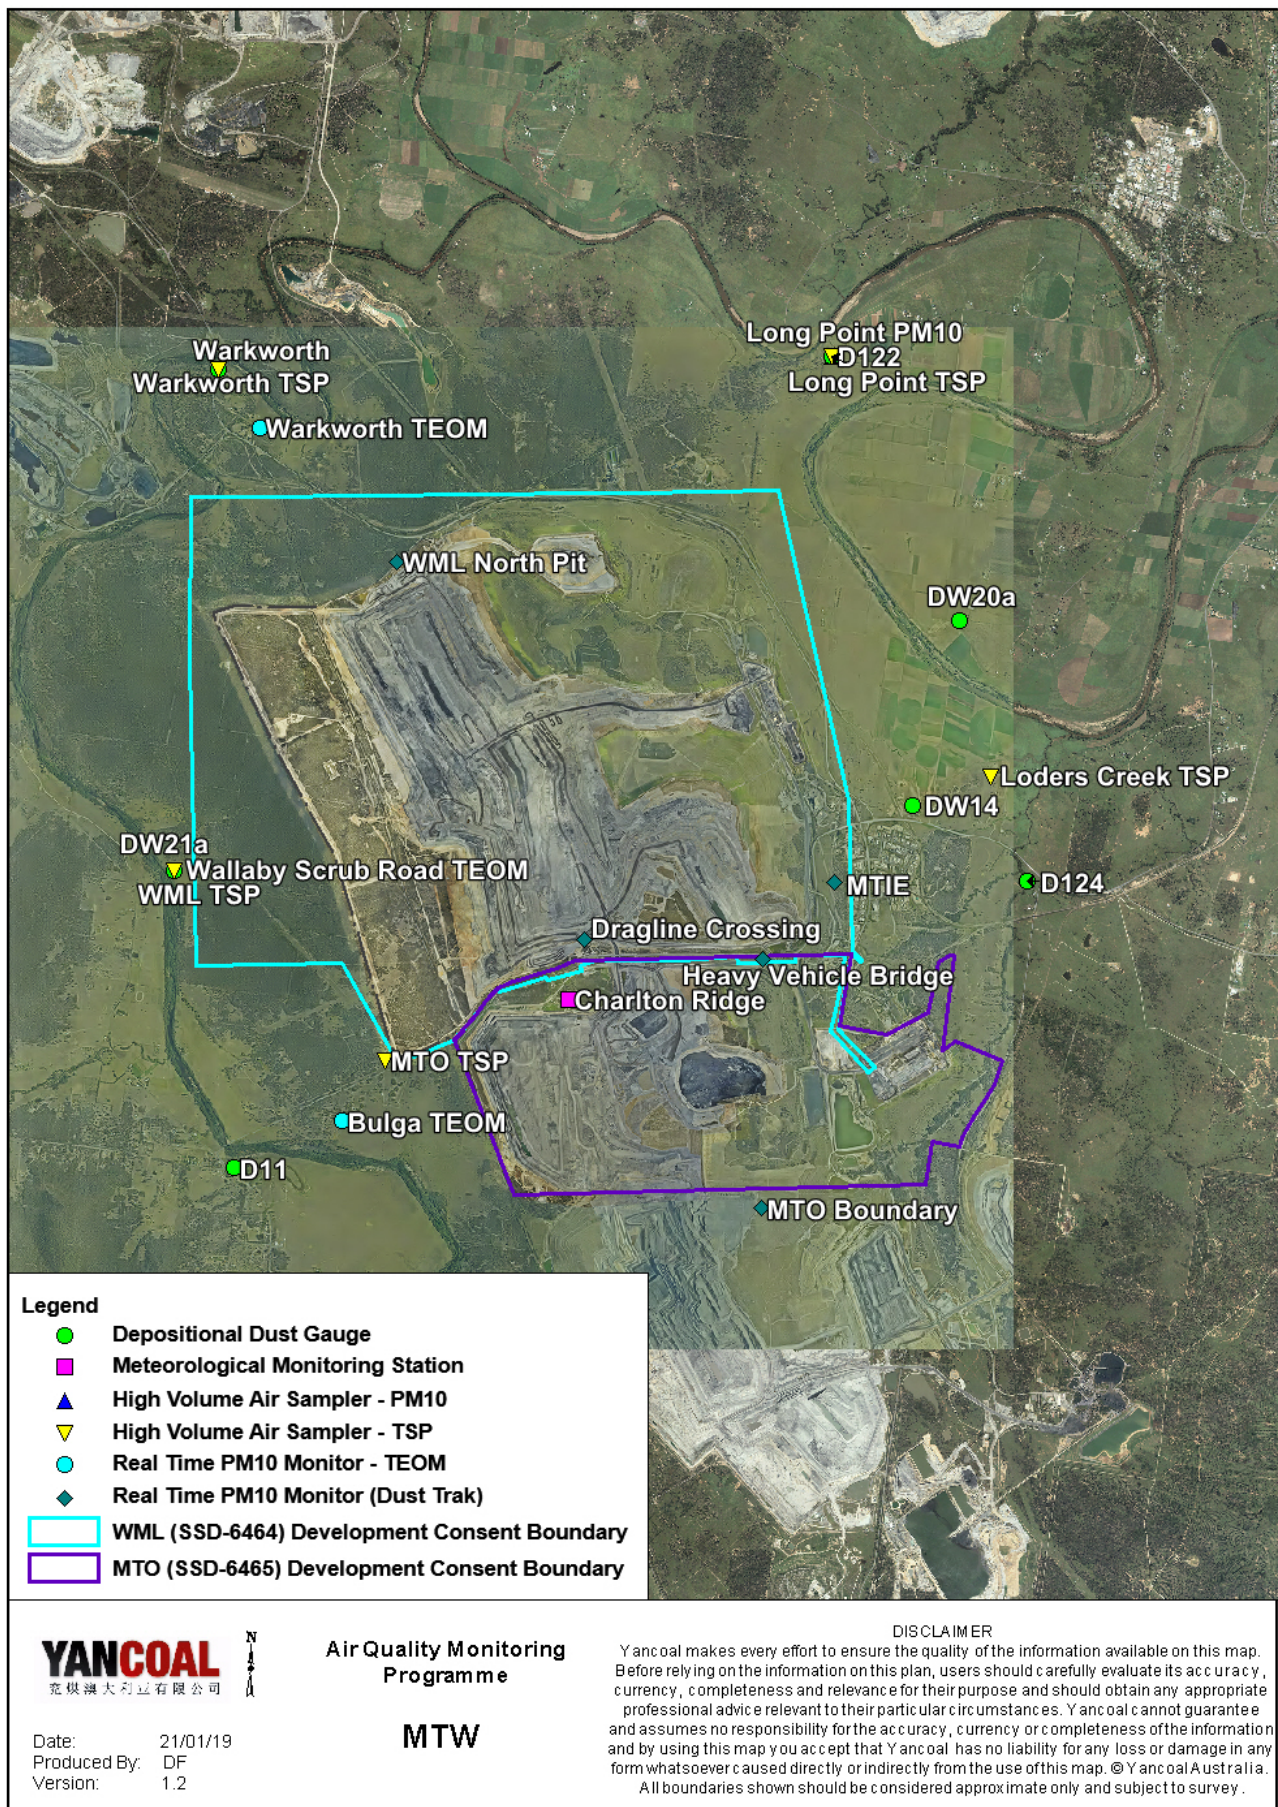
Figure 3: Air Quality Monitoring Locations

Meteorological data is collected at MTW's 'Charlton Ridge' meteorological station (refer to **Figure 3: Air Quality Monitoring Locations**).

Suspended particulates are measured by a network of High Volume Air Samplers (HVAS) measuring Total Suspended Particulates (TSP) and Particulate Matter <10µm (PM<sub>10</sub>). The location of these monitors can be found in **Figure 3**. Each HVAS was run for 24 hours on a six-day cycle in accordance with EPA requirements.

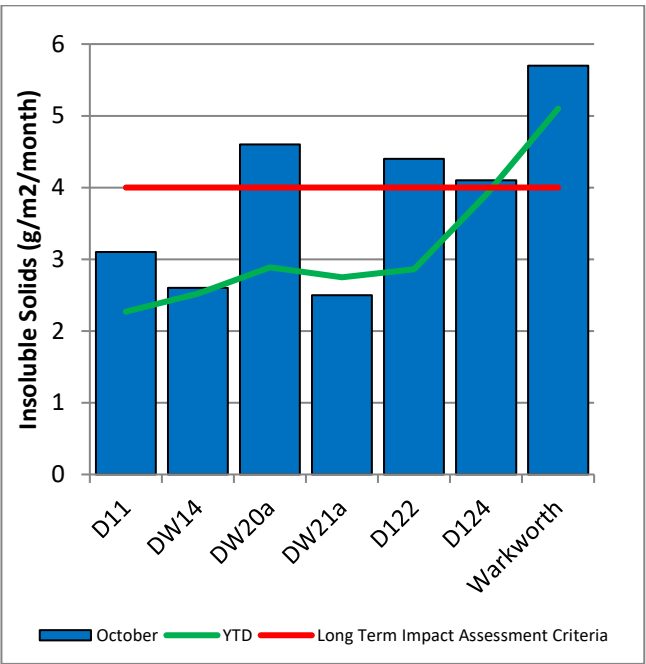
Figure 4: Depositional Dust –October 2019

**Figure 4** displays insoluble solids results from depositional dust gauges during the reporting period compared against the year-to-date average and the annual impact assessment criteria.

During the reporting period the DW20a, D122, D124 and Warkworth monitors recorded monthly results above the long-term impact assessment criteria of 4.0 g/m<sup>2</sup> per month. There is no evidence to suggest that the results are contaminated. Accordingly, the results will be included in the annual average calculation.

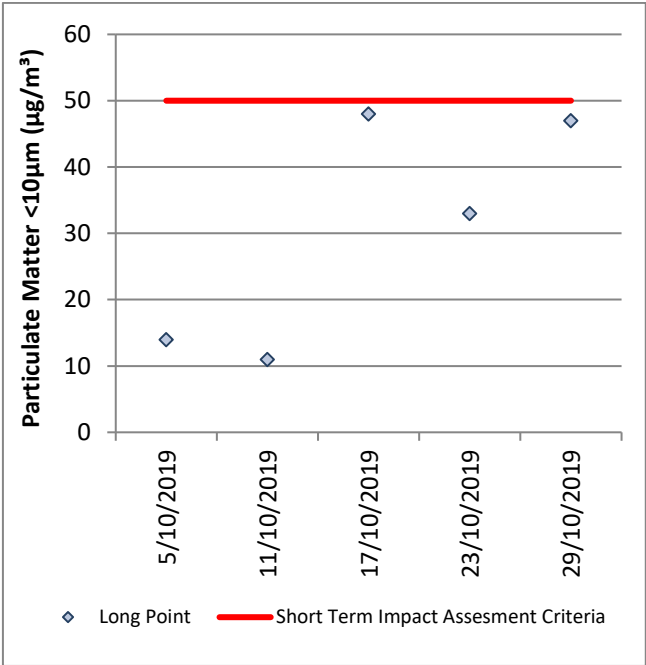
Figure 5: Individual PM10 Results – October 2019

**Figure 5** shows the individual PM<sub>10</sub> results at each monitoring station against the short-term impact assessment criteria of 50µg/m<sup>3</sup>.

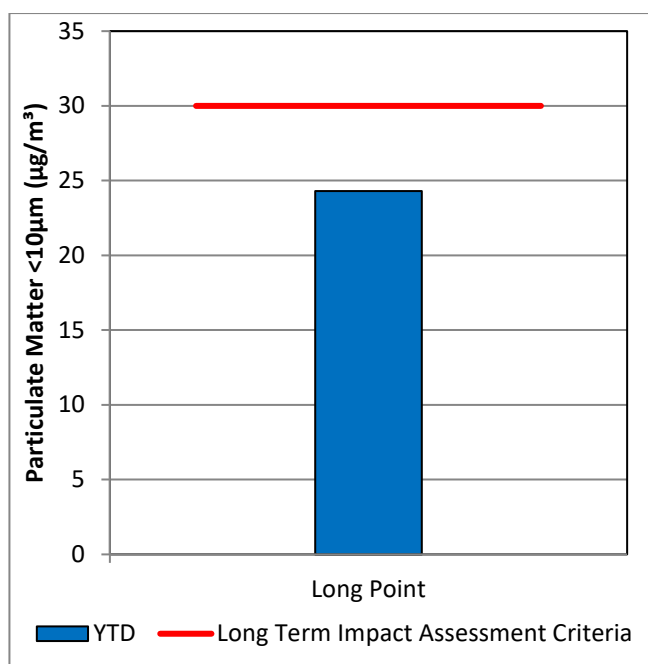
Figure 6: Annual Average PM<sub>10</sub> –October 2019

**Figure 6** shows the annual average PM10 results against the long term impact assessment criteria.

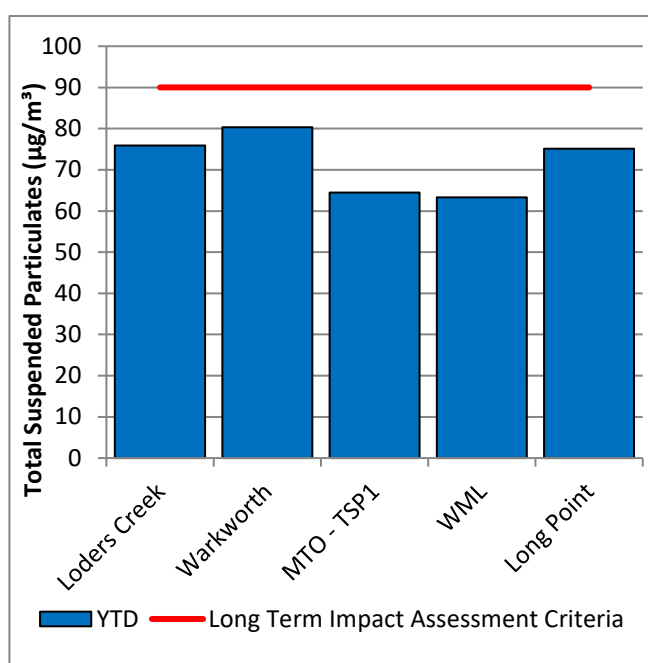
Figure 7: Annual Average Total Suspended Particulates – October 2019

Figure 7 shows the annual average TSP results compared against the long-term impact assessment criteria of 90µg/m³.

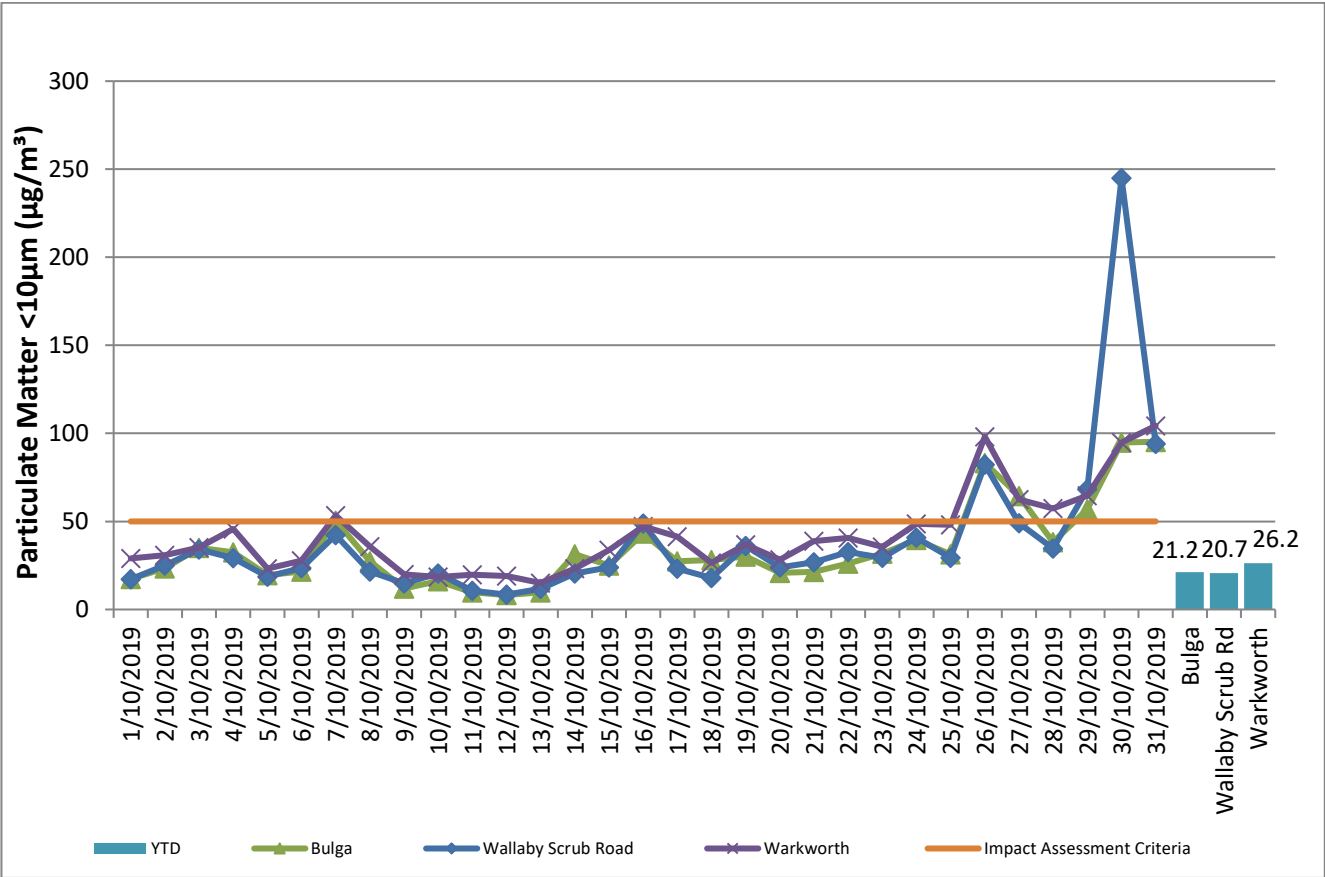
Figure 8: Real Time PM<sub>10</sub> daily 24hr average (line graphs) and YTD annual average (column graphs) – October 2019

Results for real time dust sampling are shown in Figure 8, including the daily 24-hour average PM<sub>10</sub> result and the annual PM<sub>10</sub> average.

On 7 October 2019, the Warkworth OEH and Bulga OEH TEOM’s (53.3 and 50.5 µg/m³ respectively) exceeded the short term (24hr) criteria. On 26 October 2019, the Bulga OEH, Wallaby Scrub Road and Warkworth OEH TEOM’s (83.1, 82.2 and 98.1 µg/m³ respectively) exceeded the short term (24hr) criteria. On 28 October 2019, the Warkworth OEH TEOM (57.4 µg/m³) exceeded the short term (24hr) criteria. From 29 October to 31 October 2019 inclusive, the Bulga OEH (56.8, 94.8 and 95.2 µg/m³ respectively), Wallaby Scrub Road (68.3, 245 and 94 µg/m³ respectively) and Warkworth OEH (64.7, 94.8 and 104.3 µg/m³ respectively) TEOM’s exceeded the short term (24hr) criteria. Investigation into these exceedances determined that the wind direction was generally not from MTW’s angle of influence and/or background PM<sub>10</sub> levels were elevated. The maximum potential contributions to the results were less than 75% and less than 50 µg/m³. Accordingly, MTW operations are not considered to be a significant contributor to the results as described in the MTW Air Quality Management Plan and no further action is required. Elevated PM<sub>10</sub> levels in late October 2019 are considered partially attributable to bushfires in the region. Note: The high result recorded at the Wallaby Scrub Road TEOM on 30 October 2019 was partly the result of a blocked filter, which was replaced approximately mid-morning on that day.

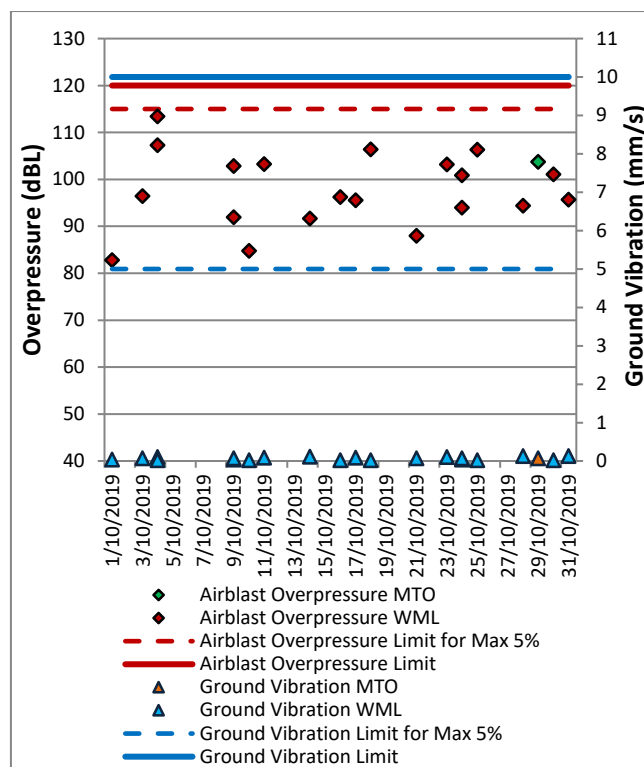
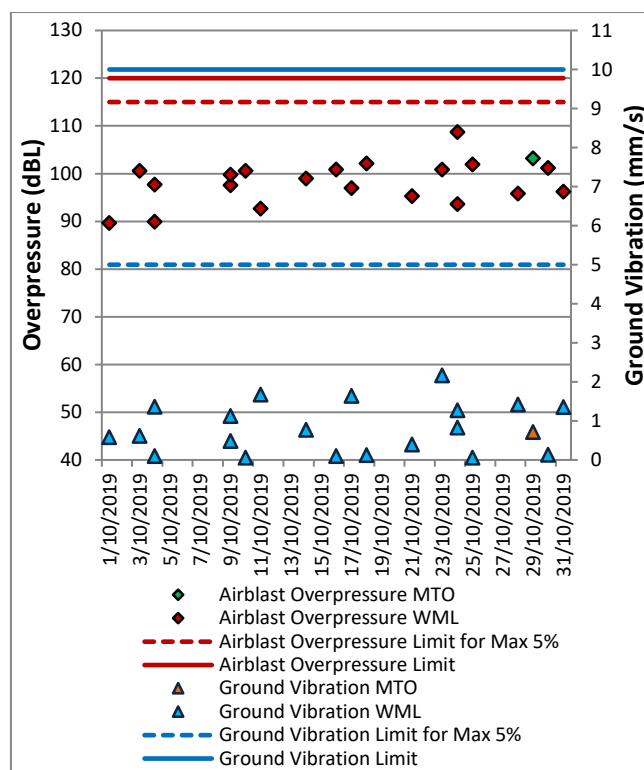
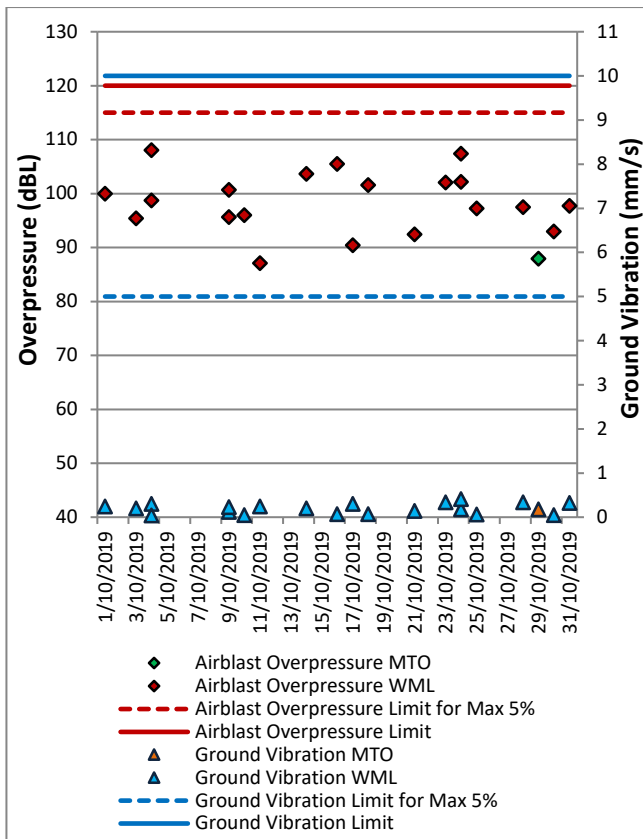
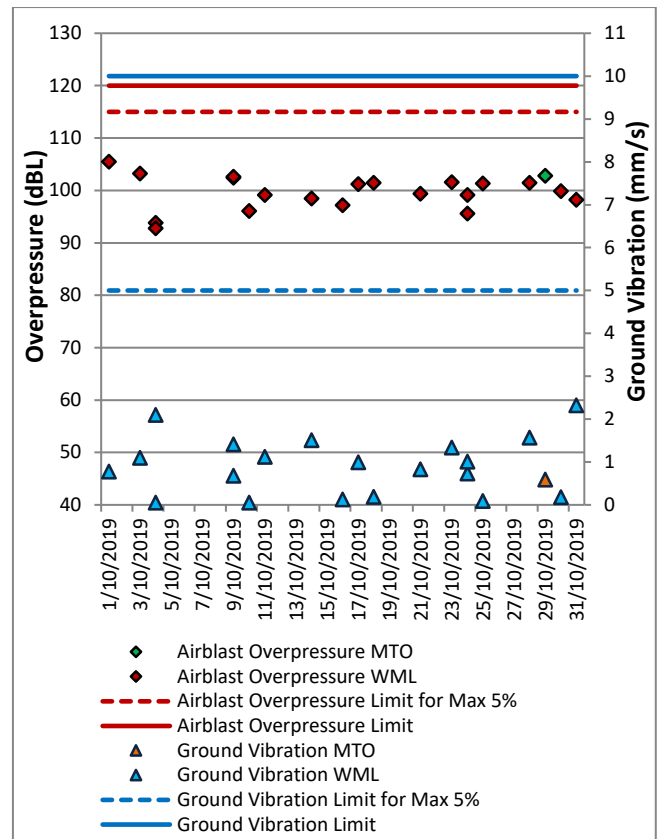
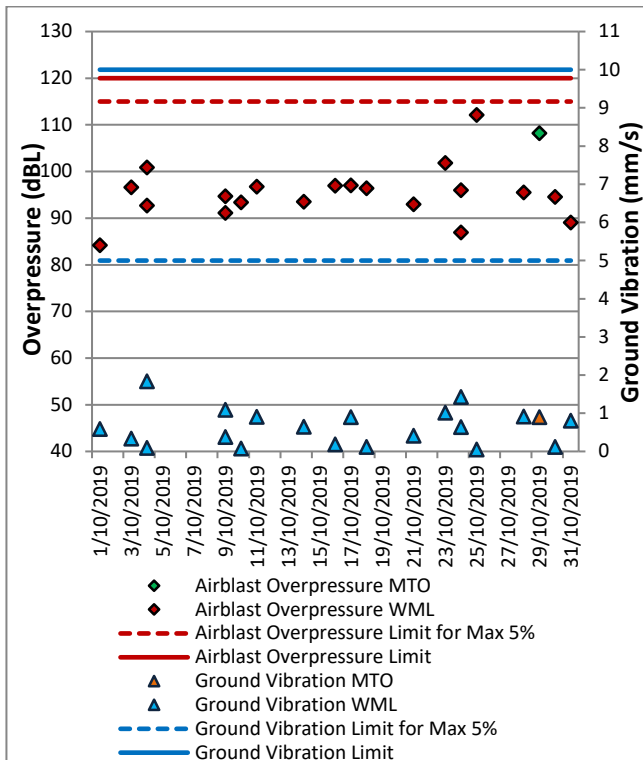
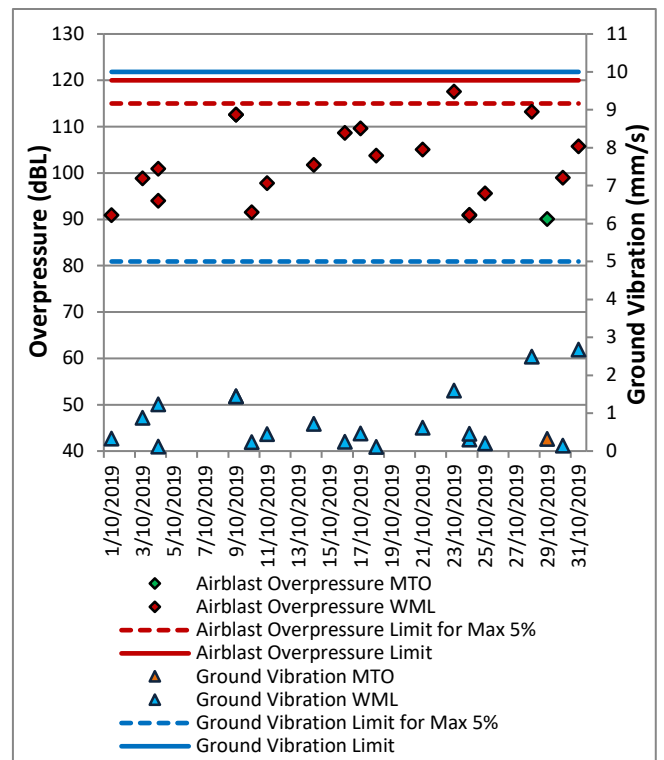
During October 2019, 21 blasts were initiated at MTW. **Figure 9** to **Figure 14** show the blast monitoring results for the reporting period against the impact assessment criteria. The criteria are summarised in **Table 2**.

During the reporting period one blast exceeded the 115 dB(L) threshold for airblast overpressure at the Warkworth blast monitoring location. No blast exceeded the 5mm/s criteria for ground vibration.

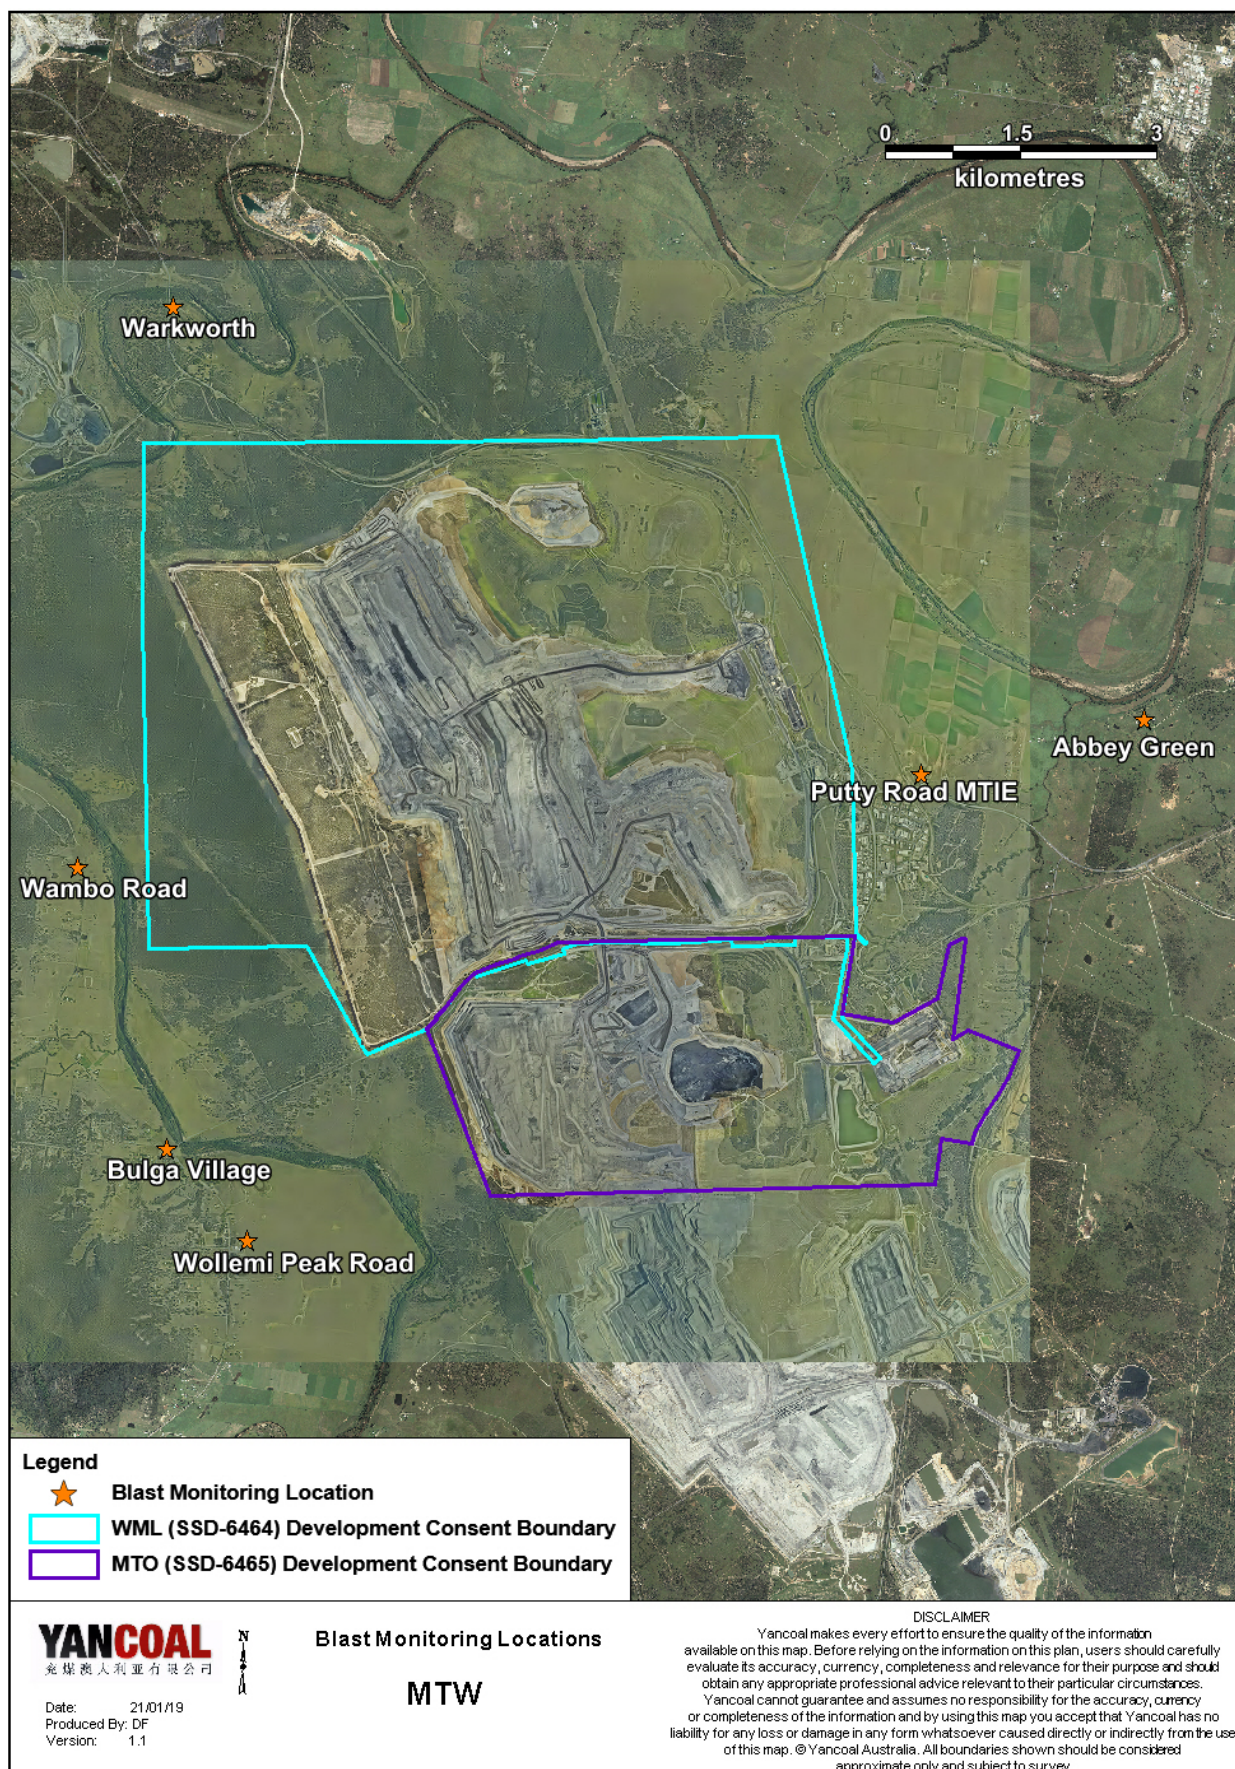
Figure 15: MTW Blast Monitoring Location Plan

MTW have a network of six blast monitoring units. These are located at nearby privately owned residences and function as regulatory compliance monitors.

The location of these monitors can be found in **Figure 15**.

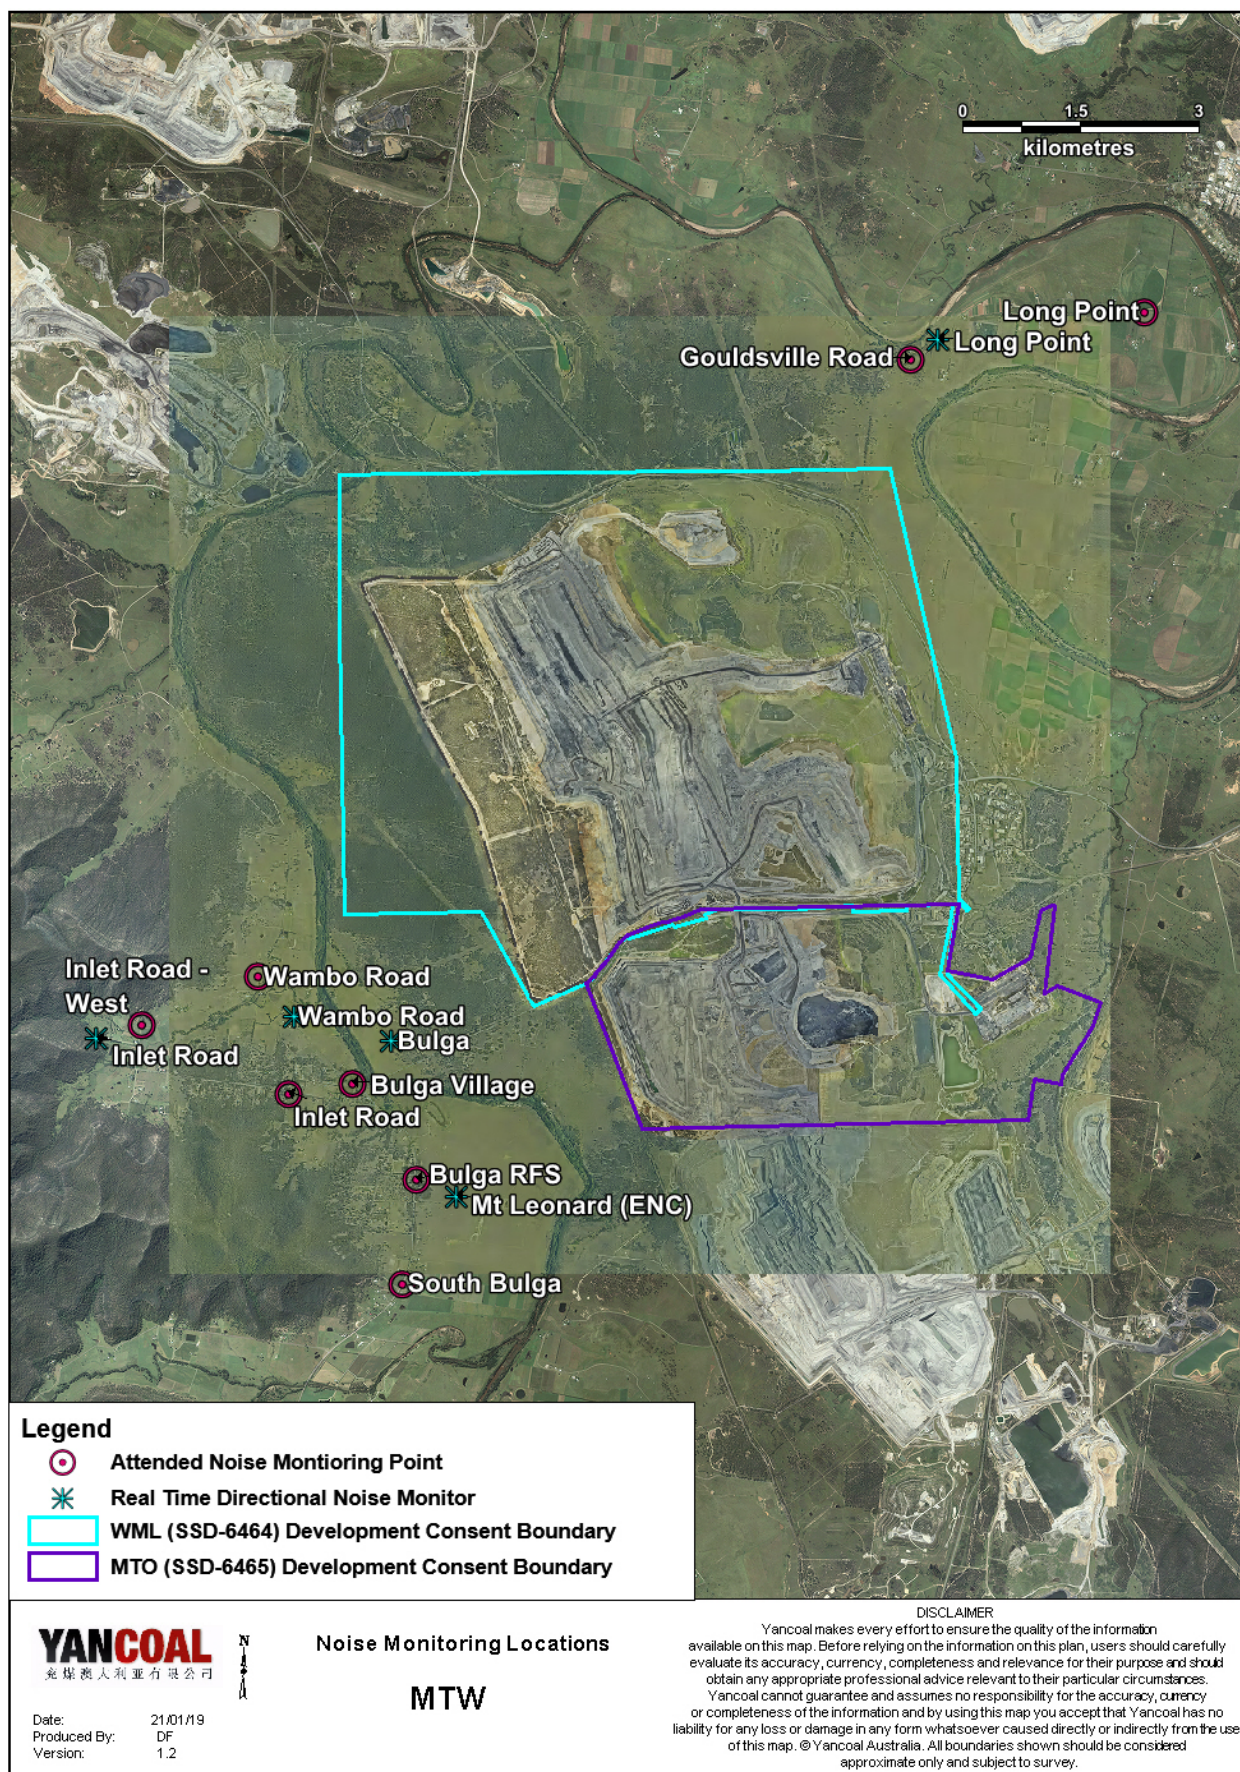
Figure 16: Noise Monitoring Location Plan

Routine attended noise monitoring is carried out in accordance with the MTW Noise Management Plan. A review against EIS predictions will be reported in the Annual Review. The purpose of the noise surveys is to quantify and describe the acoustic environment around the site and compare results with specified limits. Real time noise monitoring also occurs at five sites surrounding MTW. Noise monitoring locations are displayed in **Figure 16**.

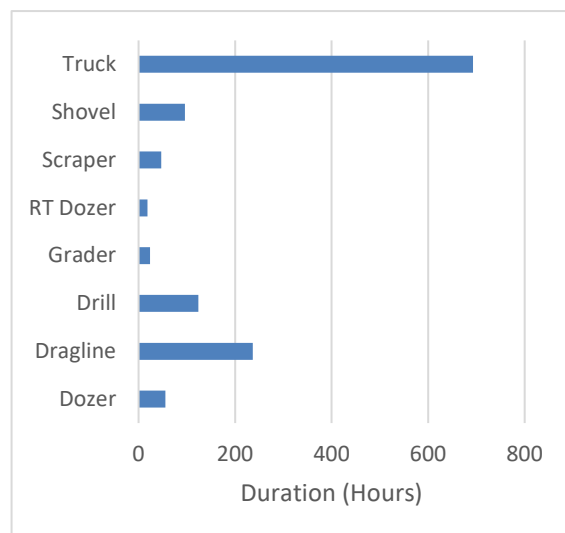
**Figure 17: Operational Downtime by Equipment Type – October 2019**

During October, a total of 1292 hours of equipment downtime was logged in response to environmental events such as dust, noise and adverse meteorological conditions. Operational downtime by equipment type is shown in **Figure 17**.

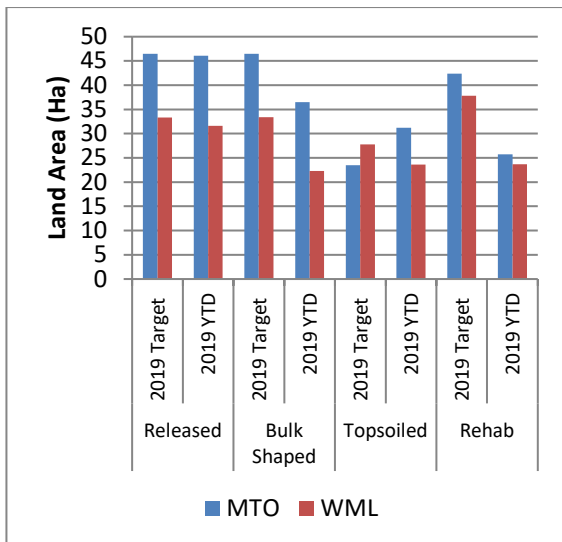
Figure 18: Rehabilitation YTD – October 2019

During October 2019, 5.4 Ha of land was bulk shaped, 6.0 Ha of land was top soiled, 8.2 Ha of land was composted and 29.5 Ha of land was rehabilitated.
