Mount Thorley Warkworth

2019 Annual Review

Mount Thorley Warkworth (MTW) is an integrated operation of two open cut coal mines, Warkworth Mining Limited (WML) and Mount Thorley Operations (MTO). This Annual Review reports on the environmental performance of MTW for the period 1 January 2019 to 31 December 2019.

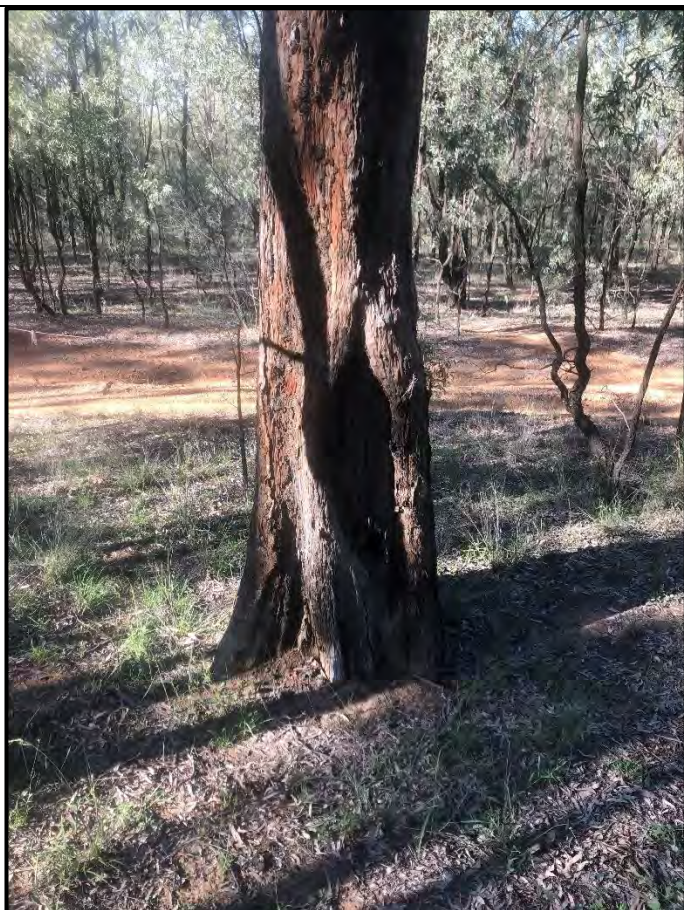
Scarred tree MTW-8

Four scarred trees are located within the approved future mining area at MTW. With the exception of MTW-70, these trees have been visited by an arborist to assess the best method of removal and relocation, and general plans developed. MTW-70 should also be assessed for removal and relocation. These scarred trees have been visited by RAPs during this compliance inspection and during other inspections and assessments. Their removal and the arborist's plans should be discussed with the CHWG, as well as the location to where they will be relocated – the Wollombi Brook ACH Conservation Area has been suggested.

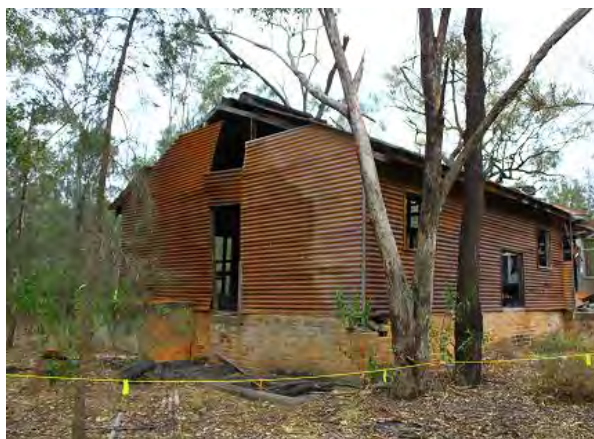
View to mess from south-east (2012)

The building is currently structurally unsound, with a large tree impacting on the roof and a number of timber elements either missing or in a deteriorated state. Corrugated asbestos roof sheeting is also missing in some places, and damaged and in poor condition where it remains. Much of the corrugated iron sheeting is corroded. Brickwork is also cracking in a number of locations resulting in significant movement outward, loss of mortar and loss of bricks along the southern and eastern elevations.

As a result, a number of structural recommendations were outlined by ERM in the CMP developed for the site in 2012. These recommendations were not intended to return the building to a serviceable state, rather they seek to do the minimum required to allow safe access to the building to prevent significant damage, and also allow safe access for asbestos removal and internal inspection of the building in the short to medium term.

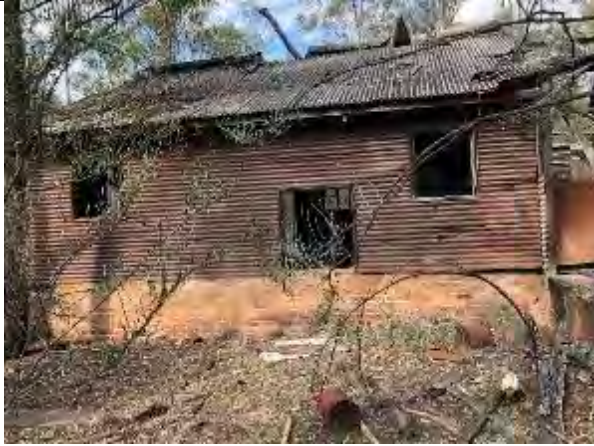
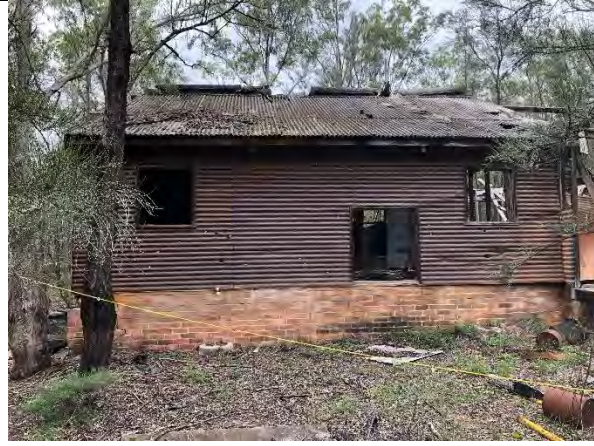
East elevation 2012-18: no discernible change – note fallen branch from tree on western side. 2018-20: no discernible change – fallen branch has moved.

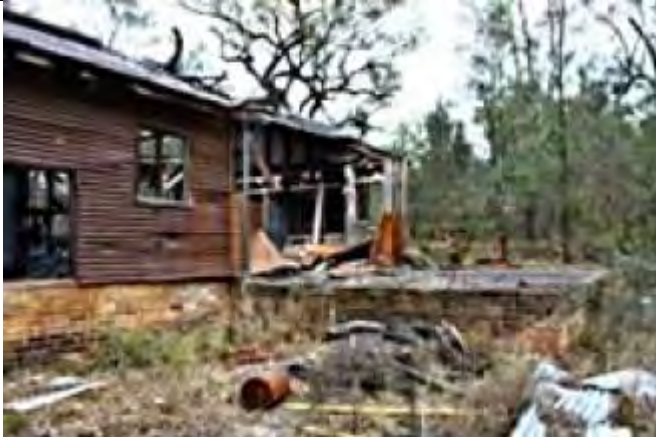
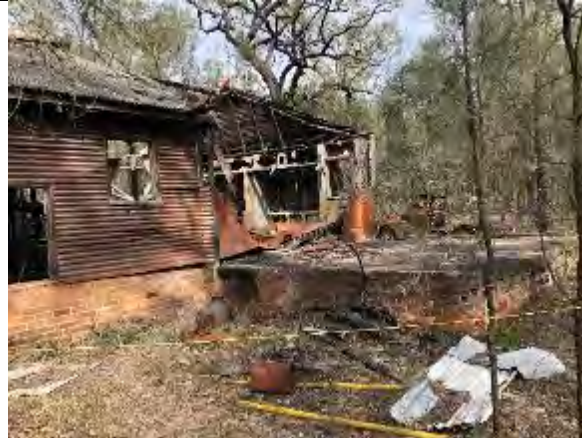
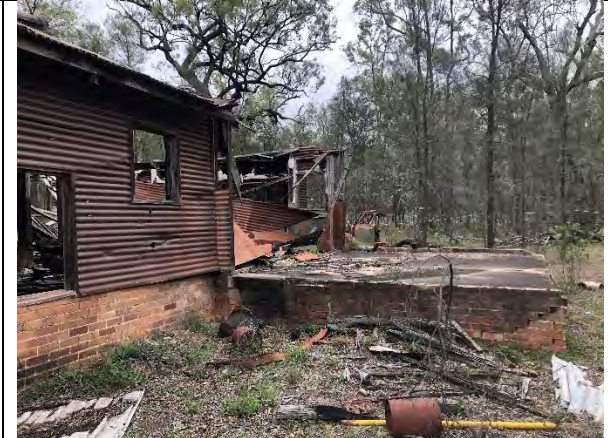
View to north-east elevation

2012-18: roof over open kitchen area has deteriorated, causing severe lean on far wall.

2018-20: top of far wall now collapsed.

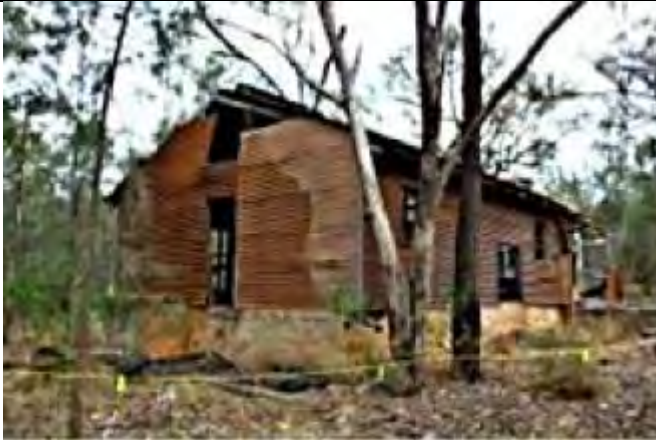
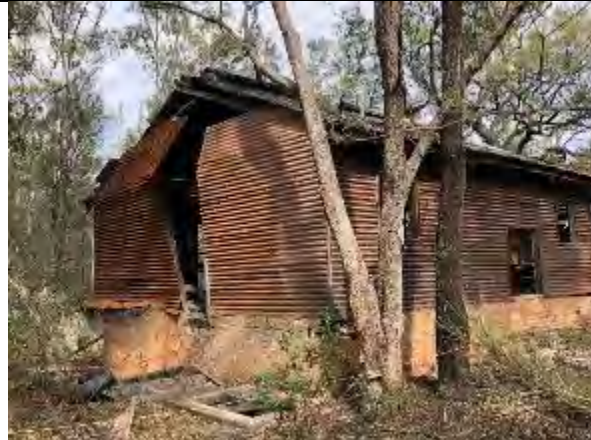
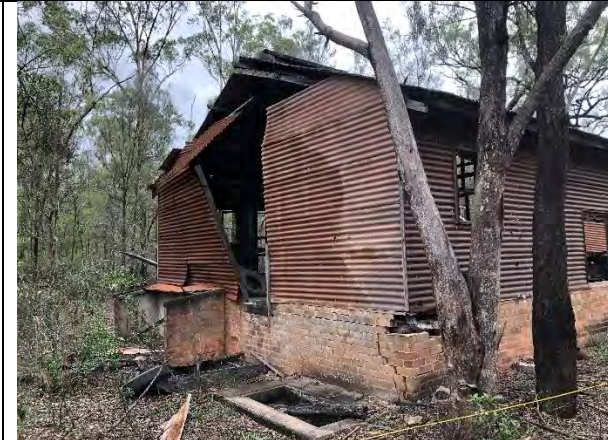
South-east elevation

2012-18: evidence of increased bow to southern wall.

2018-20: bow in wall appears to have increased.

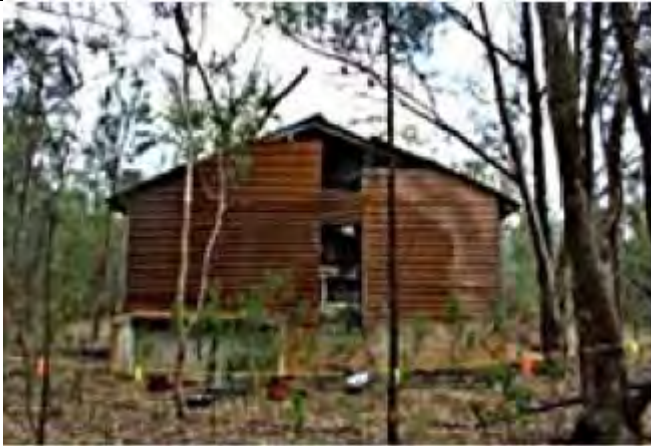
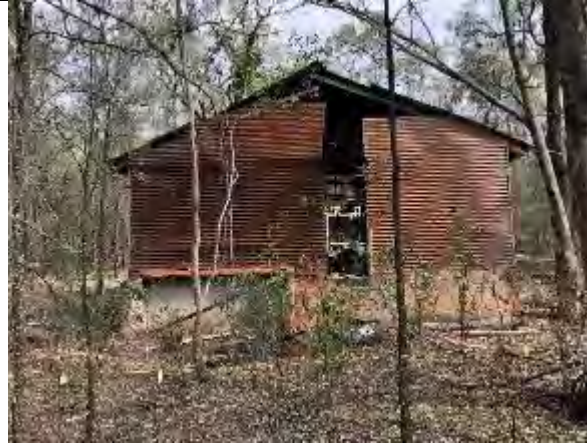
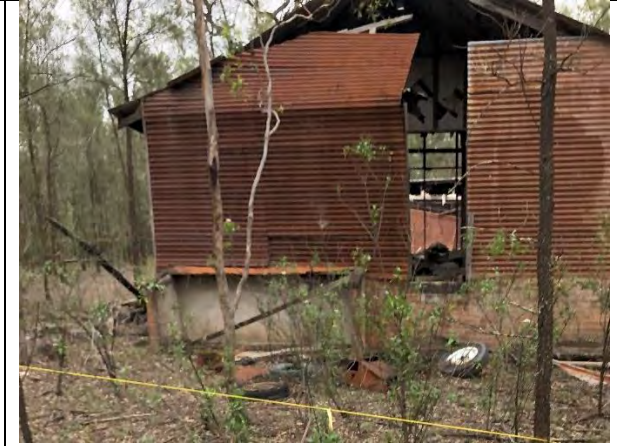
South elevation

2012-18: evidence of increased bow to southern wall and missing panel above entry.

2018-20: increased bow to southern wall.

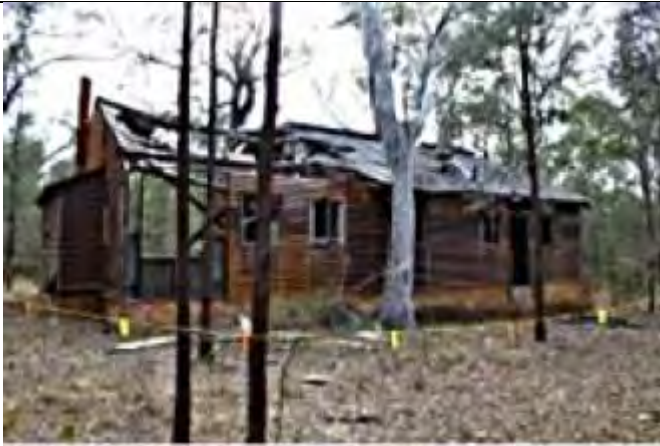
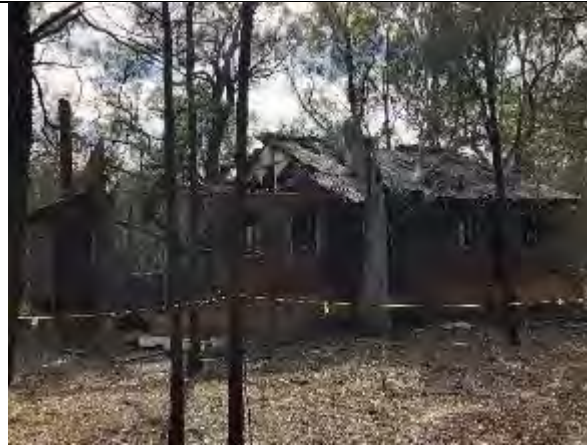
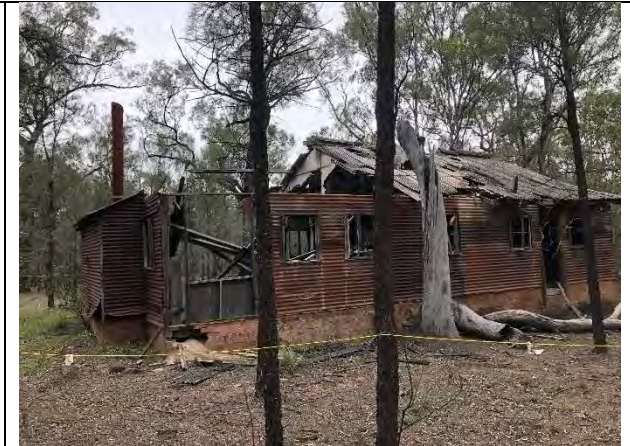
West elevation

2012-18: shows deterioration of roofing members above open kitchen area and leaning north wall, and further collapse of asbestos roof due to fallen dead tree.

2018-20: top of north wall now collapsed, further damage to roof with branch now fallen to ground.

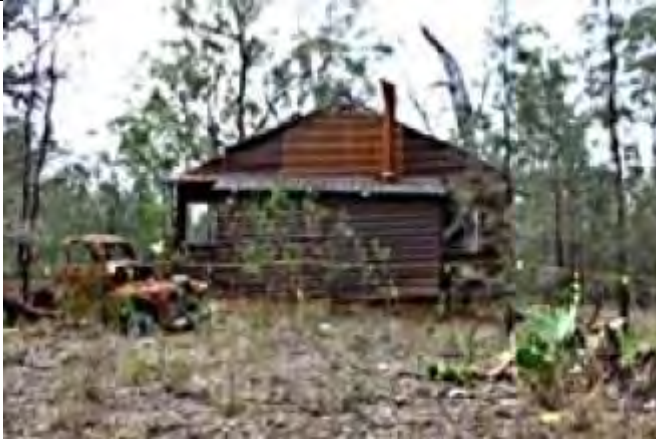
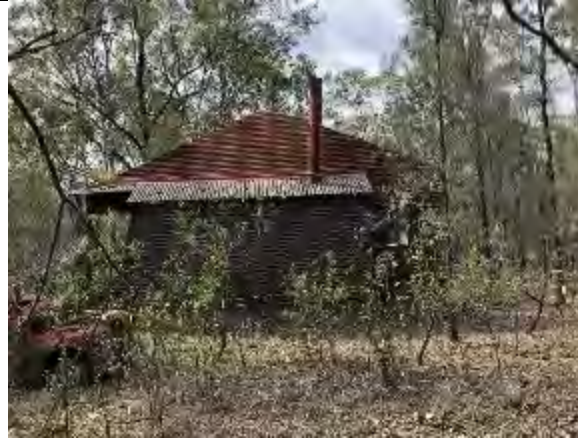
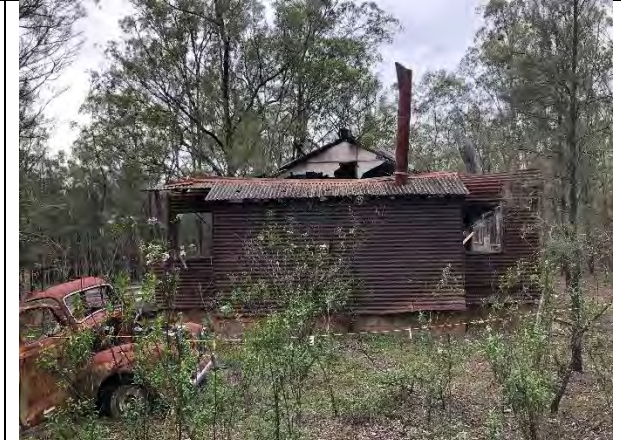
North elevation

2012-18: no discernible change.

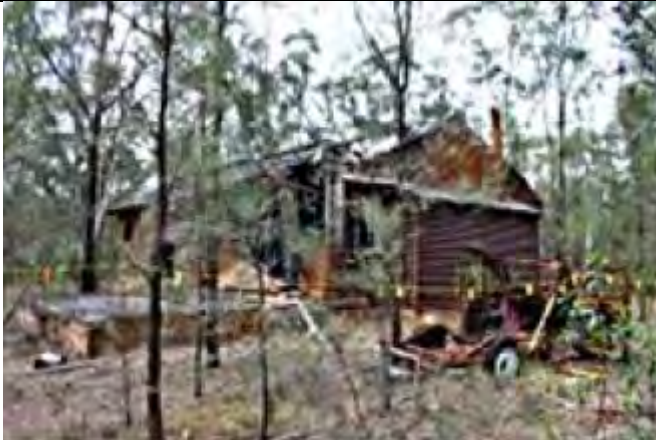
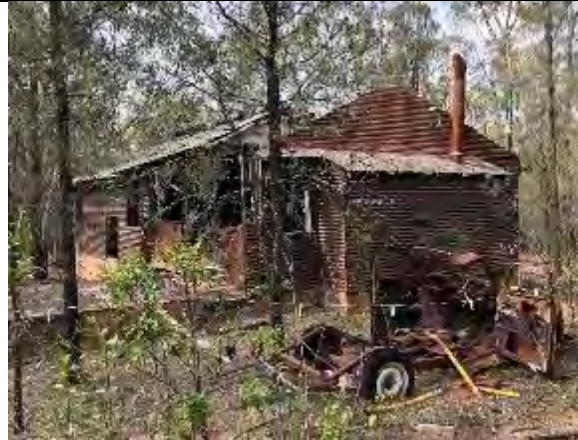
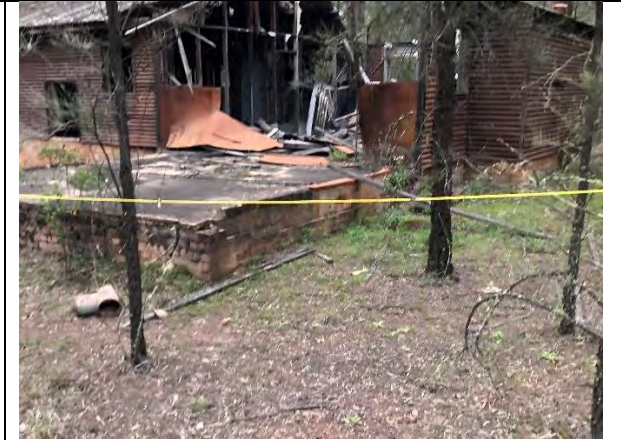
North-east elevation

2012-18: difficult to discern change.

2018-20: difficult to discern change.

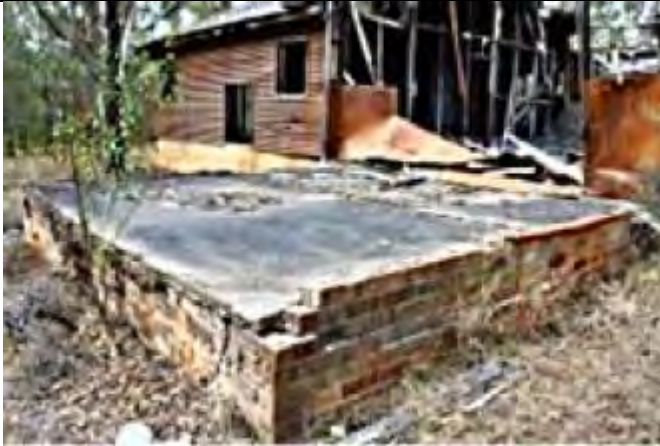
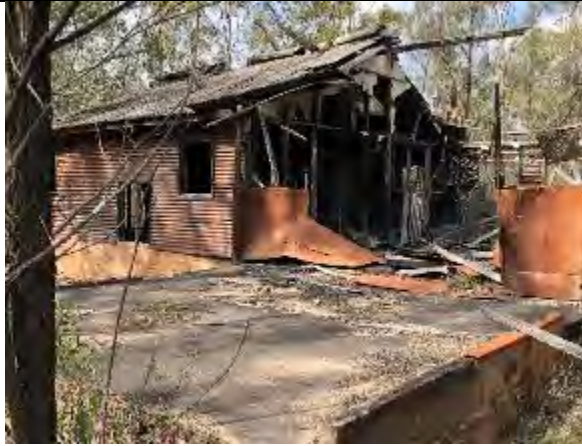
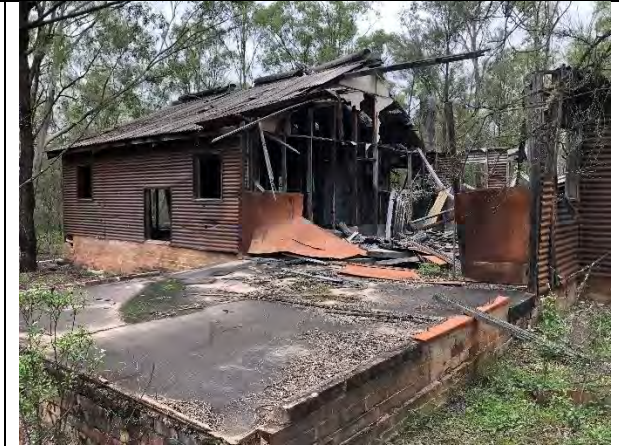
Concrete and brick foundation at east side of building

2012-18: difficult to discern change.

2018-20: no discernible change.

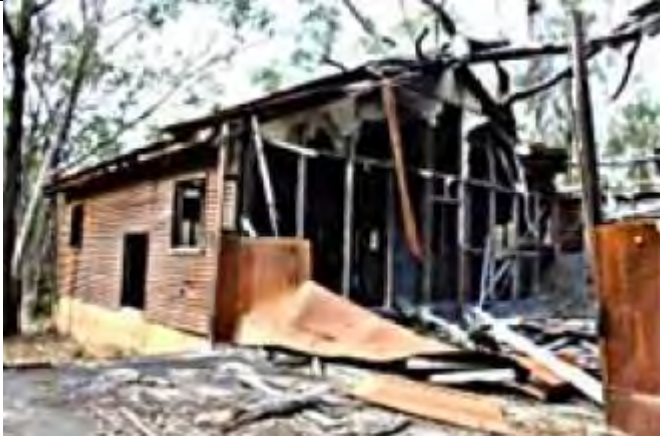
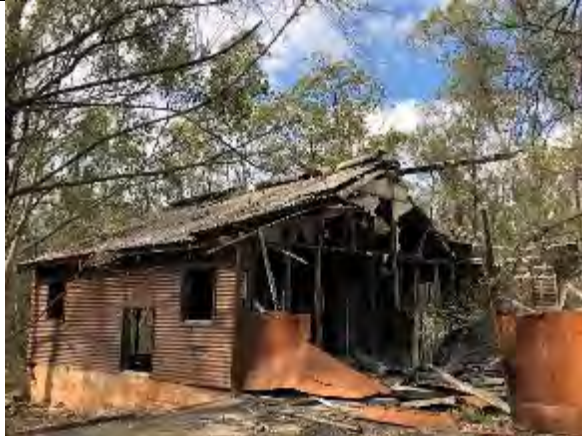
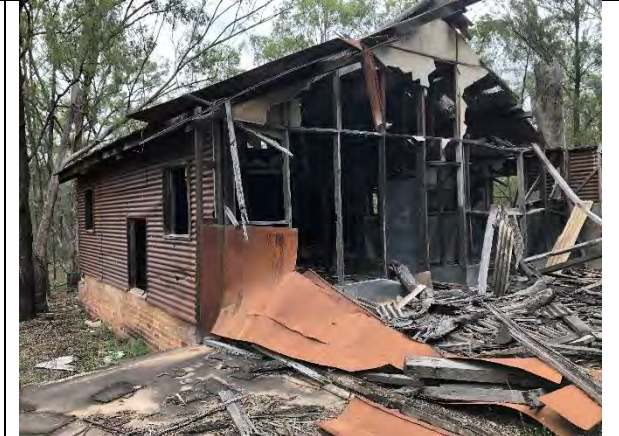
View to building interior from north-east

2012-18: shows collapse of remnant roofing members above open kitchen area.

2018-20: further minor deterioration of asbestos sheeting panelling.

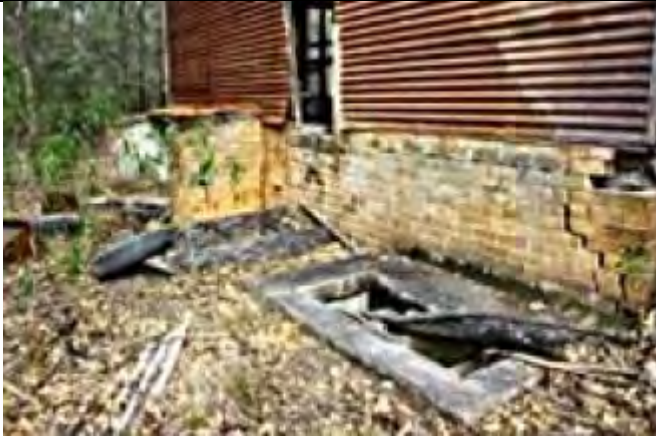
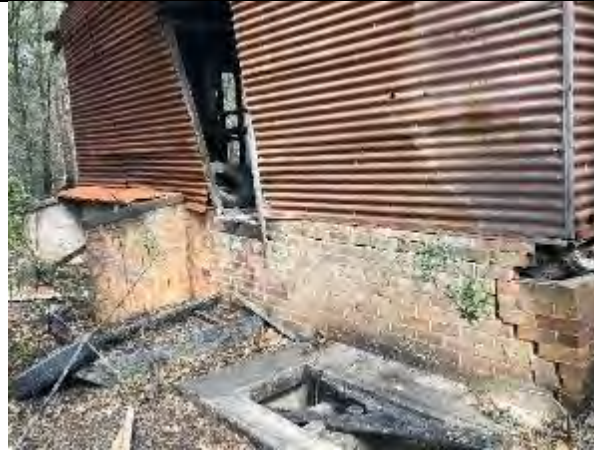
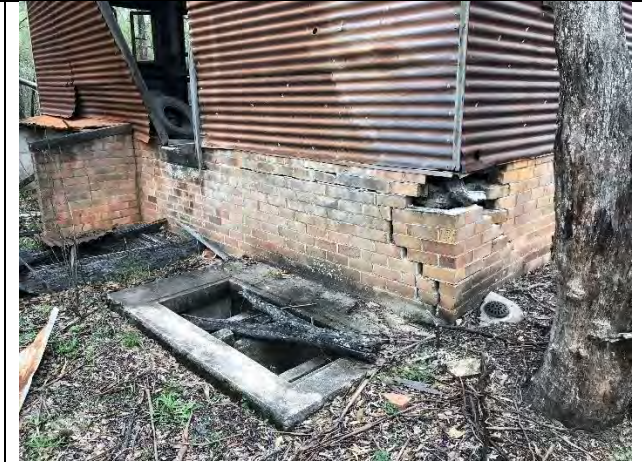
Grease trap at south end of building

2012-18: shows bow to south wall.

2018-20: shows increased bow to south wall.

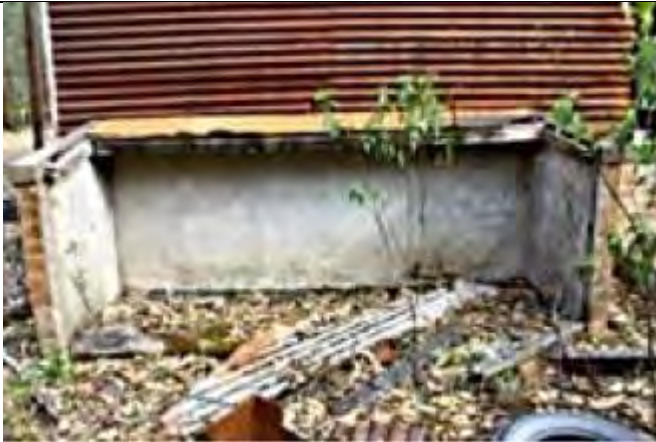
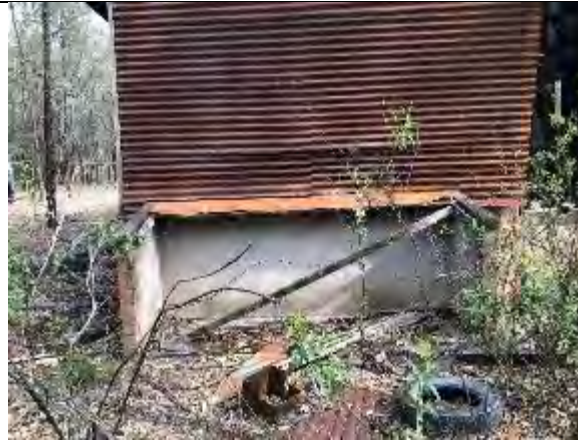
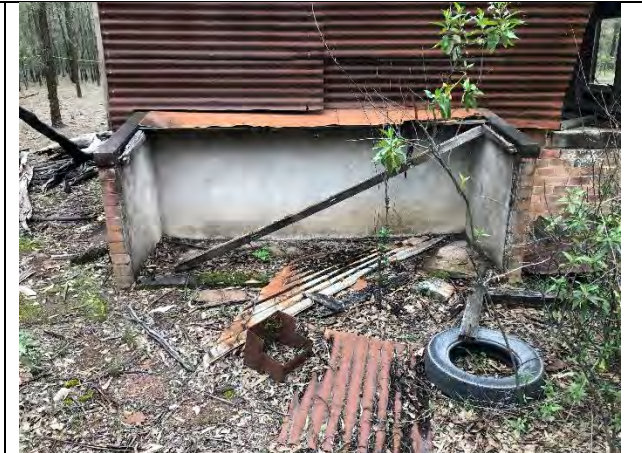
Storage area at south end of building

2012-18: further slight collapse of storage area.

2018-20: shows loosening of corrugated iron wall sheeting due to bowing in wall.

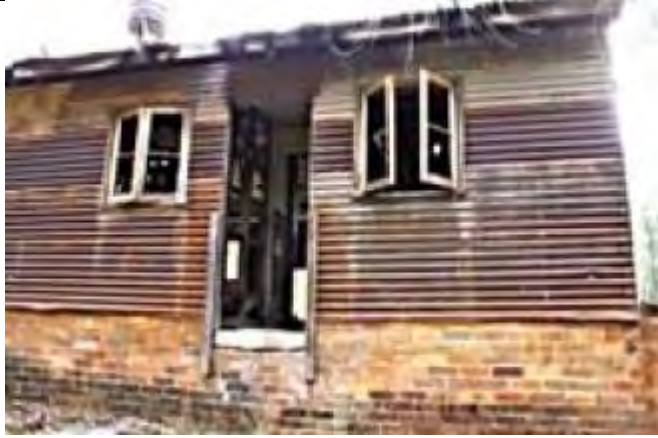
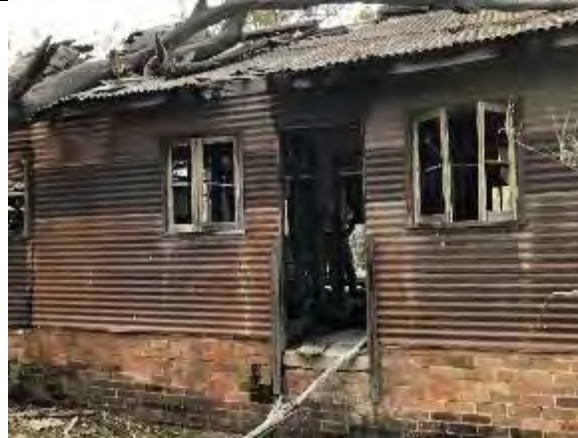
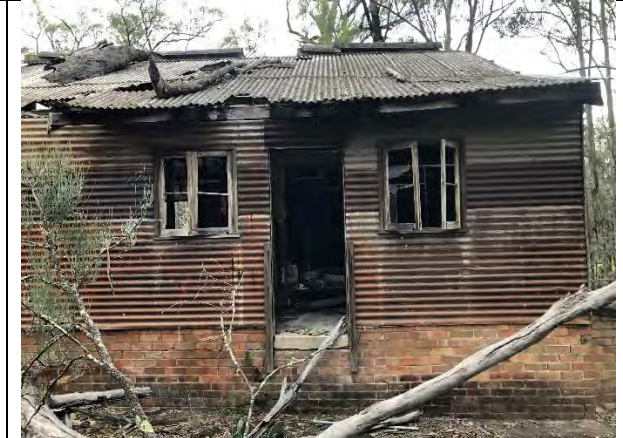
Windows and entry at west elevation

2012-18: shows large trunk/branch portions of tree collapsed on roof, which has destroyed roof ventilator.

2018-20: shows majority of branches fallen from roof, leaving increased damage to sheeting.

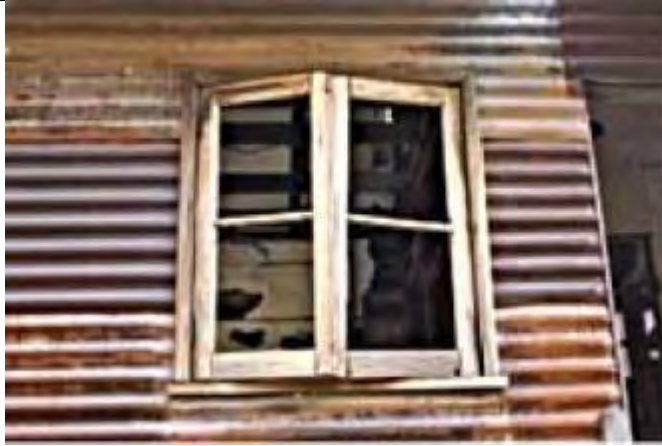
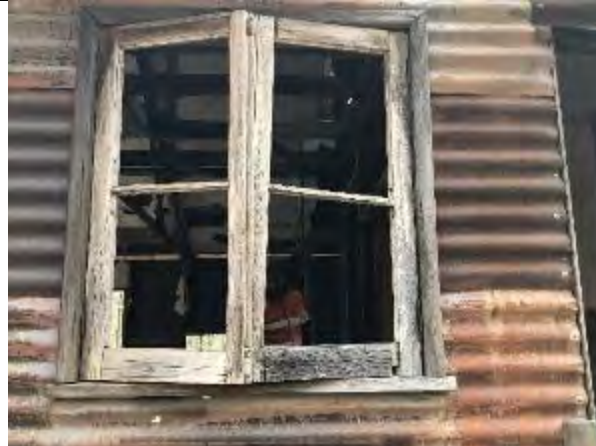
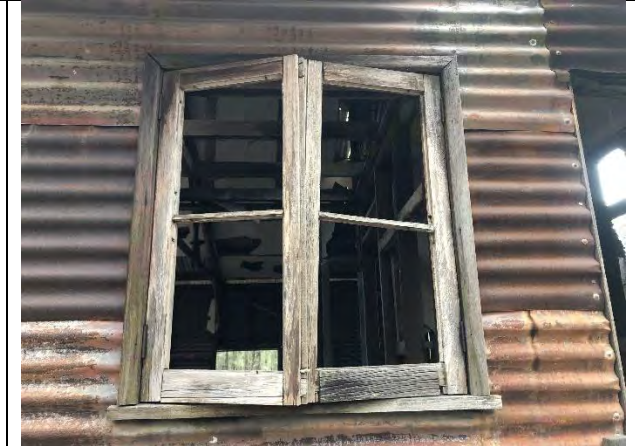
Timber window detail, west elevation

2012-18: no discernible change.

2018-20: no discernible change.

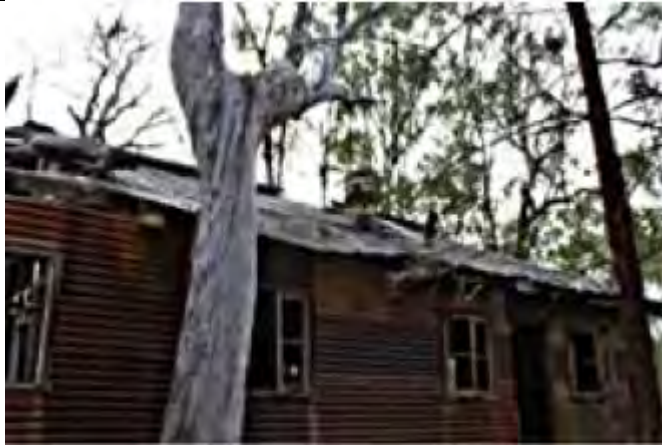
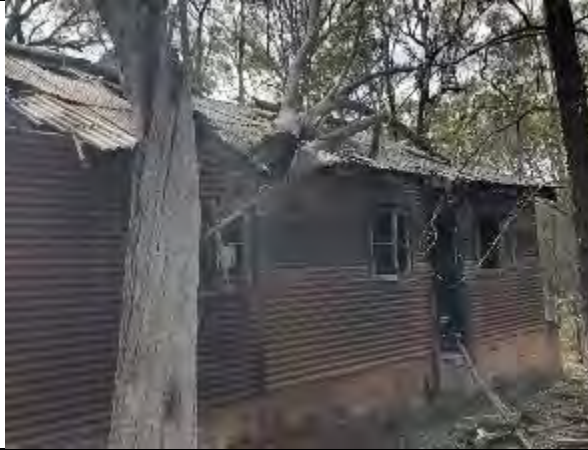
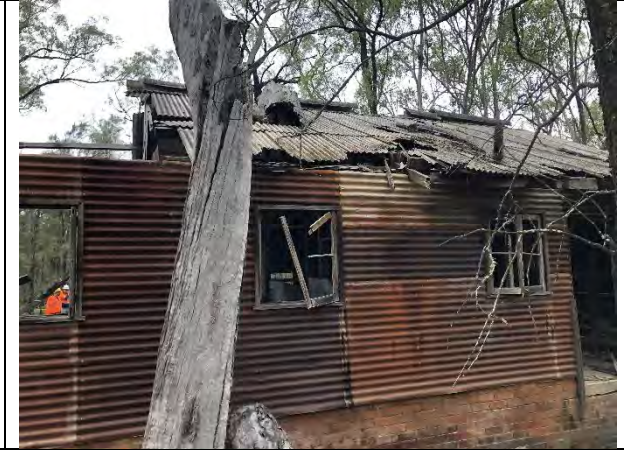
Showing cylindrical ventilator and damage to roof, view from west

2012-18: shows significant roof damage from fallen dead tree, including to ventilator.

2018-20: shows increased damage to roof sheeting from fallen branch.

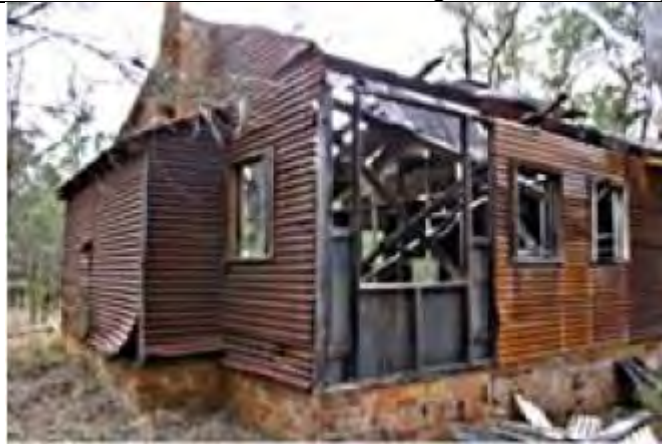
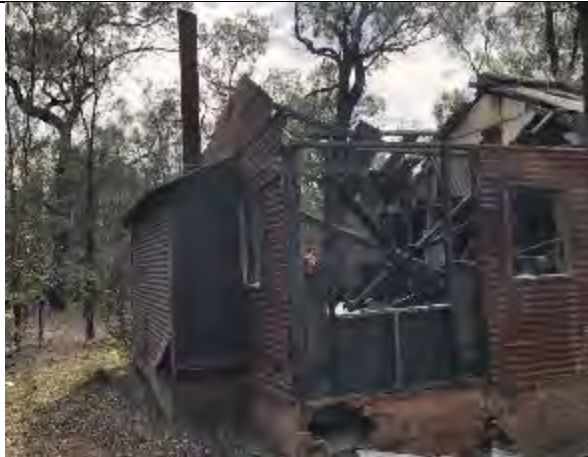
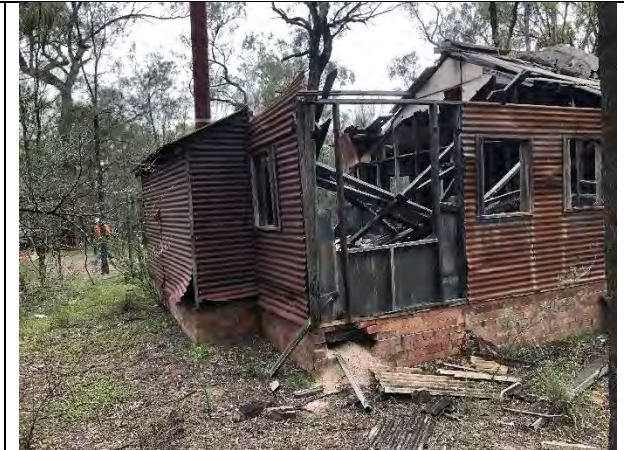
Detail of north-west elevation

2012-18: shows increased collapse over open kitchen area, as well as new damage to brick foundation at north-west corner.

2018-20: shows fallen top of north wall plus increased (animal?) damage to brick foundation at north-western corner.

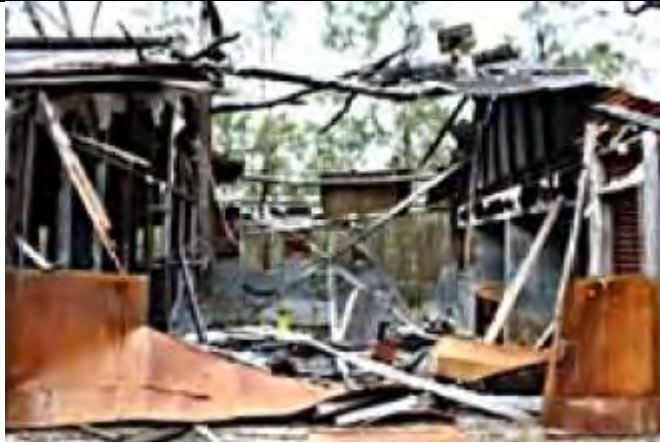
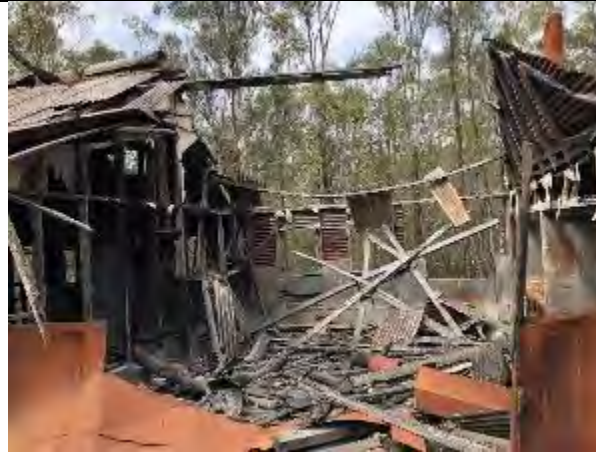
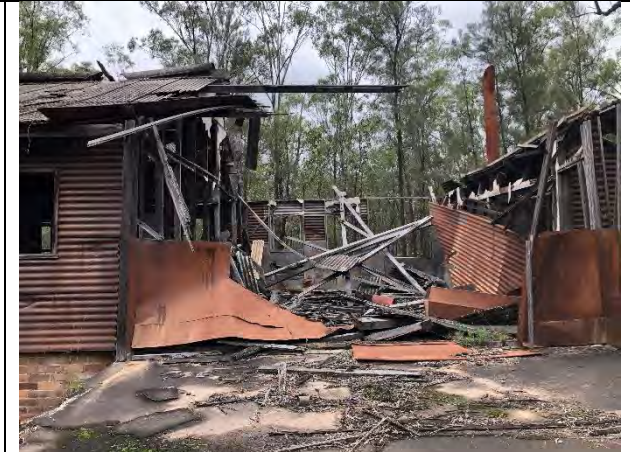
Showing interior damage at kitchen at north end of building

2012-18: shows increased collapse over and accumulation of debris within open kitchen area. Note also severe lean to north wall.

2018-20: shows collapsed top of north wall and collapse of remaining full cross-beam.

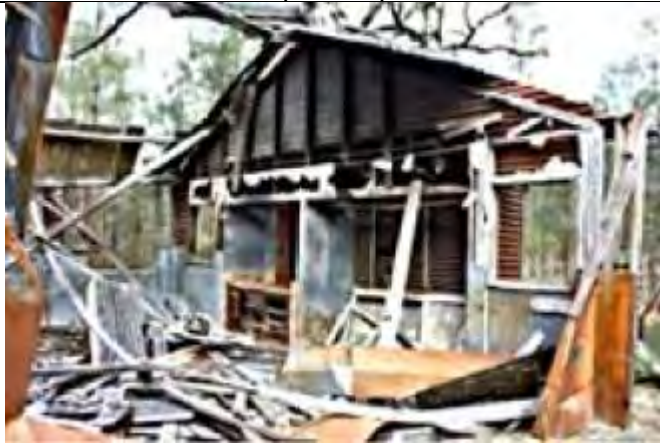
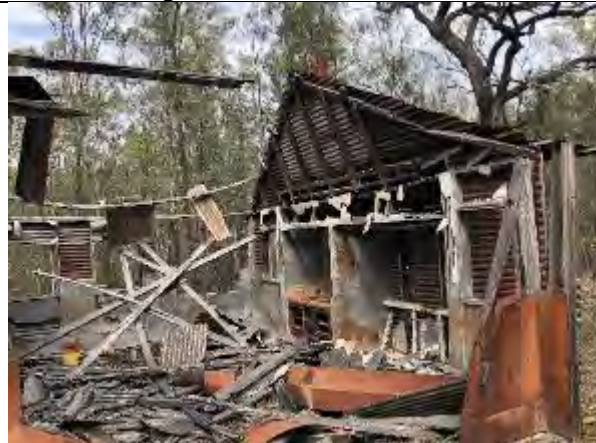
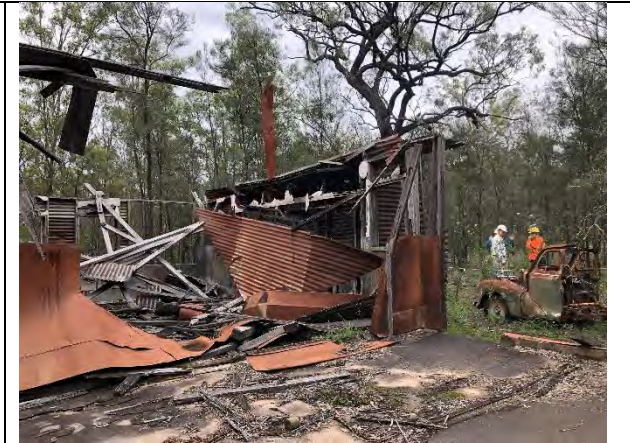
Showing interior damage at kitchen at north end of building

2012-18: shows increased collapse over and accumulation of debris within open kitchen area. Note also severe lean to north wall.

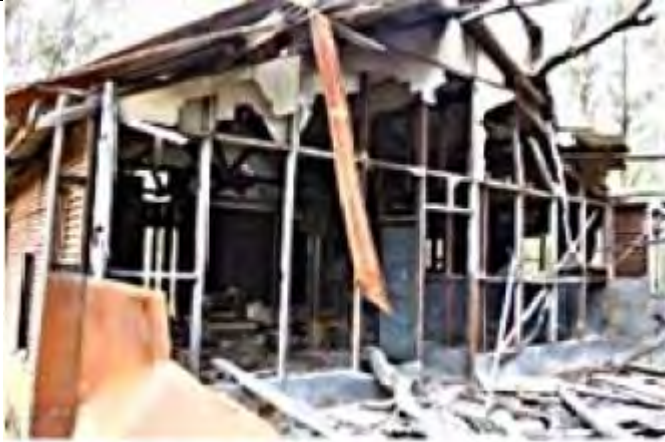
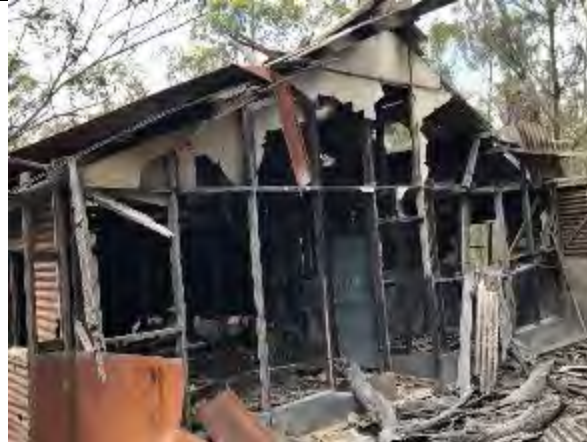
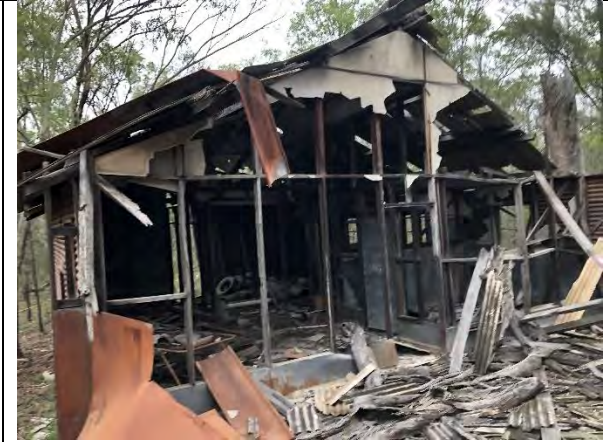
View to interior of south end of building, view from east

2012-18: shows increased collapse over open kitchen area.

2018-20: shows further minor deterioration of asbestos panelling.

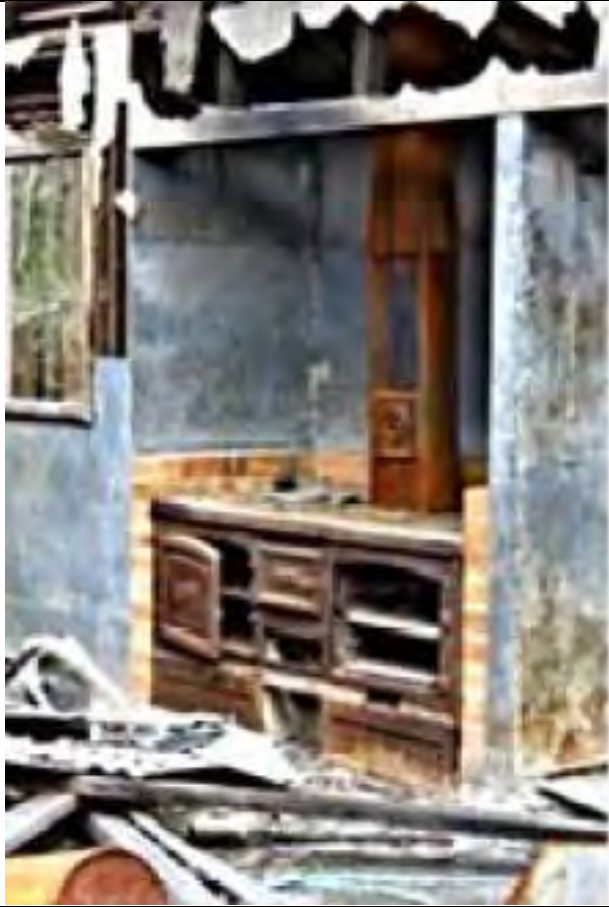
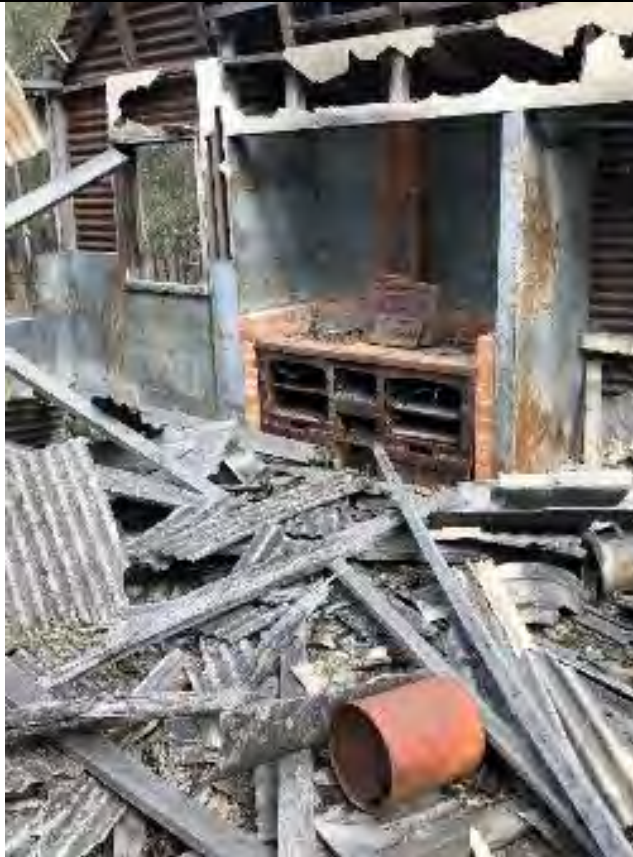
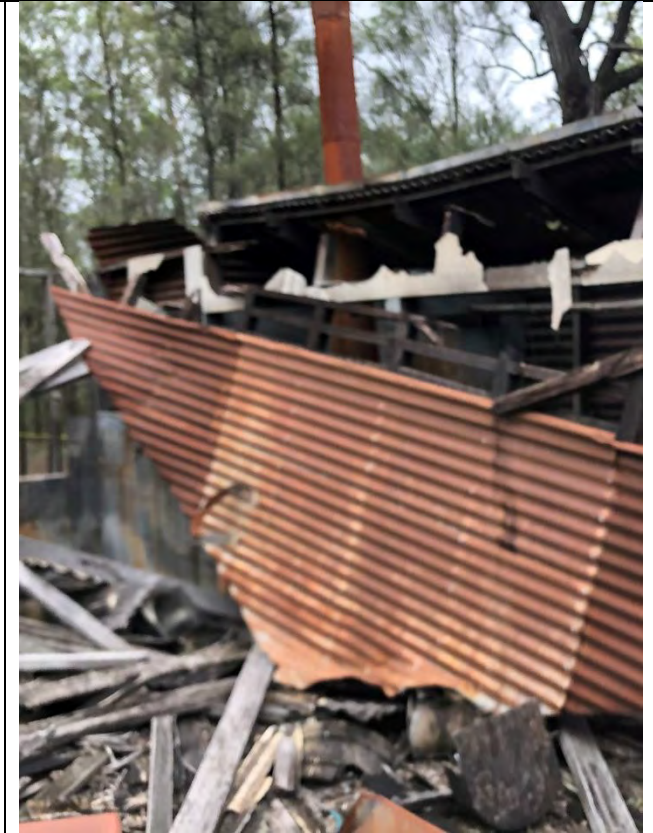
Showing stove at kitchen at north end

2012-18: note the remaining two stove doors have become unhinged and build up of debris from collapsed roof.

2018-20: stove now obscured by collapsed north wall.

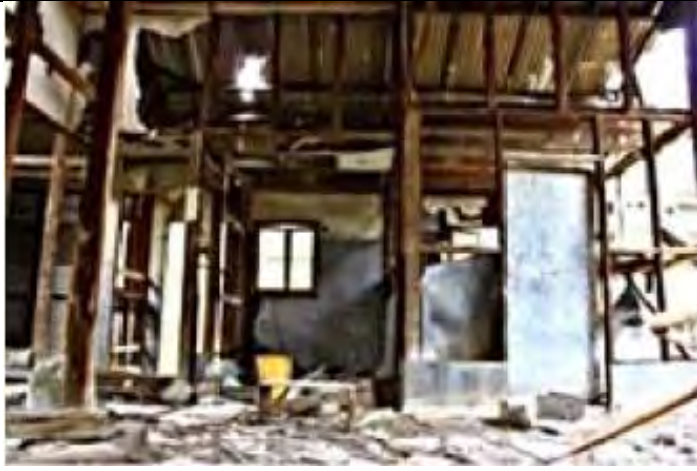
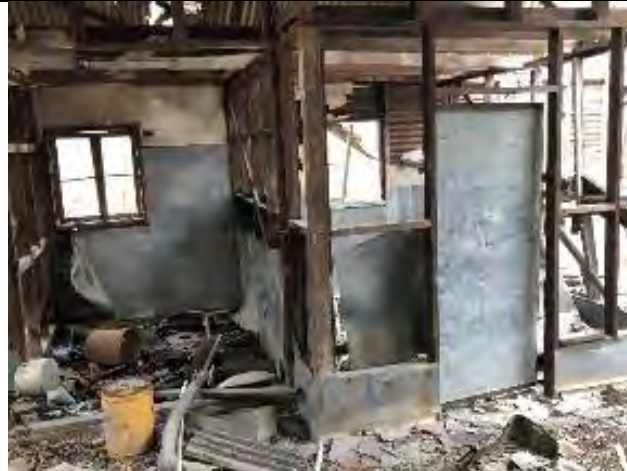
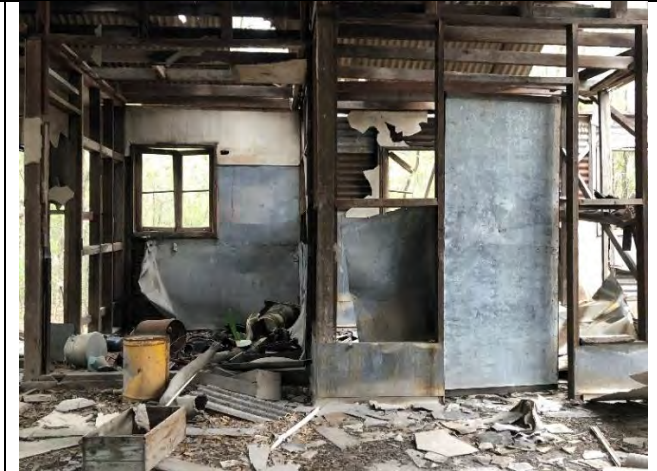
Showing west interior space

2012-18: no discernible change.

2018-20: no discernible change.

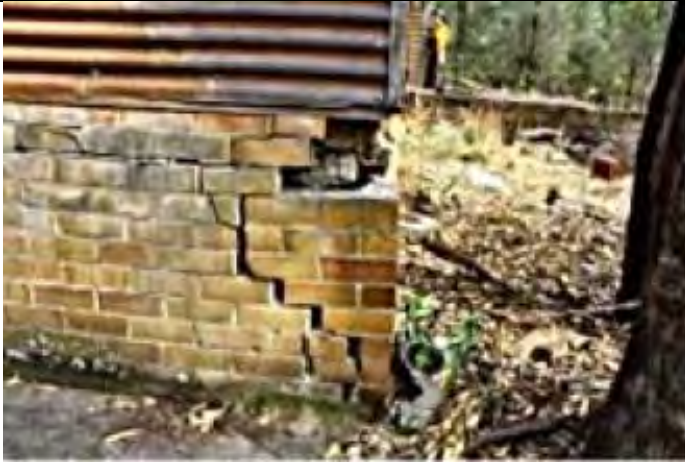
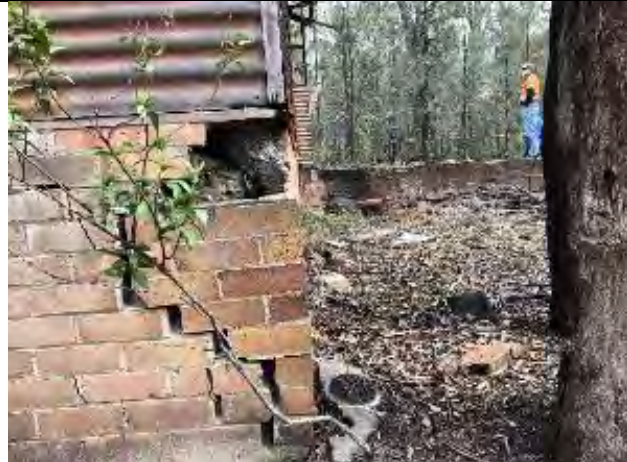
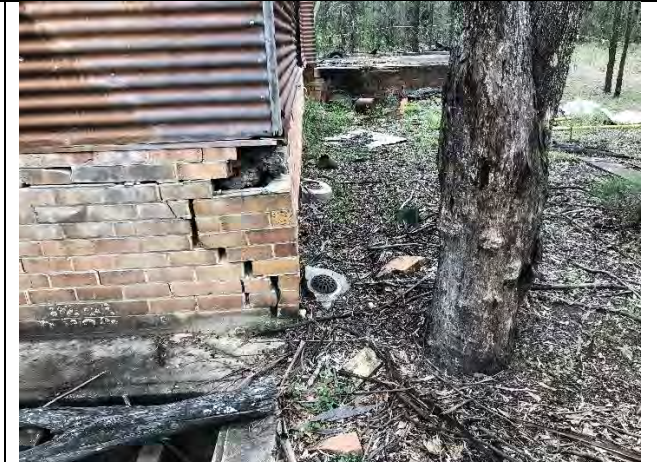
Damaged brick foundation at south-east corner

2012-18: no discernible increase to cracked brick foundation.

2018-20: further cracking of foundation (to left of shot) and some slumping of corner bricks.

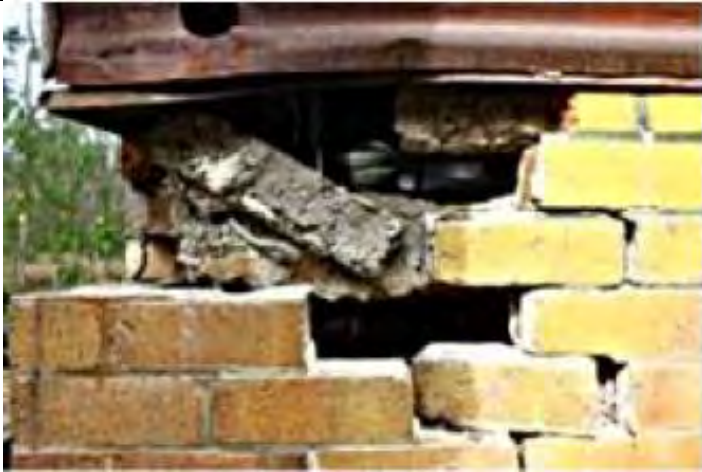
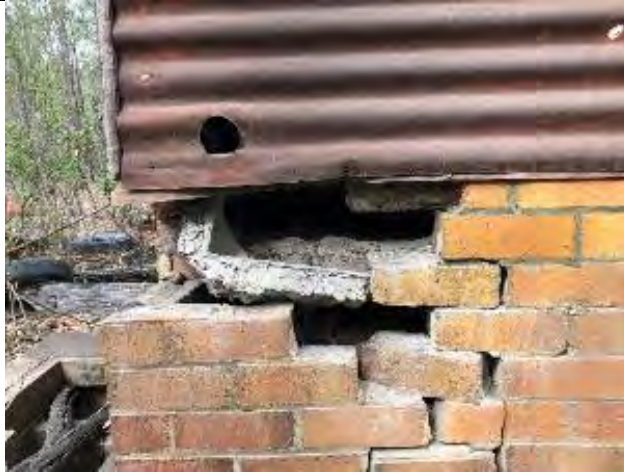
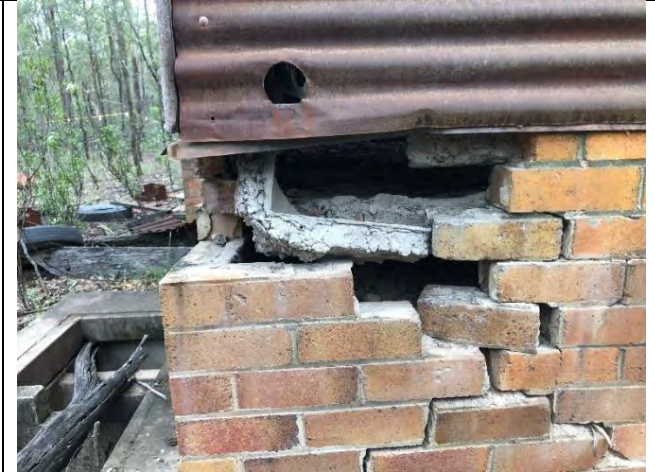
Detail of damaged brick foundation

2012-18: some further collapse of concrete/cement above brick foundation.

2018-20: some slumping outwards of corner brick foundation.

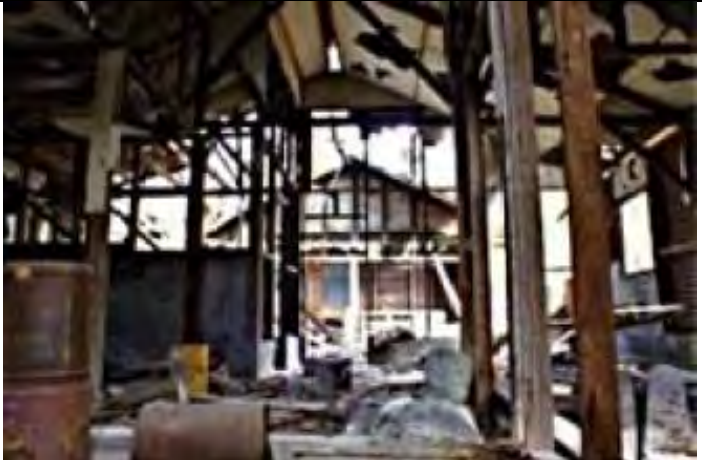
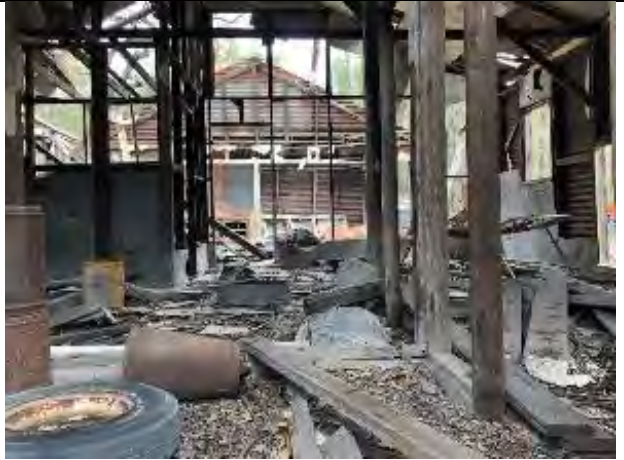
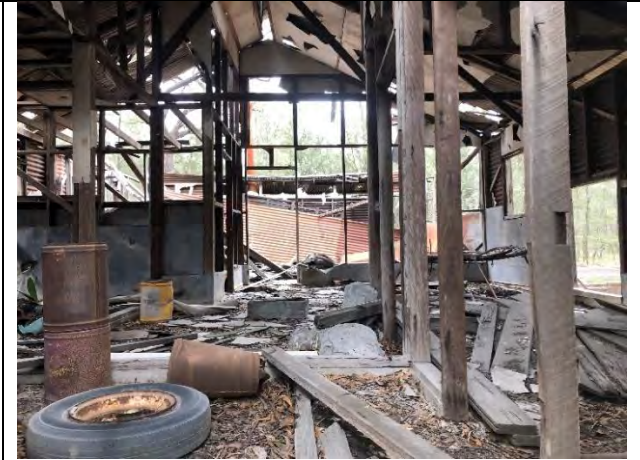
View to interior of building, looking north from south entry

2012-18: no discernible change.

2018-20: no discernible interior change, but shows collapsed north wall.
