Mount Thorley Warkworth

2019 Annual Review

Mount Thorley Warkworth (MTW) is an integrated operation of two open cut coal mines, Warkworth Mining Limited (WML) and Mount Thorley Operations (MTO). This Annual Review reports on the environmental performance of MTW for the period 1 January 2019 to 31 December 2019.

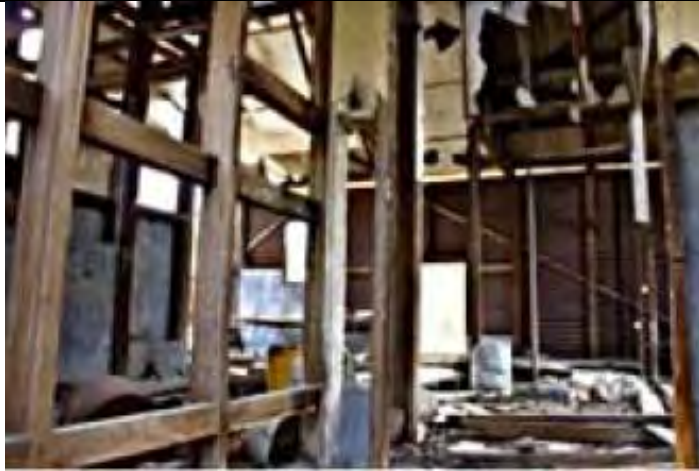
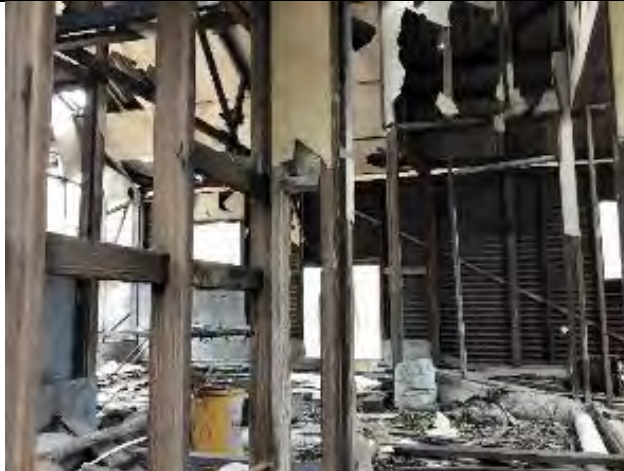
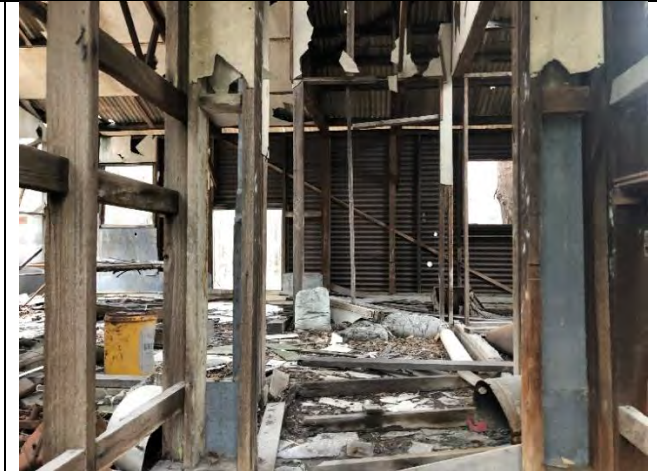
View to interior of building from entry at west

2012-18: no discernible change.

2018-20: no discernible change.

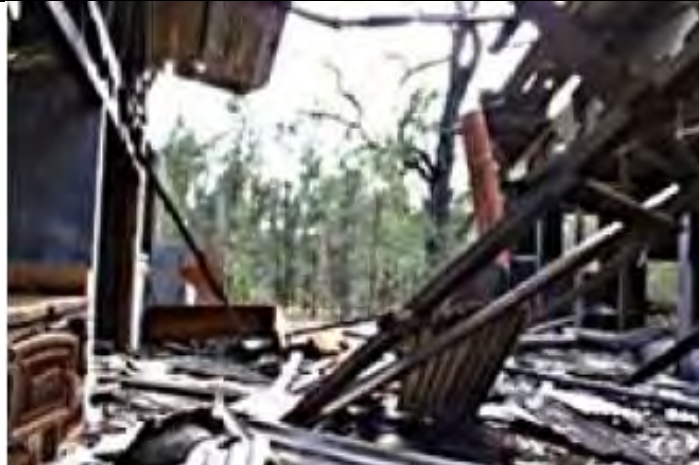
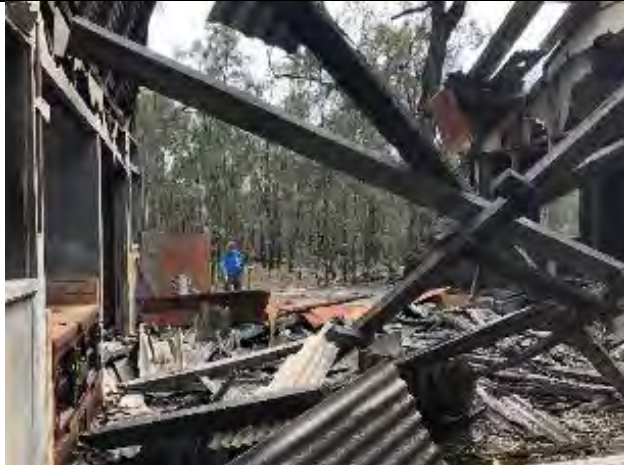
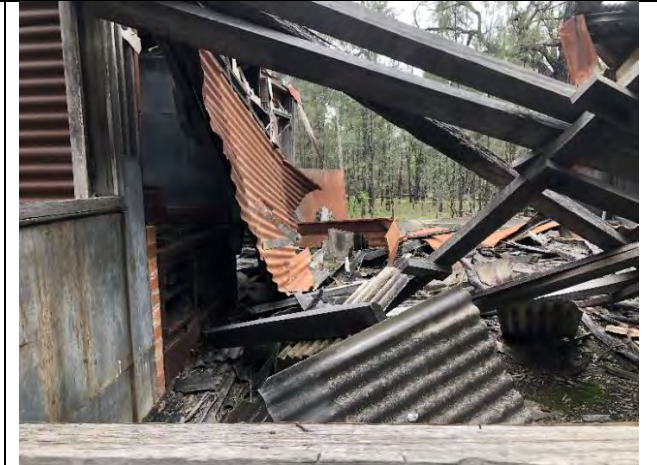
Showing interior of building, viewed from north-west corner

2012-18: shows collapsed roofing members above open kitchen area and accumulation of debris.

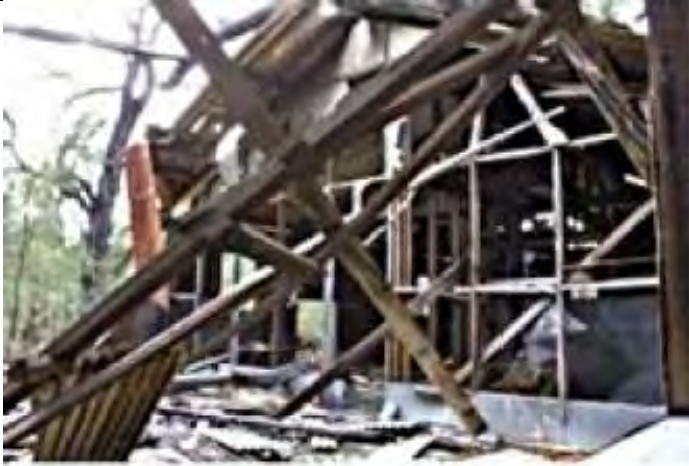
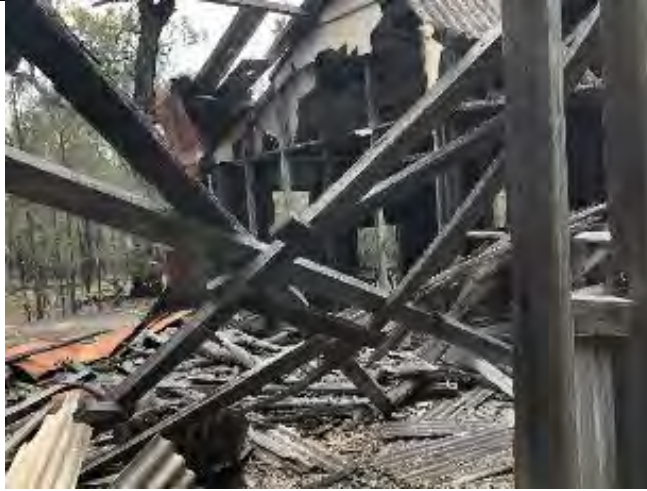
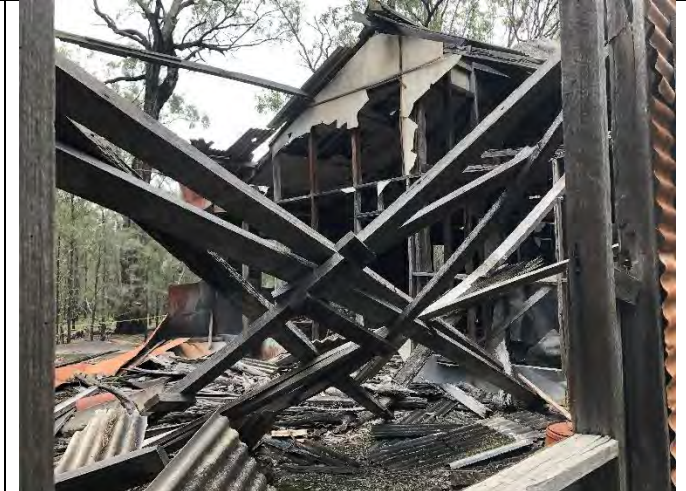
Showing interior of building, viewed from north-west corner

2012-18: shows collapsed roofing members above open kitchen area and accumulation of debris.

1. If not already conducted, have an asbestos expert assess and develop a clean up and disposal plan to deal with both the broken fragments and intact asbestos sheeting;
2. Remove any remaining tree branches from the roof. In addition, to prevent similar damage in the future, serious consideration should be given to removing or lopping those trees that are located close enough to the building that they may cause damage if they fall or drop large branches;

5. A structural engineer should then inspect the building before any further works are commenced to make further recommendations on stability requirements and structural repairs. These further works should aim to reduce the likelihood and extent of any further deterioration at the site rather than seek to rebuild or renovate as it is unlikely that there would be any valid or appropriate option to re-use the site; and

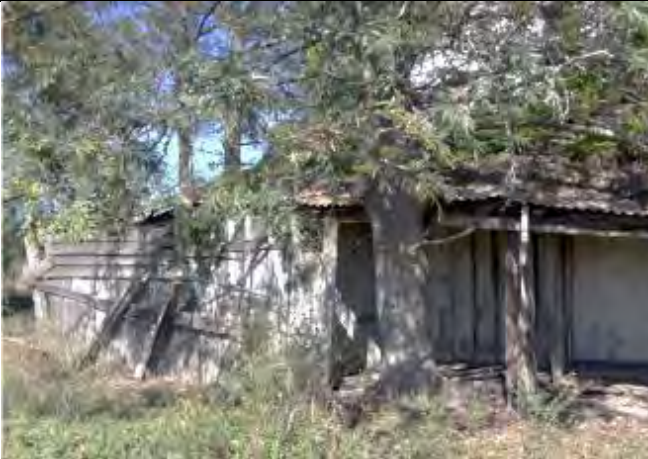
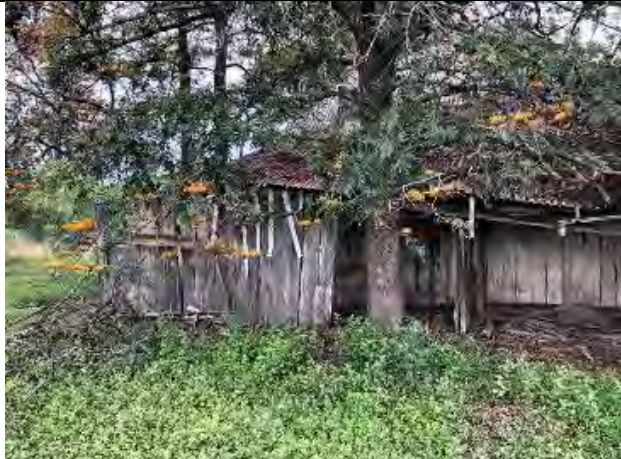
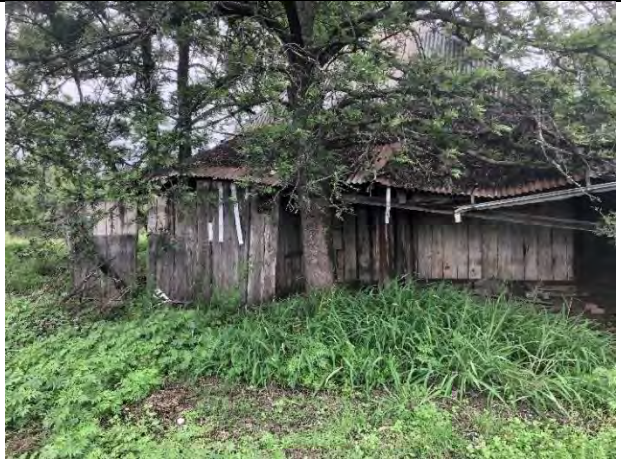
Northern entrance 2014-8: further deterioration of overlaid weatherboard. 2018-20: No major increase in deterioration.

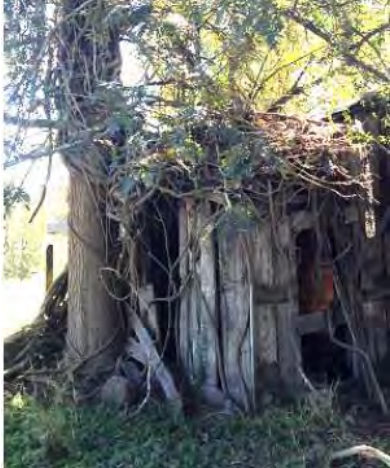
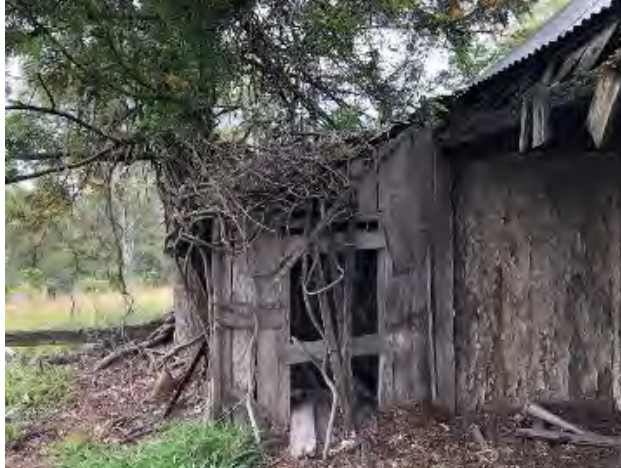
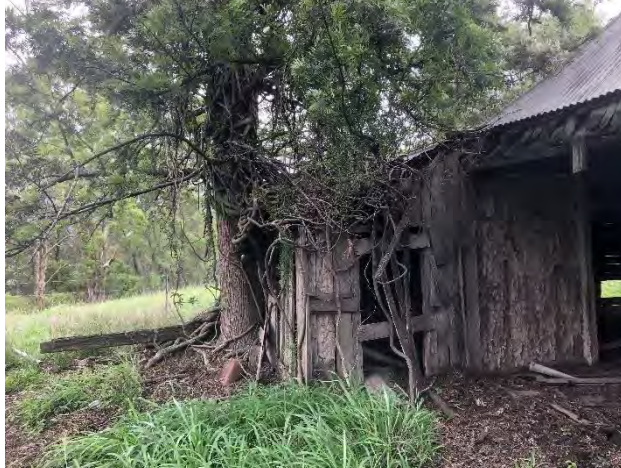
Eastern elevation 2014-8: no discernible change. 2018-20: roof slumping appears to have increased.

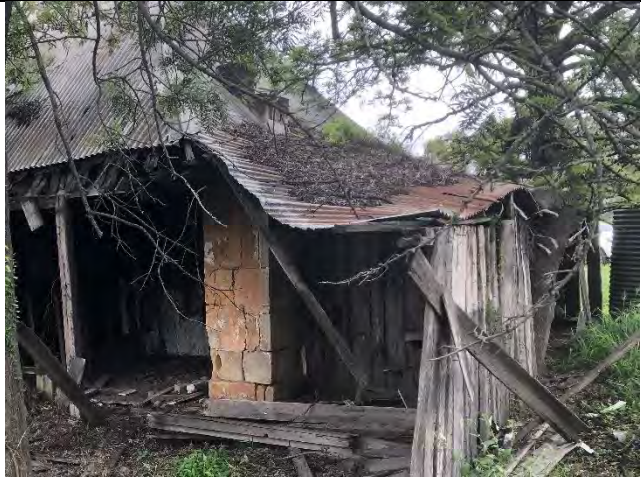
<p>South-east corner 2014-8: shows removal of vertical slabs from southern wall and further collapse of roof. 2018-20: further roof slumping and deterioration of eastern wall.</p>

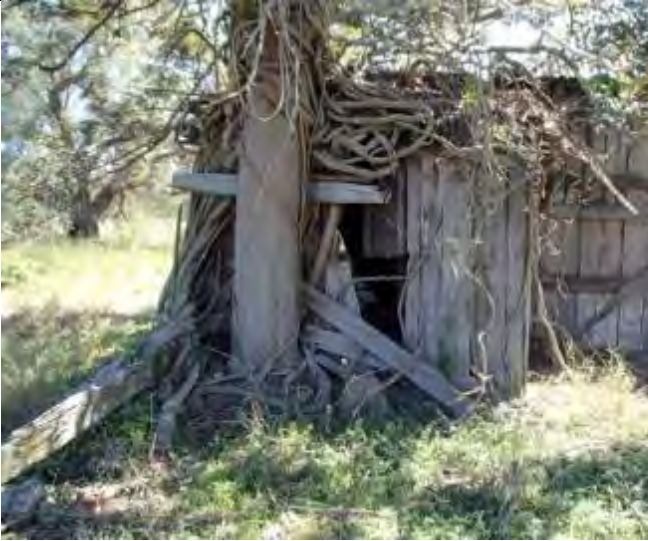
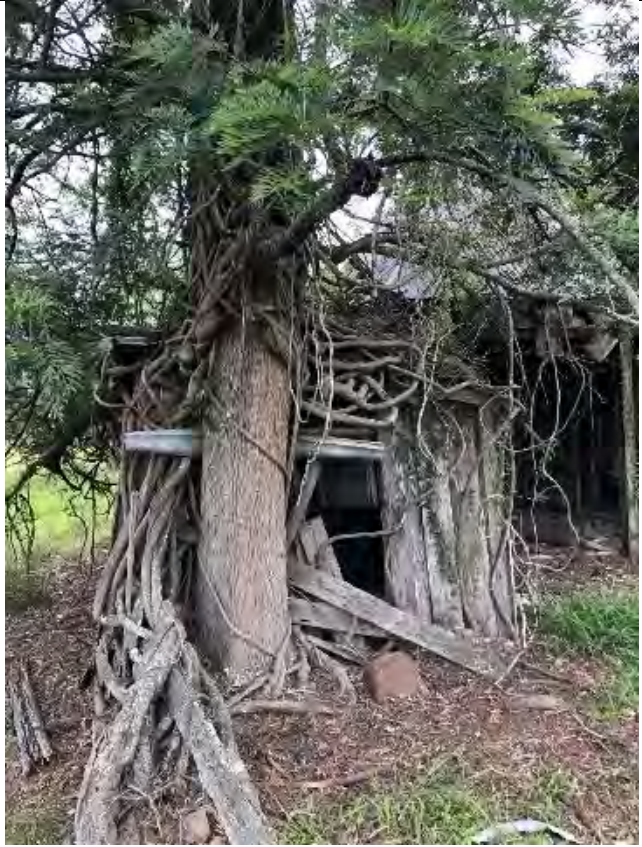
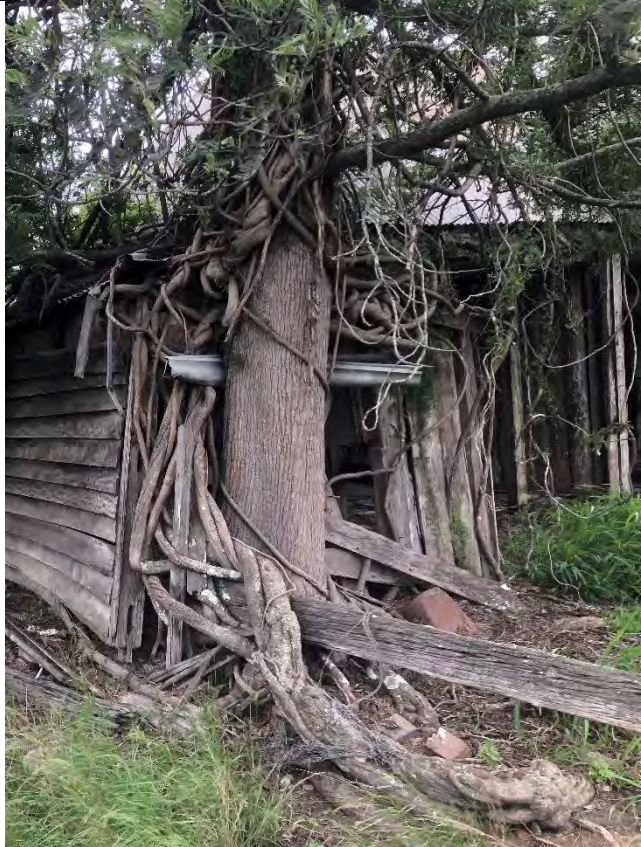
<p>View of south-west corner from south 2014-8: shows removal of vertical slabs from southern wall as well as some increase in vegetation growth. 2018-20: no discernible change but continuing vegetation impacts.</p>

4. Due to the damage caused by the removal of the vertical slabs, once the items above are complete, a structural engineer should then re-inspect the building before any further works are commenced to make further recommendations on stability requirements and structural repairs; and

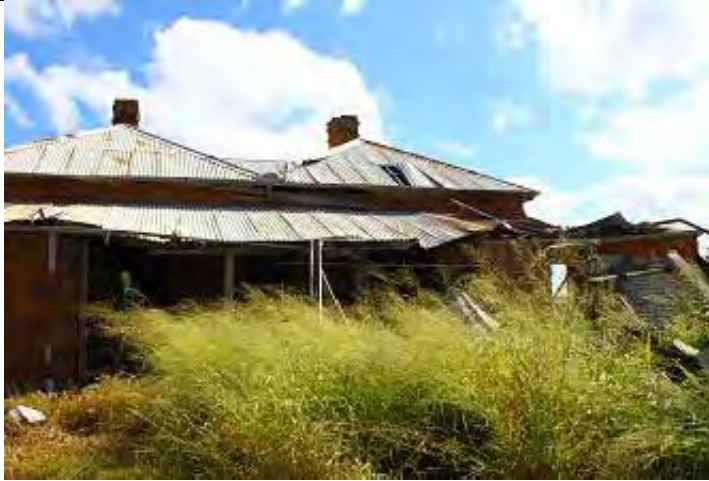
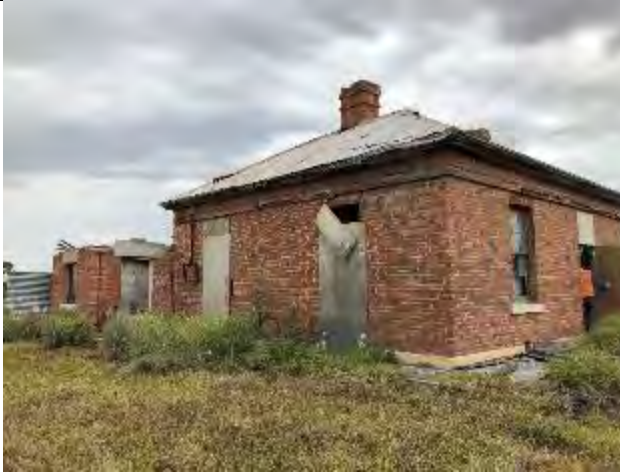
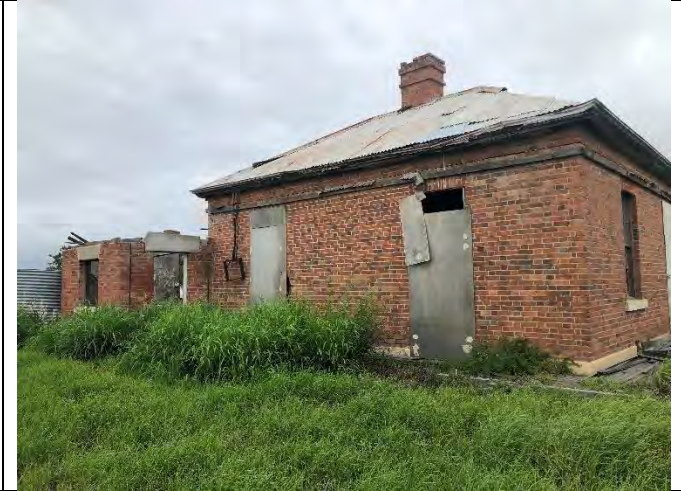
View of northern side (surrounding vegetation focus)

2015-8: grass vegetation slashed around building

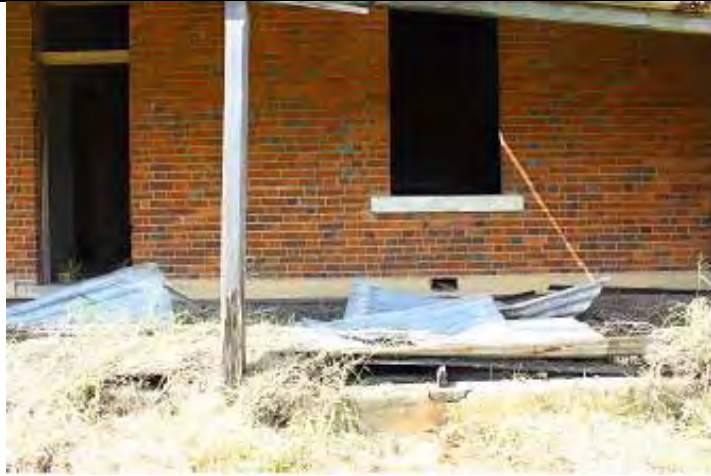
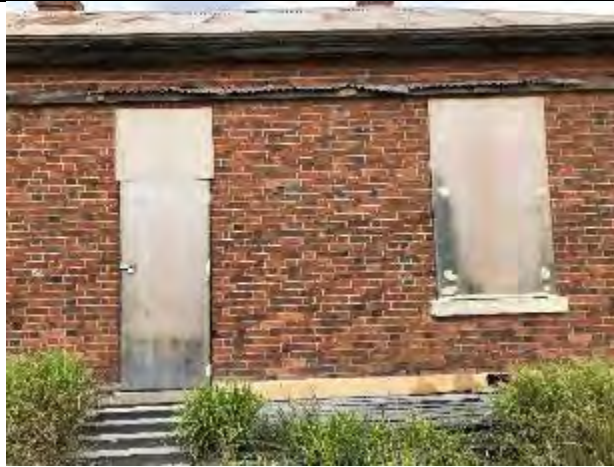
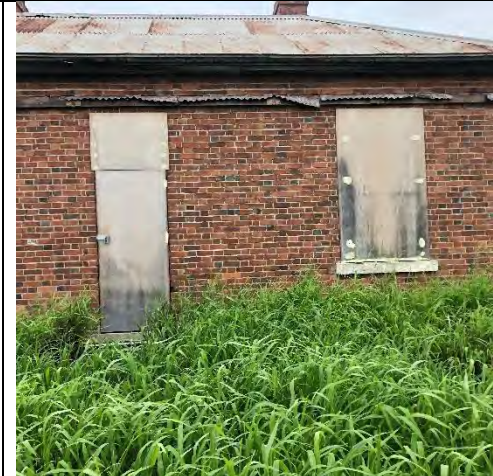
2018-20: vegetation has regrown around building

1. Implement a regular vegetation slashing and maintenance schedule for the building surrounds, ensuring all debris is clear from ground-level ventilation openings;
2. Replace any damaged plywood door/window coverings and ensure all coverings are tightly attached;
3. Patch fix any new damage to roofing sheets;
4. Implement a termite inspection regime and treat as required, giving consideration to removing the peppercorn trees surrounding the building;
5. If any asbestos or fibrous cement sheeting remains at the property, engage an asbestos removalist to remove as required;

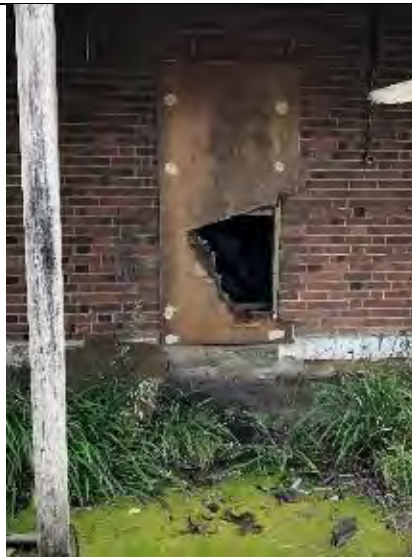
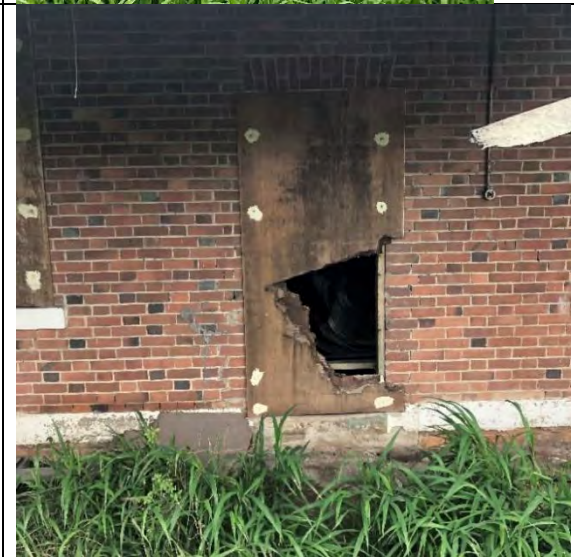
View of door and window panelling

2015-8: sheeting installed on all openings, however some repair required

2018-20: some repair of paneling required

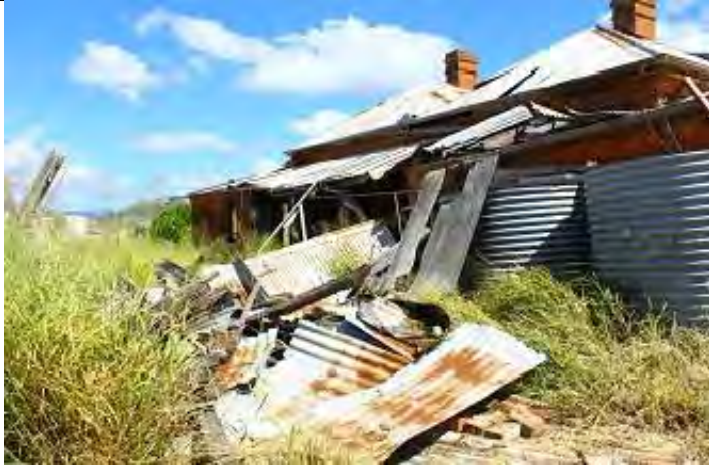
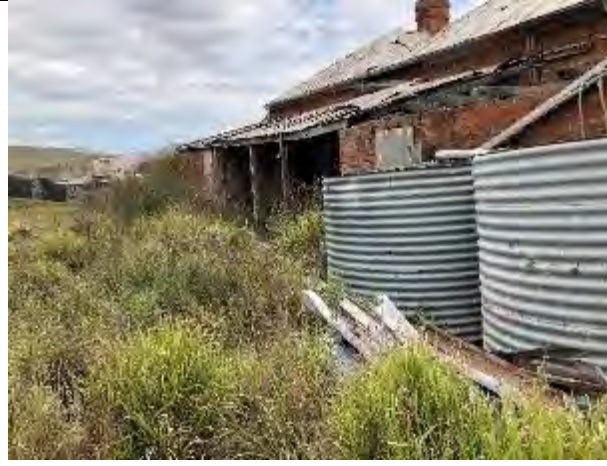
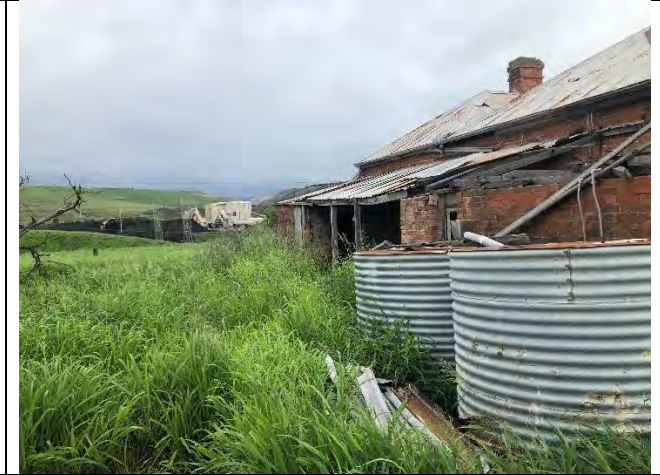
View of rear of building (focus on debris)

2015-8: debris has been cleared and stacked

2018-20: vegetation has regrown around building and stacked debris

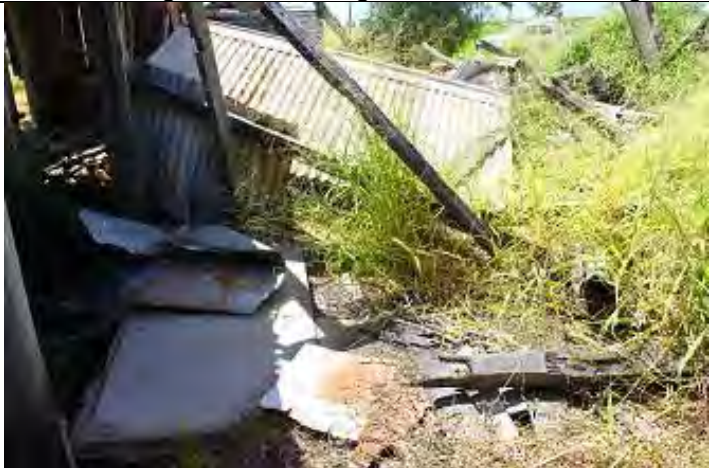
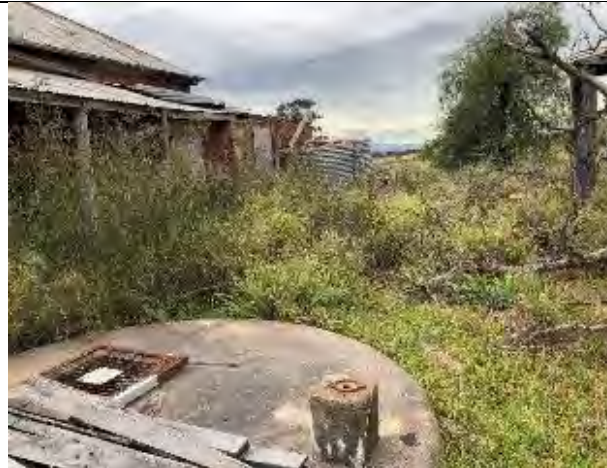
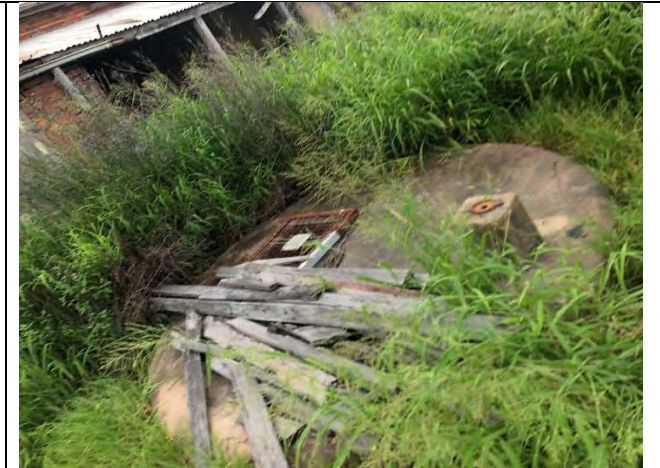
View of rear of building (focus on debris)

2015-8: debris has been cleared and stacked

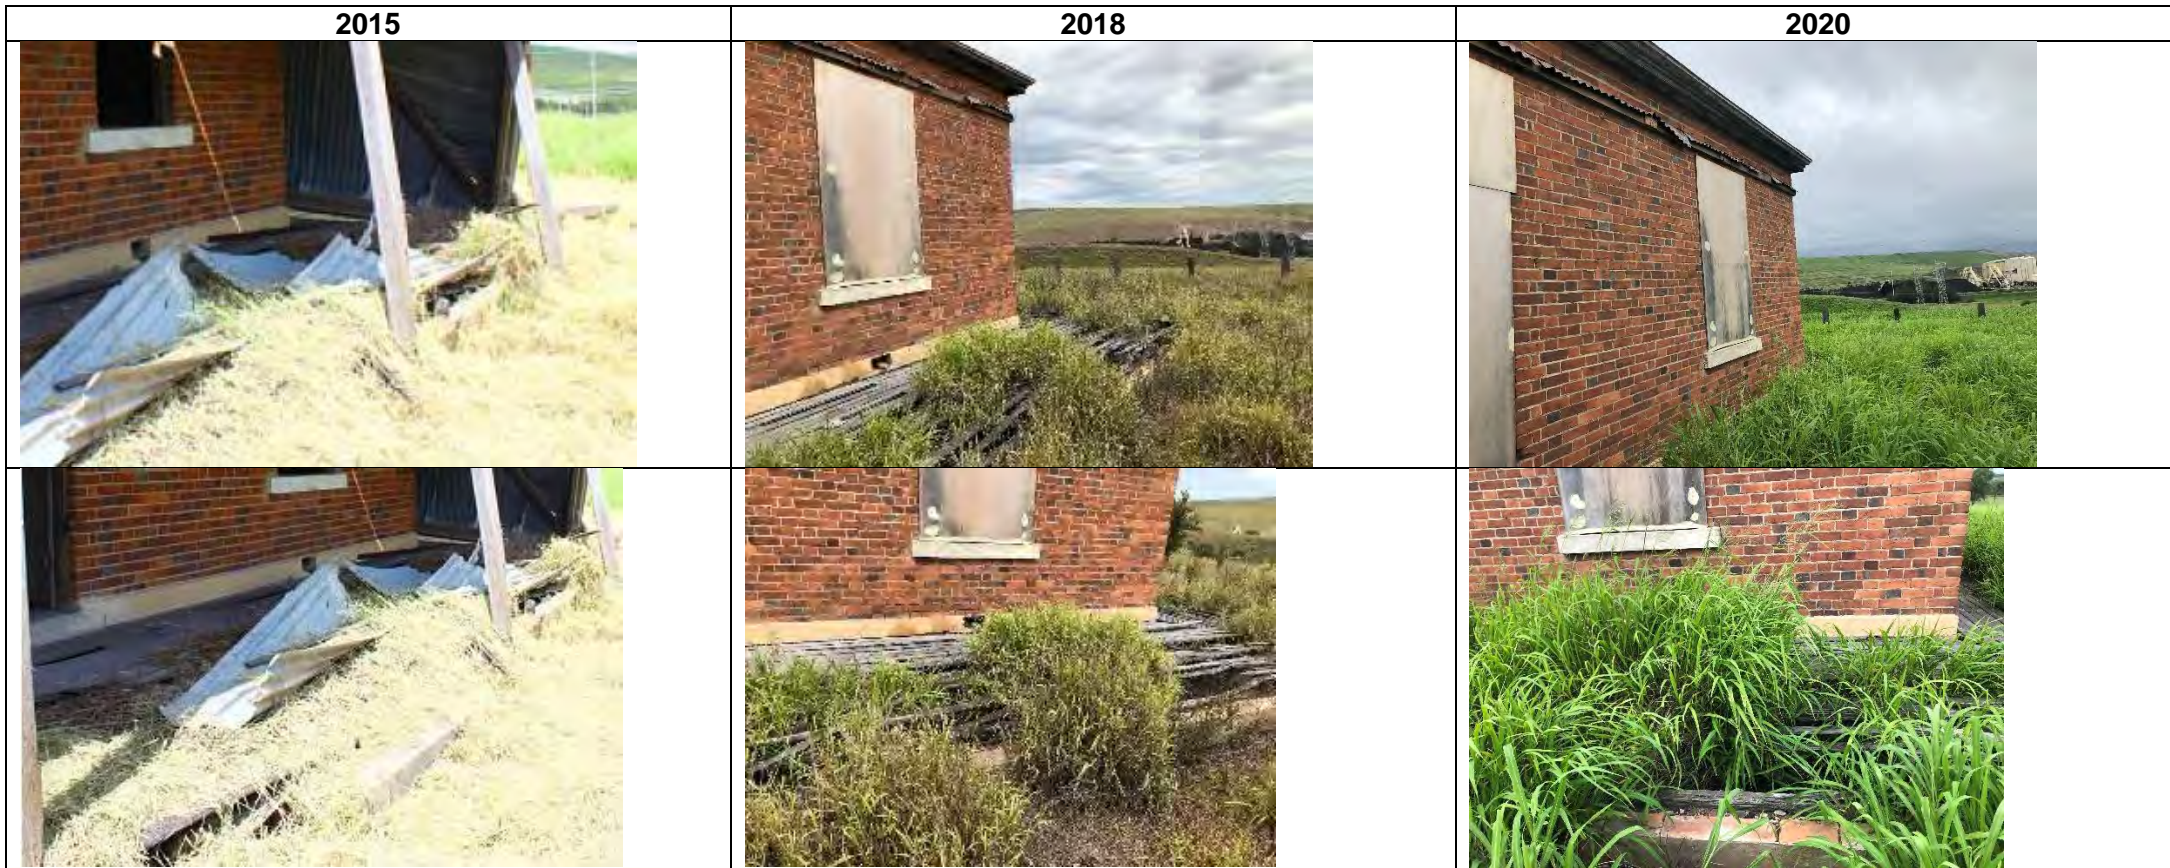
View of eastern verandah (focus on verandah floor)

2015-8: posts and sheeting removed, damaged boards remain exposed

2018-20: damaged boards remain and vegetation growth throughout

7. Reinstall verandah, including verandah decking and northern brick dwarf wall, re-using original material where possible, as per recommendations M5, M6 and L1 in the CMP conservation works schedule;

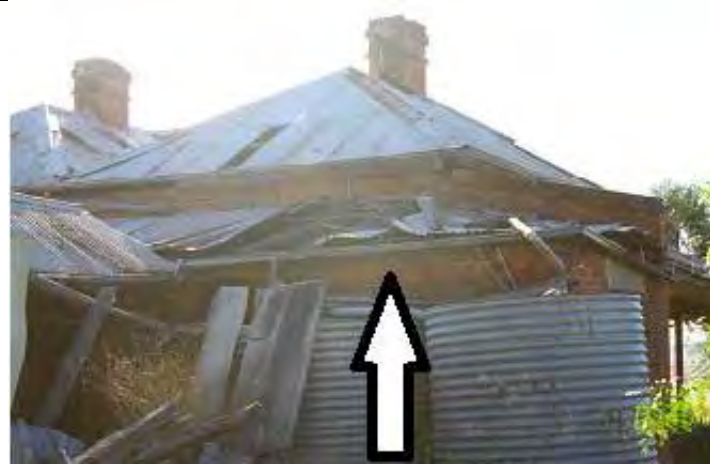
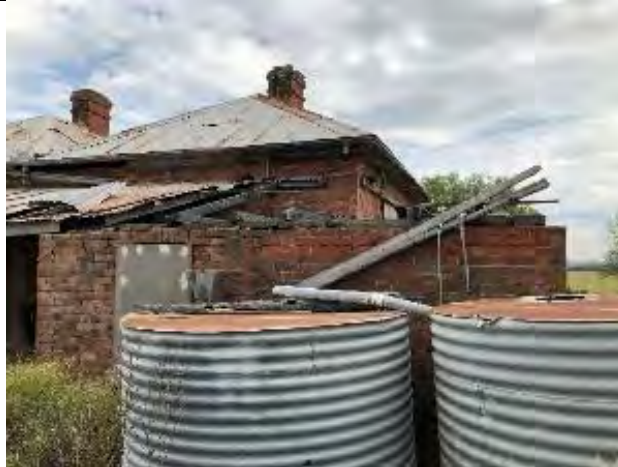
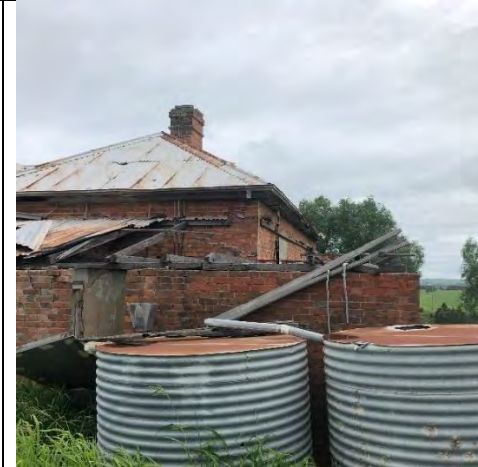
View of rear of building (focus on skillion roof)

2015-8: skillion roof and rafters have collapsed

2018-20: no discernible change

8. As the roof above Room 6 has collapsed, salvage any reusable masonry or timber and set aside within room. Engage a structural engineer to advise on feasibility of reconstructing the roof. (NB. Recommendation M9 in the CMP conservation works schedule erroneously refers to Room 5 rather than Room 6 as shown in the photograph);

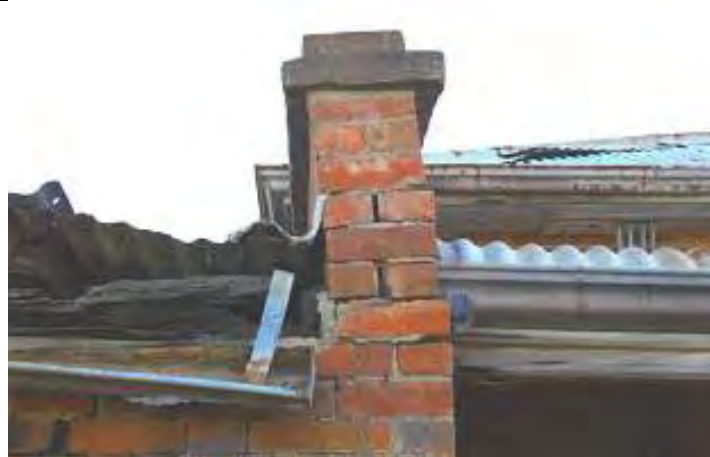
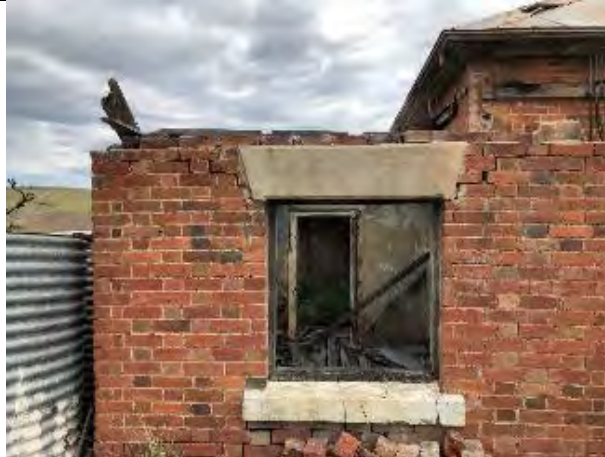
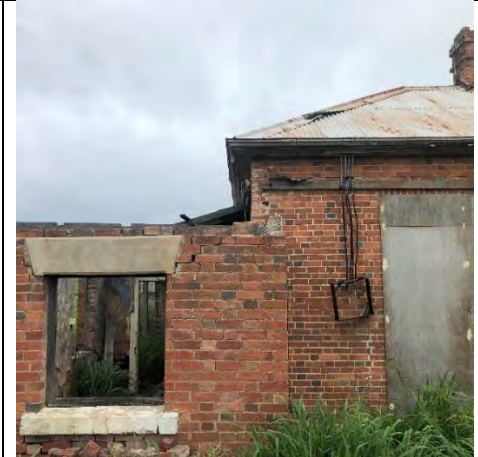
View of north-east of building (focus on top of wall)

2015-8: wall element has collapsed bricks stacked under window)

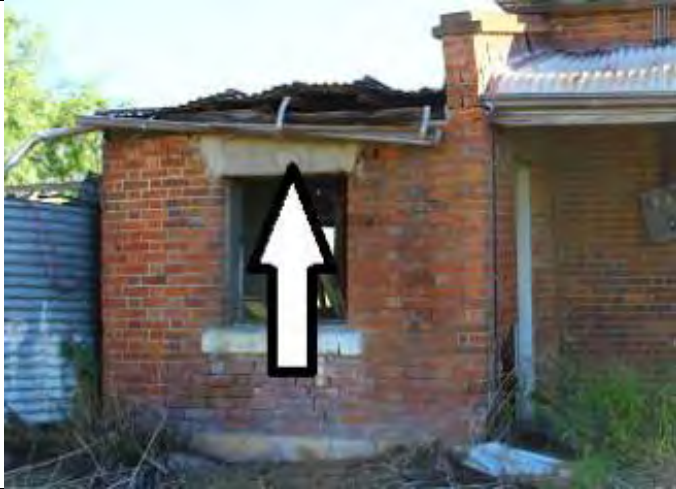
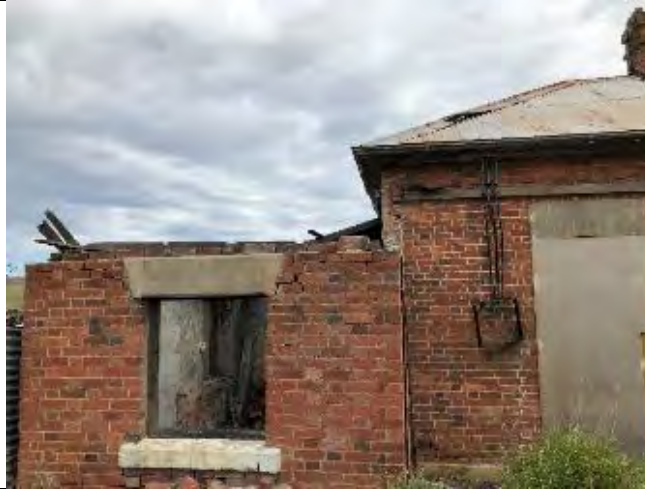
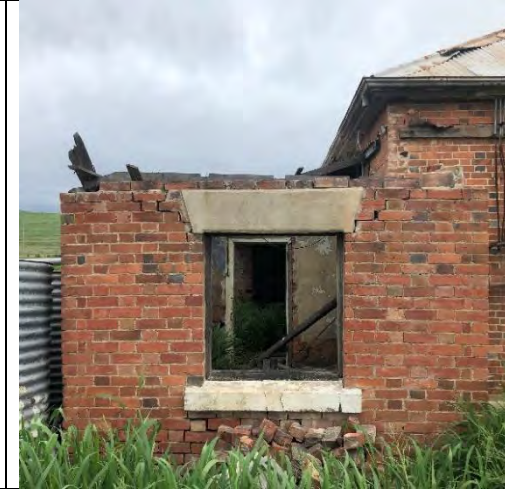
View of north-east of building (focus on skillion roof)

2015-8: roof framing, sheeting and guttering has collapsed

2018-20: no discernible change

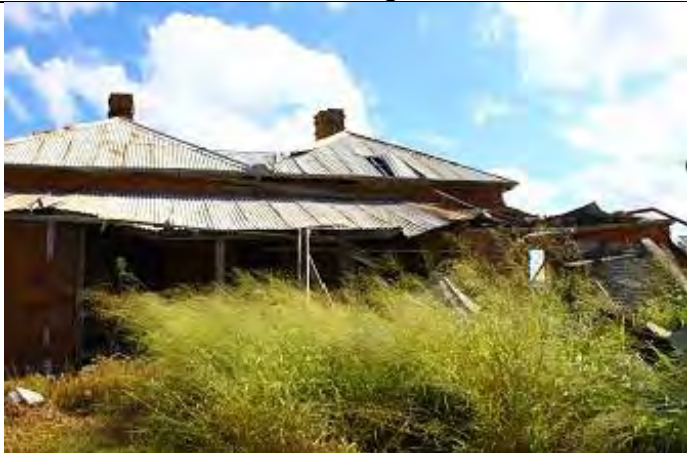
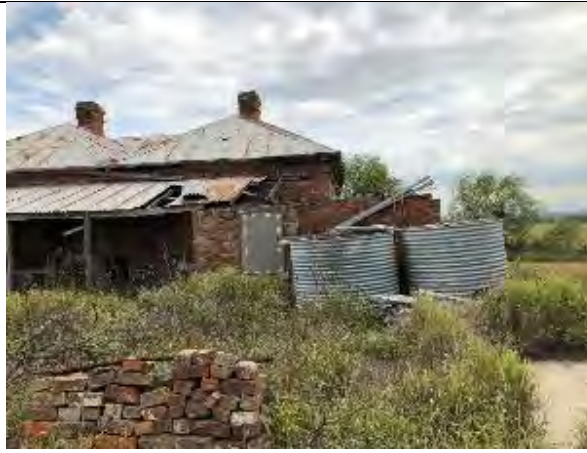
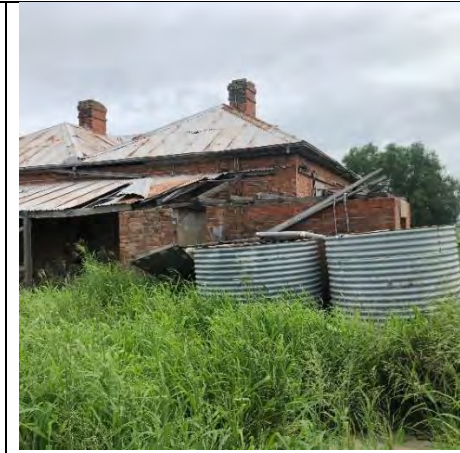
View of rear of building (focus on guttering)

2015-8: main roof holes repaired but northern section of skillion roof collapsed and guttering unchanged

9. Replace gutters around the house to match existing materials and ogee profile. Install new down-pipes and ensure they are discharging away from the building.

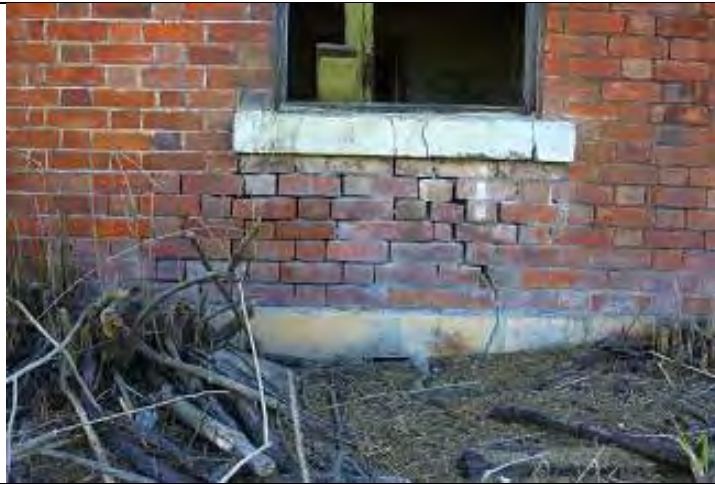
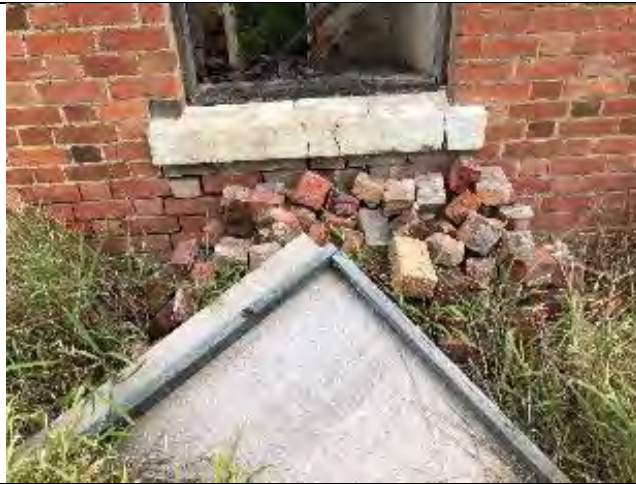
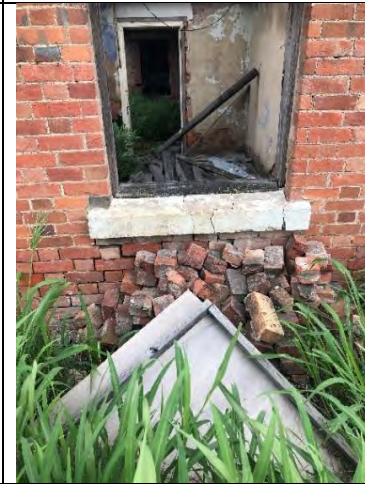
View of north-east corner of building (focus wall below window)

2015-8: bricks from roof above stacked in front of required repointing, window sheeting removed

2018-20: no discernible change

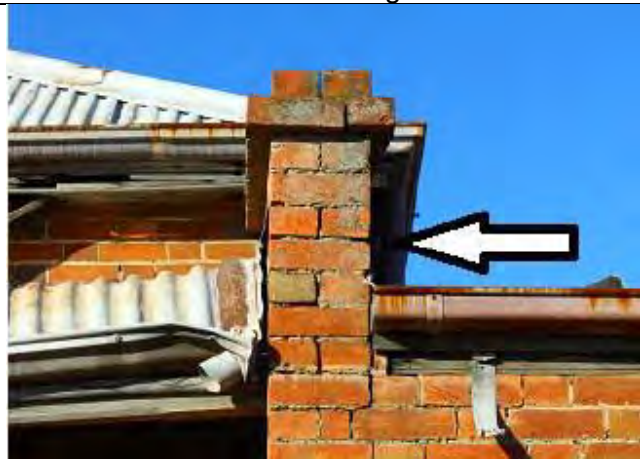
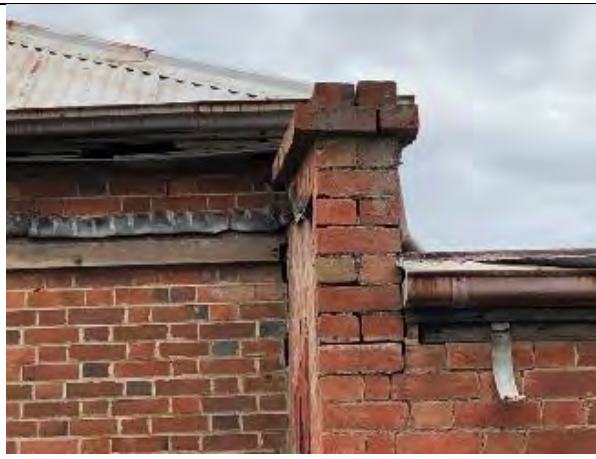
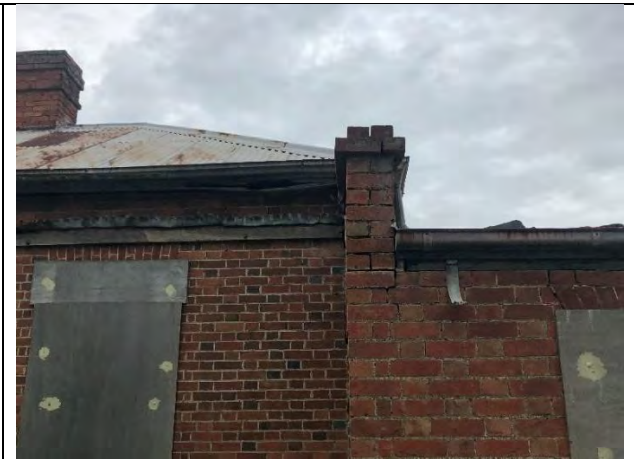
View of south-east of building (focus on top of wall)

2015-8: no discernible change

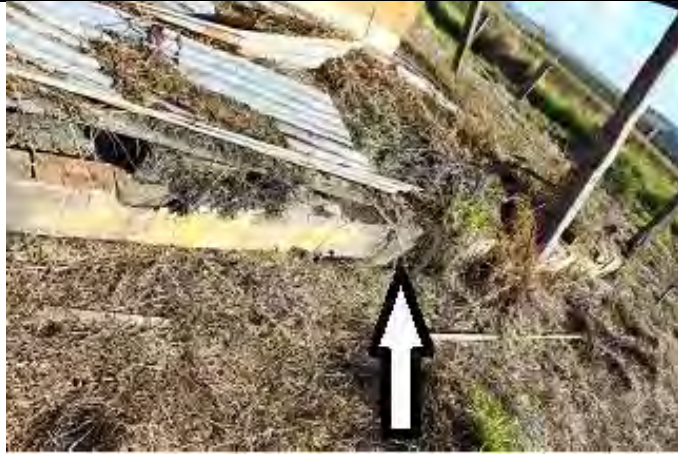
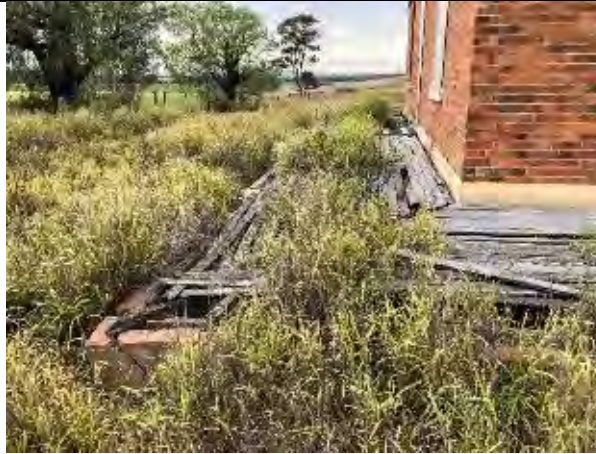
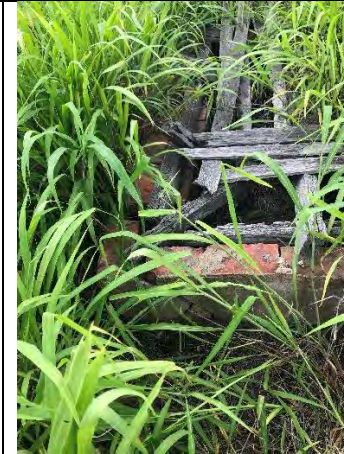
View of eastern verandah (focus on dwarf wall wall)

2015-8: debris cleared from verandah, no change to dwarf wall

2018-20: no discernible change

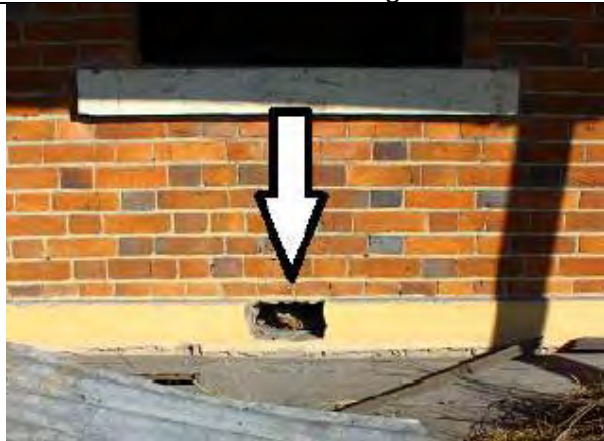
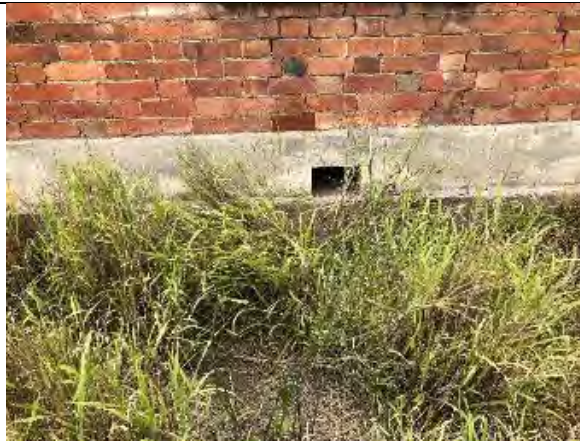
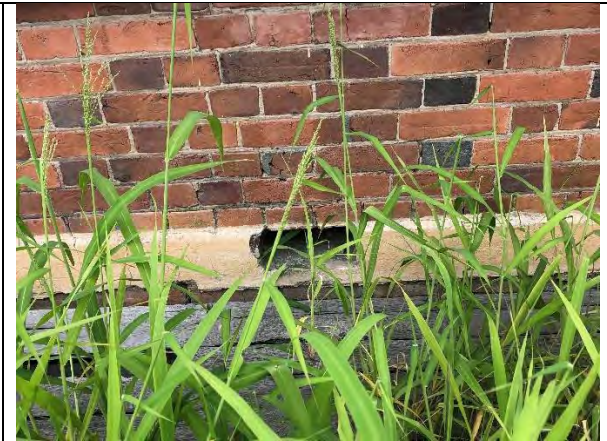
View of ventilation grilles

2015-8: grilles not replaced

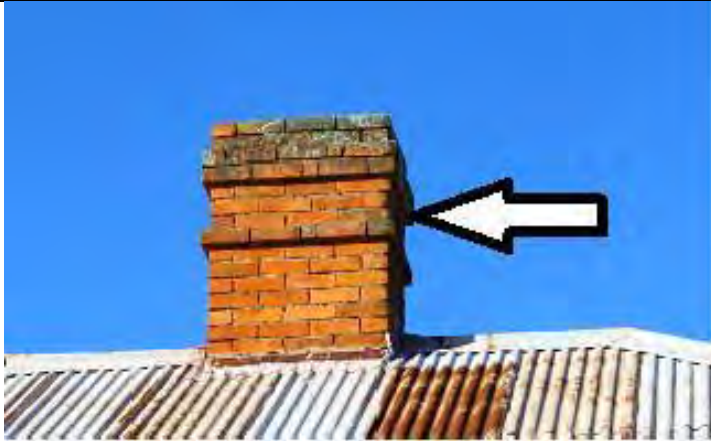
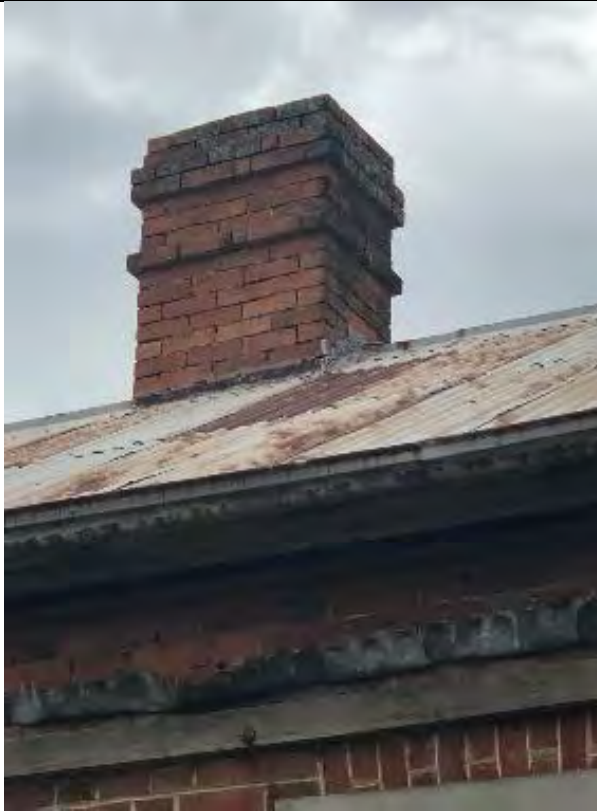
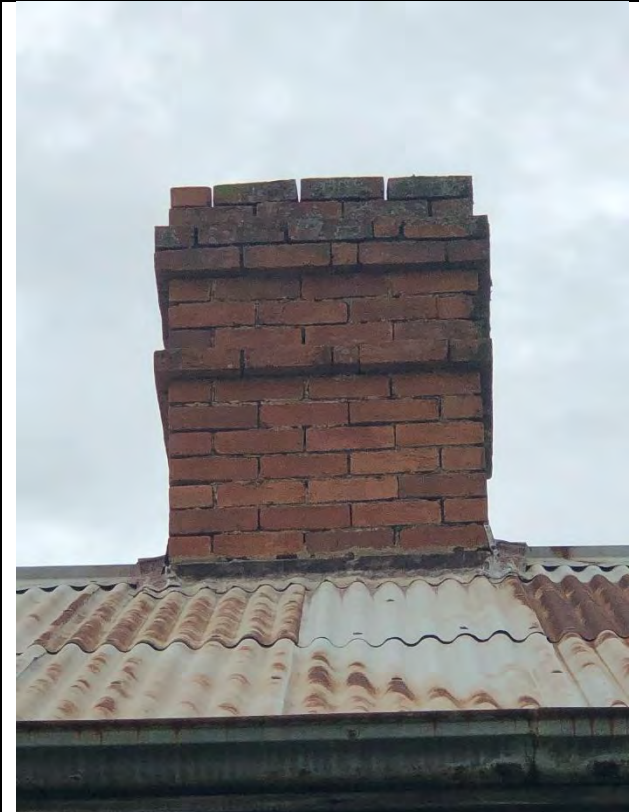
View of southern chimney

2015-8: no discernible change

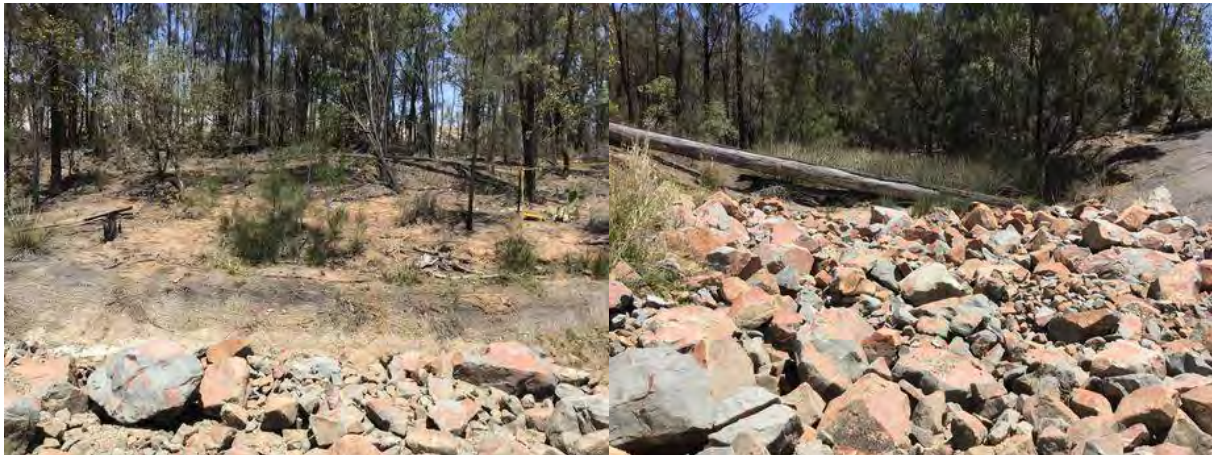
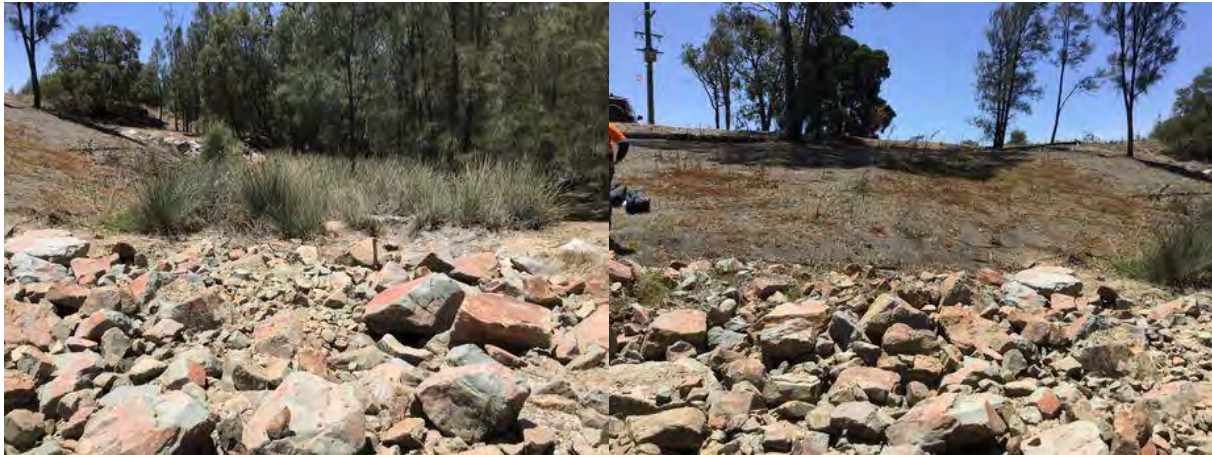
CSIRO Ephemeral Stream Assessment Classification – **Potentially Stabilising**

Plate 1 Right Bank

Plate 2 Upstream

Plate 3 Downstream

Plate 4 Left Bank
