Mount Thorley Warkworth

2019 Annual Review

Mount Thorley Warkworth (MTW) is an integrated operation of two open cut coal mines, Warkworth Mining Limited (WML) and Mount Thorley Operations (MTO). This Annual Review reports on the environmental performance of MTW for the period 1 January 2019 to 31 December 2019.

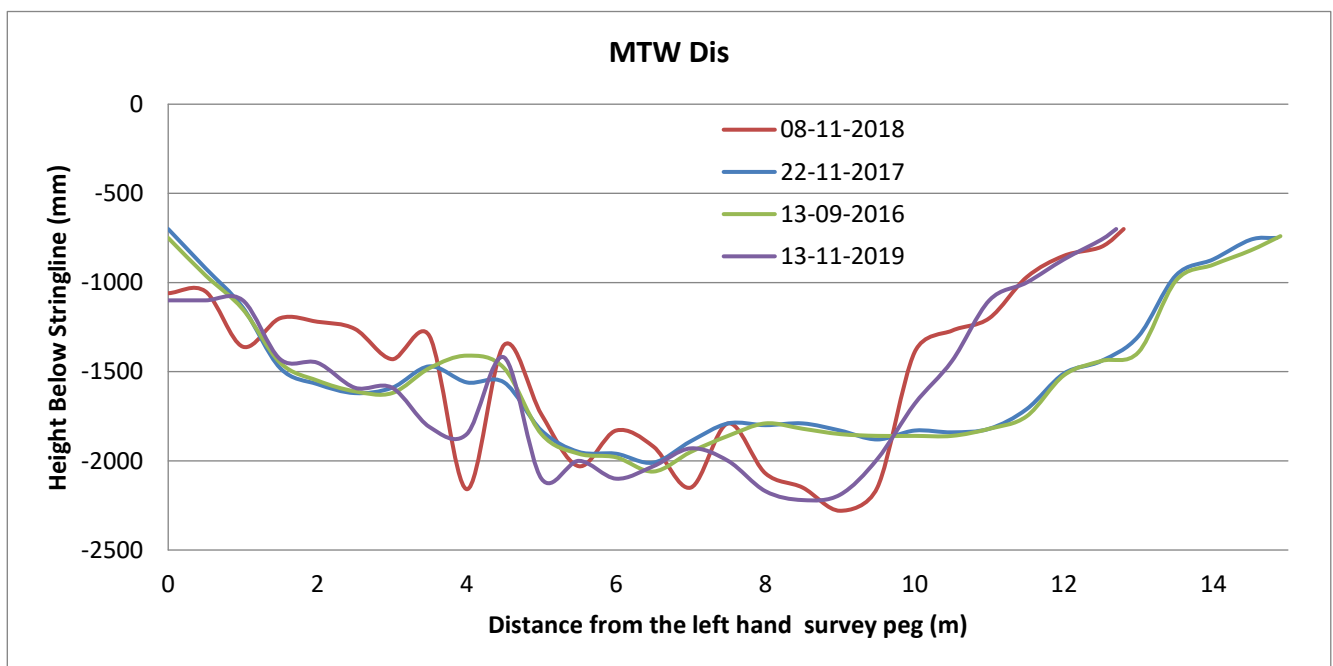
Figure 2 MTW Dis Transect Results

For the purpose of monitoring any changes to the creek, a creek line transect was established. The transect is shown in **Figure 2** and was taken from left to right looking downstream. It can be seen from this transect that the channel hasn't changed significantly since the previous monitoring cycle. It should also be noted that as part of the upgrade works, the peg on the left bank was removed which explains why this round of monitoring shows a shorter length of transect. Difference in the data appears to be within the expected transect accuracy tolerances, and it is not possible to discern if there has been bed erosion across at transect location.

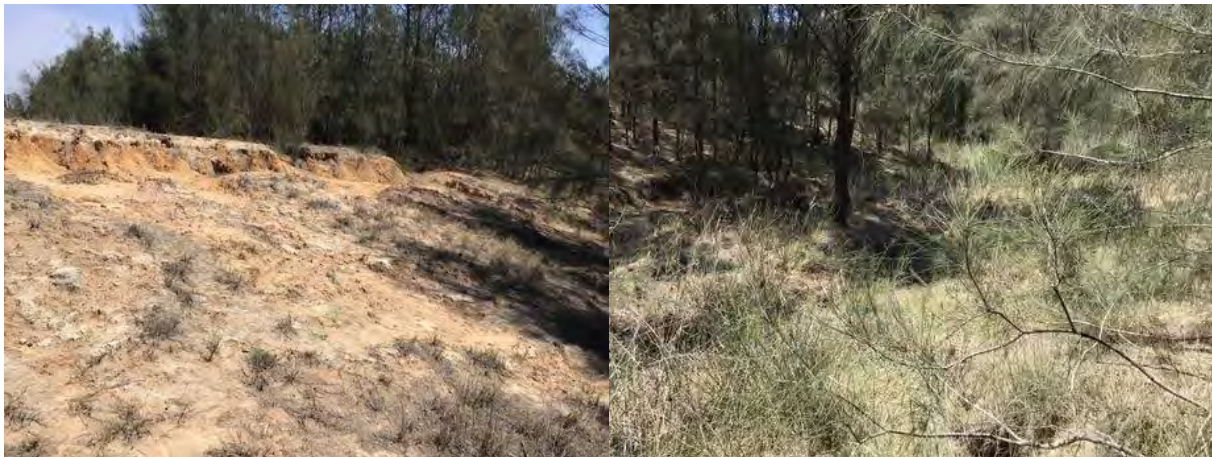
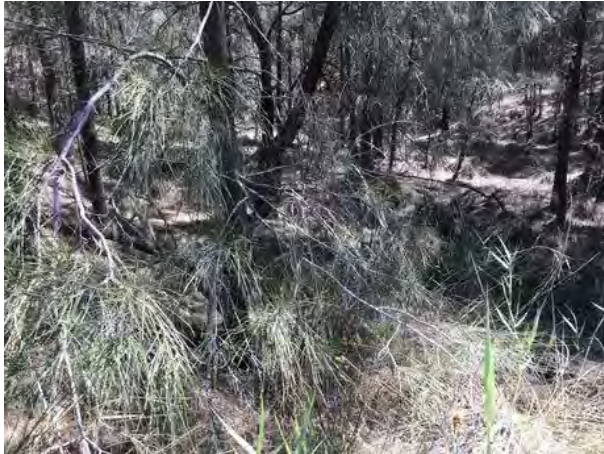
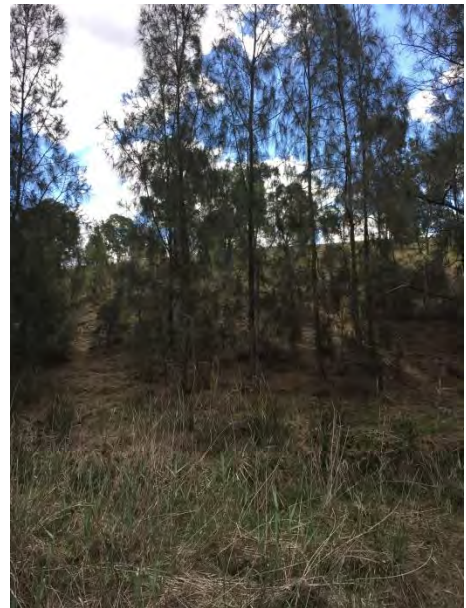
The channel at this location was observed to have a good coverage of long grass across the bed. The left bank also appears stable with good grass coverage. The right bank contains some lateral erosion (approximately 0.5m

high) at the top of the bank. The lateral erosion is forming some rill/gully erosion down this bank, however the rest of the right bank appears to be stable with good grass coverage. Overall, this location shows similar conditions to the previous monitoring cycle.

CSIRO Ephemeral Stream Assessment Classification – **Active**

Plate 5 Right Bank

Plate 6 Upstream

Plate 7 Downstream

Plate 8 Left Bank

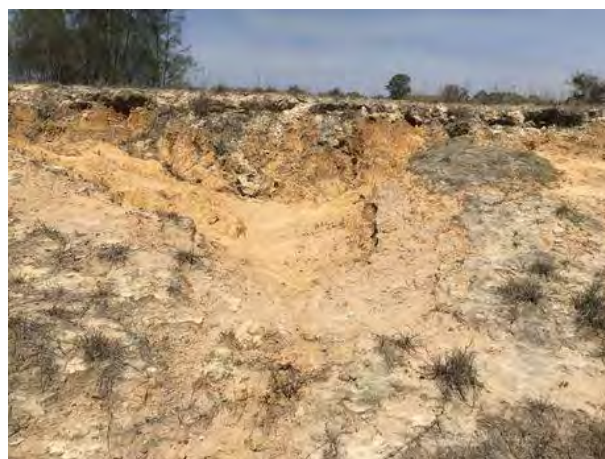
Plate 9 Erosion (top of right bank)

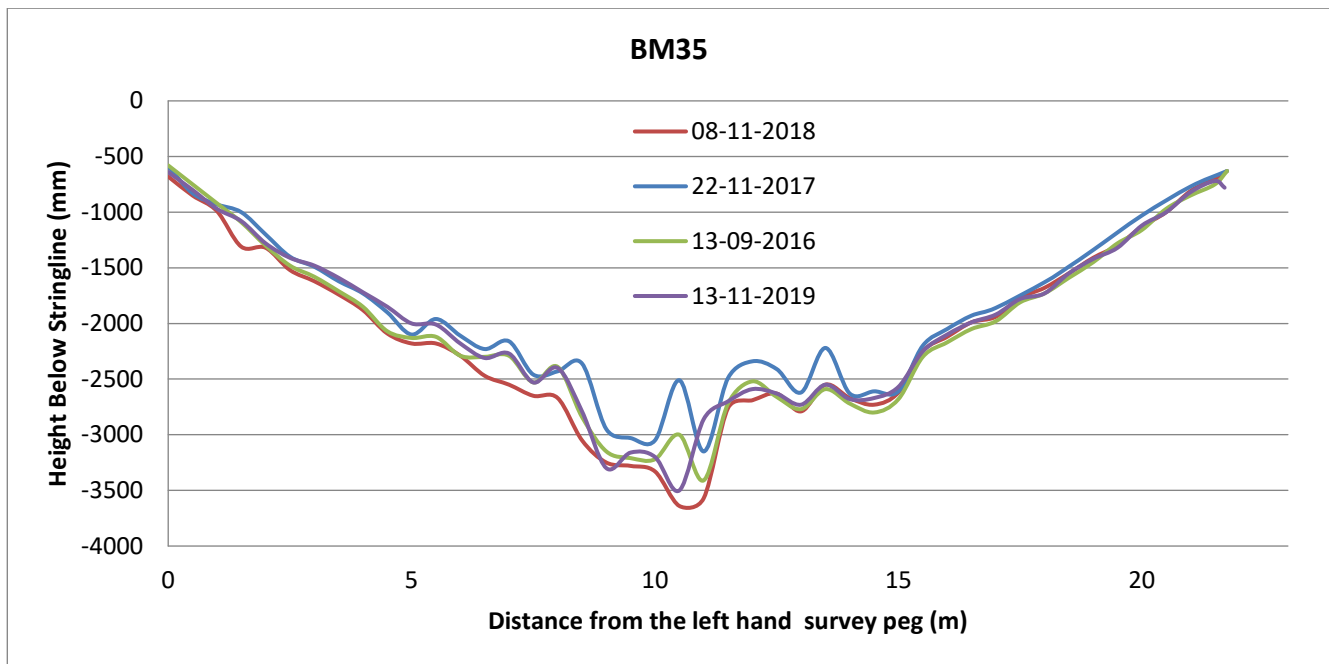
Figure 3 BM35 Transect Results

For the purpose of monitoring any changes of the creek, a creek line transect was established. The transect is shown in **Figure 3** and was taken from left to right looking downstream. It suggests that no significant scouring has occurred on the banks or creek bed since the previous monitoring cycles. Difference in the data appears to be within the expected transect accuracy tolerances.

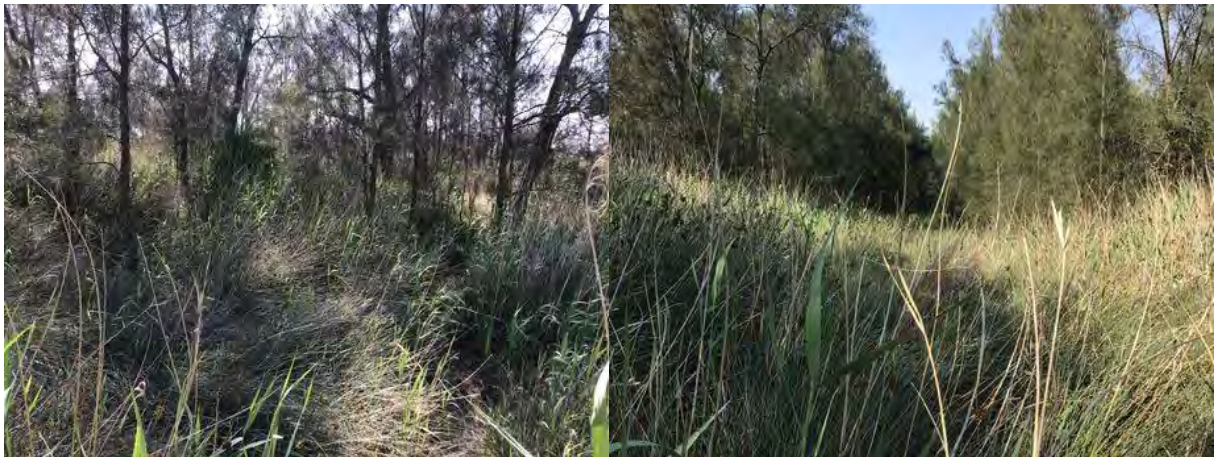
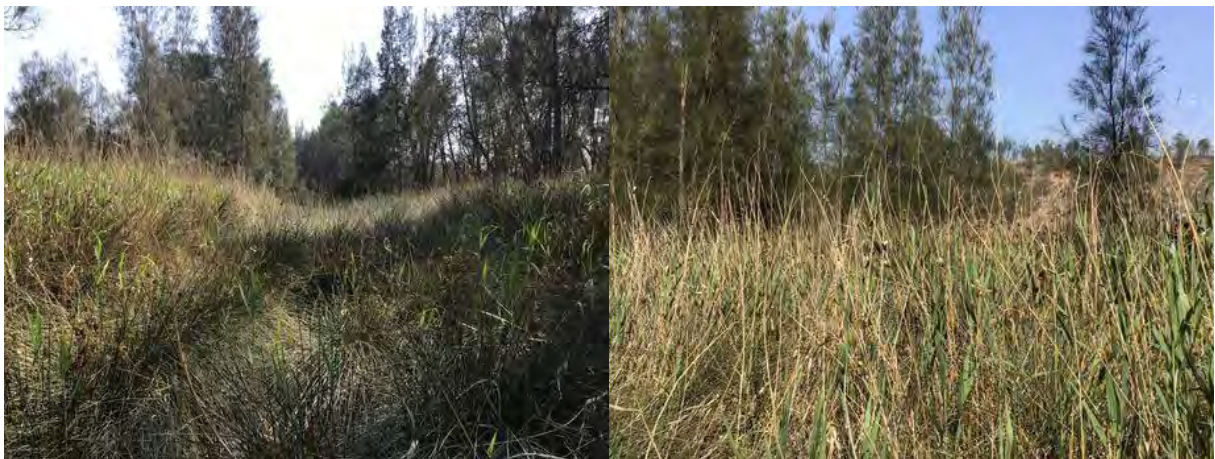
The creek bed at this monitoring point is covered by reeds and is stable. Both the left and right banks have good grass coverage and appear to be stable with gentle-moderate slopes. The creek upstream and downstream of the monitoring point also appears to be stable. The creek has a very slight meander at this monitoring point. Overall this location has remained the same as the previous monitoring cycle conditions.

CSIRO Ephemeral Stream Assessment Classification – **Stable**

Plate 10 Right Bank

Plate 11 Upstream

Plate 12 Downstream

Plate 13 Left Bank

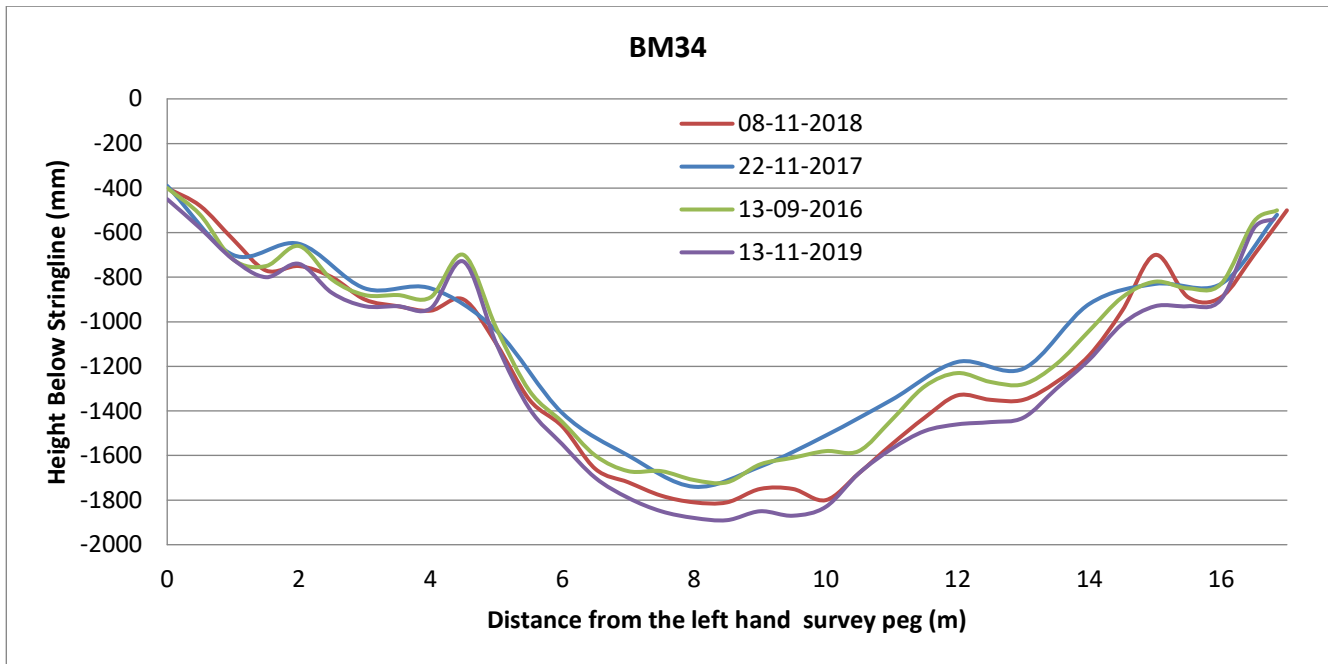
Figure 4 BM34 Transect Results

For the purpose of monitoring any changes of the creek, a creek line transect was established. The transect is shown in **Figure 4** and was taken from left to right looking downstream. It suggests that no significant scouring has occurred on the banks or creek bed since the previous monitoring cycles. Difference in the data appears to be within the expected transect accuracy tolerances at most locations. The data also suggests that across the bed and right hand bank it is likely that there has been erosion over the past 3 years.

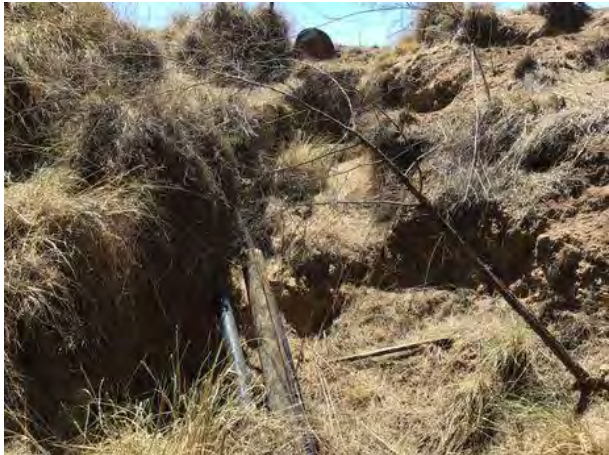
CSIRO Ephemeral Stream Assessment Classification – **Potentially Stabilising**

Plate 18 Erosion

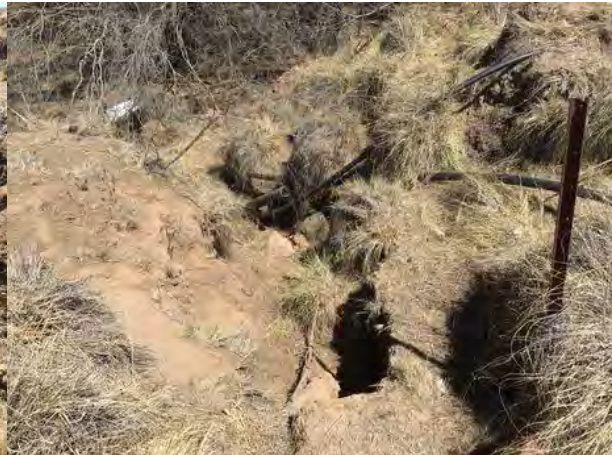
Plate 19 Erosion

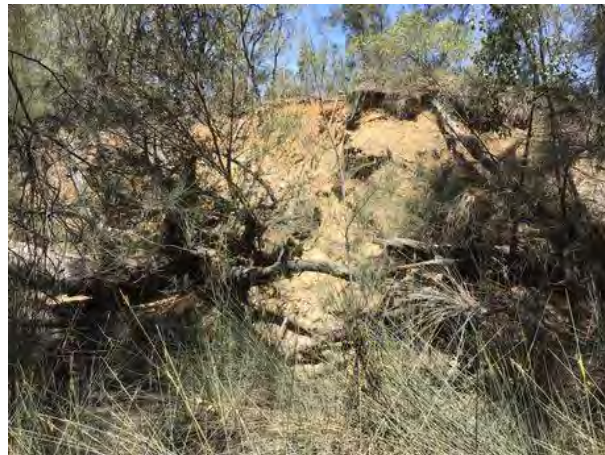
CSIRO Ephemeral Stream Assessment Classification – **Active**

Plate 26 Erosion

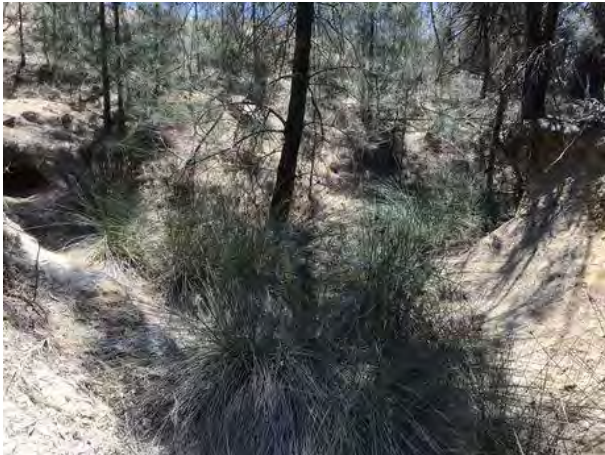
CSIRO Ephemeral Stream Assessment Classification – **Very Active**

Plate 29 Erosion

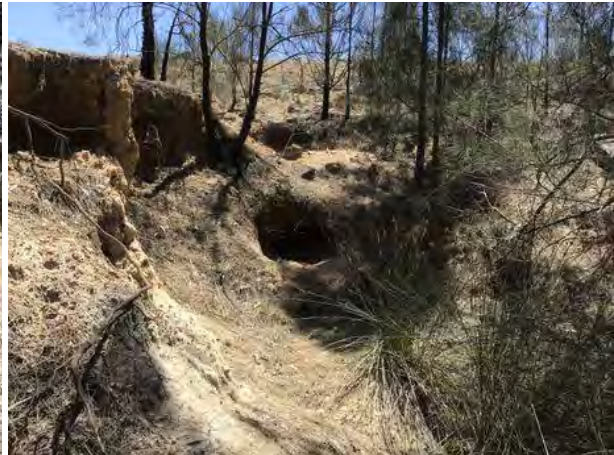
Plate 30 Tunnel Erosion

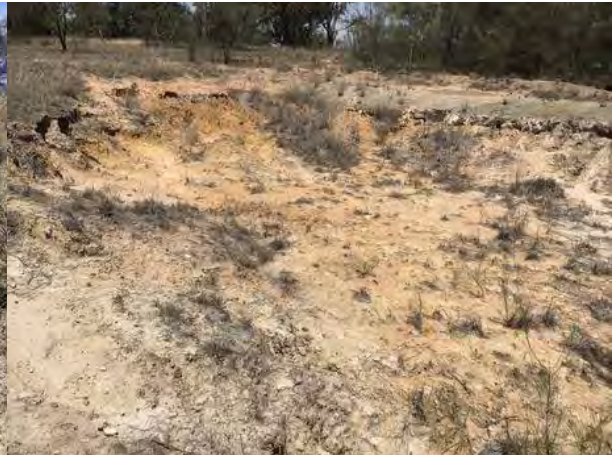
CSIRO Ephemeral Stream Assessment Classification – **Active**

Plate 37 Erosion (top of right bank)

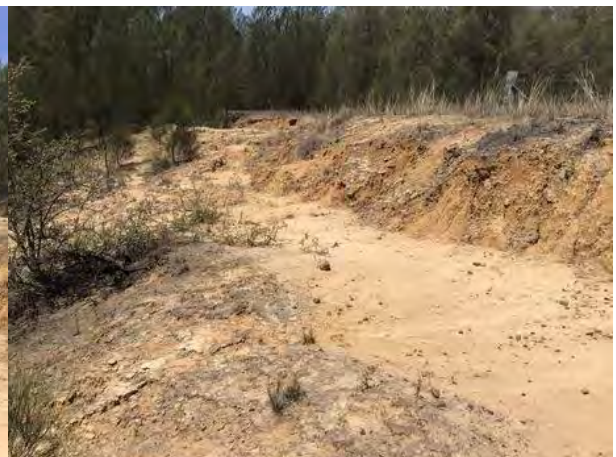
CSIRO Ephemeral Stream Assessment Classification – **Active**

Plate 39 Erosion

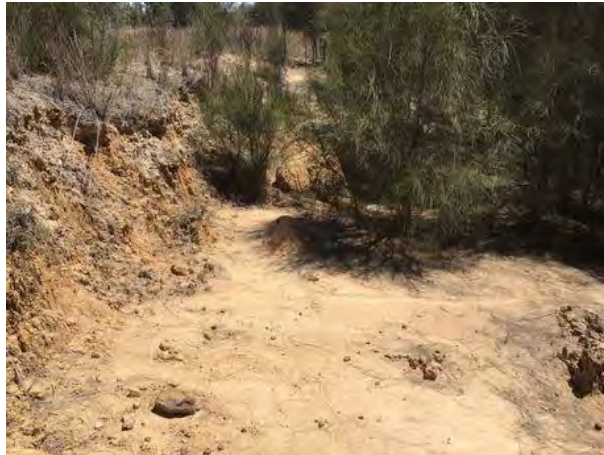
Plate 40 Erosion

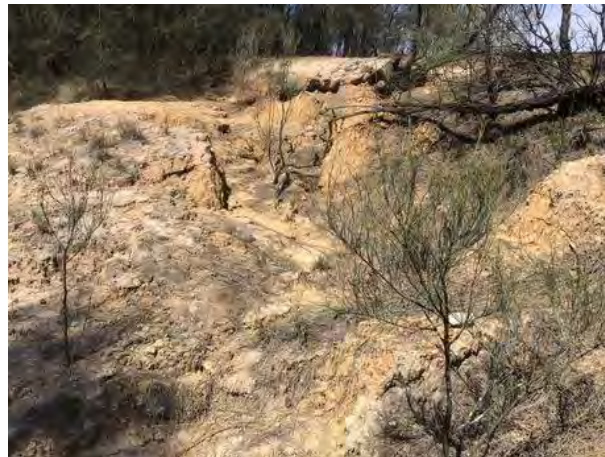
CSIRO Ephemeral Stream Assessment Classification – **Active**

Plate 45 Erosion

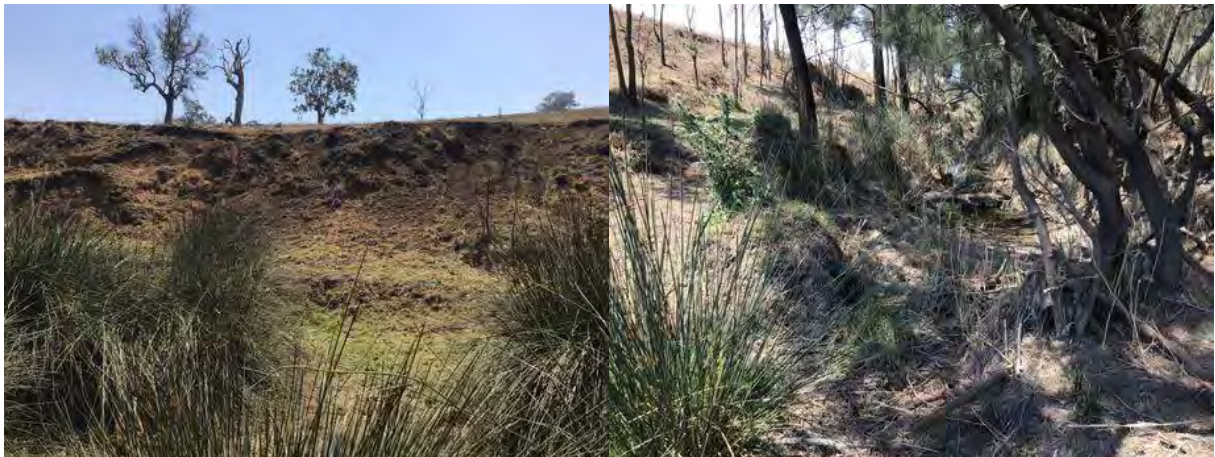
Plate 50 Right Bank

Plate 51 Upstream

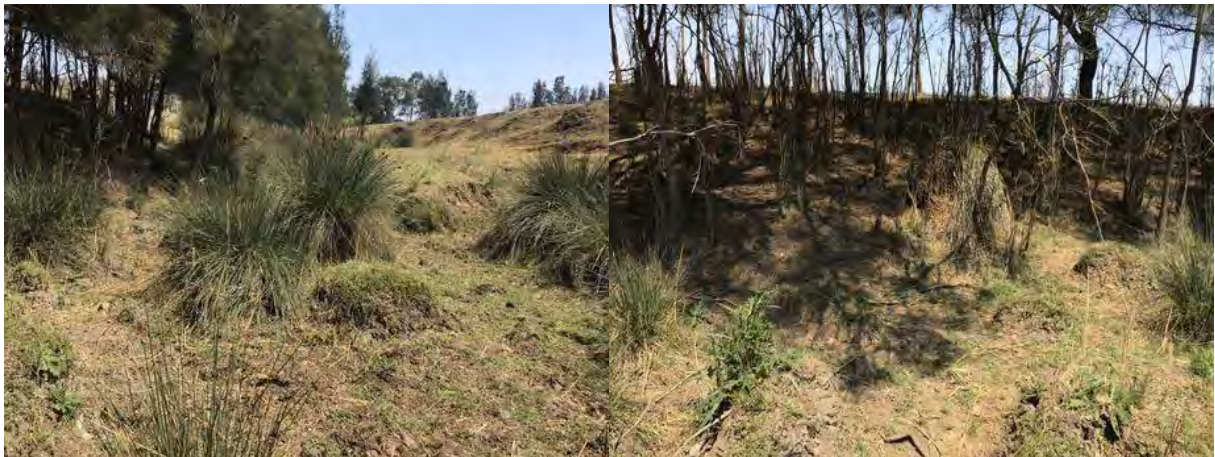
Plate 52 Downstream

Plate 53 Left Bank

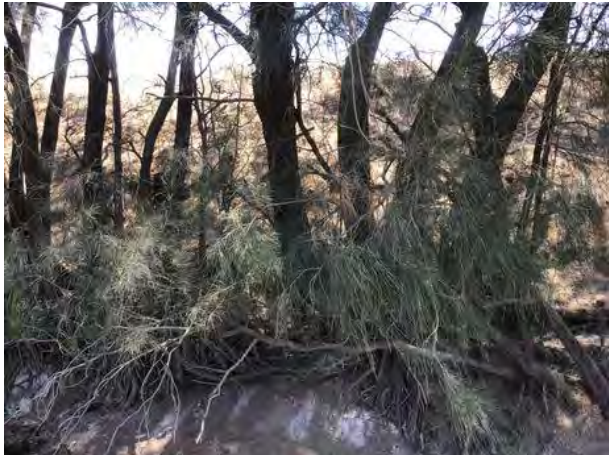
The erosion observed at LC10 is located immediately downstream of a concrete lined chute. The soil is alluvial and non-dispersive. The erosion has been created from scouring of the right bank during large flow events with the upstream chute increasing the velocity of the water to this downstream section of channel. This scouring has exposed some tree roots of some of the trees that line the creek bank. The creek has steep slopes on both banks (approximately 4m high). The creek is generally stable upstream and downstream except for some cattle tracks immediately upstream on the right bank. Limited vegetation exists in the creek bed. Overall, this monitoring location has shown similar conditions to the previous monitoring cycle.

CSIRO Ephemeral Stream Assessment Classification – **Potentially Stabilising**

Plate 54 Right Bank

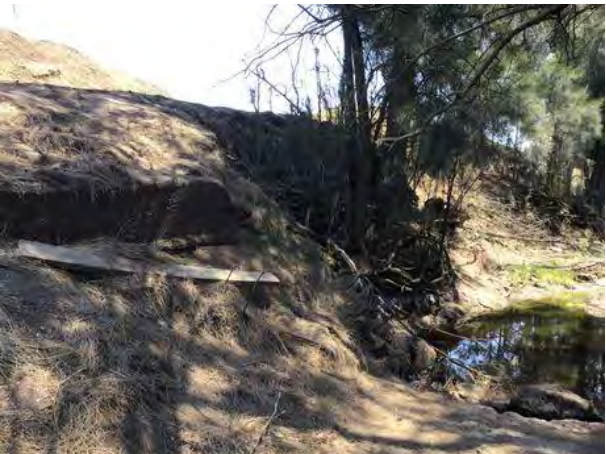
The erosion observed at LC8 included significant erosion of the left bank (approximately 0.8m high with the overall bank at approximately 2.5m high) at a location with a slight meander in the creek as shown on Plate 57. The erosion has some minor undercutting with a section of vertical banks partly stabilised by tree roots. The soil appears to be alluvial and not particularly dispersive. Trees at this location are at risk of falling over due to loss of support. The creek bed and right bank appear to be stable. Overall, this monitoring location has shown similar conditions to the previous monitoring cycle.

Plate 57 Left Bank

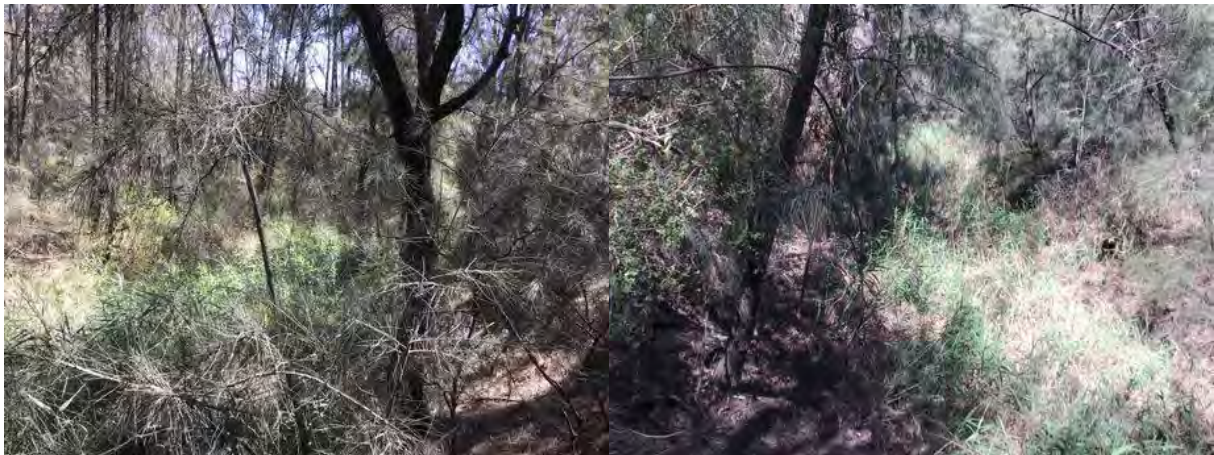
The erosion observed at LC11 includes some significant tunnelling and active erosion on the left bank with exposed vertical dispersive soil. Potential causes for this erosion include wombat holes as well as the presence of a contour bank overflow (which is located immediately upslope of the erosion). Trees were observed on both banks and creek bed. The creek bed and the right bank both show stable conditions. Overall, this monitoring location has shown similar conditions to the previous monitoring cycle.

CSIRO Ephemeral Stream Assessment Classification – **Active**

Plate 58 Upstream

Plate 59 Downstream

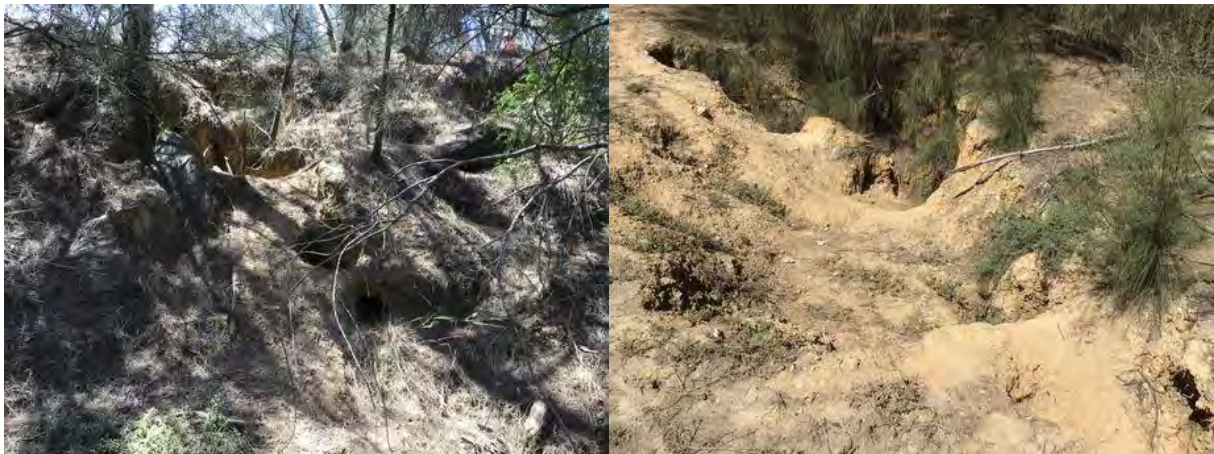
Plate 60 Erosion

Plate 61 Erosion (Top)

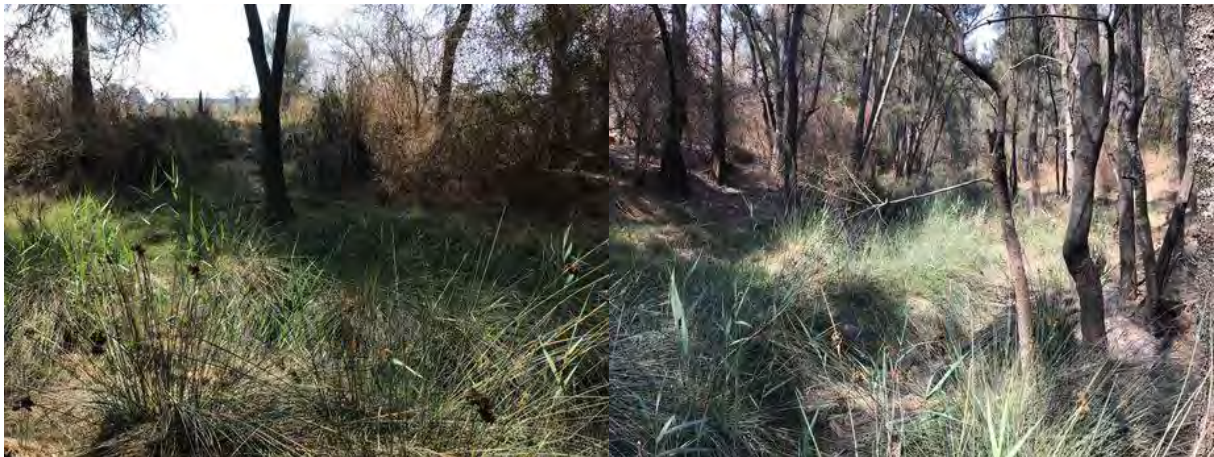
The erosion observed at LC12 includes some erosion (approximately 2m high) on the left bank with exposed vertical dispersive soil. It is likely that this erosion was at least partially caused by a fallen tree at the monitoring point location. The left bank at the monitoring point is significantly higher than the right bank. The creek bed and the right bank both show stable conditions. Overall, this monitoring location has shown similar conditions to the previous monitoring cycle.

Plate 62 Right Bank

Plate 63 Upstream

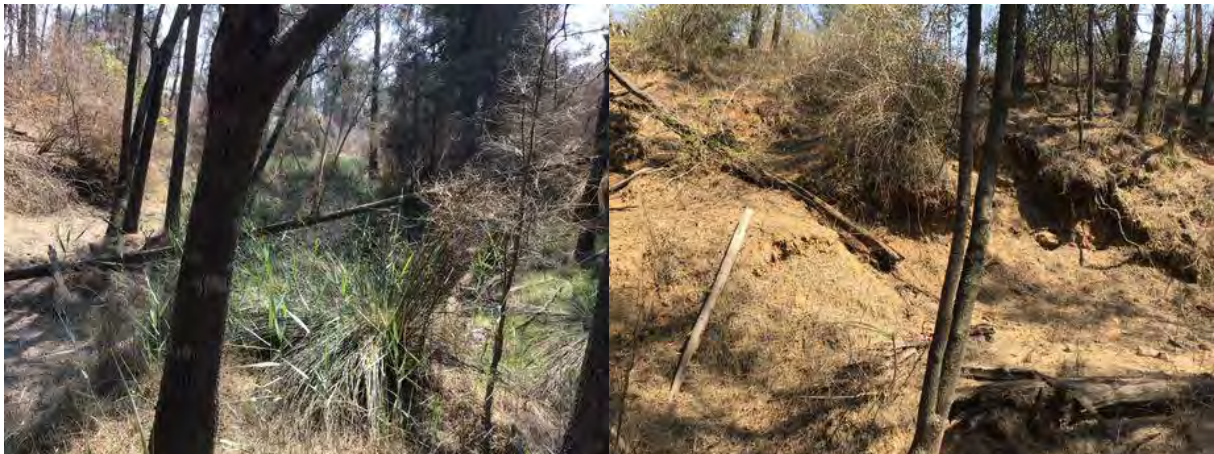
Plate 64 Downstream

Plate 65 Left Bank

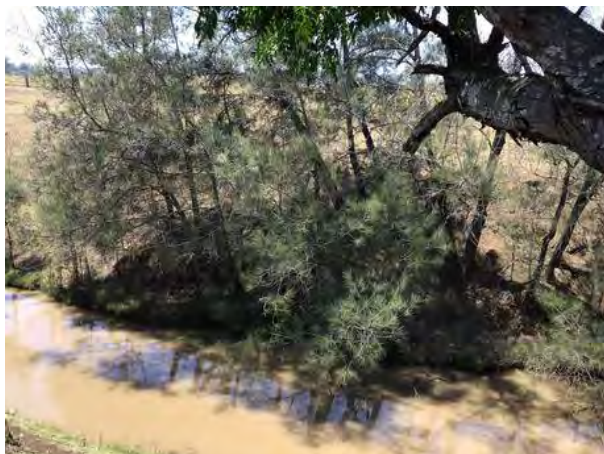
Plate 66 Right Bank

LC13 includes some erosion extending for approximately 5m on the steep left bank with exposed soil which doesn't appear to be highly dispersive. This erosion was most likely caused by livestock tracks observed upstream and downstream of the monitoring location or a localised slope failure. The creek and the right bank both show stable conditions. Overall, this monitoring location has shown similar conditions to the previous monitoring cycle.

CSIRO Ephemeral Stream Assessment Classification – **Active**
