## Mount Thorley Warkworth

### Monthly Meaningful Summary

Environment Protection Licence 1376

April 2017

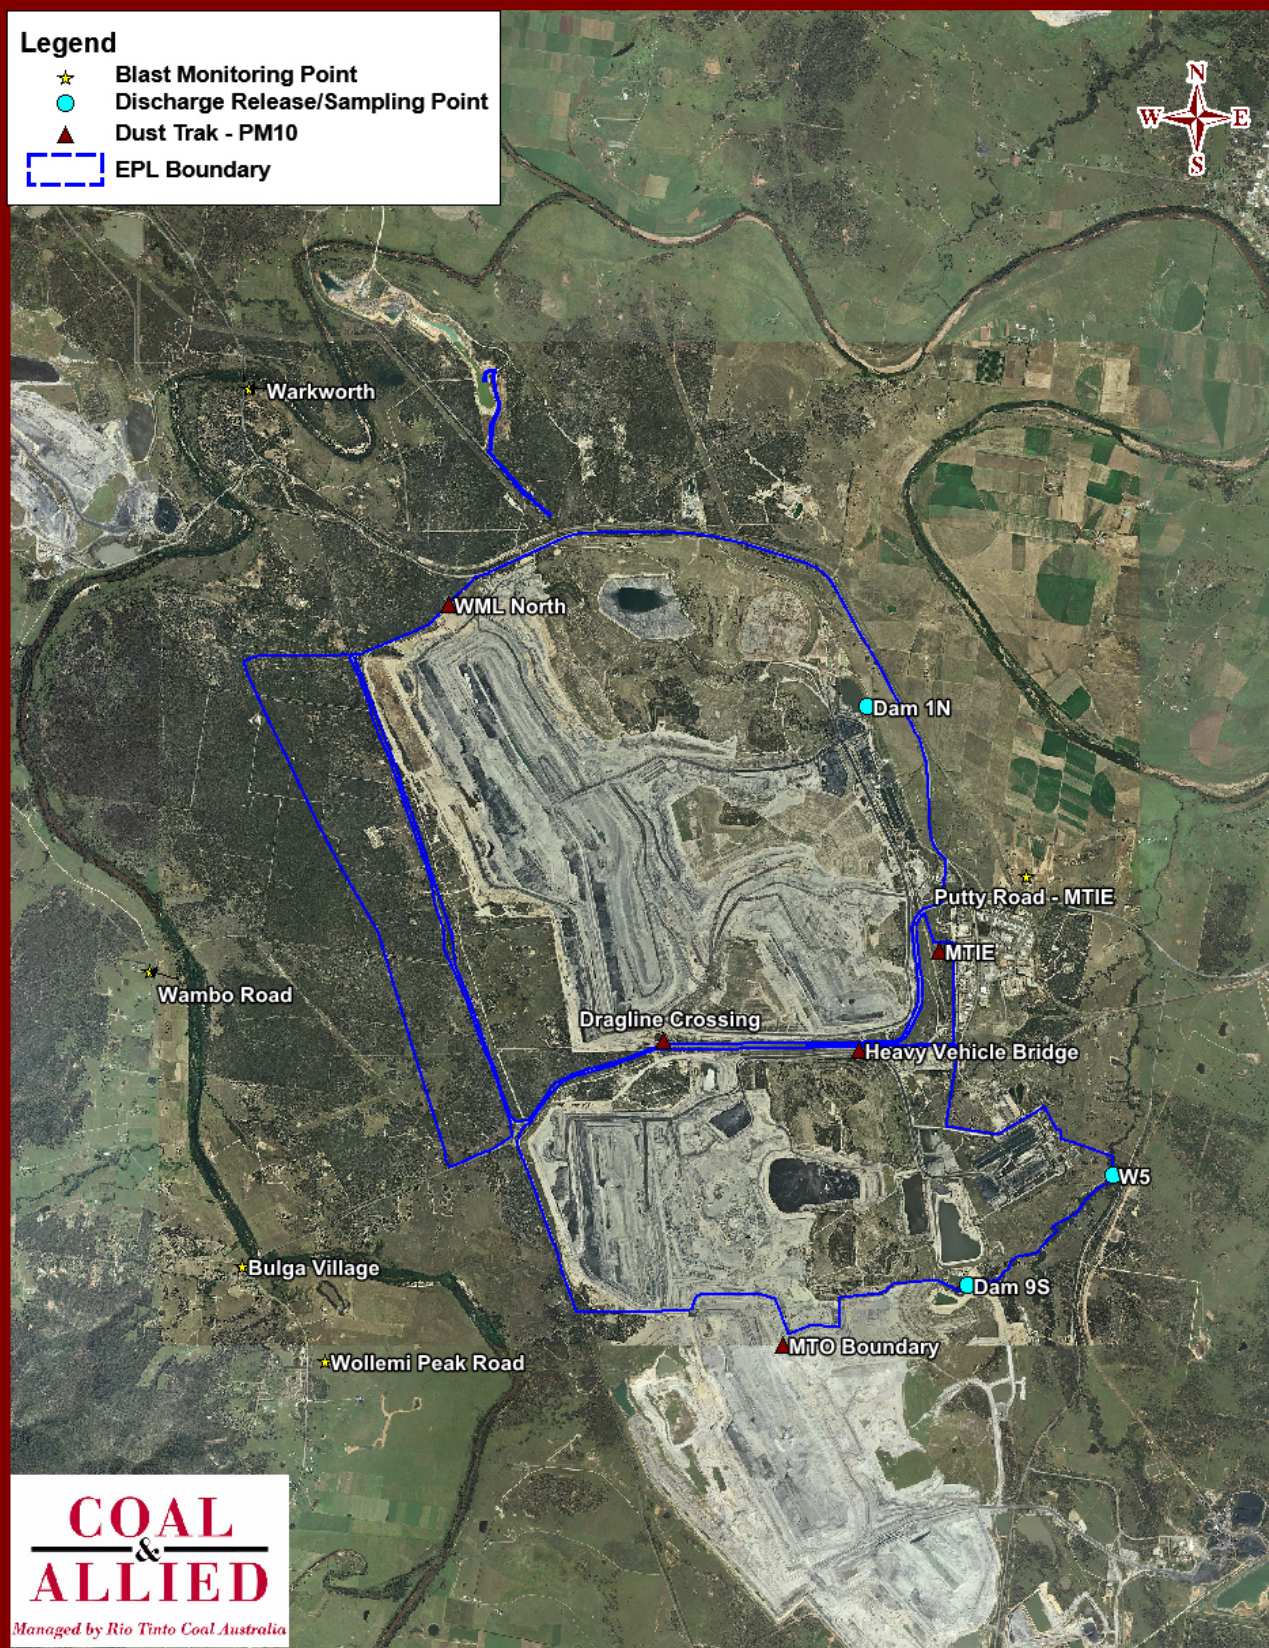
**Figure 1: Mount Thorley Warkworth Environmental Monitoring Locations**

## Environmental Monitoring Locations

- ★ Blast Monitoring Point
- Discharge Release/Sampling Point
- ▲ Dust Trak - PM10
- ▭ EPL Boundary

To monitor regional air quality, MTW operates and maintains a network of 5 Particulate Matter <10µm (PM10) Monitors (DustTrak II) on mine owned land surrounding the mining operations. The location of these monitors can be found in Appendix A – MTW Monitoring Location Plan.

The location of these sampling points can be found in Appendix A – MTW Monitoring Locations Plan.

The location of these monitors can be found in Appendix A – Mount Thorley Warkworth Environmental Monitoring Locations.
