Mount Thorley Warkworth

Monthly Environmental Report

May 2017

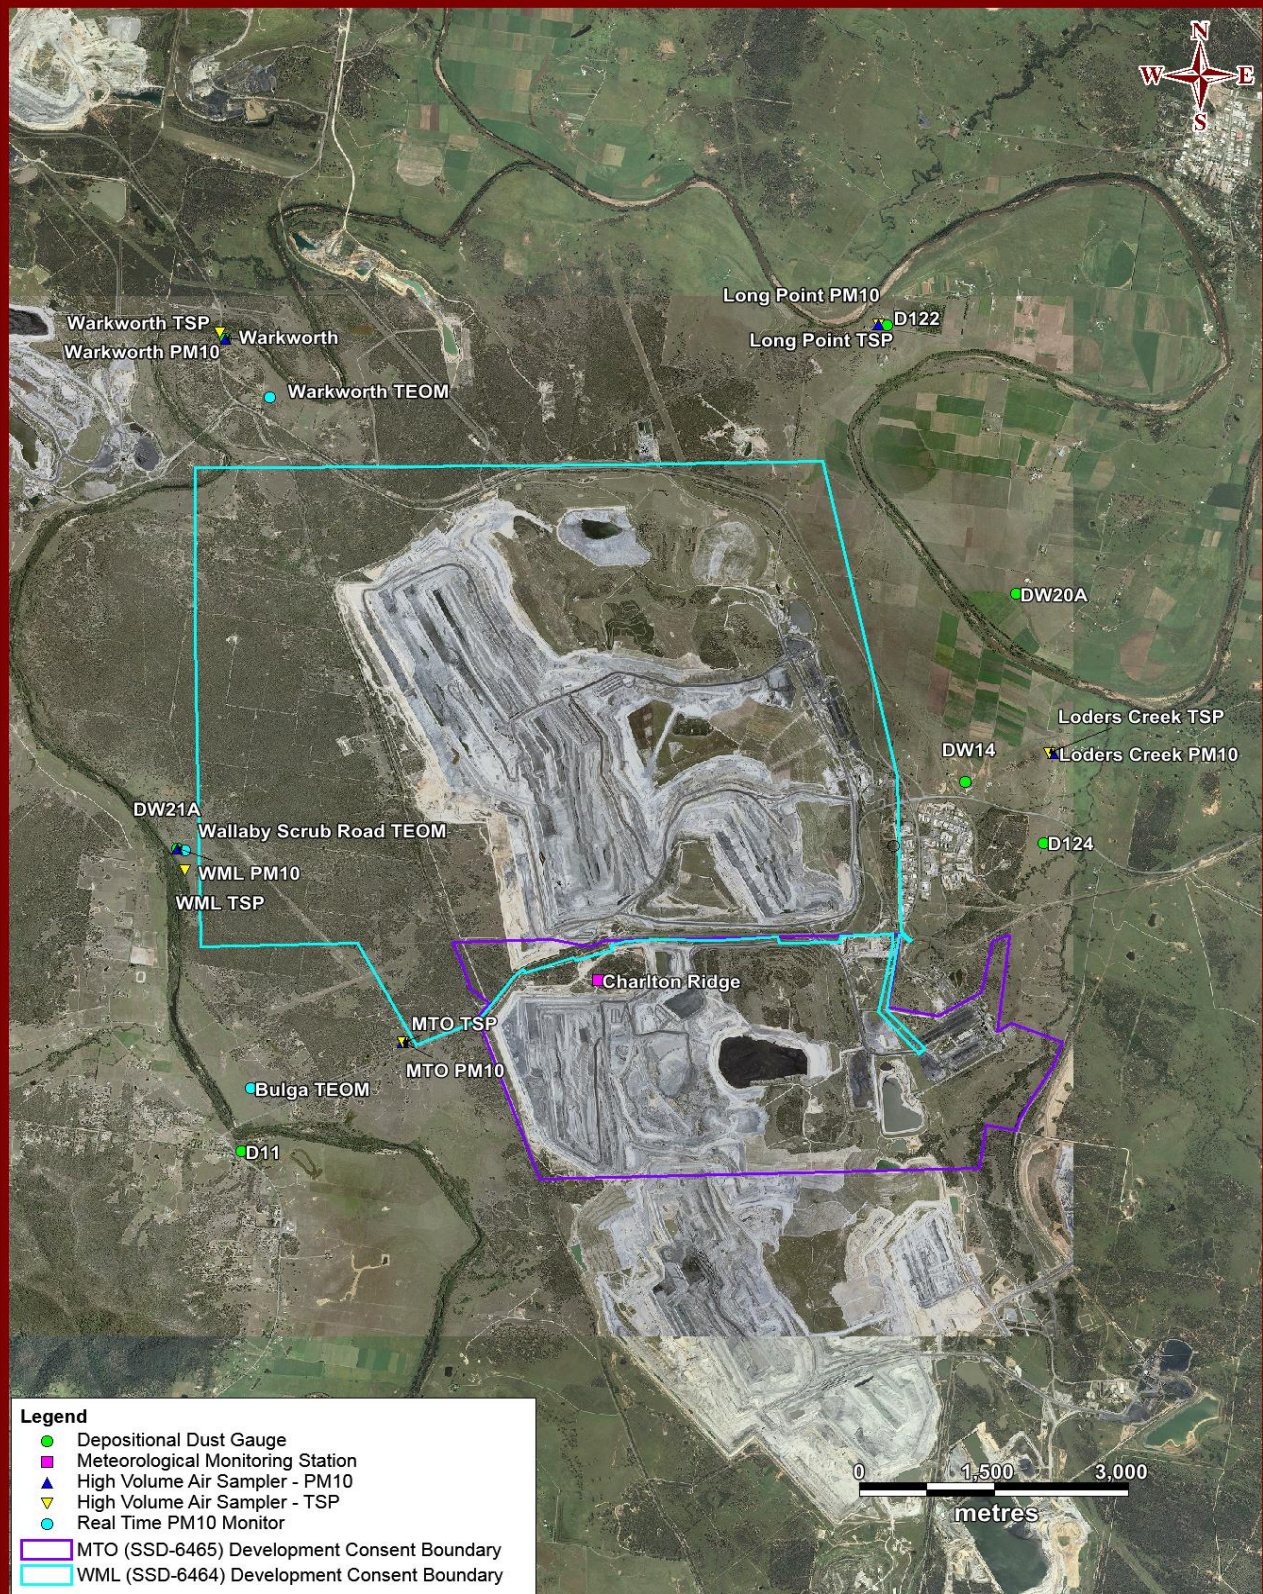
Figure 3: Air Quality Monitoring Locations

Meteorological data is collected at MTW's 'Charlton Ridge' meteorological station (refer to Figure 3: Air Quality Monitoring Locations).

Suspended particulates are measured by a network of High Volume Air Samplers (HVAS) measuring Total Suspended Particulates (TSP) and Particulate Matter <10µm (PM₁₀). The location of these monitors can be found in Figure 3. Each HVAS was run for 24 hours on a six-day cycle in accordance with EPA requirements.

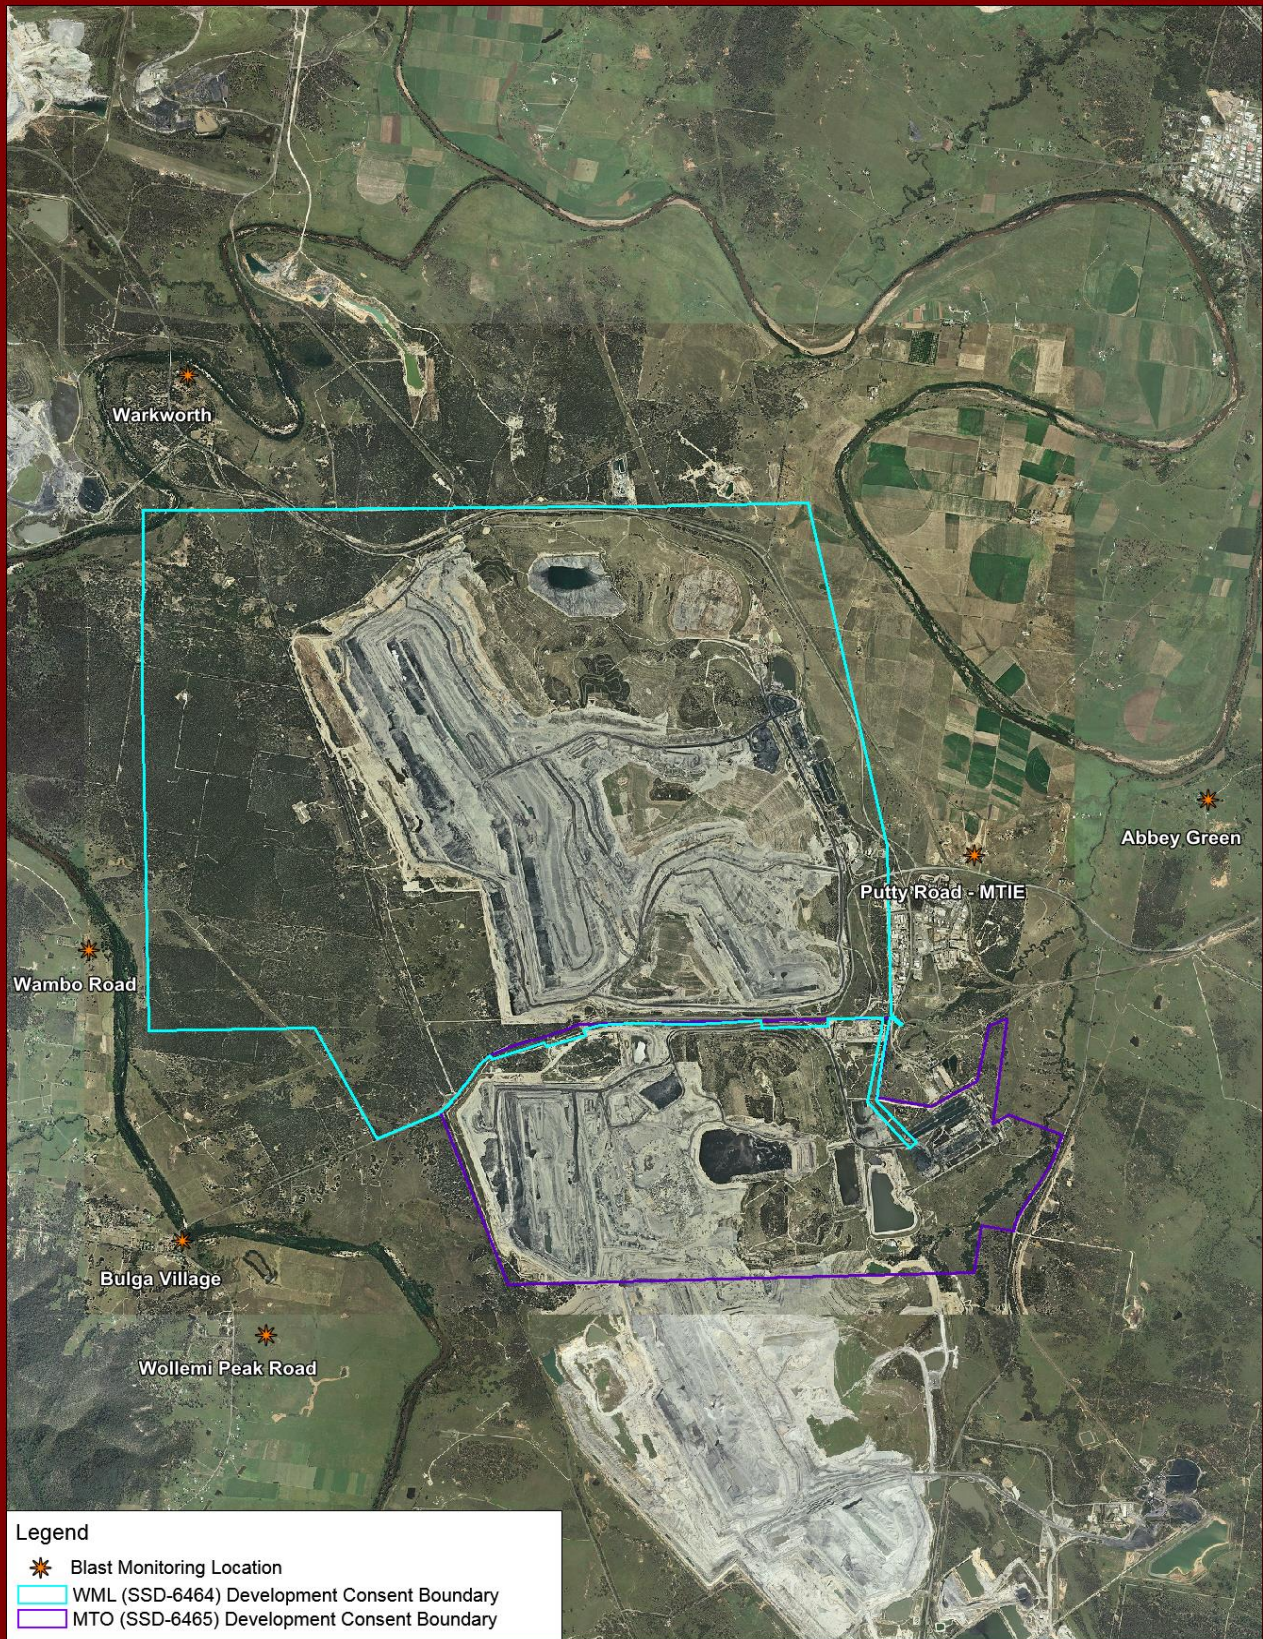
Figure 15: MTW Blast Monitoring Location Plan

MTW have a network of six blast monitoring units. These are located at nearby privately owned residences and function as regulatory compliance monitors.

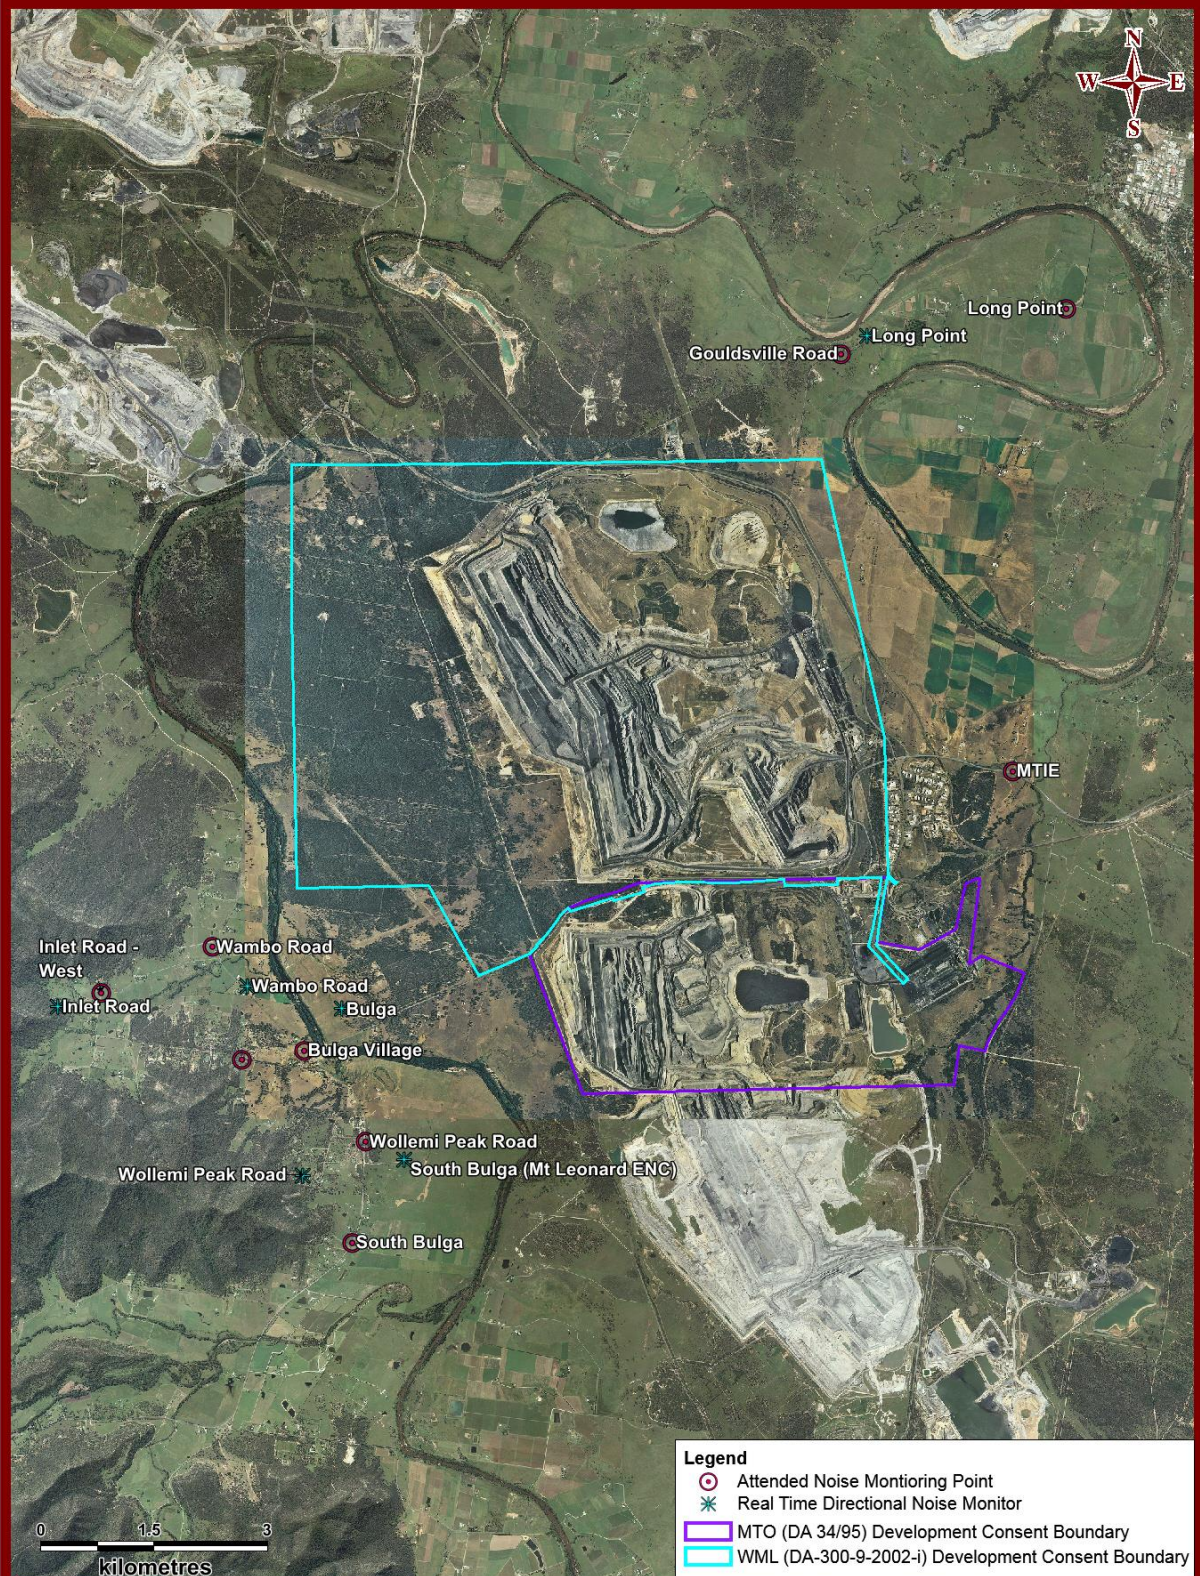
Figure 16: Noise Monitoring Location Plan

Routine attended noise monitoring is carried out in accordance with the MTW Noise Management Plan. A review against EIS predictions will be reported in the Annual Review. The purpose of the noise surveys is to quantify and describe the acoustic environment around the site and compare results with specified limits. Real time noise monitoring also occurs at nine sites surrounding MTW. Noise monitoring locations are displayed in Figure 16.
